SCI/NASS COMBINATION SIDE IMPACT INFLATABLE OCCUPANT PROTECTION REPORT

CASE NUMBER - NASS-2003-50-110C

VEHICLE - 2000 BMW 323i

CRASH DATE - December 2003

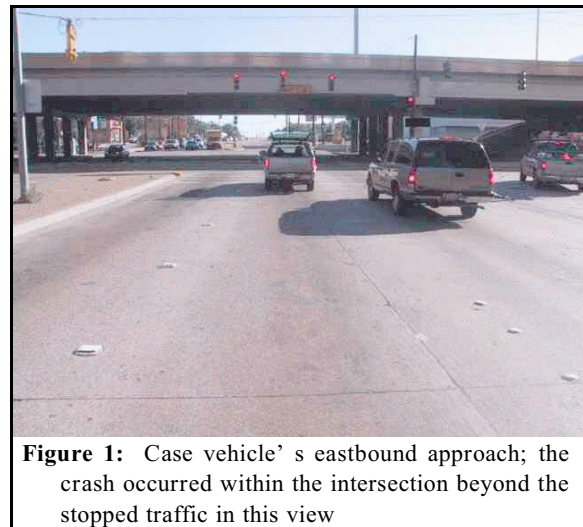
Figure 1: Case vehicle's eastbound approach; the crash occurred within the intersection beyond the stopped traffic in this view

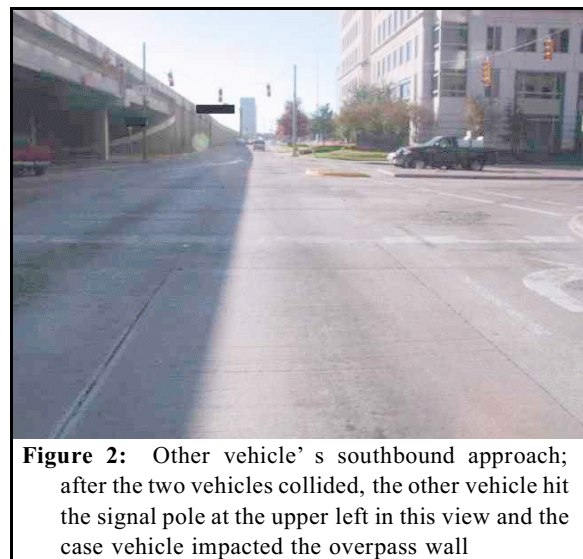
Figure 2: Other vehicle's southbound approach; after the two vehicles collided, the other vehicle hit the signal pole at the upper left in this view and the case vehicle impacted the overpass wall

toward the southeast. The other vehicle's front right corner impacted a traffic signal pole on a traffic island. The other vehicle rotated approximately 90 degrees clockwise and came to rest in the roadway, heading southwest. The case vehicle mounted the traffic island's curb, crossed the island, crossed a channelized turn lane, ran off road at the southeast corner of the intersection and its front impacted a concrete wall. The case vehicle came to rest against the wall heading southeast.

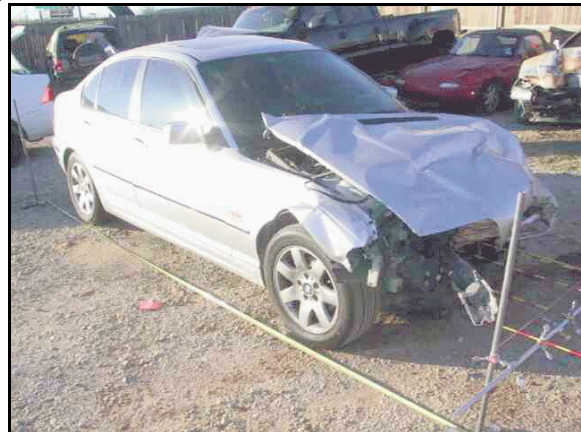
The case vehicle sustained direct contact damage across its entire front from the first impact with the other vehicle (event #1) and subsequently sustained a second frontal impact with a concrete wall (event #4), resulting in overlapping damage (Figures 3 and 4). The front bumper, grille, headlamp assemblies and both fenders were crushed rearward. The hood was displaced, with the front folded down and crushed rearward. Maximum crush was measured as 45 centimeters [17.7 inches] on the bumper near the center, where the case vehicle contacted the other vehicle's right front wheel assembly. The wheelbase was shortened 4 centimeters [1.6 inches] on the left and 3 centimeters [1.2 inches] on the right. None of the tires were deflated or restricted. The windshield had a star-pattern crack on the left above the steering wheel, probably a result of occupant contact, and stress cracking on the right, probably a result of the hood being pushed rearward. The left rear window glazing was disintegrated due to the left side impact (discussed below), and there was no other glazing damage.

Figure 3: Case vehicle's front and right; note, overlapping damage from two impacts on the front

The CDC for the case vehicle's first frontal impact (event #1, with the other vehicle) was determined to be **10-FDEW-3 (310)**. For the second frontal impact (event #4, with the concrete wall), a partial CDC was assigned as **12-FDEW-? (10)**, with the extent zone unknown due to multiple impacts in the same area. Because of the overlapping damage on the case vehicle and overlapping damage on the other vehicle, a WinSMASH reconstruction was not possible. The NASS investigator estimated that the first frontal impact was of moderate severity (24-40 km.p.h. [15-25 m.p.h.]) for the case vehicle, with the second frontal impact's severity unknown.

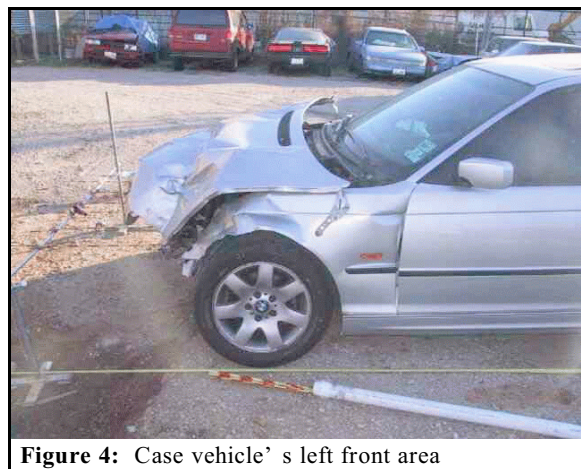
Figure 4: Case vehicle's left front area

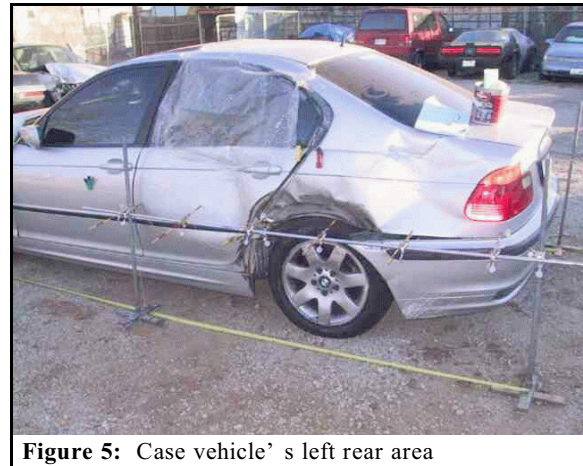
Immediately following the first impact with the pickup, the case vehicle rotated clockwise while the pickup rotated counterclockwise and the left rear of the case vehicle (**Figure 5**) impacted the right rear of the pickup. The pickup was equipped with dual rear wheels with rear fenders made of plastic/fiberglass projecting out from the pickup's bed. The case vehicle sustained direct contact on the left rear door, wheel well and rear overhang. The damage pattern shows that the case vehicle's wheel well impacted the pickup's rear tire, with a circular imprint and rubber transfer around the perimeter of wheel well. The case vehicle also contacted the pickup's very large fender, with crush on the case vehicle fore and aft of the wheel well and the left rear door window glazing shattered. Direct contact was measured as 101 centimeters [39.8 inches] and the crush profile was measured as 181 centimeters [71.3 inches] with maximum crush 4 centimeters [1.6 inches] along the top edge of the wheel well.

Figure 5: Case vehicle's left rear area

The CDC for the case vehicle's left rear impact (event #2) was determined to be **09-LZEW-2 (270)**. The WinSMASH reconstruction program was used on this impact. Because the body parts on the other vehicle were plastic/fiberglass and its crush profile could not be measured, this reconstruction was based on the CDC-only algorithm. The total, longitudinal and lateral deltaVs are, respectively: 6 km.p.h. [3.7 m.p.h.], + 1 km.p.h. [+ 0.6 m.p.h.] and + 6 km.p.h. [+ 3.7 m.p.h.]. This is a borderline reconstruction and the results appear low, but the case vehicle's second impact was certainly of minor severity (1-13 km.p.h. [1-8 m.p.h.]).

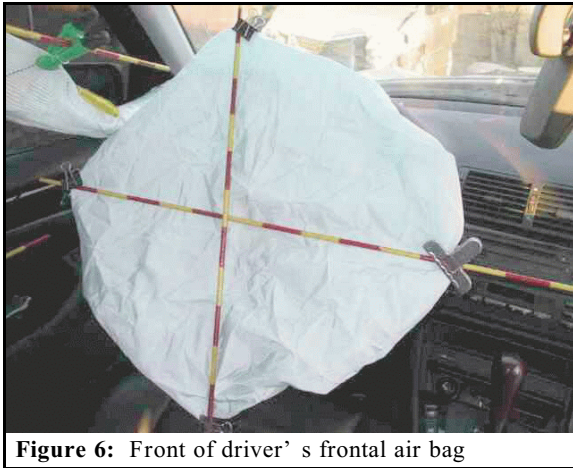
The driver's frontal air bag was mounted in the steering wheel hub, with the module cover flaps in the H configuration (**Figures 6 and 7**). The upper and lower cover flaps both measured 15.5 centimeters [6.1 inches] horizontally and 9 centimeters [3.5 inches] vertically. The deployed

driver's air bag was round with a diameter of 60 centimeters [23.6 inches]. The cover flaps opened at the tear points and there was no evidence of damage to the air bag, the cover flaps or the adjacent structures. The driver's air bag did not have any tethers and there was one vent port, of unknown size, at the 12:00 o' clock position on the back of the air bag. There was no evidence of occupant contact, nor any other marks, on the driver's frontal air bag.

Figure 6: Front of driver's frontal air bag

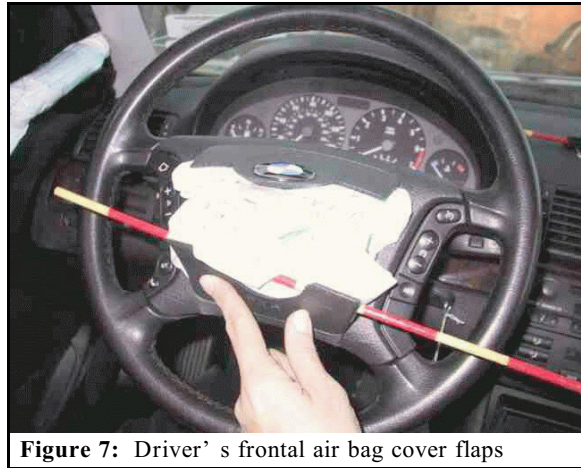
Figure 7: Driver's frontal air bag cover flaps

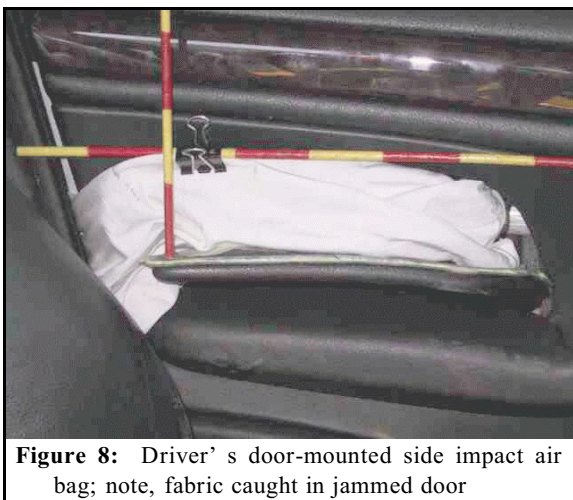
The driver's side impact air bag was mounted in the driver's door arm rest with the top surface of the arm rest serving as the module cover flap (**Figures 8 and 9**). The cover flap measured 24 centimeters [9.4 inches] longitudinally and 9 centimeters [3.5 inches] laterally, with the hinge along the inboard edge of the arm rest. The cover flap opened at the tear points and there was no evidence of damage to the cover flap or the adjacent structures. At the time of the inspection, the air bag was caught in the door and the door was jammed shut such that the air bag could not be pulled free for complete examination. (The NASS investigator indicated that the air bag must have gotten caught in the door when someone gained access to the vehicle post-crash, and there was no evidence of any malfunction of the air bag during deployment.) A complete inspection was not possible. The investigator indicated that the air bag measured 32 centimeters

Figure 8: Driver's door-mounted side impact air bag; note, fabric caught in jammed door

[12.6 inches] longitudinally. The air bag's shape is unknown, there were no tethers and no vent ports. There was no evidence of occupant contact, nor any other marks, on the parts of the air bag that could be examined.

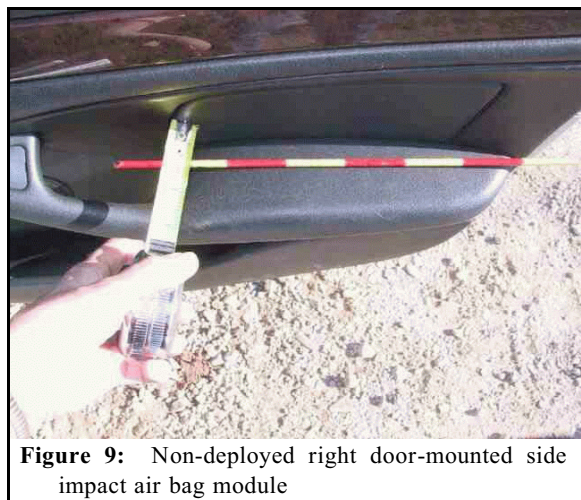
Figure 9: Non-deployed right door-mounted side impact air bag module

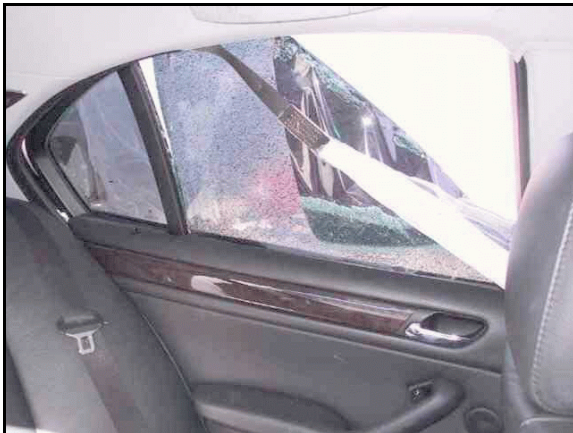
The driver's tubular head protection air bag was mounted in the left roof rail (**Figures 10 and 11**). The air bag deploys through the seam where the side trim panels meet the roof headliner and there is no cover flap. The seam opened at the tear points and there was no evidence of damage to the air bag or the adjacent structures. The deployed tubular air bag measured 125 centimeters [49.2 inches] longitudinally and was circular in profile with a diameter of 12 centimeters [4.7 inches]. There were no internal tethers or vent ports. The forward end of the air bag was tethered to the base of the upper A-pillar and the rearward end was tethered to the top of the C-pillar. There was no evidence of occupant contact, nor any other marks, on the air bag.

Figure 10: Rear portion of left roof rail-mounted tubular head protection air bag

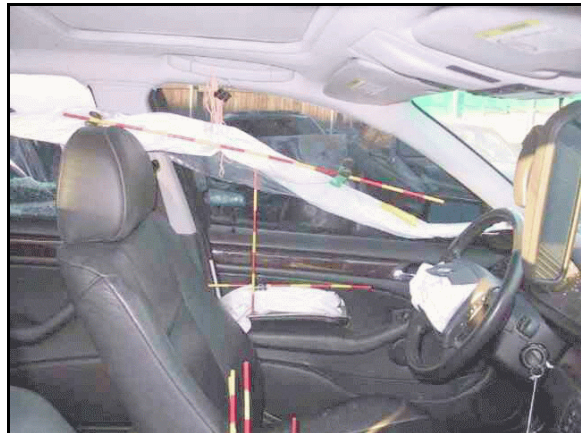
Figure 11: Front portion of left roof rail-mounted tubular head protection air bag

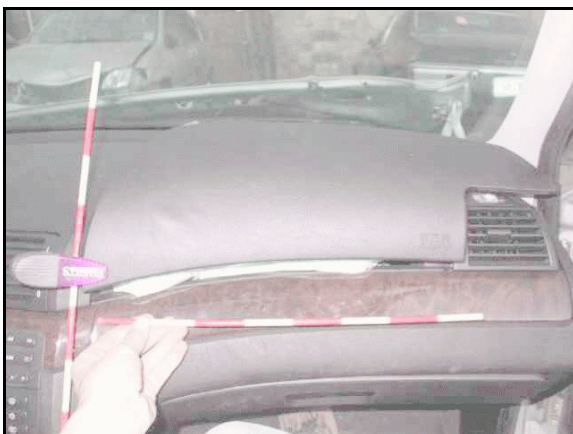
The front right passenger's frontal air bag was located in the top of the right instrument panel. The single module cover flap was irregular in shape, with the left edge curved, the right edge sculpted to fit around a vent port and the hinge on the forward (top) edge (**Figure 12**). The

Figure 12: Front right module cover flap

cover flap' s overall dimensions were measured as 51 centimeters [20 inches] horizontally and 21 centimeters [8.3 inches] vertically. The cover flap opened at the tear points and there was no evidence of damage to the air bag, the cover flap or the adjacent structures. The deployed front right passenger' s frontal air bag was rectangular (**Figure 13**), measuring 53 centimeters [20.9 inches] horizontally and 60 centimeters [23.6 inches] vertically. There were two vent ports, at the 10:00 o' clock and 2:00 o' clock locations, and no tethers. There was no evidence of occupant contact nor any other marks on the air bag.

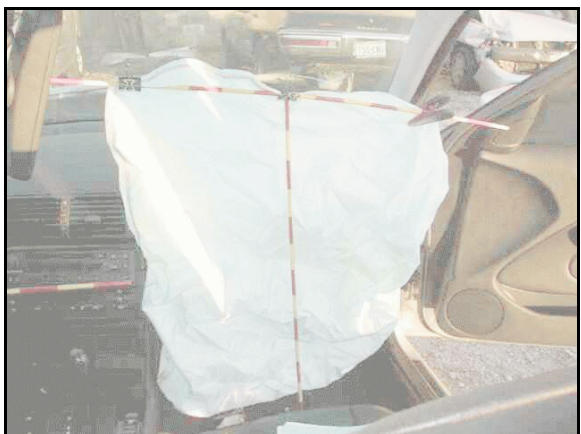
Figure 13: Front of front right air bag

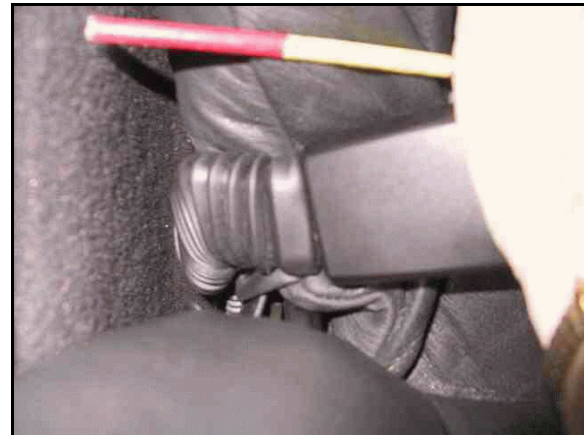
Figure 15: Passenger' s actuated pretensioner; note, buckle stalk deformed; see also Figure 14

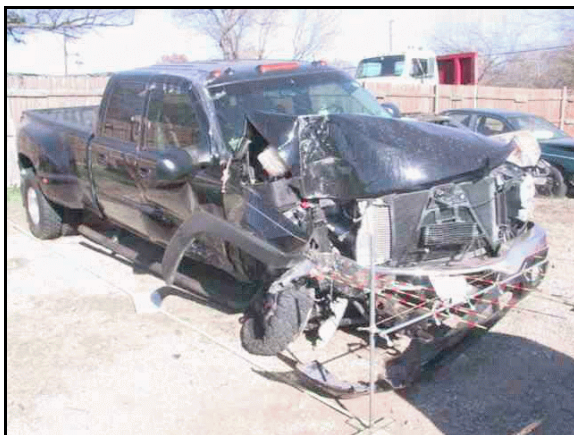
Figure 16: Other vehicle, showing overlapping damage at front right corner area

The first and third events caused overlapping damage (**Figures 16, 17 and 18**). The right

front wheel assembly/axle was broken with the wheel bent inward at the top. Direct contact extended rearward along the fender and onto the front right door. The crush profile was measured as 186 centimeters [73.2 inches] long, with maximum crush 12 centimeters [4.7 inches] low on the door, slightly aft of the A-pillar. The CDC for the first impact was determined to be **01-RYEW-3 (40)**. Because of overlapping damage on the Sierra and on the case vehicle, a reconstruction was not possible. The NASS investigator estimated that the first impact was of moderate severity (24-40 km.p.h. [15-25 m.p.h.]) for the Sierra.

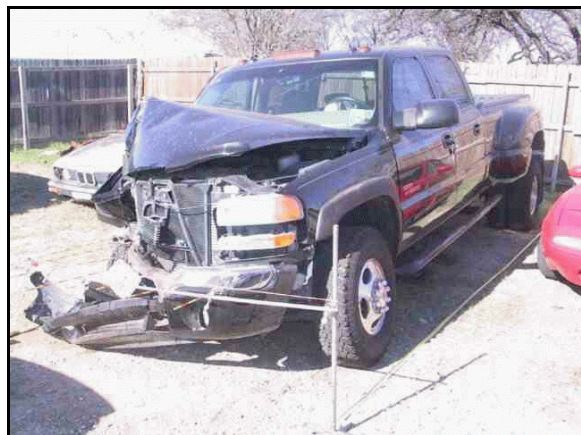
Figure 17: Other vehicle, front and left side, showing front damage

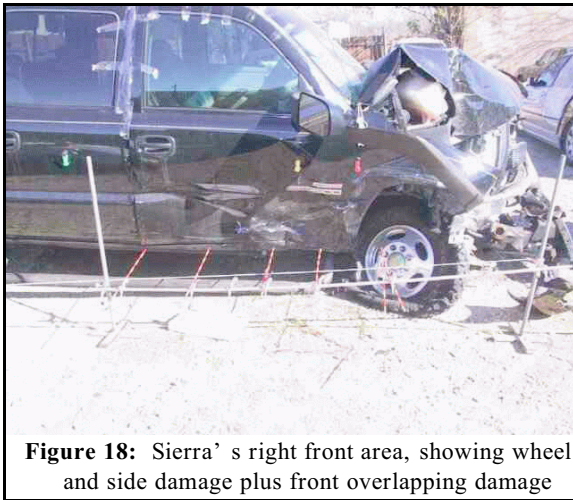
Figure 18: Sierra's right front area, showing wheel and side damage plus front overlapping damage

The impact with the pole (event #3) involved the Sierra's front right corner area. Direct contact was measured as 21 centimeters [8.3 inches] wide, with maximum crush measured as 72 centimeters [28.3 inches] slightly inboard from the right bumper corner. The CDC for the third event was determined to be **12-FREE-3 (0)**. The WinSMASH reconstruction program, barrier algorithm based on the measured frontal profile, was used on the pole impact. The total, longitudinal and lateral deltaVs are, respectively: 28 km.p.h. [17.4 m.p.h.], -28 km.p.h. [-17.4 m.p.h.] and 0 km.p.h. [0 m.p.h.]. This is a borderline reconstruction because of the overlapping damage at the right front corner, but the results appear reasonable. The pole impact was of moderate severity (24-40 km.p.h. [15-25 m.p.h.]) for the Sierra.

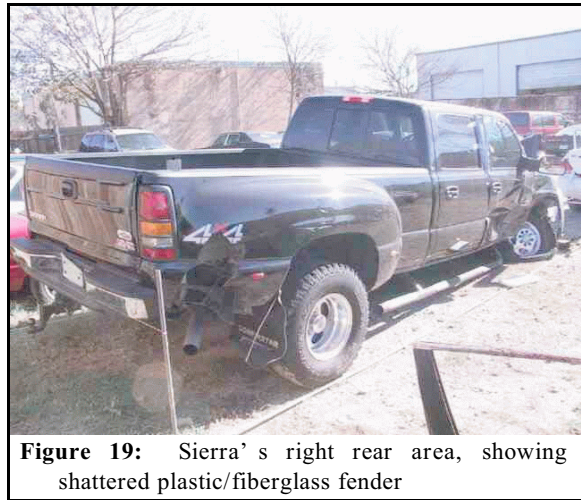
The second event (**Figure 19**) involved the Sierra's right rear tandem wheel assembly and fender. The fender was made of plastic/fiberglass and portions of the fender shattered and broke away such that a crush profile could not be obtained. The CDC for the side slap was determined to be **03-RBEW-1 (90)**. The WinSMASH reconstruction program was used on this impact. Because the crush profile could not be measured, this reconstruction was based on the CDC-only algorithm. The total, longitudinal and lateral deltaVs for the Sierra are, respectively: 3 km.p.h. [1.9 m.p.h.], 0 km.p.h. [0 m.p.h.] and -3 km.p.h. [-1.9 m.p.h.]. This is a borderline reconstruction and the results appear low, but the Sierra's second impact was certainly of minor severity (1-13 km.p.h. [1-8 m.p.h.]).

Figure 19: Sierra's right rear area, showing shattered plastic/fiberglass fender

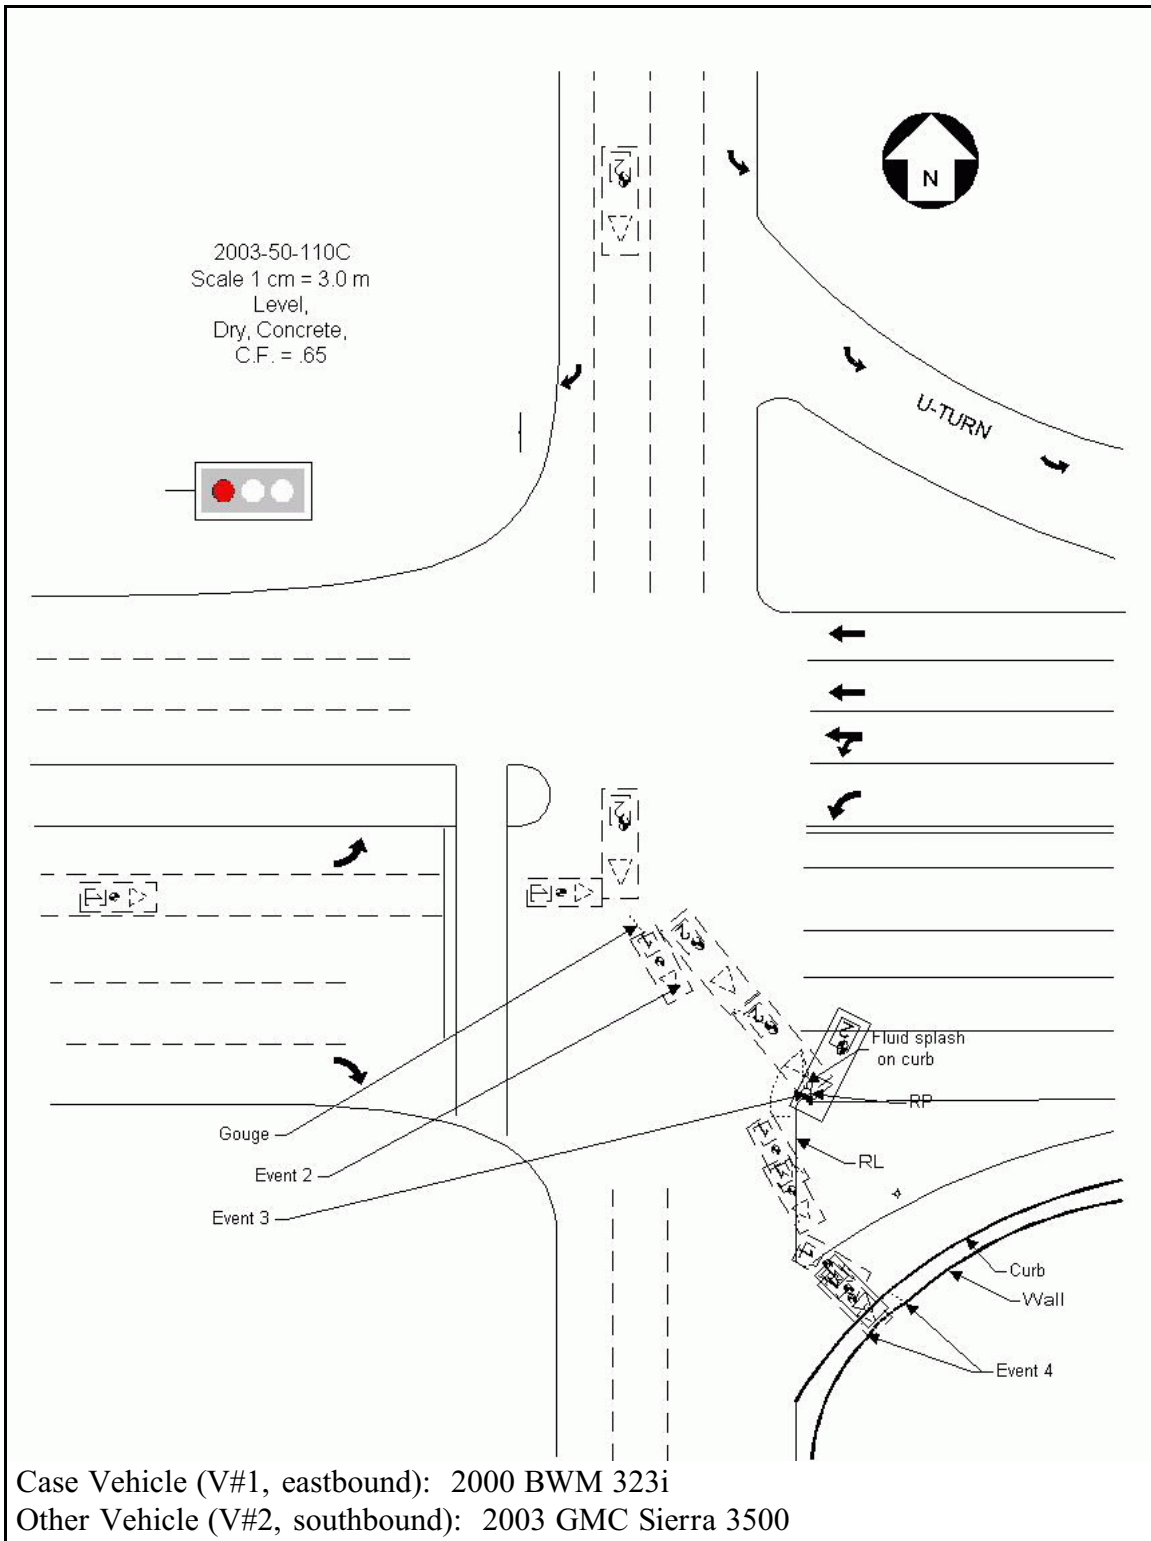
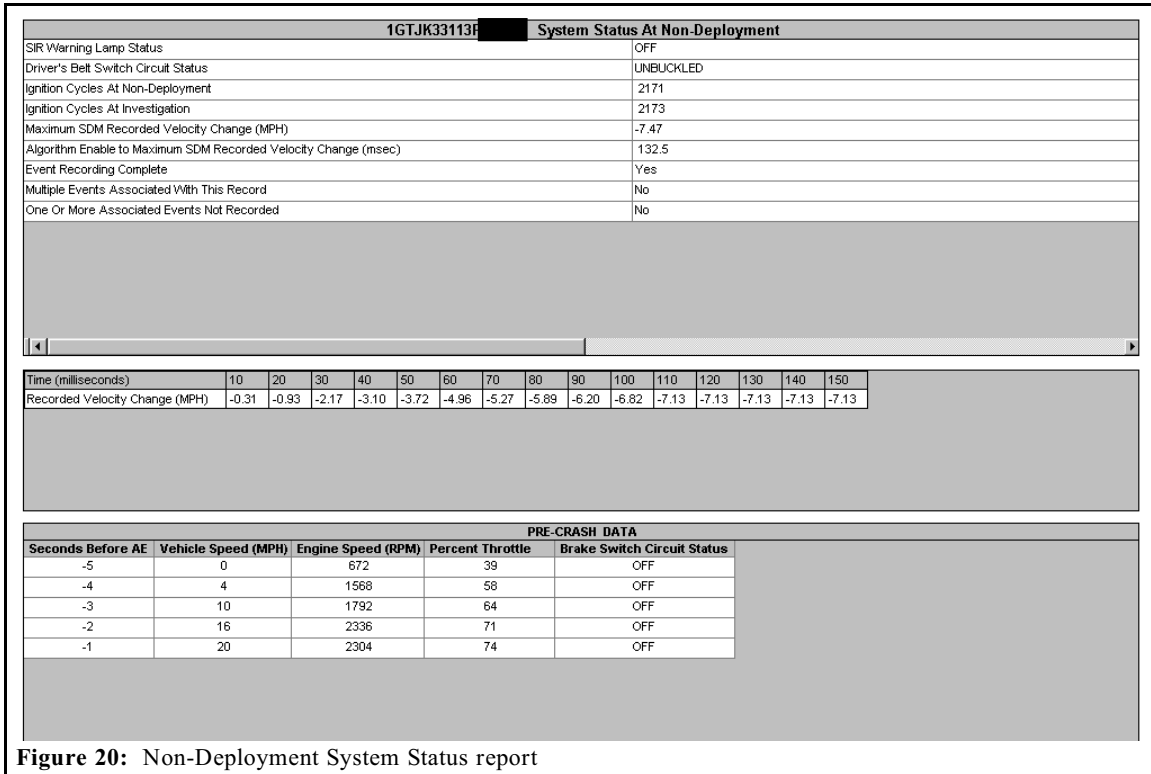
Figure 20: Non-Deployment System Status report

The System Status at Non-Deployment (**Figure 20**) and System Status at Deployment (**Figure 23**) reports indicate that both events were recorded on ignition cycle 2,171 and the download was accomplished on ignition cycle 2,173. On both reports, the warning lamp is reported as off, indicating no faults in the automatic restraint system, and the driver' s safety belt is reported as unbuckled. The Deployment report indicates that there were 1.2 seconds between the non-deployment and the deployment events. The non-deployment event was the first harmful event in the NASS case (front of case vehicle into right side of Sierra) and the deployment event was event #3 in the NASS case (front of Sierra into a non-breakaway pole).

The Non-Deployment Pre-Crash data and graph (**Figures 20 and 21**) indicate that the Sierra was stopped, with engine rpms at idle speed and the brake light circuit open at approximately 5 seconds prior to the non-deployment algorithm enable (AE). The Sierra' s driver apparently accelerated, with throttle percentage, engine rpms and travel speed increasing over the next four seconds. The Sierra was traveling 32 km.p.h. [20 m.p.h.] with 74 percent throttle and no braking at approximately one second prior to the non-deployment AE. The Non-Deployment Velocity Change data and graph (**Figures 20 and 22**) show a gradual drop to -11.5 km.p.h. [-7.13 m.p.h.] at 150 milliseconds [0.15 seconds] after AE. The maximum recorded longitudinal velocity change for the non-deployment event is reported as 12.0 km.p.h. [-7.47 m.p.h.] at 132.5 milliseconds [0.1325 seconds] after AE.

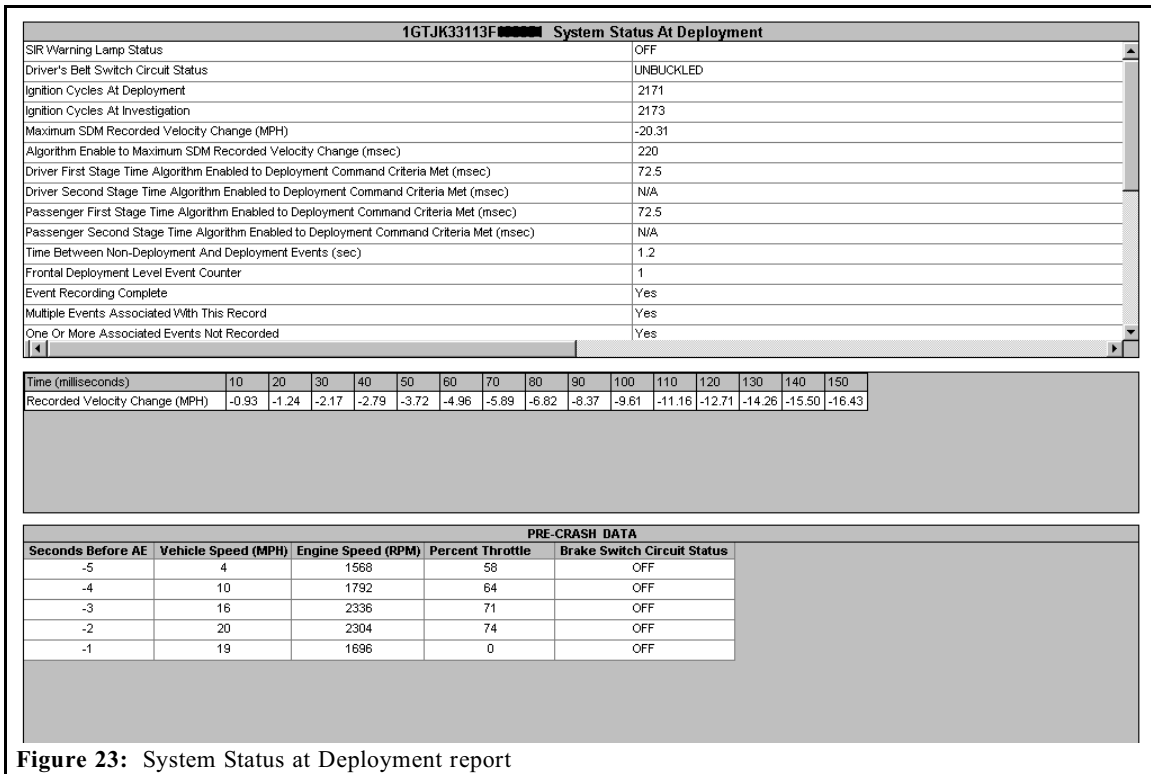
Figure 23: System Status at Deployment report

The Deployment Pre-Crash data and graph (**Figures 23 and 24**) repeat the non-deployment pre-crash data, with one additional data point added (i.e., the deployment pre-crash recording for -5 through -2 seconds is identical to the non-deployment data for -4 through -1 seconds). For the last one second interval prior to AE for the deployment event, the throttle dropped to zero percent input, engine rpms dropped proportionally, travel speed declined to 30.6 km.p.h. [19 m.p.h.] and the brake light circuit remained open. The System Status at Deployment report (**Figure 23**) indicates that first stage deployment of the driver and front right passenger air bags was commanded at 72.5 milliseconds [0.0725 seconds] after AE for the deployment event. The report also indicates that second stage deployment was not commanded. The Deployment Velocity Change data and graph (**Figures 23 and 25**) show a steady drop to -26.4 km.p.h. [-16.43 m.p.h.] at 150 milliseconds [0.15 seconds] after AE, after which the recording ceased. The maximum longitudinal velocity change is reported as -32.7 km.p.h. [-20.31 m.p.h.] at 220 milliseconds [0.22 seconds] after AE.
