### SCI/NASS COMBINATION SIDE IMPACT INFLATABLE OCCUPANT PROTECTION REPORT

CASE NUMBER - NASS-2003-72-078K

VEHICLE - 2003 AUDI QUATTRO

CRASH DATE - July 2003

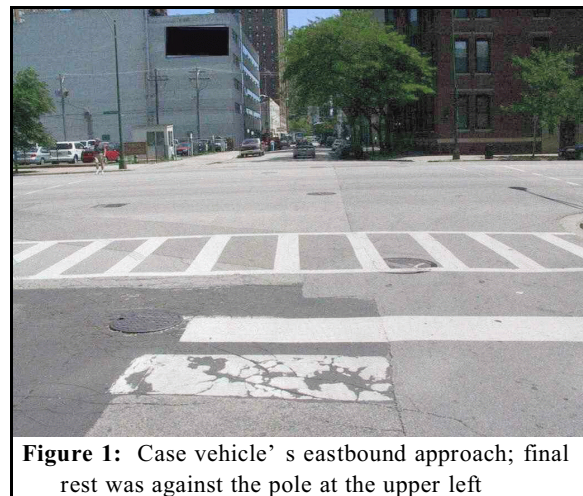
The case vehicle was traveling east in the eastbound lane of a two-lane local street, approaching a four-leg intersection and intending to continue east (**Figure 1**). The other vehicle was traveling north in the inside northbound through lane of the intersecting two-lane roadway that was part of a divided trafficway, and was intending to continue north (**Figure 2**). It was daylight, the weather was clear, the road surface was dry and with no apparent defects. The speed limit on both roadways was 56 km.p.h. [35 m.p.h.]. There was a stop sign for the case vehicle and no traffic control for the other vehicle. The case vehicle entered the intersection across the other vehicle's path. The case vehicle driver observed the other vehicle and braked at the last moment.

**Figure 1:** Case vehicle's eastbound approach; final rest was against the pole at the upper left

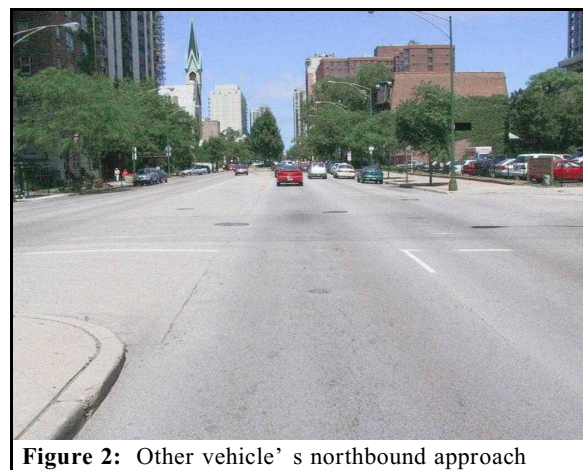
**Figure 2:** Other vehicle's northbound approach

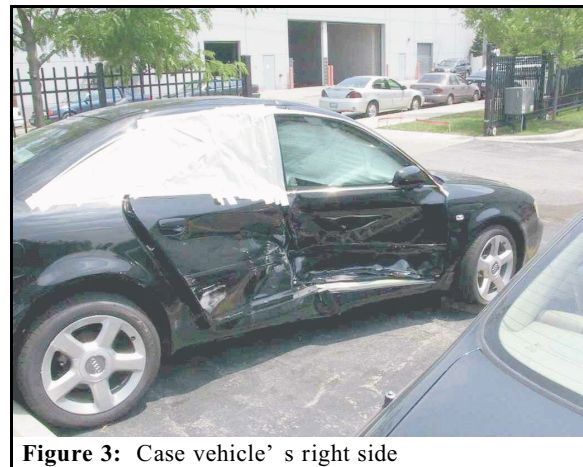
Figure 3: Case vehicle's right side

The case vehicle was hit on the right side (**Figures 3 and 5**) by the full width of the other vehicle's front, centered approximately on the right B-pillar, with direct damage on both right doors. The crush profile was measured as 179 centimeters [70.5 inches] long, with maximum crush of 39 centimeters [15.4 inches] slightly forward of the B-pillar on the lower right front door. In addition to the two right doors, the right door sill sustained direct damage, and there was minor induced buckling on the right roof rail. The right back door window glazing and the fixed glazing rearward of the right back door was shattered, and there was no other glazing damage.

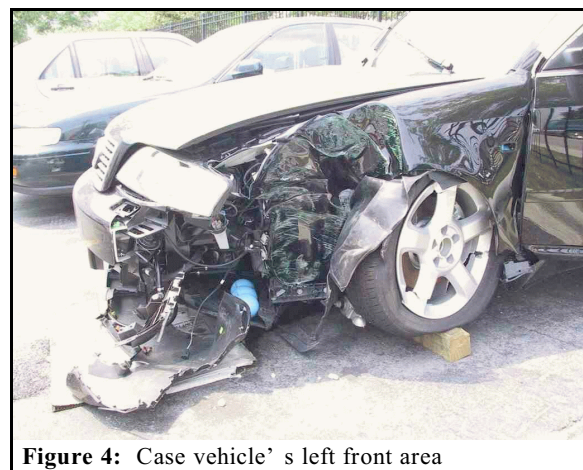
Figure 4: Case vehicle's left front area

The case vehicle's left front area (**Figures 4 and 6**) impacted the base of a non-breakaway, heavy steel pole. The left fender was crushed inward and rearward, with abrading and paint transfers from the pole. The rearward movement of the left fender pulled the left end of the front bumper cover rearward and tore it off. The headlamp assembly was displaced but otherwise undamaged, and the engine compartment was exposed, but the hood was not damaged. The left front wheel was restricted by the damaged fender, the two front tires were both flat and there was no other wheel/tire damage.

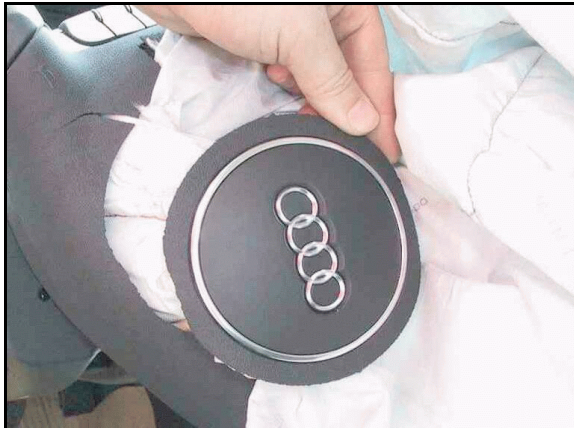
**Figure 7:** Driver's frontal air bag module cover flap

The driver's frontal air bag was located in the steering wheel hub. The module's single cover flap was circular, with a diameter of 13 centimeters [5.1 inches] (**Figure 7**). The cover flap opened at the designated points and there was no evidence of damage to the cover flap or the air bag, but the vinyl-like covering on the hub had tears radiating out from the circular flap opening. The air bag was round with a diameter of 60 centimeters [23.6 inches] (**Figure 8**). There were four tethers and one vent port, of unknown size, at the 12 o'clock position on the back of the air bag. There was a faint yellow fluid stain and a scuff near the center on the front of the air bag fabric and no other evidence of contact.

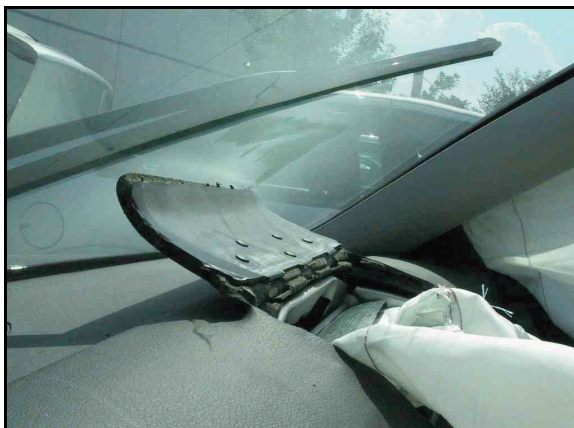
**Figure 9:** Passenger's frontal air bag module cover flap, viewed from left

The front right passenger's frontal air bag was located in the top of the right instrument panel. The single cover flap was rectangular and measured 26 centimeters [10.2 inches] horizontally and 13 centimeters [5.1 inches] vertically (**Figure 9**). The flap was hinged at the top and opened at the tear points with no apparent damage to the air bag, the flap or the adjacent structures. The air bag was approximately rectangular (**Figure 10**), but its measurements are not known. The air bag had one tether and one vent port, of unknown size, located at the 12:00 o' clock position on the top surface of the air bag.

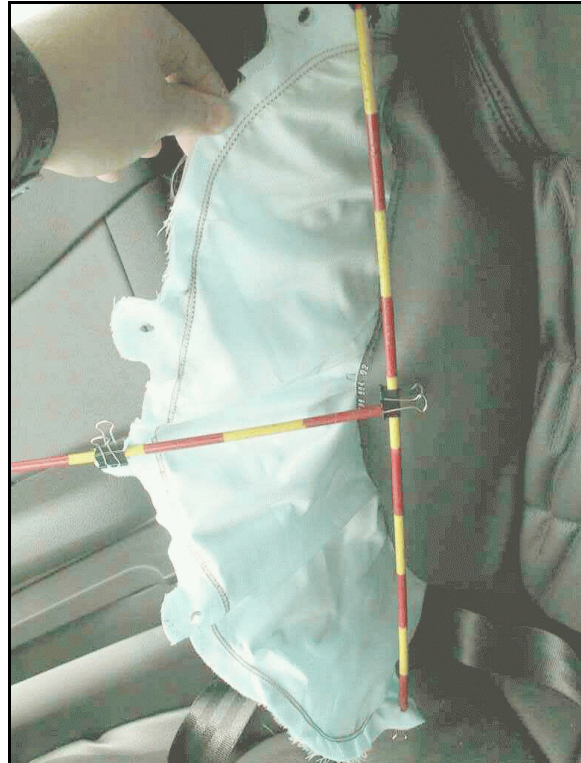
**Figure 11:** Front right seat back-mounted side impact air bag

The front right passenger's seat back-mounted side impact air bag was mounted in the outboard edge of the front right seat back. The module was covered by the fabric of the seat's upholstery and this came open along pre-stressed seams (**Figure 11**). There was no evidence of damage to the air bag, the flap or the adjacent structures. The air bag was semi-circular in shape, approximately 48 centimeters [18.9 inches] vertically and 20 centimeters [7.9 inches] horizontally.

There were no tethers or vent ports. There was no evidence of occupant contact, nor any other marks, on the air bag.

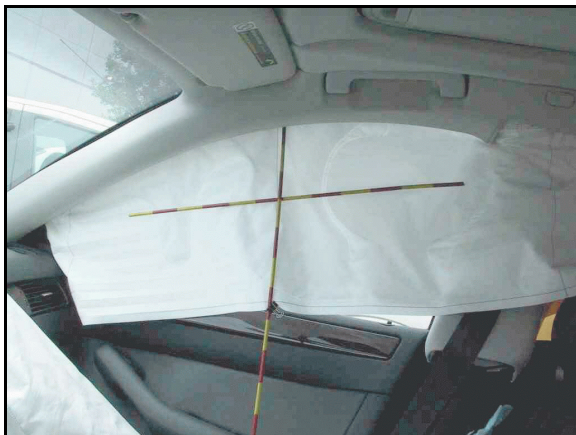
**Figure 12:** Front seat portion of right curtain wall

The right inflatable curtain air bag was mounted in the right roof rail, behind a trim panel that runs along the upper A-pillar rearward to the C-pillar and spans the junction where the roof headliner meets the side. This panel comes open along the outboard edge, allowing the air bag to emerge. There was no evidence of damage to the air bag, the trim panel or the adjacent structures. The deployed curtain covered the entire length of the right side of the passenger compartment, from the point where the A-pillar meets the instrument panel (**Figure 12**) rearward

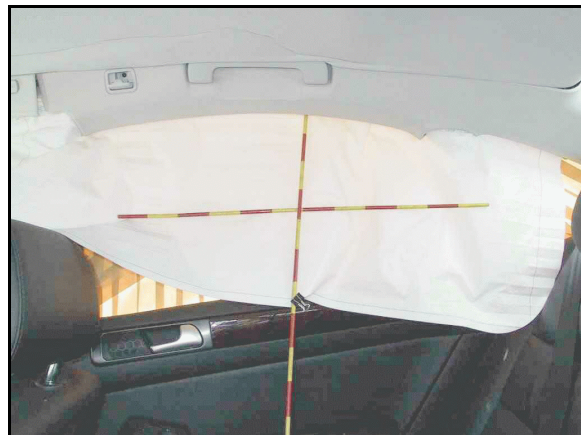
**Figure 13:** Back seat portion of right curtain wall

to just beyond the C-pillar (**Figure 13**). The deployed curtain was rectangular, measuring approximately 140 centimeters [55.1 inches] from front to rear and 36 centimeters [14.2 inches] from top to bottom. There was a scuff on the curtain's fabric in the back seat area that appeared to be the result of occupant contact, and no other marks on the inflatable curtain.

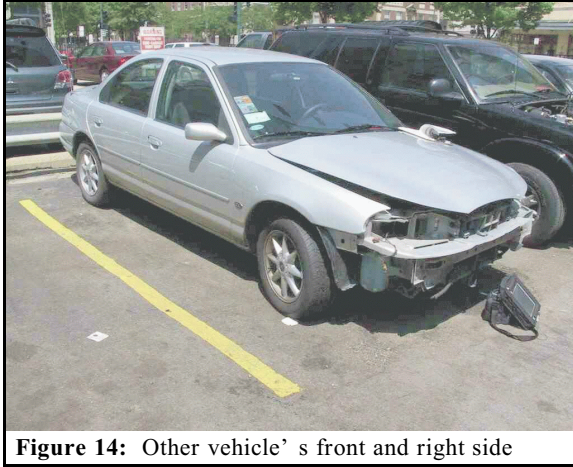
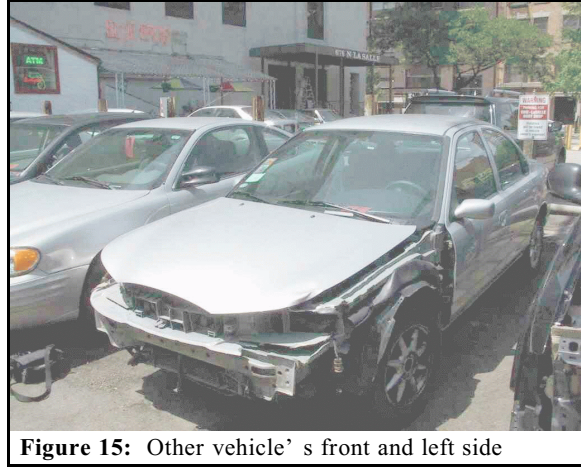
The other vehicle was under repair and partially disassembled at the time of inspection (Figures 14 and 15). The bumper cover, grille, headlamp/turn signal assemblies and the left fender were removed. Based on an examination of the damaged parts, it was determined that the Contour sustained direct contact across the entire front. The engine hood was slightly displaced and there was an area of induced damage on the left edge, probably from crush damage on the left

fender. The wheelbase was shortened by 1 centimeter [0.4 inches] on both sides. None of the tires were damaged or restricted, and there was no glazing damage.
