SCI/NASS COMBINATION CASE REPORT

CASE NUMBER - NASS-2003-73-059A
LOCATION - Indiana
VEHICLE - 2001 CHEVROLET MONTE CARLO
CRASH DATE - April 2003

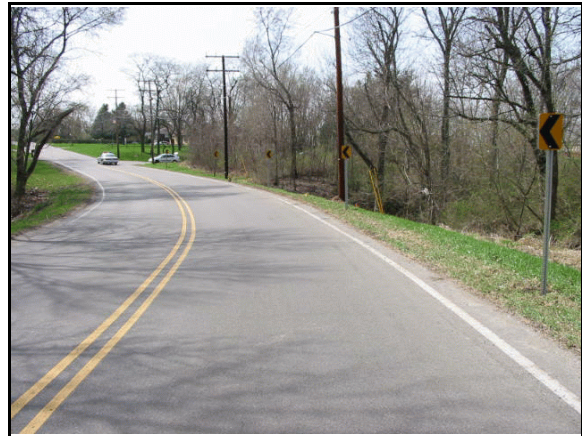
The case vehicle was traveling west in the westbound lane of a two-lane local road and was entering a curve to the left (**Figure 1**). It was daylight, the weather was cloudy, the asphalt road surface was dry and with no apparent defects. The speed limit was 48 km.p.h. [30 m.p.h.]. A witness who was traveling west on the same roadway ahead of the case vehicle stated that she observed the case vehicle swerving back and forth in its lane. The case vehicle apparently continued straight ahead instead of negotiating the curve and departed the right (north) road edge (**Figure 2**). The case vehicle impacted a curve arrow sign and uprooted the sign post (event #1). The roadside descended into a steep downhill slope and the case vehicle began to tip to the right. The front center-left area of the case vehicle impacted a timber utility pole, causing the case vehicle's driver and front right passenger air bags to deploy, shearing the pole (event #2) and causing the case vehicle to begin rotating counterclockwise. The steepness of the embankment's slope caused the case vehicle to roll to the right (event #3, NASS Rollover Type = Fall-Over), rolling two quarter-rolls as it tumbled down the embankment while rotating counterclockwise. The case vehicle came to rest on its roof at the base of the embankment, heading south (**Figure 3**).

Figure 1: Case vehicle's westbound approach

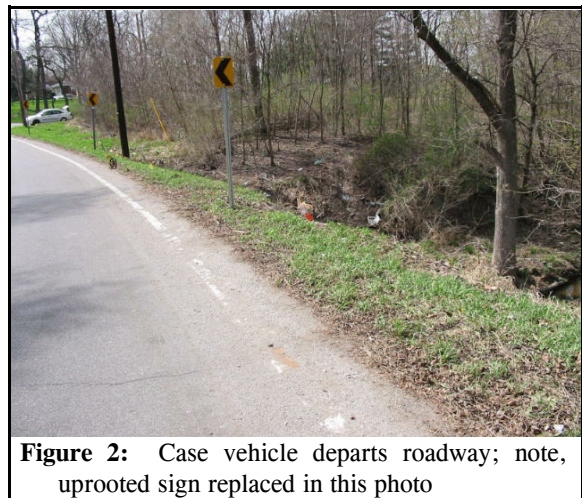
Figure 2: Case vehicle departs roadway; note, uprooted sign replaced in this photo

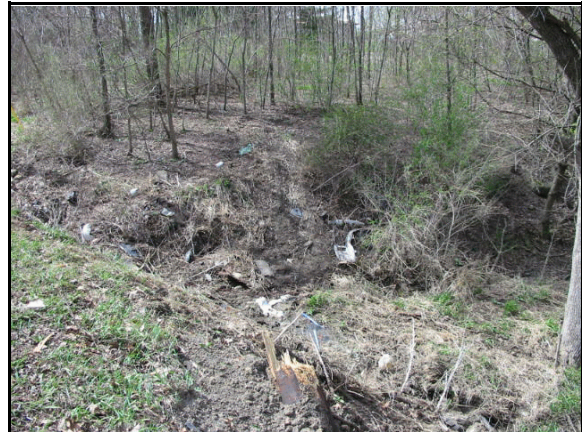
Figure 3: Sheared pole (foreground) and the case vehicle's area of final rest, on its roof at the bottom of the embankment

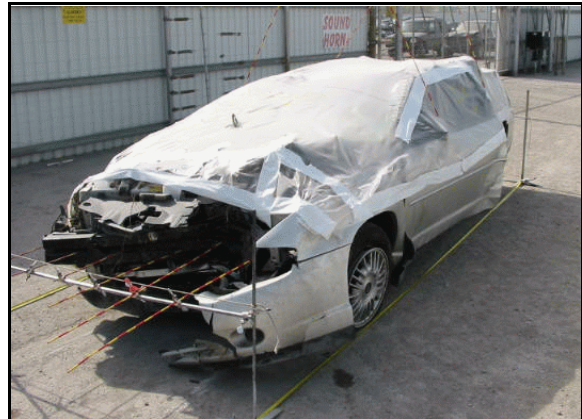
The case vehicle was wrapped in plastic sheeting with the front bumper, grille and hood missing at the time of the inspection (**Figures 4 and 5**). The location where the case vehicle impacted the curve arrow sign (event #1) could not be determined and the CDC is unknown. Based on damage to engine components, direct contact with the timber utility pole was determined to be in the left-center area of the front, centered at 28 centimeters [11.0 inches] inward from the front left bumper corner. Maximum crush from the pole impact was measured as 61 centimeters [24.0 inches] at C2, slightly left of the center. The wheelbase was shortened by 1 centimeter [0.4 inches] on both sides. The CDC for the pole impact (event #2) was determined to be **12-FYEN-3 (10)**. There was a deep downward indentation in the windshield header and the roof indicating that the sheared pole probably contacted the roof structures as the case vehicle passed over the pole's foundation. Because the pole was sheared, this impact is not eligible for the WinSMASH reconstruction program. Based on the measured crush profile, the barrier equivalent speed was calculated as 40 km.p.h. [24.8 m.p.h.].

Figure 4: Case vehicle's front and left side

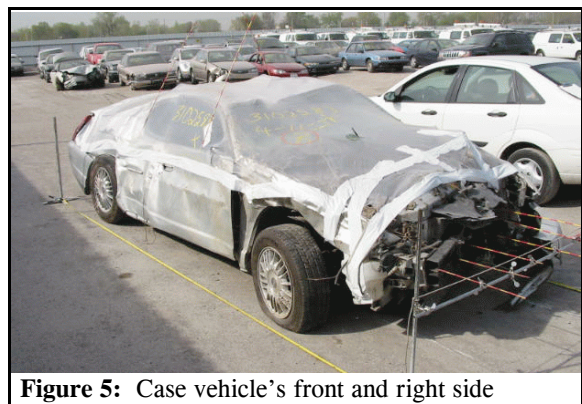
Figure 5: Case vehicle's front and right side

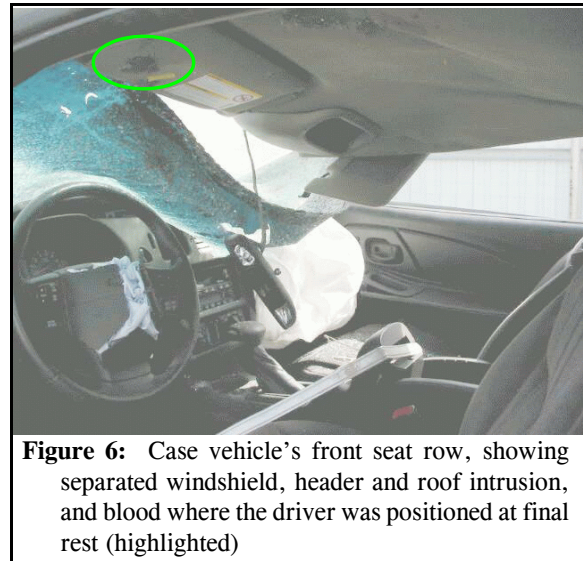
There were numerous intrusions, including: the windshield header downward across the entire width (14 centimeters [5.5 inches] on the right, 5 centimeters [2.0 inches] on the left); the entire roof downward (16 centimeters [6.3 inches] at the front right and approximately 5 centimeters [2.0 inches] at the back left); the backlight header downward across the entire width (7 centimeters [2.8 inches]); the right door and B-pillar laterally (12 centimeters [4.7 inches]); and others. The only evidence of occupant contact was blood smears on the headliner and sunvisor above the driver's seat area, where the driver was positioned as he was suspended, upside down, by the restraint system when the case vehicle came to at final rest (**Figure 6**).

Figure 6: Case vehicle's front seat row, showing separated windshield, header and roof intrusion, and blood where the driver was positioned at final rest (highlighted)

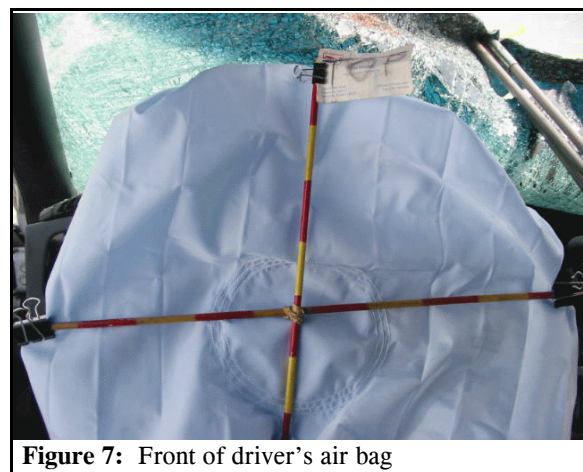
The driver's air bag was located in the steering wheel hub. The module cover flaps opened to the left and right. Each flap measured 7 centimeters [2.8 inches] horizontally and 9 centimeters [3.5 inches] vertically. There was no evidence of damage to the flaps or the adjacent structures. The driver's air bag was round with a diameter of 53 centimeters [20.9 inches]. There was no damage to the bag and no evidence of occupant contact (**Figure 7**).

Figure 7: Front of driver's air bag

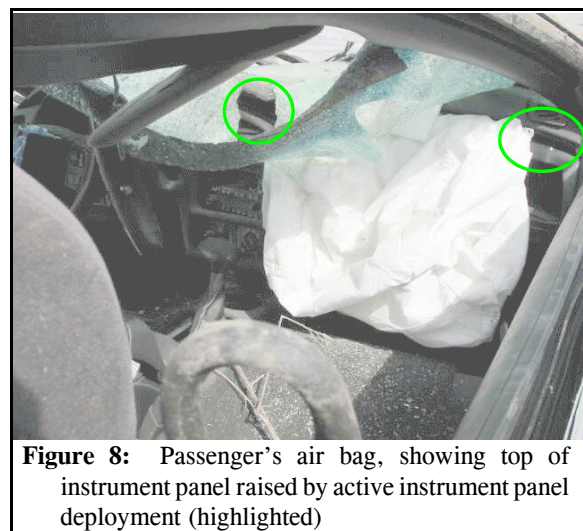
The front right passenger's air bag was located in the mid-mount position, on the front of the instrument panel, in a configuration that the manufacturer refers to as an "active instrument panel" (**Figure 8**). There are no module cover flaps as such. Rather, as the deploying air bag

Figure 8: Passenger's air bag, showing top of instrument panel raised by active instrument panel deployment (highlighted)

expands, it forces the top of the instrument panel upward, causing the points of attachment to break away and creating an opening between the horizontal top and the vertical front of the instrument panel. The air bag deploys through this opening. The deployed front right air bag was rectangular, measuring 55 centimeters [21.6 inches] horizontally and 40 centimeters [15.7 inches] vertically. There was no damage to the passenger's air bag and no contact evidence.

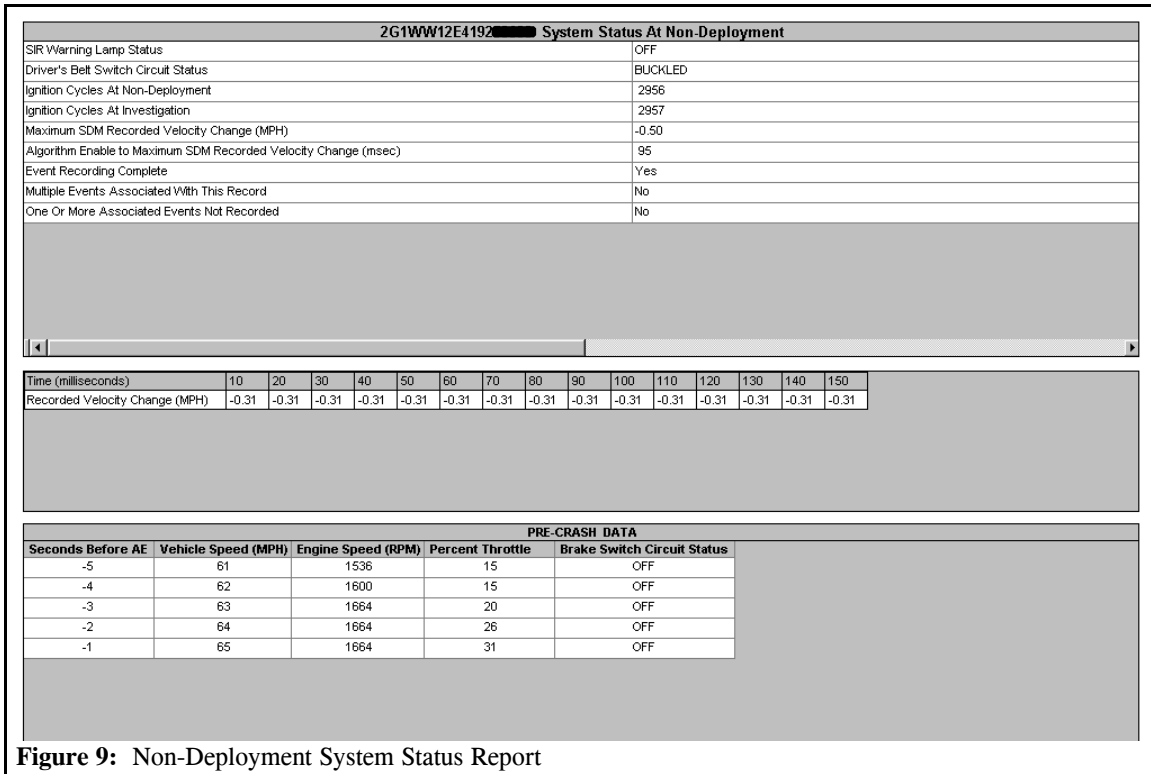
Figure 9: Non-Deployment System Status Report

The case vehicle's event data recorder was successfully downloaded. The Sensing and Diagnostic Module (SDM) reports are included at the end of this document. The EDR recorded a non-deployment event (**Figures 9 - 11**) associated with event #1 (the sign post impact), and a deployment event (**Figures 12 - 14**) associated with event #2 (the utility pole impact).

The two System Status Reports both show that the Supplemental Inflatable Restraint (SIR) warning lamp was OFF, indicating no error conditions in the automatic restraint system, the driver's safety belt was buckled and both the non-deployment and deployment events occurred during ignition cycle 2,956 (**Figures 9 and 12**). Both System Status Reports show that the case vehicle was traveling at 100 km.p.h. [62 m.p.h.] several seconds prior to the collision events, with throttle input and engine speed rising and travel speed increasing to 105 km.p.h. [65 m.p.h.] at one second prior to algorithm enable for the deployment event. The brake light circuit was never on at any time during the recorded pre-impact interval. The Deployment System Status Report (**Figure 9**) indicates that the deployment event occurred 0.6 seconds after the non-deployment event, which seems reasonable based on the scene geometry. Maximum longitudinal velocity change for the non-deployment event was recorded as -0.8 km.p.h. [-0.5 m.p.h.] at 95 milliseconds [0.095 seconds] after algorithm enable. For the deployment event, maximum longitudinal velocity change was -26.5 km.p.h. [-16.45 m.p.h.] at 107.5 milliseconds [0.1075 seconds] after algorithm enable. First stage deployment was commanded at 12.5 milliseconds [0.0125 seconds] after algorithm enable and the criteria for second stage deployment were not met. The Deployment Event Velocity Change Graph (**Figure 14**) shows delta V accumulating gradually, reflecting the "soft" nature of the impact as the case vehicle pushed against the pole and eventually fractured and sheared it. Velocity change recording ceased after 110 milliseconds [0.11 seconds].
