**CALSPAN ON-SITE POTENTIAL SAFETY-RELATED DEFECT  
INVESTIGATION**

**CASE NO: CA03-003**

**VEHICLE: 1993 ISUZU RODEO**

**CRASH DATE: JANUARY 2003**

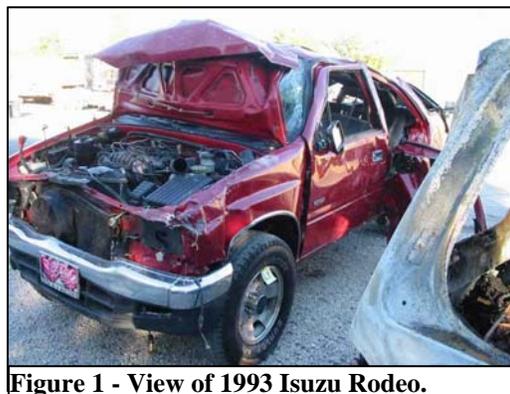
**Figure 1 - View of 1993 Isuzu Rodeo.**

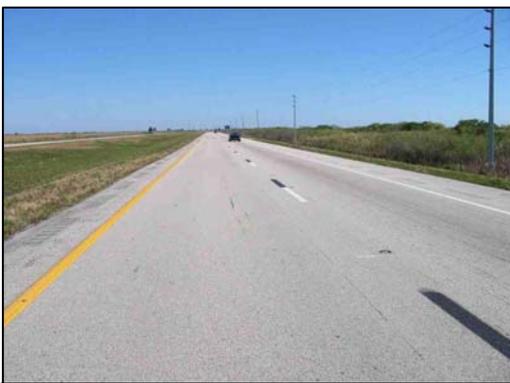
The Isuzu continued in an easterly direction (**Figure 2**) as the driver apparently initiated a counterclockwise steering maneuver in an attempt to maintain control of the vehicle. The Isuzu initiated a counterclockwise yaw as the remaining right rear tire sidewall and wheel began to mark in a dotted gouge pattern on the asphalt surface. The right rear yaw mark began 41.4 m (135.8’) east of the previously noted tire mark that resulted from the air out. As the vehicle continued to yaw counterclockwise, the right front tire marked 18.2 m (59.7’) east of the start point of the right rear yaw mark. At this point, the left front tire departed the inboard road edge and the vehicle had rotated approximately 35 degrees CCW. The left rear tire yaw mark began 9.7 m (31.8’) east of the start point of the right front. As this tire began to mark, it had crossed the right front tire mark and exceeded the degrees of rotation that a driver can typically recover from by steering and accelerating into the direction of yaw. **Figure 3** is a view of the vehicle’s point of roadway departure.

**Figure 2 - Eastbound approach of the vehicle.**

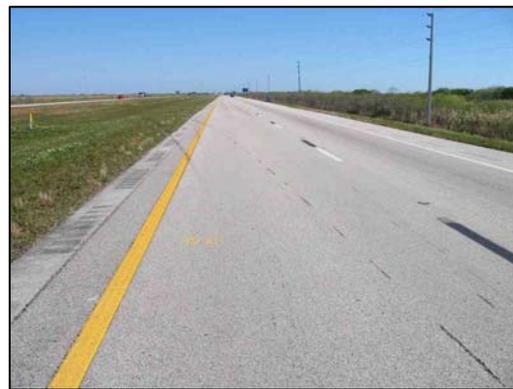
**Figure 3 - CCW tire marks leading to road departure.**

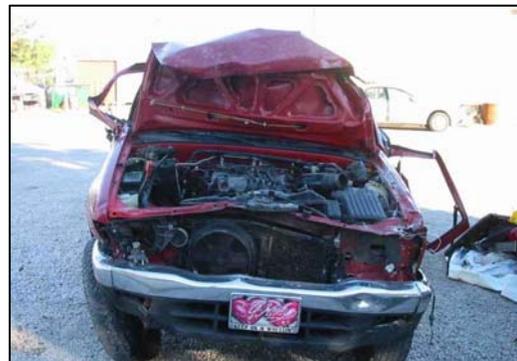
The 1993 Isuzu Rodeo sustained severe damage as a result of the seven-quarter turn rollover (**Figure 4**). The frontal plane exhibited minor damage across the front bumper with moderate displacement of the radiator support which was crushed rearward approximately 20 cm (8"). The hood latch released which allowed the hood to buckle rearward more than 90 degrees. The hood contacted the windshield during the rollover and associative glass from the windshield was embedded into the paint of the hood. The windshield laminate bond held;

**Figure 4 - Frontal and left side planes of the vehicle.**

however, approximately 90 percent of the laminate was torn from the vehicle during the crash. The left fender was deformed at its leading edge and multiple abrasions were present on the hood and left fender typical of a rollover event.

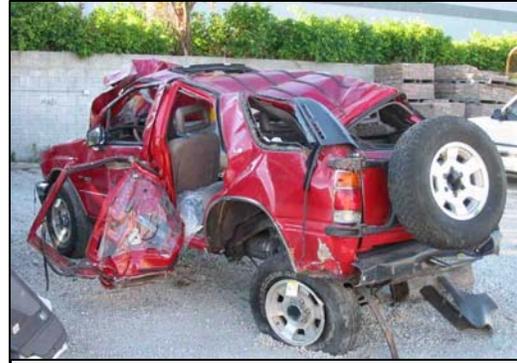
The left side of the vehicle sustained damage along its entire length and the side glazing at all four glazing locations was shattered (**Figure 5**). The left rear door was torn from the side of the vehicle and the door's latch and striker became separated during the roll sequence. The door's latch released as the backing panel became deformed and the C-pillar mounted striker bar rotated approximately 45-degrees outward responding to the damage flow. The roof side rail was crushed 6 cm (2.5") below its original position at 3 cm (1") forward of the left B-pillar and grass was embedded in the left front window frame. The left C-pillar crushed downward 18 cm (7"). The leaf spring of the left rear wheel was fractured at the front hangar and the bottom shock mount was also fractured.

**Figure 5 - Left and back planes of the vehicle.**

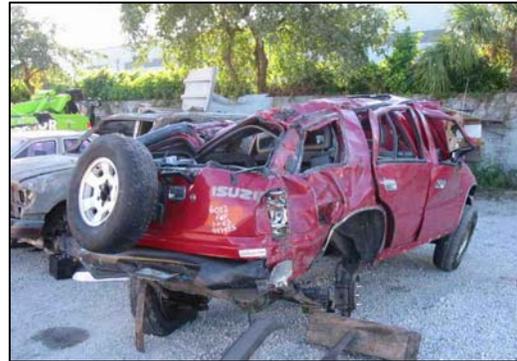
The maximum crush was to the backlight header in the vehicle's cargo area (**Figure 6**). The vertical crush measured 18 cm and was located at the right side D-pillar. The backlight header at the left side D-pillar was also crushed downward 10 cm (4"). The rear tailgate was a two-piece unit equipped with a downward opening door with the backlight glazing that was hinged at the top aspect of the backlight header. The backlight was disengaged from the latch lever arms and completely shattered. The combination of the downward crush of the rear hatch and the window opening exposed approximately 70 percent of the rear cargo area as an ejection portal.

**Figure 6 - Back plane of vehicle.**

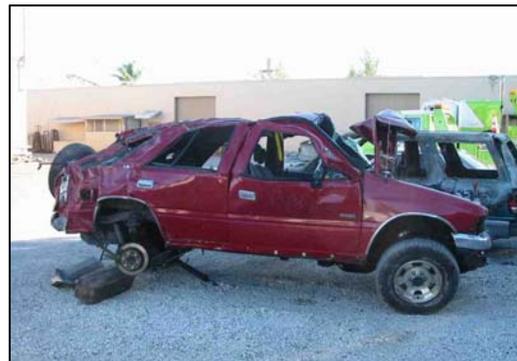
The right side of the vehicle sustained moderate damage as a result of the rollover (**Figure 7**). The right quarter panel was crushed laterally approximately 15 cm (6") and the right D-pillar was displaced forward 23 cm (9"). The four right side window glazings were shattered. Both right side doors jammed closed during the impact sequence responding to the body distortion of the vehicle.

**Figure 7 - Right side of the vehicle.**

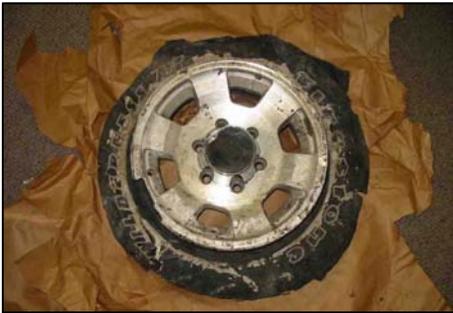
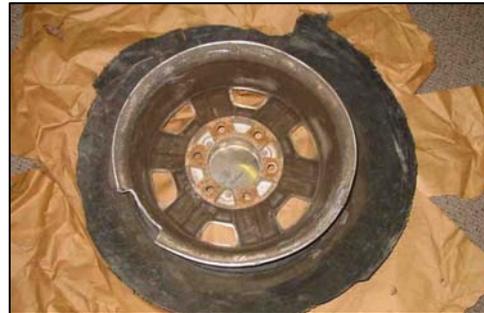
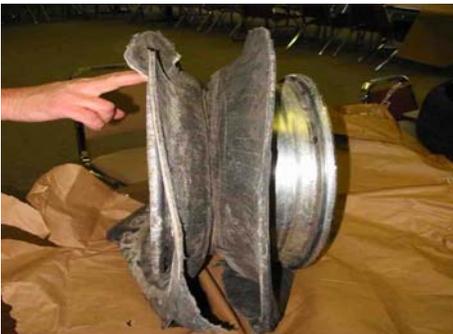
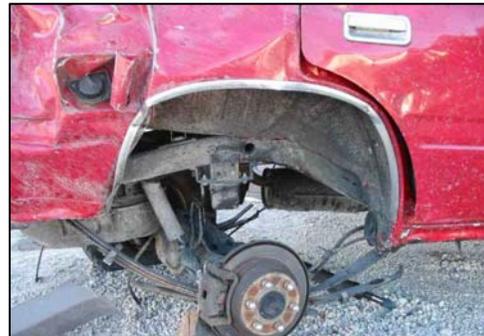
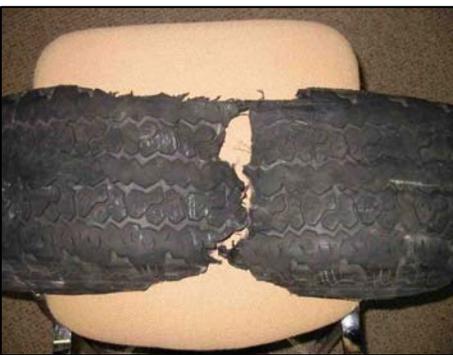
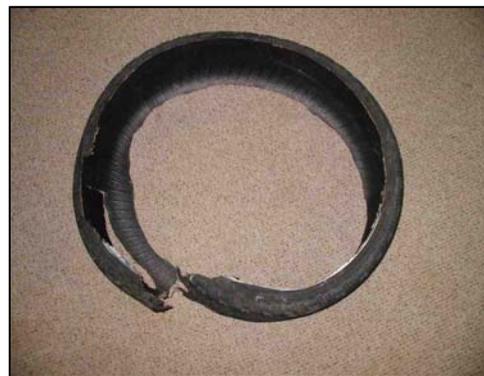
The right rear tire tread separated from the sidewalls of the tire following an air-out of the tire. The damage was not consistent with the patterns typical of a tread separation event. The right rear wheel well was devoid of the characteristic transfer patterns normally associated with tread separation events. The alloy wheel was heavily abraded due to damage incurred during the rollover. The abrasions were circumferential and a 10 x 3 cm (4 x 1") area of the rim was missing. On the inner aspect of the rim, an 11 x 3 cm (4.25 x 1") dent was present that was 5 cm (2") in depth. The wheel and tire components were held by the investigating police agency for evidentiary purposes allowing only a minimal inspection. The investigating agency limited the time available for the inspection and it consisted of a brief examination and photographic images. **Figures 8 – 13** exhibit the damage to the right rear wheel of the vehicle.

**Figure 8 - Outer aspect of right rear wheel.**

**Figure 9 - Inner aspect of right rear wheel.**

**Figure 10 - Vertical view of right rear wheel.**

**Figure 11 - Right rear wheel well and axle.**

**Figure 12 - View of right rear tread.**

**Figure 13 - View of post-crash right rear tread.**

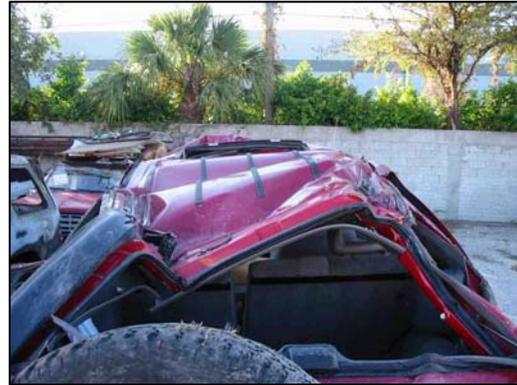
The top plane of the vehicle sustained damage along the entire roof structure, with the greatest extent of the crush primarily to the back third of the plane (**Figure 14**). The roof was significantly creased from the left C-pillar to the right B-pillar extending rearward. The glazing within the sunroof was completely disintegrated and the four rails comprising the roof rack were all fractured. The maximum crush to the roof was within the cargo area of the vehicle at the D-pillar point of the backlight header and measured 40 cm (16"). The Collision Deformation Classification (CDC) for the rollover event was 00-TDDO-5.

**Figure 14 - View of roof and backlight header area.**

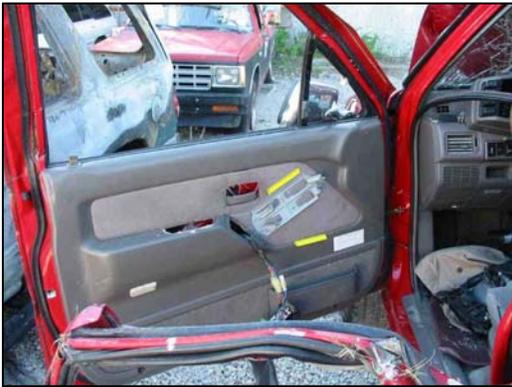
Five discernable areas of occupant contact were identified during the SCI investigation. The power window switch unit housed within left front armrest was fractured from its mounting plate and the door panel was slightly bowed (**Figure 15**). The damage pattern

was not consistent with the damage flow of the exterior of the vehicle and was probably the result of the driver's left upper leg interacting with the component.

**Figure 15 - Contact evidence on front left door panel.**

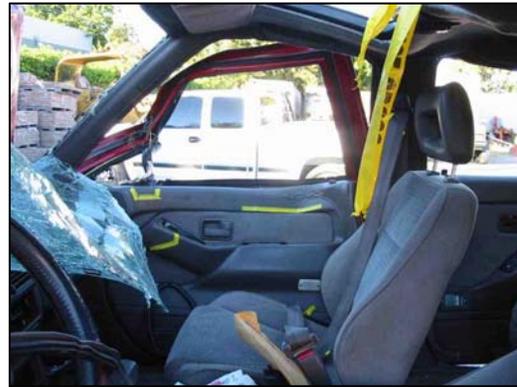
The right front door panel was bowed outward a distance of 18 cm (7.25") with associative fabric transfers embedded within the upper aspect of the panel. The fabric transfers were located 55 – 72 cm (21.75 – 28.5") rear of the leading edge of the door panel and 0 – 5 cm (0 – 2") below the beltline. The armrest contained associative abrasions 65 – 80 cm (25.5 – 31.5") aft of the door panel's leading edge and 23 – 28 cm (9 – 11") below the beltline. A separate scuff mark was identified at the top aspect of the door panel. The scuff was located 19 – 25 cm (7.5 – 9.8") aft of the door panel's leading edge and 1 – 3 cm (0.5 – 1.25") below the beltline. A "blackish" transfer was identified at the forward aspect of the front right door panel's window switch. The transfer was located 20 – 28 cm (8 – 11") aft of the leading edge of the door panel and 14 – 20 cm (5.5 – 8") below the beltline. The power window switch was dislodged from its housing. **Figure 16** is an overall view of the loading patterns on the front right door panel.

**Figure 16 - Contact evidence on front right door panel.**

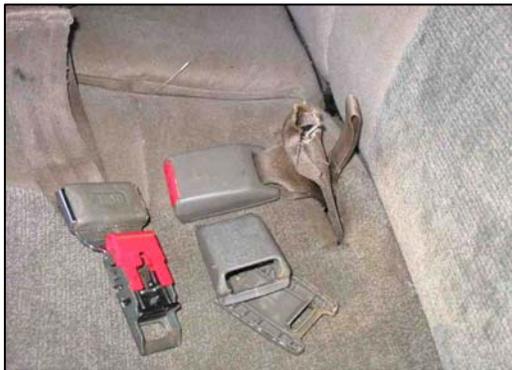
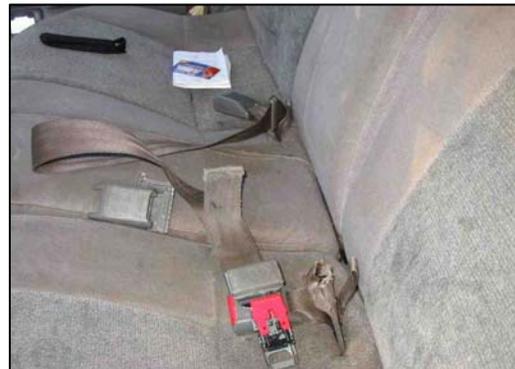
The center rear lap belt was adjustable with a locking latch plate. The buckle was mounted on the left side of this seat position and was marked with CENTER. The lap belt webbing was found at the time of the SCI inspection nearly fully extended with 17 cm (6.5”) of webbing protruding from the latch plate and 93 cm (36.5”) of webbing looping around the cinch bar to the anchor point. The buckle assembly was torn from the tethered webbing at the buckle loop by occupant loading of the lap belt. The latch plate was found engaged in the buckle which was separated from the plastic housing. The release mechanism was operational. There was no distinct loading evidence on the lap belt webbing. As a consequence of the torn webbing, the child passenger was fully ejected from the vehicle. **Figures 17** and **18** are views of the damaged second row center lap belt.

**Figure 17 - Post-crash condition of center lap belt.**

**Figure 18 - Another view of center lap belt.**

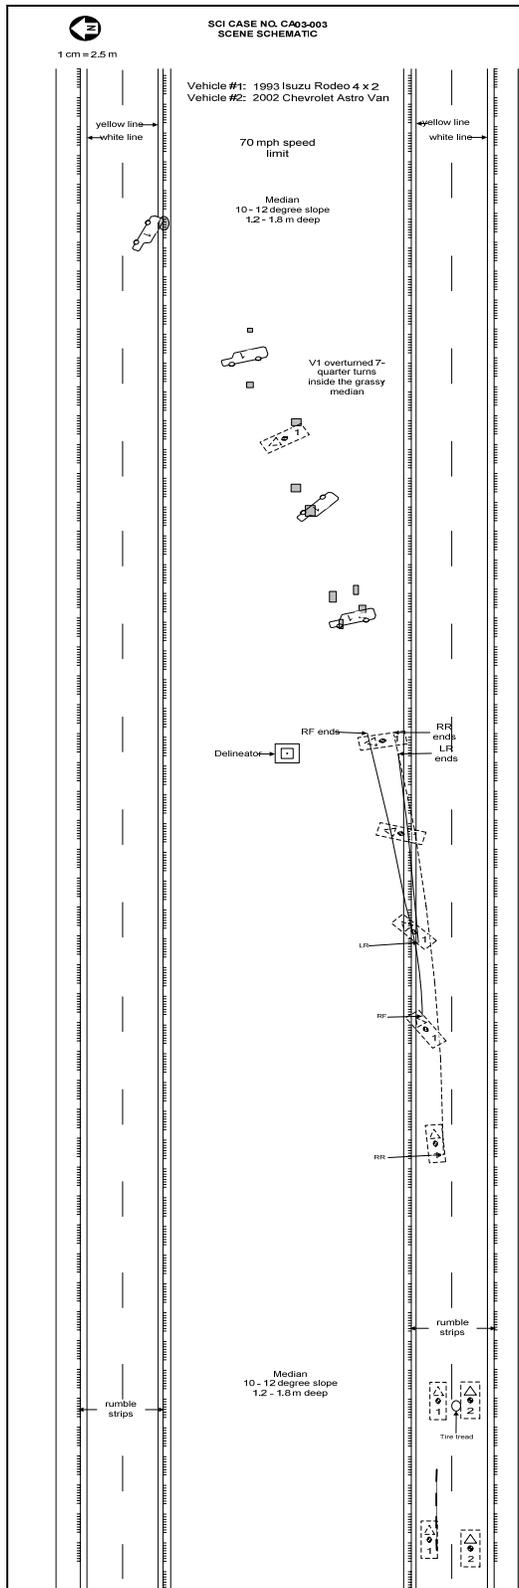
**Figure 19 – SCI Scene Schematic**

The crash occurred on a four-lane divided interstate roadway during daylight hours. At the time of the crash, the asphalt road surface was dry and the weather was clear. The travel lanes were 3.7 m (12') in width and bordered by a 3.2 m (10.5') outboard shoulder and a 1.3 m (4.3') wide paved inboard shoulder. Tactile rumble strips were cut into both shoulders and began 0.7 m (2.3') outboard of the edge lines. The travel lanes were delineated by a broken white lane line. The east/westbound travel lanes were divided by a 24 m (78') wide depressed grass median. The median sloped at a shallow grade to a depth of 1.5 m (5') at the centerline of the median. It should be noted that the median was composed of grass growing in a soft sandy soil. The interstate roadway was straight and level with a posted speed limit of 113 km/h (70 mph). The SCI scene schematic is included as **Figure 19** at the end of this narrative report.
