**GENERAL DYNAMICS ON-SITE AMBULANCE CRASH INVESTIGATION
SCI TECHNICAL SUMMARY REPORT**

CASE NO. CA03-004

VEHICLE – 1997 FORD E-350 TYPE III AMBULANCE

CRASH DATE – JANUARY 2003

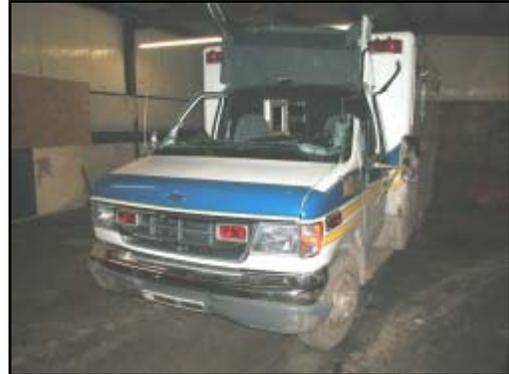
Figure 1. Damaged 1997 Ford E-350/Horton Ambulance

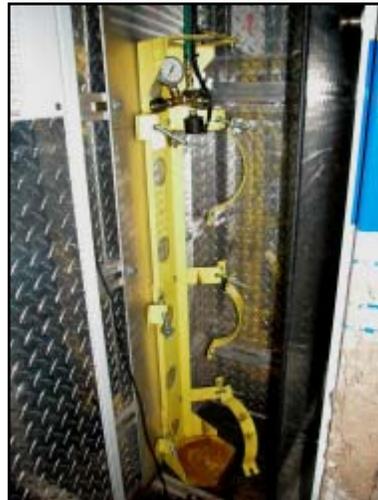
The forward exterior compartment on the left aspect housed an H-size oxygen cylinder that measured 110.5 cm (43.5") in height and 17.8 cm (7.0") in diameter. The H-cylinder was secured with a steel cylinder bottle bracket (**Figure 4**) mounted to the forward aspect of the left front exterior cabinet. The bracket was configured with three heavy-duty steel semi-circular clasps, which were secured to the bracket on the each side by 7.9 mm (5/16") diameter bolts that measured 10.2 cm (4.0") in length and wing nuts. The clasps measured 25.4 cm (10.0") in width, 4.4 cm (1.8") in height, and the semi-circular diameter measured 17.8 cm (7.0"). The three clasps were located 13.3 cm (5.5"), 50.8 cm (20.0"), and 88.9 cm (35.0") above the bottom of the bracket, respectively. The volume of oxygen at the time of the crash was not known.

Figure 4. View of oxygen cylinder bracket

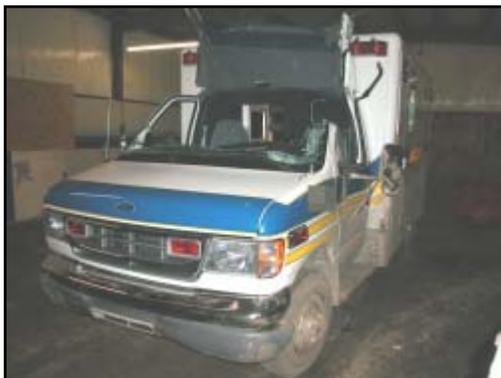
The 1997 Ford E-350/Horton ambulance sustained minor damage as a result of the crash (**Figure 10**). Both A-pillars were cut by rescue personnel and the roof was folded rearward to facilitate the extrication of the driver. Minor deformation to the front bumper and rear step were a result of towing and removal from the crash scene.

Large amounts of dirt were present on the left front wheel, left side running board, and the left side aspect of the patient compartment. The left front wheel sustained abrasions. The left outside mirror was abraded and rotated counterclockwise (CCW). The forward mount on the top aspect and both bottom mounts for the outside mirror were separated from the exterior door panel. The left front door panel sustained minor induced damage as a result of the lateral mirror frame displacement caused by the left side rollover (**Figure 11**). Induced damage also resulted from rescue efforts as the left A-pillar and the door window frame was cut.

Figure 10. Front left view of damaged ambulance

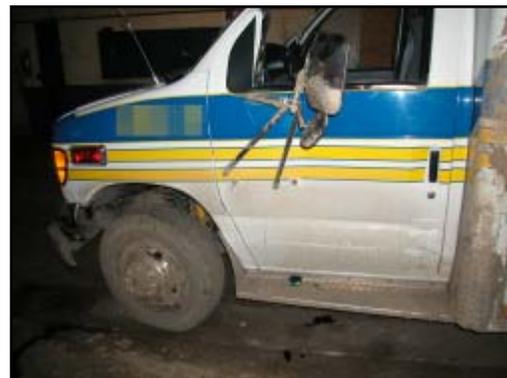
Figure 11. Left front view showing displaced mirror and door damage

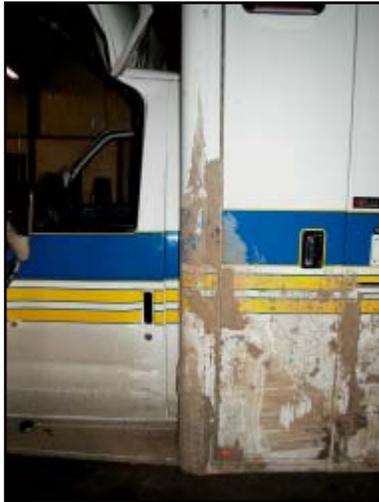
The left front corner of the patient compartment outboard of the cab sustained moderate abrasions from the rollover (**Figure 12**). The abrasions began 62.2 cm (24.5”) from the top aspect of the patient compartment and extended a vertical distance of 153.7 cm (60.5”). The forward corner of the drip rail along the top aspect of the left side of the patient compartment was also abraded (**Figure 13**). The abrasion measured 1.9 cm (0.8”) in length. The 144.8 cm (57.0”) long diamond plate trim piece that was located on the bottom aspect of the patient compartment, forward of the rear wheel was separated. The aluminum splash guard that was contoured to the rear wheel well was also separated. The Collision Deformation Classification (CDC) for the rollover event was 00-LDAO-1.

Figure 12. View of abrasions on left front corner of the patient compartment

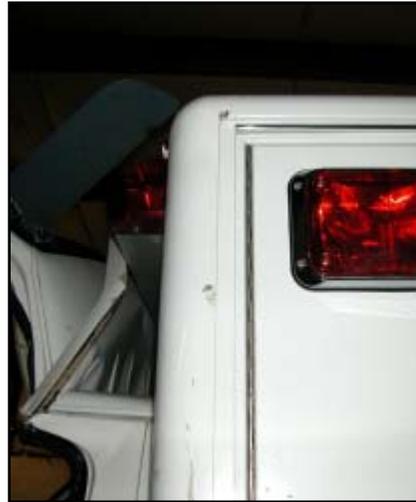
Figure 13. Close up of abrasion on the forward corner of the drip rail

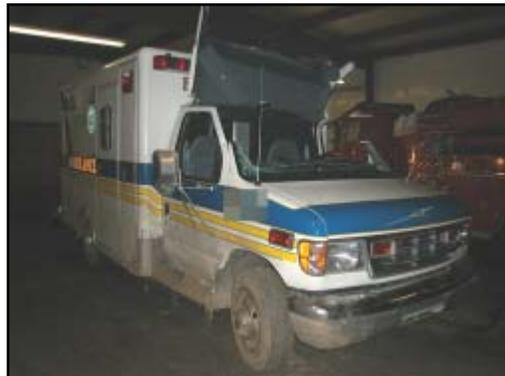
Large amounts of dirt were also present on the right front wheel, the right side running board, and the lower aspect of the right side of the patient compartment (**Figure 14**). The right front wheel cover was deformed on the center aspect. The rear aspect of the right front fender was deformed slightly at the bottom aspect. The lower diamond plate trim piece aft of the right rear wheel was separated.

Figure 14. Right side view of the ambulance

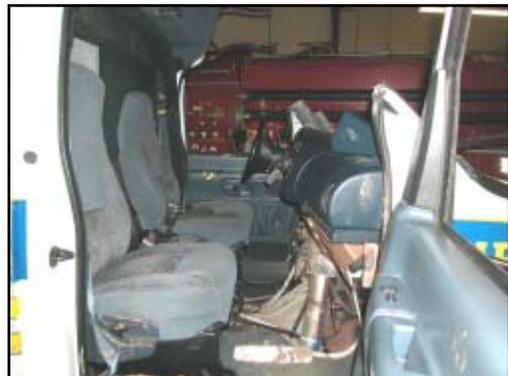
Interior damage to the cab of the 1997 Ford E-350/Horton ambulance as a result of the crash was minor (**Figure 15**). Two lacerations were present on the upper interior surface of the left front door armrest that measured 1.9 cm (0.8”) and 1.3 cm (0.5”). The interior door damage may have been attributed to extrication efforts, as they were not consistent with occupant contact. The interior trim piece on the left B-pillar was separated. At the time of the vehicle inspection, the plastic trim panel under the front right passenger’s air bag cover flap was removed, the center console which contained the emergency radio and warning device switches was removed, and the center engine shroud was removed. The removal of these components was performed post-crash.

Figure 15. Interior view across the cab of the ambulance

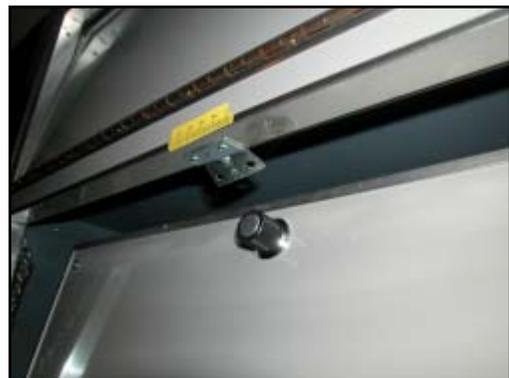
The cabinet doors on the front right wall of the patient compartment sustained damage from occupant contact. A 10.2 cm (4.0”) section of the aluminum frame around the top door was deformed from occupant contact on the top aspect. A 5.1 cm (2.0”) section was deformed on the top right side aspect. The two center cabinet doors on the front right wall of the patient compartment were displaced forward from occupant contact (**Figure 16**). Both doors were hinged at the bottom aspects and the spring-loaded cam locks were displaced forward past

Figure 16. Close-up of displaced cabinet door

the metal stop brackets. The forward displacement of the second (from the top) cabinet door measured 2.5 cm (1.0"). The forward displacement of the third (from the top) door measured 7.0 cm (2.8"). The bottom cabinet door frame sustained an area of deformation that measured 20.3 cm (8.0") along the top center aspect.

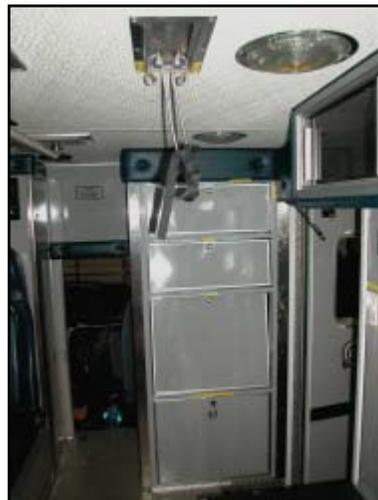
The IV holder on the right side of the assist rail was deformed from occupant loading. The IV holder was deformed forward and slightly CCW (**Figure 17**).

A plastic bracket was located on the right wall aft of the right side door 55.9 cm (22.0") above the bench seat that held an aerosol can of antibacterial cleanser. The bracket was fractured and the aerosol can was displaced as a result of occupant contact.

The hinged plastic cover of the sharps/waste cabinet forward of the squad bench seat was fractured on the inboard aspect. The fracture measured 10.2 cm (4.0") in length and was oriented at a 45 degree angle. It began below the spring-hinged flap and extended toward the front inboard corner.

Figure 17. View of deformed IV bag holder, fractured aerosol can bracket, and deformed cabinetry

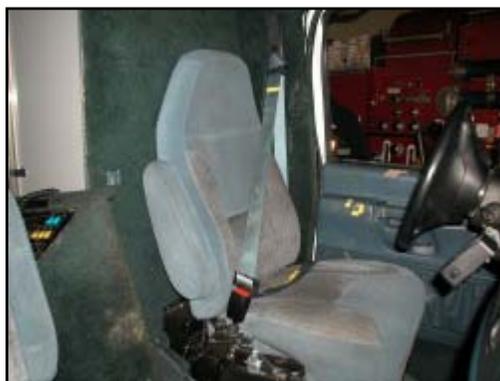
The front seat positions in the 1997 Ford E-350/Horton ambulance were configured with manual 3-point lap and shoulder belts with sliding latch plates. Both manual restraints were configured with adjustable D-rings that were in the full-down positions and had 8.9 cm (3.5") of vertical travel. There was no loading evidence on the driver's latch plate plastic, or D-ring. However, the safety belt webbing exhibited stretching over a total distance of 91.4 cm (36.0"), which began 31.8 cm (12.5") above the outboard plastic sleeve. An area of multiple small abrasions was located 49.5 cm (19.5") from the outboard sleeve and extended 17.8 cm (7.0") along the face of the webbing. Both frontal manual restraints were also equipped with buckle pretensioners located on the inboard aspects of the seats. The pretensioners did not fire as a result of the crash. The driver's seat belt is shown in **Figure 18**.

Figure 18. View of drivers safety belt and buckle pretensioner

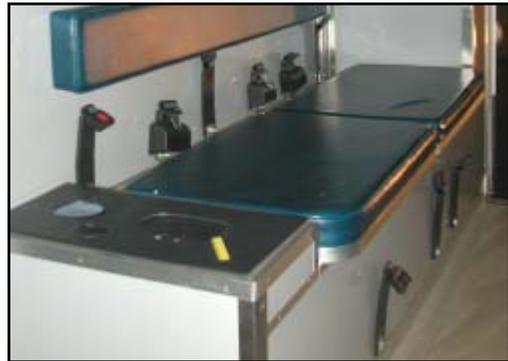
The patient compartment seating areas were configured with manual lap belts with ALR's and sewn latch plates. Tags sewn on the webbing indicated that the date of manufacture was July 1995. The retractor and buckle assemblies were vertically mounted on the wall behind each seating position on the squad bench seat and "CPR" seat. The lower anchor bolts for the retractor and buckle assemblies were mounted with a 90 degree steel mounting bracket to the right wall and the base of the seats and approximately 13.3 cm (5.3") below the height of the seat cushions. The buckle assemblies were mounted with plastic sleeves that measured 17.8 cm (7.0") in height above the anchor bolts. The buckles and webbing extended 6.4 cm (2.5") above the top aspect of the sleeves.

Figure 19. View of manual restraints on the squad bench seat

The distance between the retractor assemblies and the buckle assemblies on the right side squad bench seat measured 30.5 cm (12.0") for each of the three seating positions. In addition, three buckle assemblies were mounted on the inboard face of the bench and centered vertically between the floor and the cushions to facilitate the restraint of a stretcher on the squad bench seat. Plastic sleeves that measured 17.8 cm (7.0") in height were mounted with a single bolt on the bottom aspects, and the webbing and buckles extended 6.4 cm (2.5") above the sleeves. The forward-most buckle was located 66.0 cm (26.0") rear of the forward edge of the bench seat, and the remaining two buckle assemblies were spaced 55.9 cm (22.0") and 25.4 cm (10.0") apart, respectively.
