### ON-SITE CERTIFIED ADVANCED 208-COMPLIANT VEHICLE INVESTIGATION

CASE NUMBER - IN-03-006  
LOCATION - Texas  
VEHICLE - 2003 CHEVROLET SILVERADO  
CRASH DATE - January 2003

Submitted:  
February 5, 2004  
Revised:  
November 1, 2006

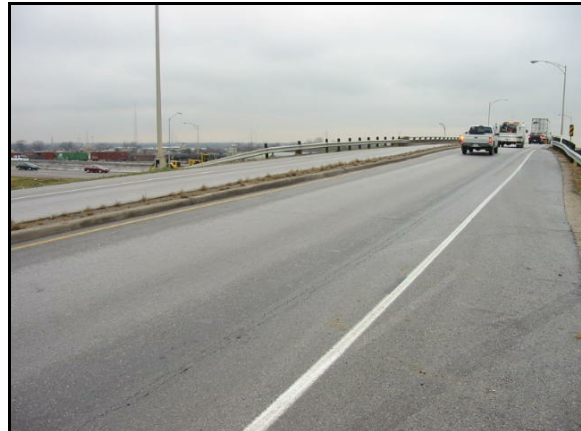
The case vehicle was traveling north in the northbound lane of a one-lane, one-way roadway that was part of a divided trafficway (i.e., there was one travel lane in each direction, separated by a curbed narrow median) that served as an exit/entrance ramp allowing access between an east-west Interstate highway and a north-south urban expressway. The Buick was traveling south in the southbound roadway of the same trafficway. It was snowing and the asphalt pavement was wet. The posted speed limit was 56 km.p.h. [35 m.p.h.]. The case vehicle had been negotiating a curve to the left and was entering a straight section of the road, traveling up a slope on the approach to an overpass. The case vehicle driver lost control and the case vehicle veered sharply across the separator and into the southbound lane (**Figure 1**).

**Figure 1:** Case vehicle's northbound path of travel, at the approximate location where the driver lost control and crossed into the southbound lane (case photo #04)

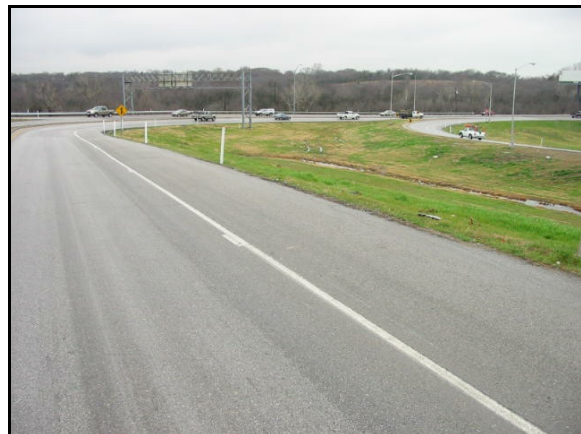
The right front corner of the case vehicle was impacted by the front of the Buick. The case vehicle was redirected in a southwesterly direction while rotating counterclockwise and the Buick was redirected in a southwesterly direction. As the Buick continued forward and to the right, its left rear contacted the right front corner of the case vehicle. Both vehicles slid off the west edge of the roadway and come to rest on the roadside heading approximately east (**Figure 2**).

**Figure 2:** Approximate final rest area for both vehicles, on the grassy slope along the west edge of the southbound roadway (case photo #13)

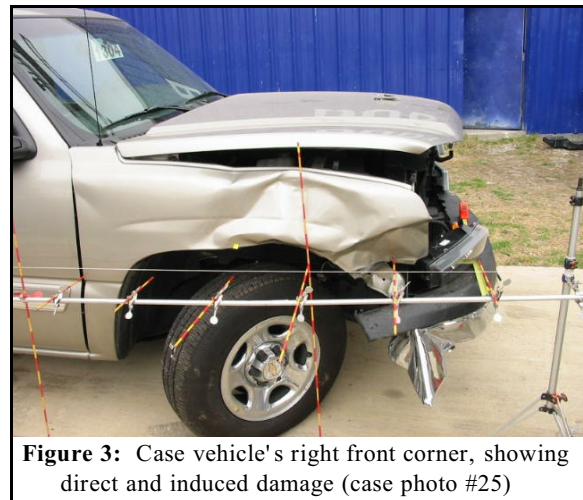
The case vehicle's initial contact with the Buick involved the right front fender and wheel, and the front bumper and fascia (**Figure 3**). Direct damage began 370 centimeters [145.7 inches] forward of the right rear axle and extended 78 centimeters [30.7 inches] forward along the fender to the bumper corner. Maximum crush was measured as 11 centimeters [4.3 inches] at C5. The wheelbase was not changed. The case vehicle's right front fender, front bumper, bumper fascia, and right front headlamp and turn lamp assemblies were directly damaged and crushed inward. There was no glazing damage (**Figure 4**).

**Figure 3:** Case vehicle's right front corner, showing direct and induced damage (case photo #25)

The case vehicle manufacturer's recommended tire size was P235/75R16 and the case vehicle was equipped with four Goodyear “Wrangler ST” tires of the recommended size. The right front wheel/tire was not physically restricted or damaged, but the leading edge was pushed inward with damage to the suspension/steering mechanism, and the wheel was immobile (**Figure 3**). There was no other wheel/tire damage.

Based on the vehicle inspection, CDCs for the case vehicle were determined to be: **03-RFEW-2 (100)** for event one and: **03-RFMW-1 (90)** for event two. The WinSMASH reconstruction program, damage algorithm based on the measured crush profile of both vehicles, was used on the case vehicle's highest severity (first) impact. The Total, Longitudinal, and Lateral Delta Vs are, respectively: 10.0 km.p.h. [6.2 m.p.h.], + 1.7 km.p.h. [+ 1.1 m.p.h.], and -9.8 km.p.h. [-6.1 m.p.h.]. WinSMASH values for the second impact could not be determined due to the overlapping damage but the crash severity for this impact was estimated to be minor (2-13 km.p.h. [1-8 m.p.h.]).

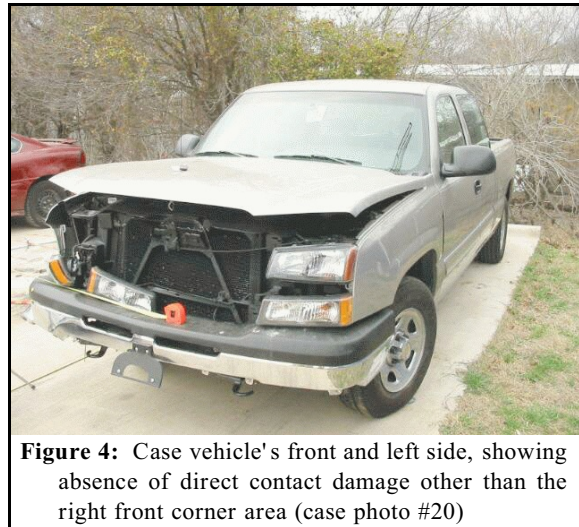
**Figure 4:** Case vehicle's front and left side, showing absence of direct contact damage other than the right front corner area (case photo #20)

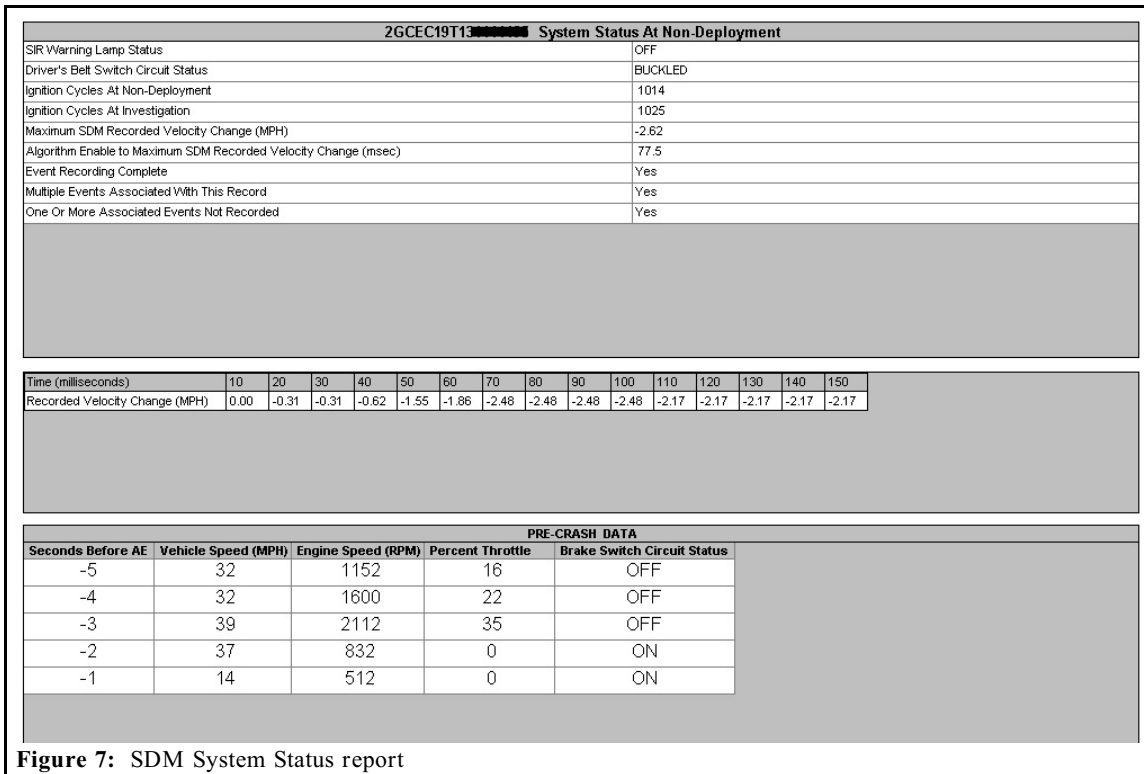
Figure 7: SDM System Status report

The SDM's System Status report (**Figure 7**) shows that the SIR Warning Lamp was off, meaning there were no faults detected in the automatic restraint system. The driver's safety belt was buckled, the crash occurred on ignition cycle 1,014 and the download was obtained on ignition cycle 1,025. The event recording was noted as complete, with multiple events associated with this record, meaning more than one event occurred within five seconds of the original algorithm enable.

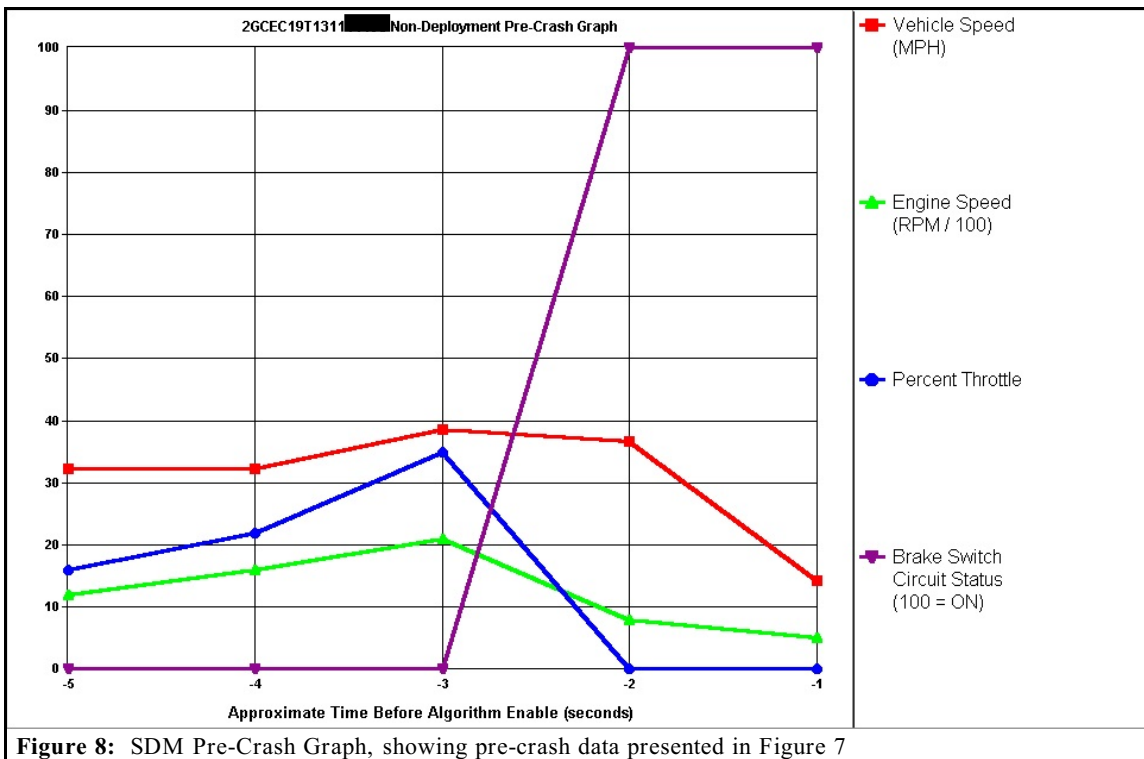
Figure 8: SDM Pre-Crash Graph, showing pre-crash data presented in Figure 7

The SDM's Non-Deployment Pre-Crash Data show that the case vehicle was traveling 51.5 km.p.h. [32 m.p.h.] five seconds prior to algorithm enable and accelerated to 62.8 km.p.h. [39 m.p.h.] at three seconds prior. Between -3 and -2 seconds, throttle input dropped to zero, the brakes were activated and the vehicle began to decelerate. At -1 second, the vehicle had slowed to 22.5 km.p.h. [14 m.p.h.]. The pre-crash data are presented as a table in **Figure 7** and shown graphically in **Figure 8**.

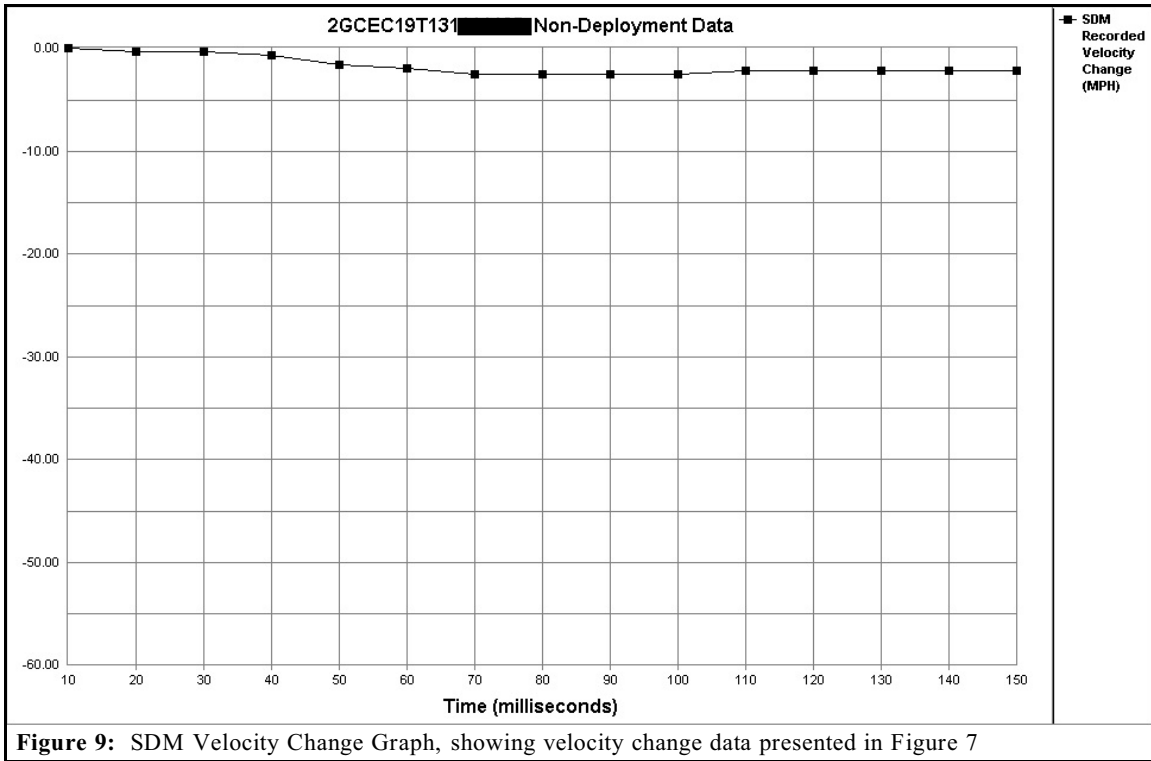
The SDM's Non-Deployment Velocity Change Data show negative longitudinal delta V accumulating gradually to -4.0 km.p.h. [-2.48 m.p.h.] at 70 milliseconds [0.070 seconds] after algorithm enable, with maximum velocity change -4.2 km.p.h. [-2.62 m.p.h.] at 77.5 milliseconds [0.0775 seconds]. The velocity change data are presented as a table in **Figure 7** and are shown graphically in **Figure 9**.
