TRANSPORTATION RESEARCH CENTER

ON-SITE CERTIFIED ADVANCED 208- COMPLIANT VEHICLE INVESTIGATION

CASE NUMBER - IN-03-005
LOCATION - ILLINOIS
VEHICLE - 2003 CHEVROLET K1500 TAHOE
CRASH DATE - January 2003

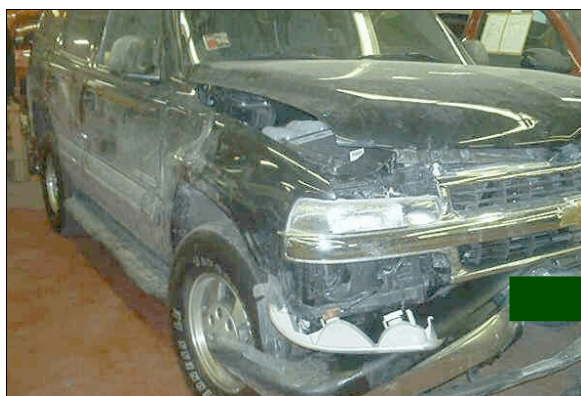
Figure 3: Body shop photo showing case vehicle's front right direct damage and induced damage to right fender and right front door (case photo #109)

Crash: The front (**Figure 3**) of the case vehicle impacted the left passenger area (**Figure 4**) of the Volvo, causing the Volvo to rotate counter-clockwise out of the case vehicle's travel path, while moving in a south-southwesterly direction. The Volvo's driver seat back-mounted, side air bag and the Volvo's left side curtain air bag deployed as a result its left side impact from the case vehicle.

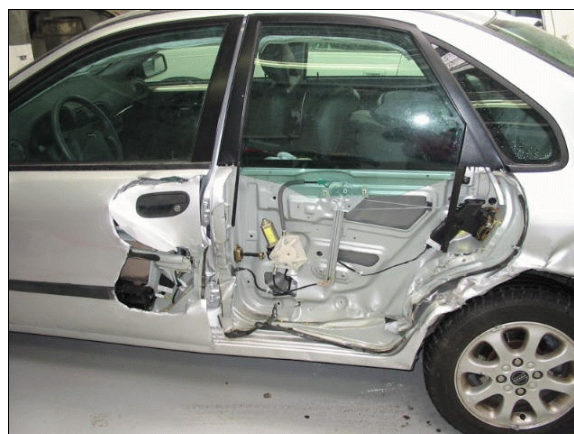
Figure 4: Impact on Volvo's left passenger area caused by front of case vehicle; Note: impact deployed Volvo's driver seat back-mounted side air bag and left side curtain air bag (case photo #63)

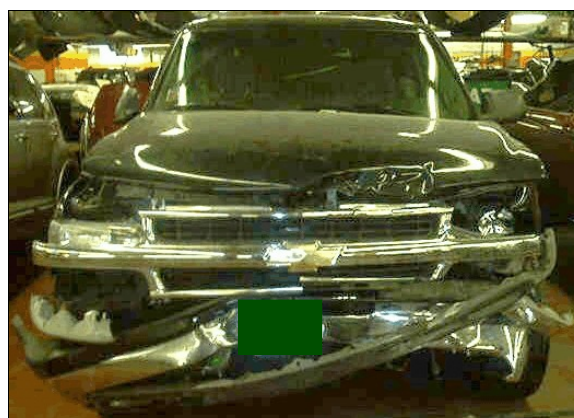
Post-Crash: As a result of the initial impact, the case vehicle continued in its southwesterly direction, and the front (**Figure 5** and **Figure 6** below) of the case vehicle impacted the concrete

Figure 5: Body shop photo of case vehicle's frontal damage showing damage across entire front (case photo #108)

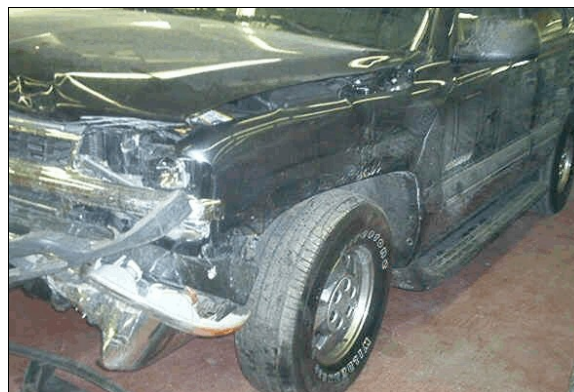
Figure 6: Body shop photo showing case vehicle's front left direct damage and induced damage to left fender and left front door (case photo #111)

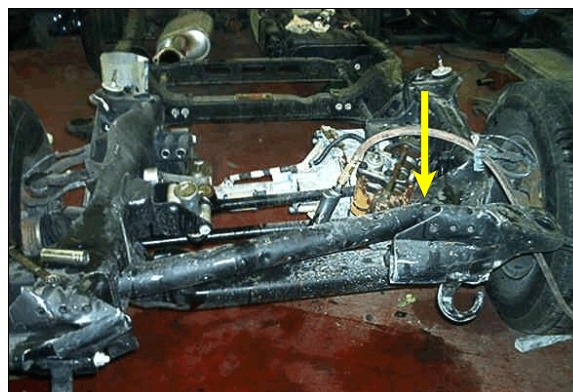
Figure 8: Body shop photo of case vehicle's frame showing damage to frame's front cross-member (case photo #113)

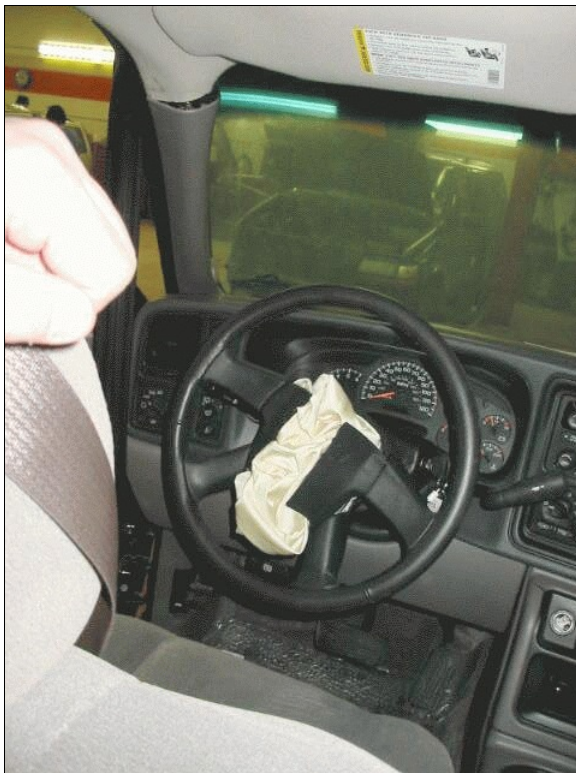
Figure 9: Case vehicle’s driver seating area showing no apparent evidence of occupant contact to the steering wheel, instrument panel, or green-house components (case photo #23)

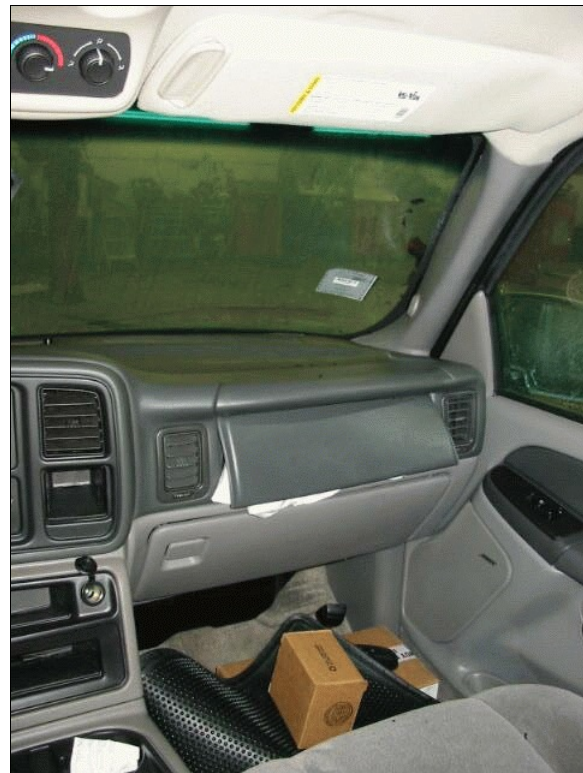
Figure 10: Case vehicle’s front right passenger seating area showing no apparent occupant contact evidence to the instrument panel or greenhouse components (case photo #25)

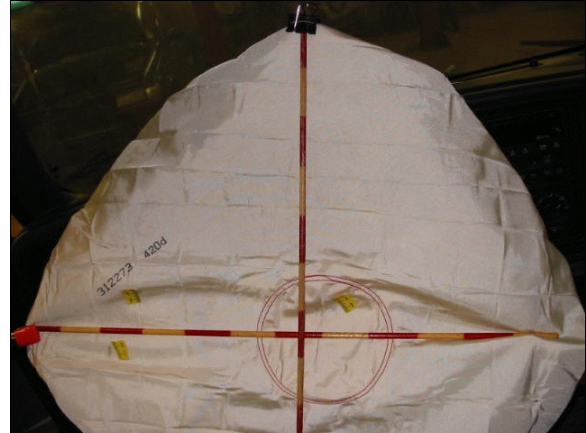
Figure 13: Case vehicle's deployed driver air bag showing makeup smear within center circular stitching and possible contacts toward 9 o'clock position (case photo #29)

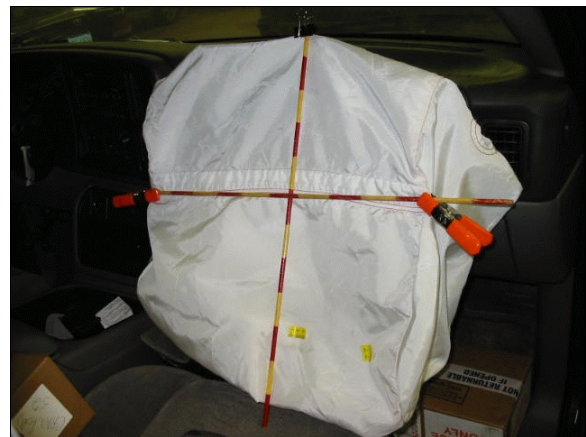
The front right passenger's air bag was located in the middle of the instrument panel. There was a single, essentially rectangular, modular cover flap. The cover flap was made of a semi-pliable vinyl. The flap's dimensions were 39 centimeters (15.4 inches) at the lower horizontal seam and 13.5 centimeters (5.3 inches) along both vertical seams. The profile of the case vehicle's instrument panel was flush with the leading edge of the cover flap. The distance between the mid-center of the front right seat back, as positioned at the time of the vehicle inspection, and the front surface of the air bag's fabric at full excursion was 25 centimeters (9.8 inches). An inspection of the front right air bag module's cover flap and the air bag's fabric revealed that the cover flap opened at the designated tear points, and there was no evidence of damage during the deployment to the air bag or the cover flap. The front right passenger's air bag was designed with one wide tether that measured approximately 39 centimeters (15.4 inches) in width. The front right air bag had two vent ports, approximately 3 centimeters (1.2 inches) in diameter, located at the 9:30 and 2:30 clock positions. The deployed front right air bag was rectangular with a height of approximately 60 centimeters (23.6 inches) and a width of approximately 50 centimeters (19.7 inches). An inspection of the front right passenger's air bag fabric revealed that there was some kind of fluid stain evidence apparent on the front surface of the air bag's fabric near the center of the lower right quadrant [i.e., 10 centimeters (3.9 inches) from the bottom and 6 centimeters (2.4 inches) inboard from the right edge]. In addition, there was some irregular scuffing at the lower center of the bag [i.e., 8 centimeters (3.1 inches) from the bottom and 18 centimeters (7.1 inches) inboard from the right edge—**Figure 14**].

Figure 14: Front surface of case vehicle's deployed front right passenger air bag showing a stain and a scuff in the middle of the lower right quadrant and toward the 6 o'clock position, respectively (case photo #39)

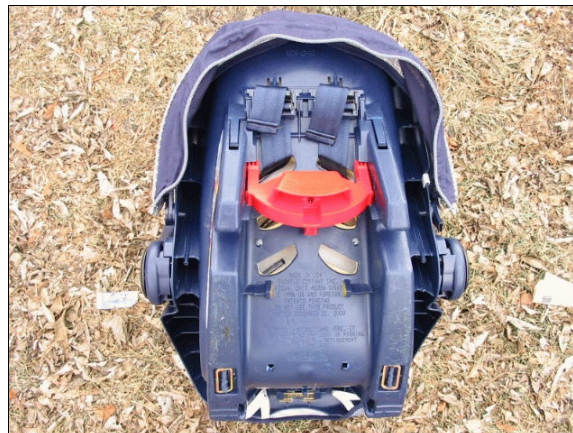
seat revealed no apparent damage or fractures to the base or the seat's shell (**Figure 19**). The position of the child seat's carrying handle (**Figures 16** and **18** above) at the time of the crash is unknown. This contractor has no indication that the handle was other than in its down position.

Figure 19: Overhead view of underneath side of shell of infant child safety seat used by case vehicle's back center passenger; Note: no apparent damage (case photo #105)

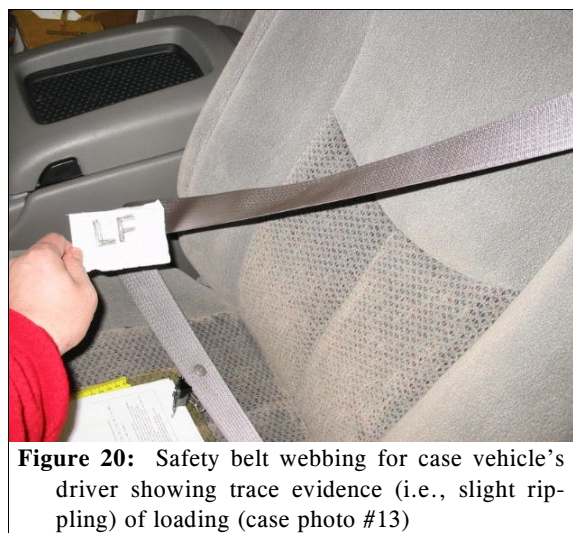
Based on this contractor's vehicle inspection and supported by the interview with the case vehicle's front right passenger and the **EDR** data, the driver was restrained by her available, active, three-point, integral lap-and-shoulder, safety belt system; the belt system was not equipped with a pretensioner. There was no mention by the front right passenger of belt pattern bruising and/or abrasions to the driver's torso, and while the inspection of the driver's seat belt webbing, shoulder belt guide, and latch plate found no obvious loading evidence on the integrated safety belt's webbing or latch plate, the webbing was slightly rippled indicating trace loading (**Figure 20**).

Figure 20: Safety belt webbing for case vehicle's driver showing trace evidence (i.e., slight rippling) of loading (case photo #13)

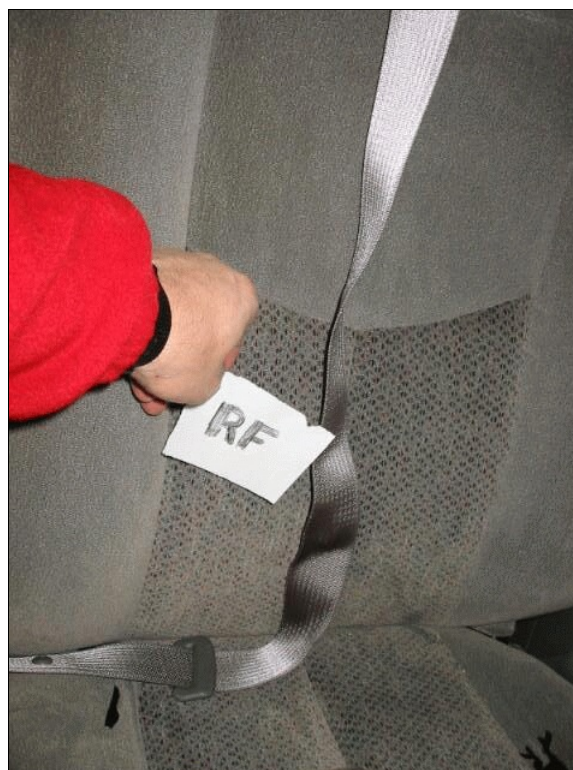
Figure 21: Safety belt webbing for case vehicle's front right passenger showing a wavy pattern indicative of occupant loading (case photo #17)

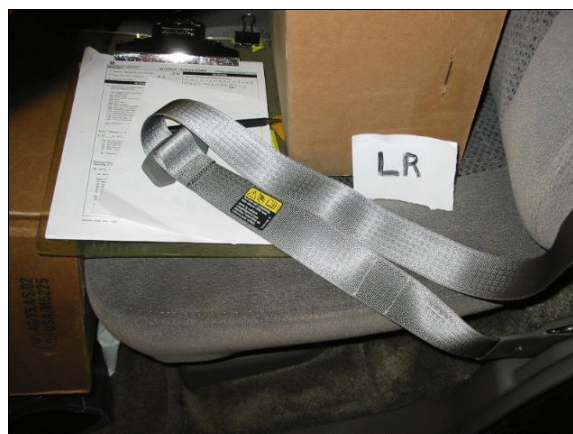
Figure 22: Seat belt webbing for case vehicle's back left passenger showing a wavy pattern indicative of occupant loading (case photo #51)

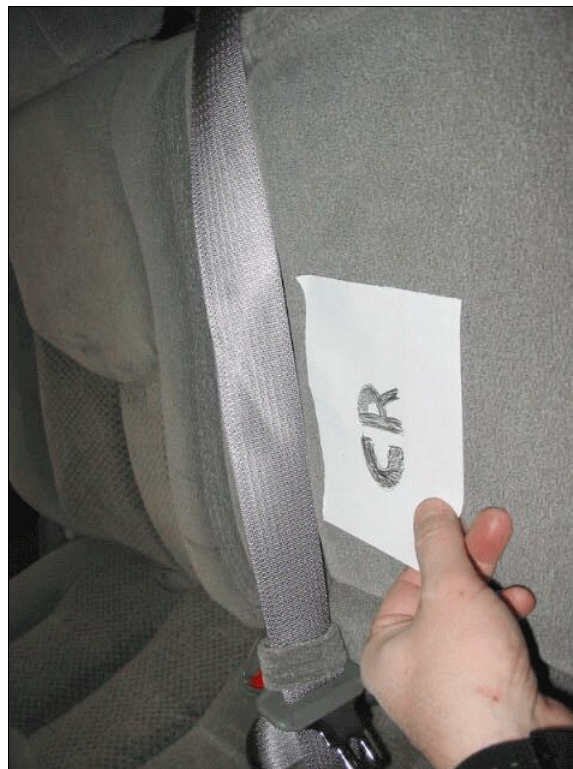
Figure 23: Seat belt webbing for case vehicle's back center passenger showing stress marks indicative of restraint usage (case photo #54)

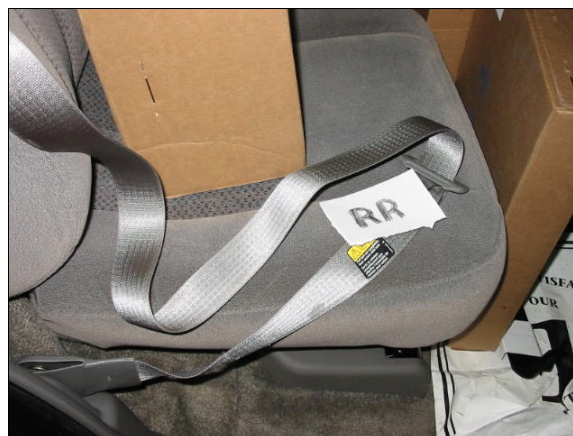
The second seat right passenger was restrained by her available, active, three-point, lap-and-shoulder, safety belt system; however, given this child's stature, it is unknown if but unlikely that the torso portion of the safety belt engaged this child's shoulder as designed. There was no mention by the front right passenger of belt pattern bruising and/or abrasions to the second seat right passenger's torso, but the inspection of the second seat right passenger's seat belt webbing and latch plate showed only trace evidence of usage during this crash (**Figure 24**).

Figure 24: Seat belt webbing for case vehicle's back right passenger showing stress marks indicative of occupant loading (case photo #48)

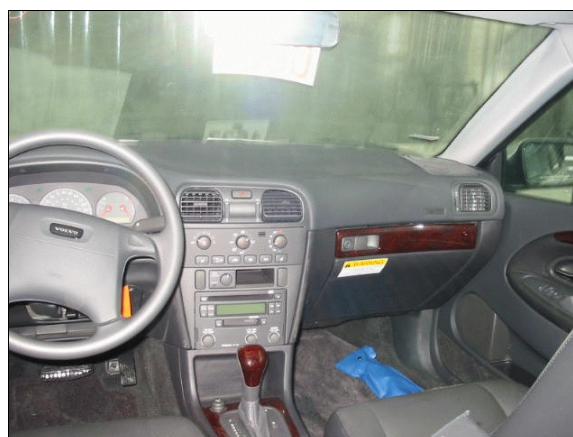
Figure 25: Volvo's front seating area showing non-deployed driver and front right passenger air bags; Note: steering wheel, instrument panel, and greenhouse area show no apparent evidence of occupant contact (case photo #70a)

Neither frontal air bag deployed (**Figure 25** above) as a result of the Volvo's left side impact (**Figure 4** above) with the case vehicle nor was either driver or front right passenger knee bolsters damaged or deformed.

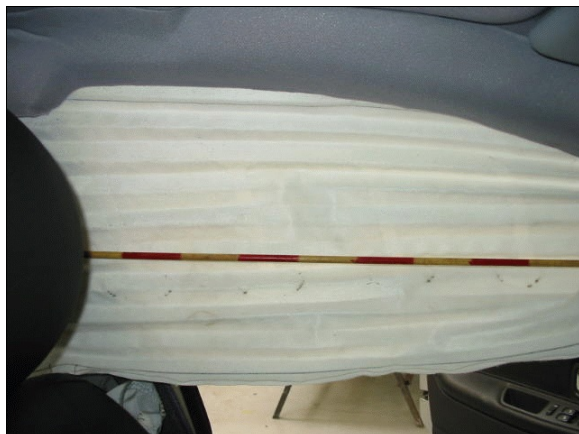
Figure 30: Inboard surface of Volvo’s left side inflatable curtain protecting driver’s seating area; Note: a hair and a possible lip print were found on the curtain’s fabric (case photo #84)

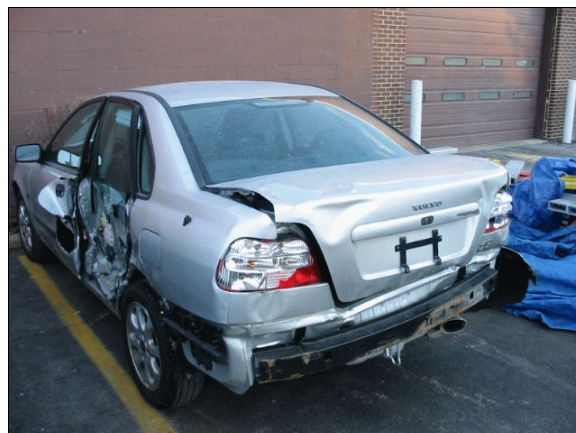
Exterior Damage: Based on the vehicle inspection, the CDCs for the Volvo were estimated as: **08-LZEW-2** (250 degrees) and **04-BDEW-1** (130 degrees). No crush profile or maximum crush were taken on the Volvo’s left side impact because the door surface was cut by pneumatic shears. No crush profile was taken on the impact to the Volvo’s back (Figure 32) because this impact occurred with a longitudinal barrier and the case vehicle was not involved. The Volvo manufacturer’s recommended tire size was: P195/60R15, and the Volvo’s tires were the recommended size. The Volvo’s tire data are shown in the table below. At the time of inspection, none of the Volvo’s tires were damaged, deflated, or physically restricted. The Volvo was towed due to damage.

Figure 32: Damage to Volvo’s left and back surfaces viewed from left of back; Note: greatest damage to Volvo’s back occurred to back right bumper (case photo #64)

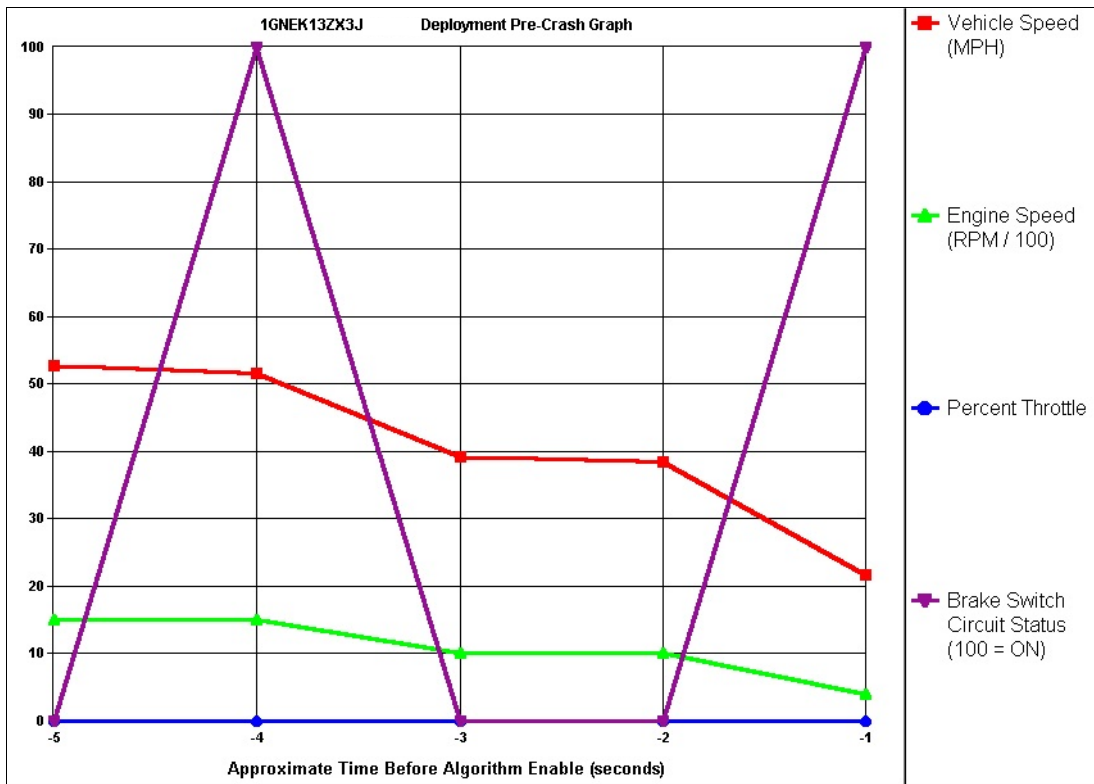
Figure 34: Case vehicle's pre-crash speed and brake switch circuit status showing that the vehicle's speed was recorded at 85 km.p.h. (53 m.p.h.), with the brake not activated, at approximately 5 seconds prior to algorithm enable and that the brake switch had been activated twice, once during the 4th and again during the 1st recorded sample periods prior to algorithm enable.

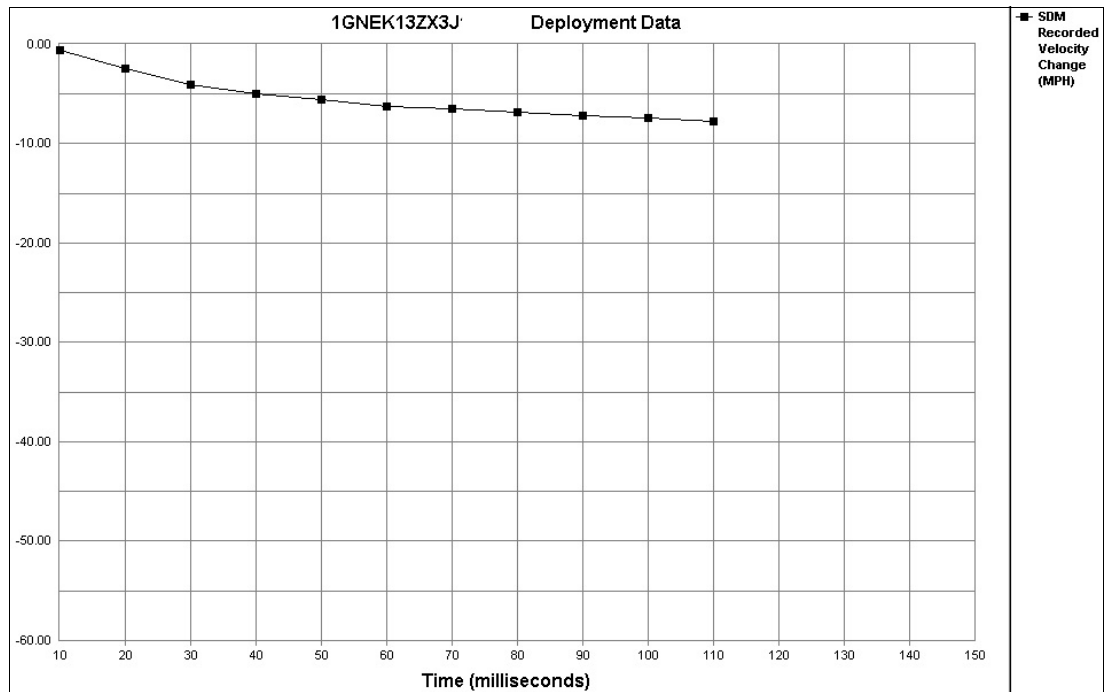
Figure 35: The case vehicle sustained a velocity change of approximately 12.5 km.p.h. (7.8 m.p.h.) during the first 110 milliseconds after the algorithm was enabled; maximum velocity change was recorded as 13.0 km.p.h. (8.1 m.p.h.) at 120 milliseconds
