**TRANSPORTATION SCIENCES  
CRASH DATA RESEARCH CENTER**

**SIDE IMPACT OCCUPANT PROJECTION INVESTIGATION**

**VERIDIAN CASE NO: CA03-012**

**VEHICLE: 2003 FORD CROWN VICTORIA POLICE INTERCEPTOR**

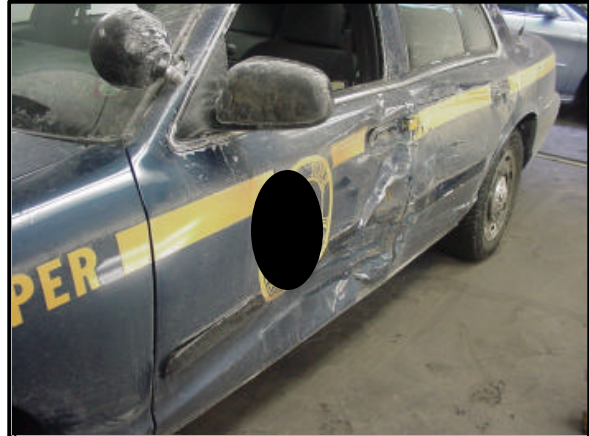
This investigation focused on the occupant protection provided by the left side impact air bag in a 2003 Ford Crown Victoria that deployed during a left side impact crash with a 1993 GMC Sonoma pick-up truck. The Ford Crown Victoria was a New York State Police Troop Car equipped with the Police Interceptor package. The Ford was equipped with a passive safety system that consisted of advanced driver and front right passenger air bags, front safety belt retractor pretensioners, and seat mounted side impact air bags for the front occupants. The left side impact air bag deployed as a result of a minor left side impact, **Figure 1**. There were no injuries as a result of the crash.

**Figure 1: Left side damage to the Ford.**

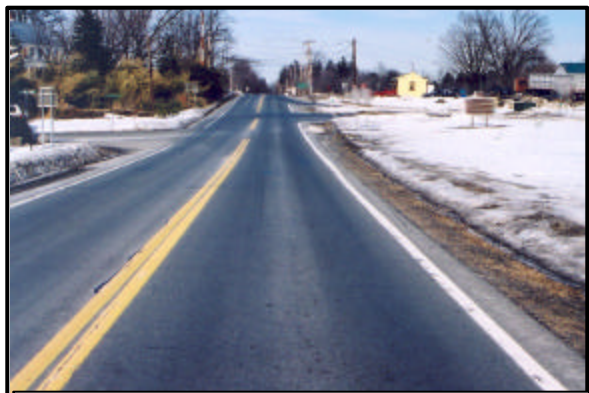
**Figure 2: Northbound trajectory view.**

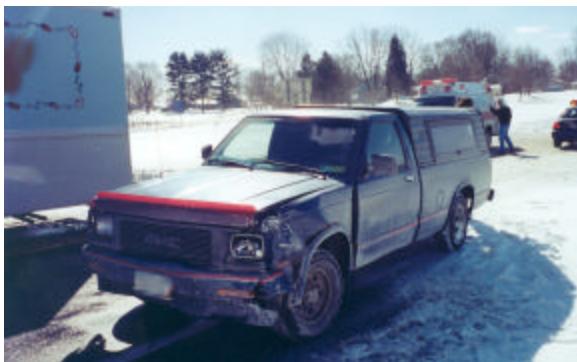
**Figure 4: Southeast view of the final rest position of the GMC.**

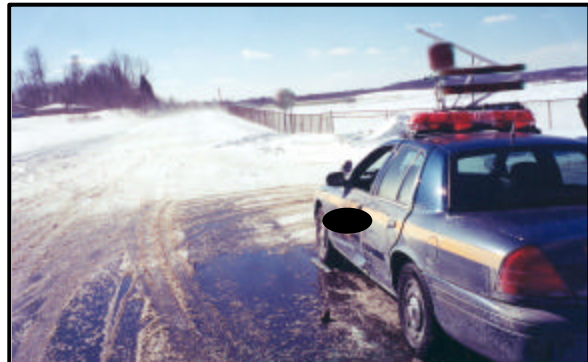
**Figure 3: Southward view of the final rest position of the Ford.**

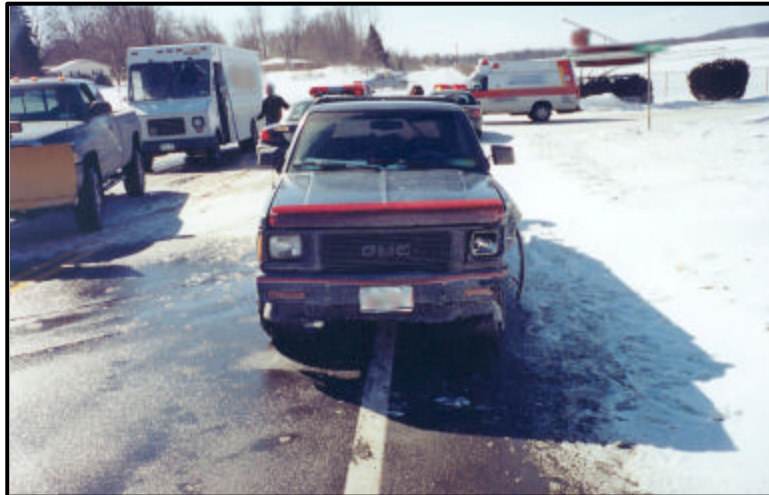
The 1993 GMC Sonoma, **Figure 5**, was not available for inspection. Analysis of the police photographs indicated the collision damage was isolated to the outboard 10 cm (4 in) of the left corner of the front bumper. The contact pattern then wrapped onto the left front fender

approximately 20 cm (12 in). The maximum crush was located at C1 and was an estimated 8 cm (3 in). The Collision Deformation Classification (CDC) was 12-FYEE-1.

**Figure 5: Front view of the GMC.**

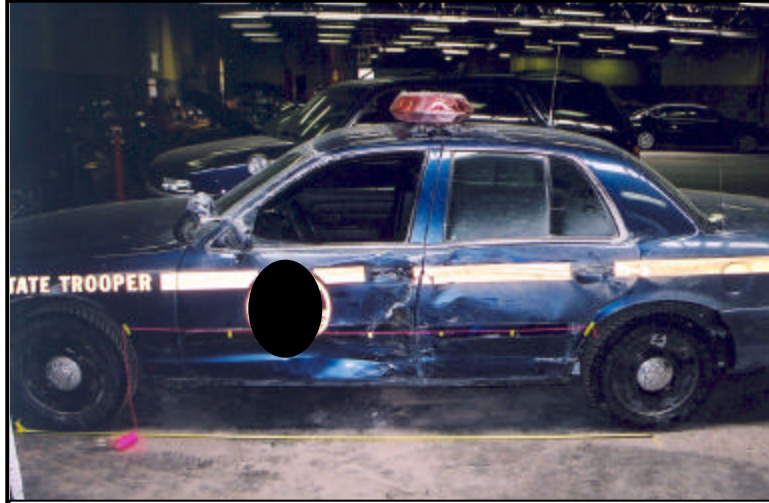
The left side plane of the Ford sustained 169.4 cm (66.7 in) of direct contact damage. The direct contact began 203.7 cm (80.2 in) forward of the left rear axle and ended 33.8 cm (13.3 in) forward of the rear axle. The impact damage was greater in magnitude on the left front door, in the area of initial engagement, and pocketed forward of the B-pillar. The contact then tapered to abrasions and paint transfer on the left rear door as the vehicles separated. The residual crush profile measured at the mid door elevation was as follows: C1 = 0, C2 = 0, C3 = 0.5 cm (0.2 in), C4 = 10.9 cm (4.3 in), C5 = 7.1 cm (2.8 in), C6=0. The maximum crush was located 27.4 cm (10.8 in) forward of the B-pillar at C4. The front door was jammed shut by deformation. The right rear door remained operational. The force of the impact shattered the left front glazing. The Collision Deformation Classification (CDC) was 11-LPEW-1. The total delta V calculated by the Damage Only Algorithm of the WINSMASH model was 9.0 km/h (5.6 mph). The longitudinal and lateral delta V components were -6.9 km/h (-4.3 mph) and 5.8 (3.6 mph), respectively.

**Figure 6: Left side view of the damaged Ford.**

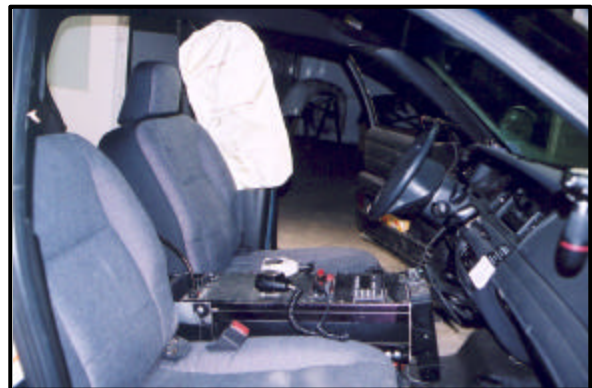
**Figure 7** is an interior view depicting the deployed side air bag. The left side impact air bag module was located in the outboard aspect of the seat back. The module measured 36 cm (14 in) in length and was located 25 cm (10 in) above the seat cushion. The air bag was designed to offer both head and thorax protection. The module was identified by the following manufacturer's nomenclature:

**Figure 7: Right interior view depicting the deployed side impact air bag.**

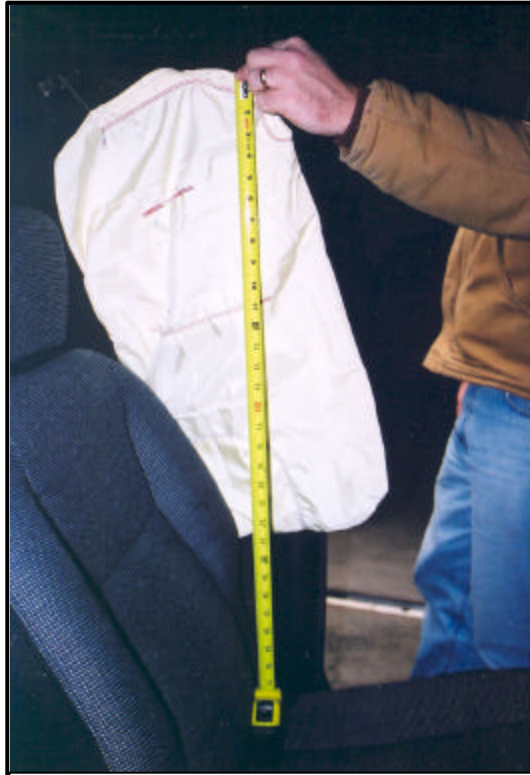
The air bag was rectangular in shape and measured 63.5 cm x 24.1 cm (25.0 in x 9.5 in), height by width. The forward excursion of the bag was measured from the seat bolster. The estimated depth of the thorax aspect of the inflated bag was 8 cm (3 in). The inflation was controlled an internal tether. The tether stitching measured 15 cm (6 in). A tether in the head aspect of the bag controlled the depth of inflation to an estimated 5 cm (2 in). The bag was not externally vented.

**Figure 8** is a close-up view of the deployed air bag.

**Figure 8: Deployed side impact air bag.**

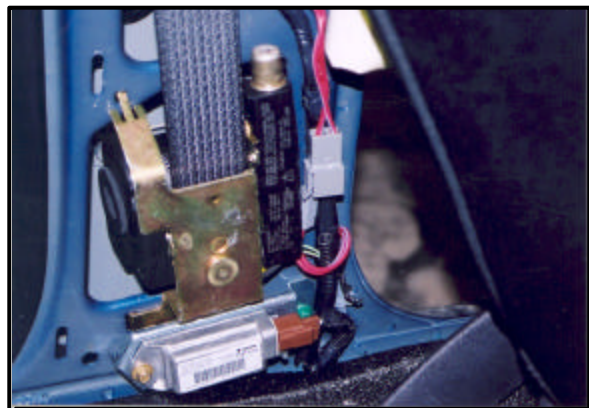
The deployment of the side impact air bag was controlled Restraint Control Module (RCM) located on the center tunnel. The RCM received side impact sensing from the satellite sensor located below the retractor at the base of the B-pillar. **Figure 9** is a view depicting the satellite sensor. The following nomenclature identified the sensor:

**Figure 9: Location of the side impact sensor.**

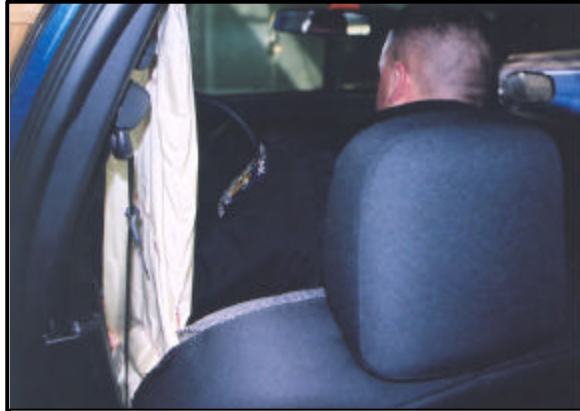
The driver of the Ford was a NYS Trooper with a stated height and weight of 180 cm (71 in) and 107 kg (235 lb). At the time of the impact, he prepared for the impact by leaning to the right away from the side structure and window. He recalled the air bag deploying and inflating past his left arm. The inflating air bag contacted the outboard aspect of his upper arm without

displacing the extremity. He was not injured in the event. **Figure 10** is a reconstructed view of his position at the time of the impact.

**Figure 10: Reconstructed position of the driver at impact.**

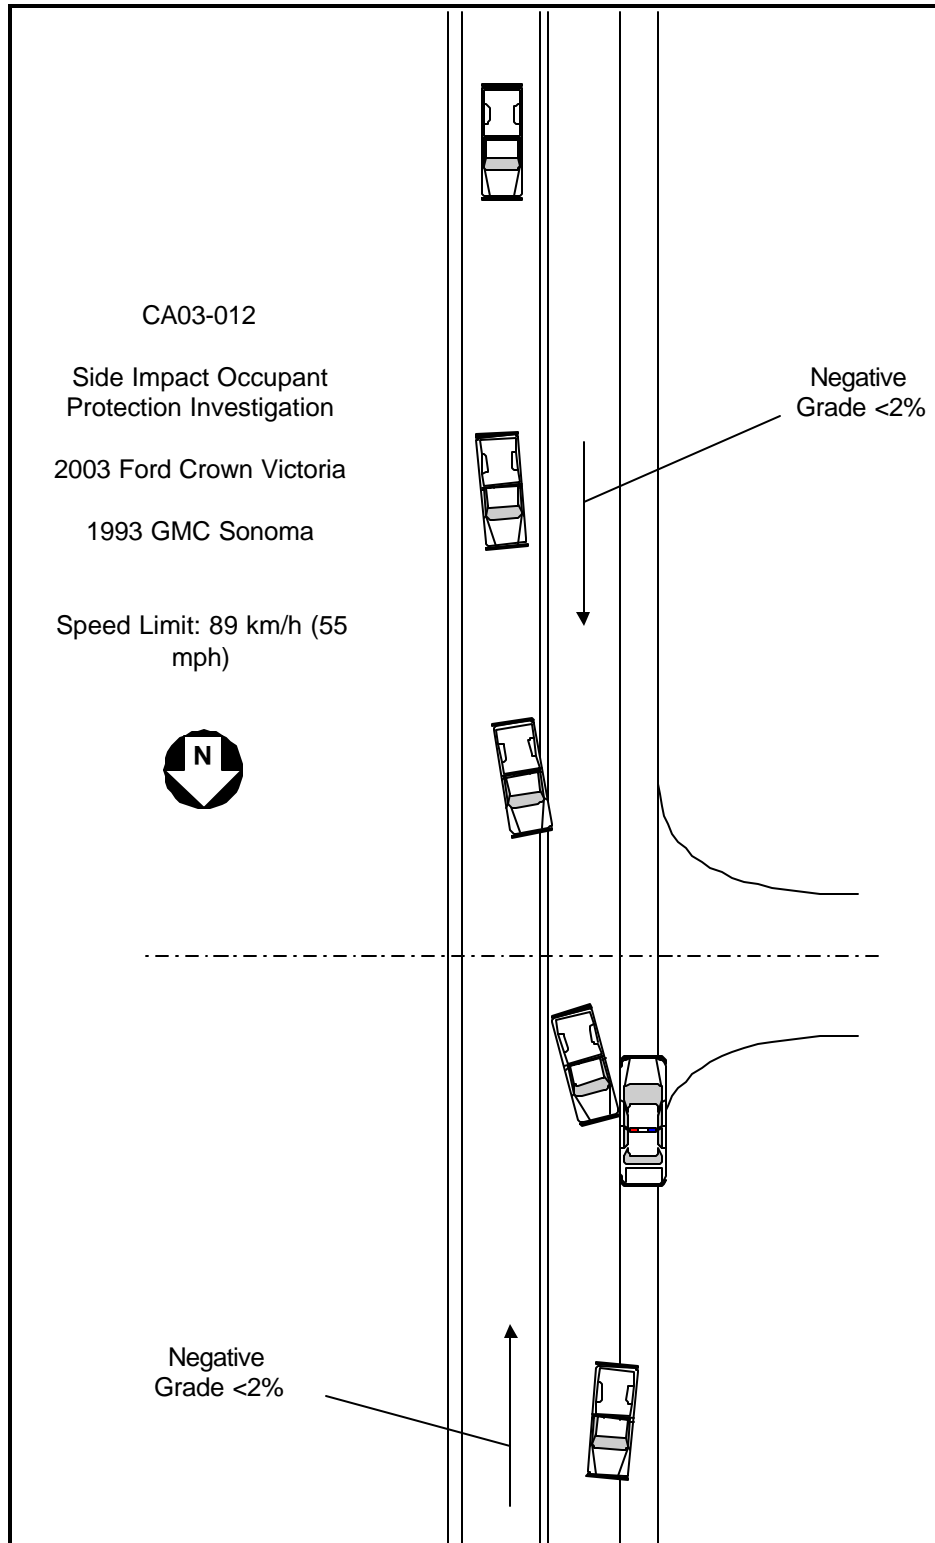
Figure 11: Crash Schematic.

The left aspect of the GMC's front bumper impacted the left side of the Ford at the center aspect of the front door. The Principle Direction of the impact Force (PDOF) was in the 11 o'clock sector with respect to the Ford. The impact speed of the GMC was an estimated 24 km/h (15 mph). The impact induced deceleration caused the Ford's left side impact air bag to deploy. The GMC was deflected along the left side of the Ford and disengaged from contact in the area of the left C-pillar. The GMC then came to a controlled stop approximately 18 m (60 ft) north of the Ford on the west shoulder. Neither the NYS Trooper nor the GMC driver were injured in the crash. Both vehicles were driven from the scene at the conclusion of the police investigation. **Figures 3 and 4** are on-scene photographs taken during the police investigation. A schematic of the crash is attached to the end of this report **Figure 11**.
