SIDE IMPACT OCCUPANT PROJECTION INVESTIGATION

VERIDIAN CASE NO: CA03-012

VEHICLE: 2003 FORD CROWN VICTORIA POLICE INTERCEPTOR

CRASH DATE: FEBRUARY, 2003

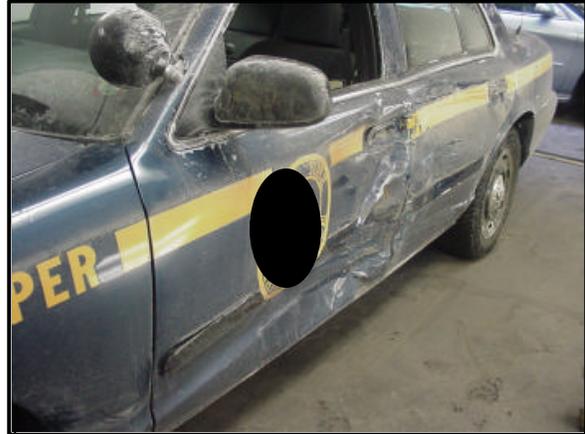
This investigation focused on the occupant protection provided by the left side impact air bag in a 2003 Ford Crown Victoria that deployed during a left side impact crash with a 1993 GMC Sonoma pick-up truck. The Ford Crown Victoria was a New York State Police Troop Car equipped with the Police Interceptor package. The Ford was equipped with a passive safety system that consisted of advanced driver and front right passenger air bags, front safety belt retractor pretensioners, and seat mounted side impact air bags for the front occupants. The left side impact air bag deployed as a result of a minor left side impact, **Figure 1**. There were no injuries as a result of the crash.

Figure 1: Left side damage to the Ford.

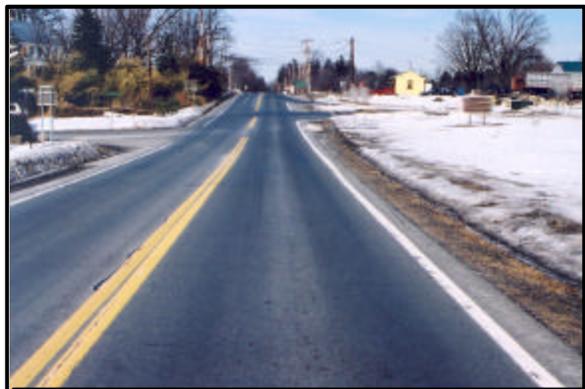
Figure 2: Northbound trajectory view.

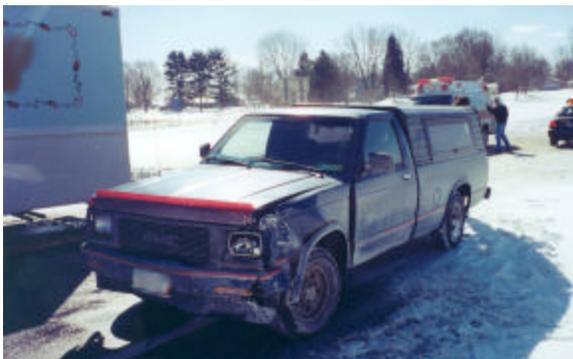
Figure 4: Southeast view of the final rest position of the GMC.

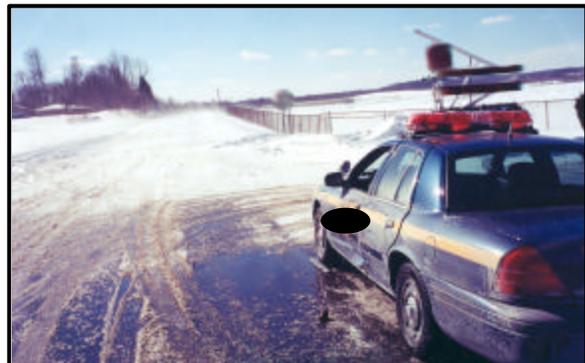
Figure 3: Southward view of the final rest position of the Ford.

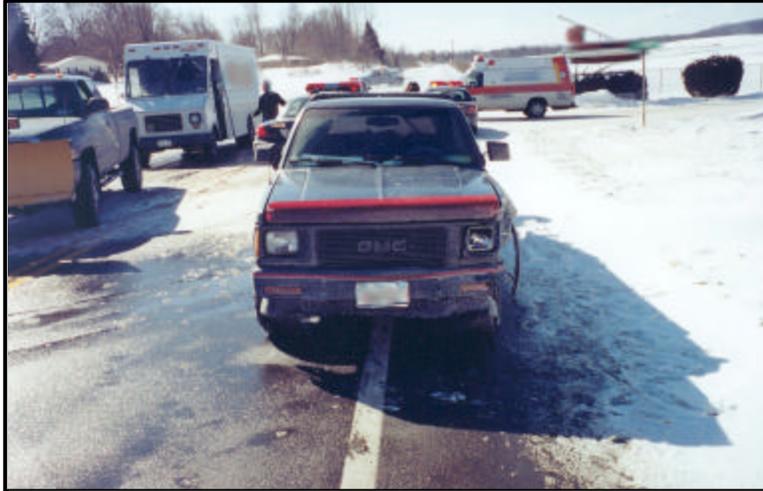
The 1993 GMC Sonoma, **Figure 5**, was not available for inspection. Analysis of the police photographs indicated the collision damage was isolated to the outboard 10 cm (4 in) of the left corner of the front bumper. The contact pattern then wrapped onto the left front fender

approximately 20 cm (12 in). The maximum crush was located at C1 and was an estimated 8 cm (3 in). The Collision Deformation Classification (CDC) was 12-FYEE-1.

Figure 5: Front view of the GMC.

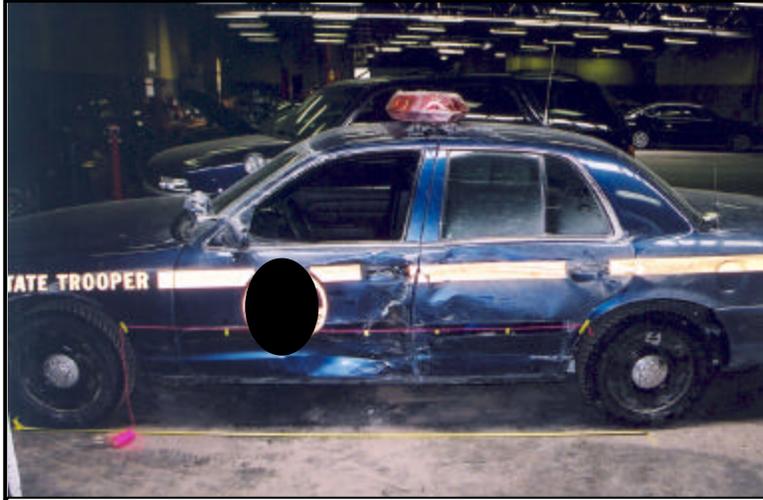
The left side plane of the Ford sustained 169.4 cm (66.7 in) of direct contact damage. The direct contact began 203.7 cm (80.2 in) forward of the left rear axle and ended 33.8 cm (13.3 in) forward of the rear axle. The impact damage was greater in magnitude on the left front door, in the area of initial engagement, and pocketed forward of the B-pillar. The contact then tapered to abrasions and paint transfer on the left rear door as the vehicles separated. The residual crush profile measured at the mid door elevation was as follows: C1 = 0, C2 = 0, C3 = 0.5 cm (0.2 in), C4 = 10.9 cm (4.3 in), C5 = 7.1 cm (2.8 in), C6=0. The maximum crush was located 27.4 cm (10.8 in) forward of the B-pillar at C4. The front door was jammed shut by deformation. The right rear door remained operational. The force of the impact shattered the left front glazing. The Collision Deformation Classification (CDC) was 11-LPEW-1. The total delta V calculated by the Damage Only Algorithm of the WINSMASH model was 9.0 km/h (5.6 mph). The longitudinal and lateral delta V components were -6.9 km/h (-4.3 mph) and 5.8 (3.6 mph), respectively.

Figure 6: Left side view of the damaged Ford.

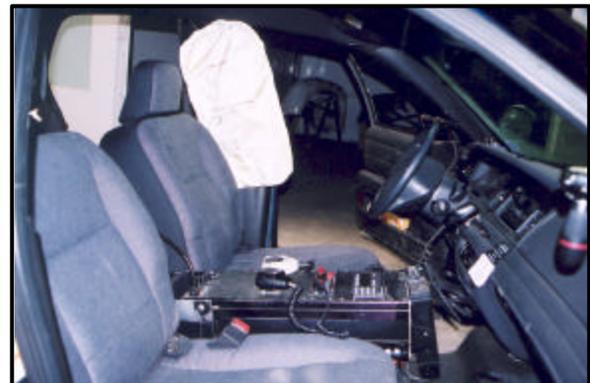
Figure 7 is an interior view depicting the deployed side air bag. The left side impact air bag module was located in the outboard aspect of the seat back. The module measured 36 cm (14 in) in length and was located 25 cm (10 in) above the seat cushion. The air bag was designed to offer both head and thorax protection. The module was identified by the following manufacturer's nomenclature:

Figure 7: Right interior view depicting the deployed side impact air bag.

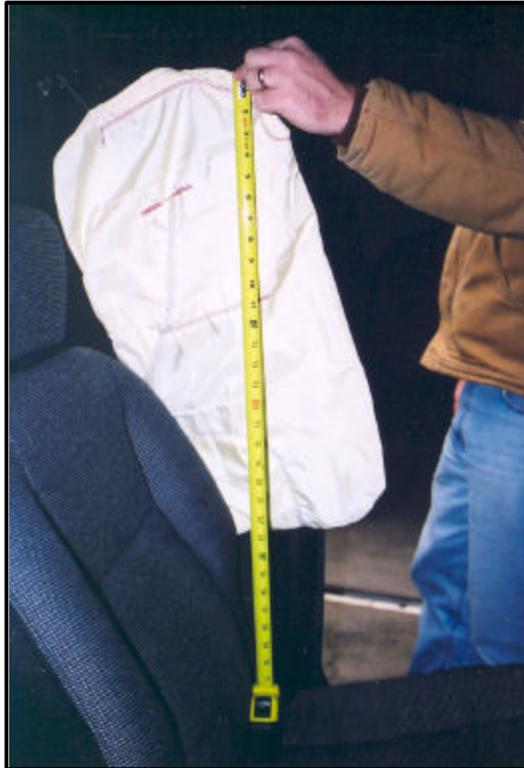
The air bag was rectangular in shape and measured 63.5 cm x 24.1 cm (25.0 in x 9.5 in), height by width. The forward excursion of the bag was measured from the seat bolster. The estimated depth of the thorax aspect of the inflated bag was 8 cm (3 in). The inflation was controlled an internal tether. The tether stitching measured 15 cm (6 in). A tether in the head aspect of the bag controlled the depth of inflation to an estimated 5 cm (2 in). The bag was not externally vented.

Figure 8: Deployed side impact air bag.

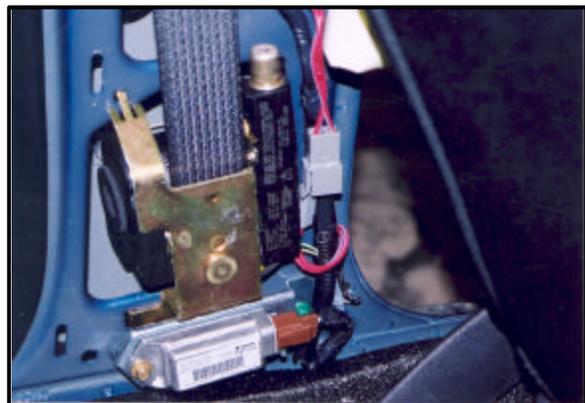
The deployment of the side impact air bag was controlled Restraint Control Module (RCM) located on the center tunnel. The RCM received side impact sensing from the satellite sensor located below the retractor at the base of the B-pillar. **Figure 9** is a view depicting the satellite sensor. The following nomenclature identified the sensor:

Figure 9: Location of the side impact sensor.

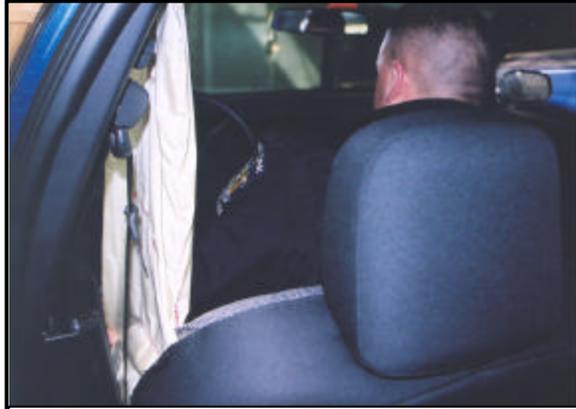
The driver of the Ford was a NYS Trooper with a stated height and weight of 180 cm (71 in) and 107 kg (235 lb). At the time of the impact, he prepared for the impact by leaning to the right away from the side structure and window. He recalled the air bag deploying and inflating past his left arm. The inflating air bag contacted the outboard aspect of his upper arm without

displacing the extremity. He was not injured in the event. **Figure 10** is a reconstructed view of his position at the time of the impact.

Figure 10: Reconstructed position of the driver at impact.

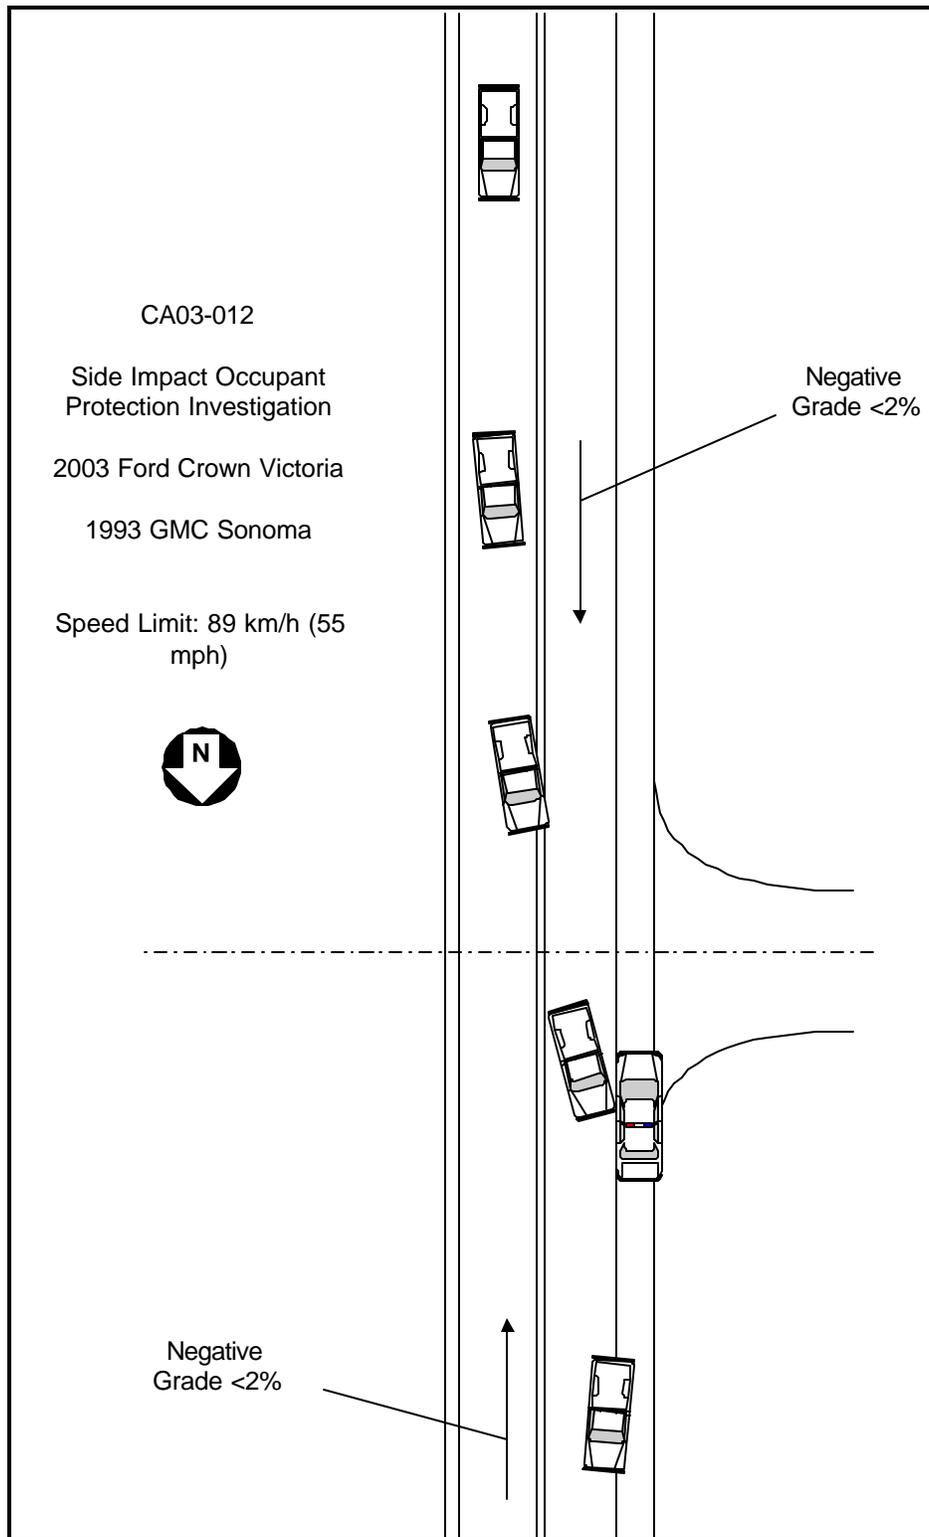
Figure 11: Crash Schematic.

The left aspect of the GMC's front bumper impacted the left side of the Ford at the center aspect of the front door. The Principle Direction of the impact Force (PDOF) was in the 11 o'clock sector with respect to the Ford. The impact speed of the GMC was an estimated 24 km/h (15 mph). The impact induced deceleration caused the Ford's left side impact air bag to deploy. The GMC was deflected along the left side of the Ford and disengaged from contact in the area of the left C-pillar. The GMC then came to a controlled stop approximately 18 m (60 ft) north of the Ford on the west shoulder. Neither the NYS Trooper nor the GMC driver were injured in the crash. Both vehicles were driven from the scene at the conclusion of the police investigation. **Figures 3 and 4** are on-scene photographs taken during the police investigation. A schematic of the crash is attached to the end of this report **Figure 11**.
