## ON-SITE AIR BAG INVESTIGATION

CASE NUMBER - IN-03-015

VEHICLE - 2002 CHEVROLET MONTE CARLO

CRASH DATE - March 2003

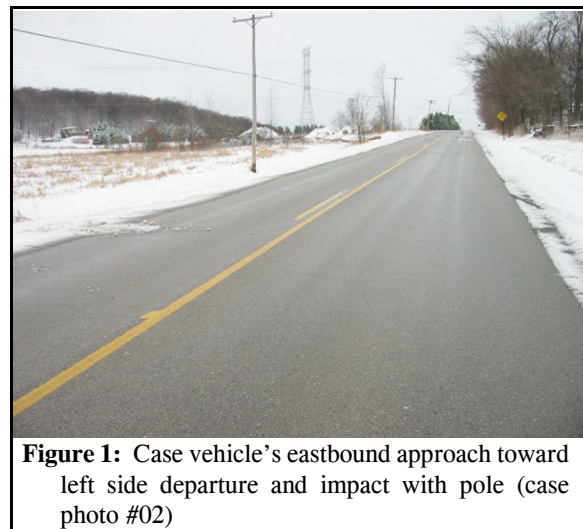
The case vehicle was traveling east in the eastbound lane of a two-lane, undivided county roadway (i.e., there was one lane in each direction) and intended to continue straight ahead. The speed limit was 72 km.p.h. [45 m.p.h.], the roadway was straight and level and the asphalt road surface was in good repair. The opposing lanes were separated by a solid yellow line for eastbound traffic and a broken yellow line for westbound. The paved surface was 7.6 meters [25 feet] wide, with narrow gravel shoulders and a shallow drainage ditch on each side. The roadway was covered with snow and ice and the case vehicle encountered a patch of ice, causing it to go out of control. The case vehicle's driver reported that she released the accelerator, pumped the brakes and attempted to steer to regain control but the car ran off the road to the left, probably in a slight counterclockwise yaw, prior to the crash. The crash occurred off the roadway to the left (north) (**Figure 1**).

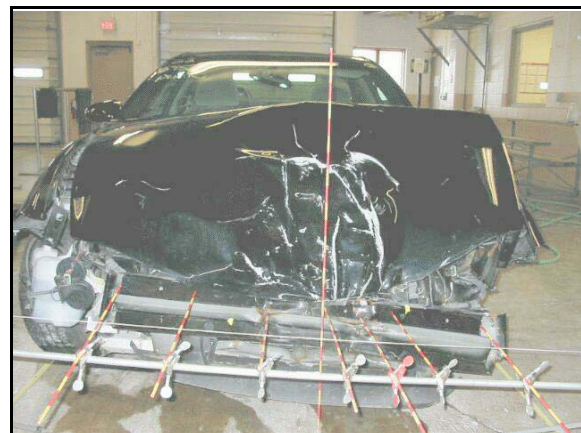
The case vehicle's contact with the utility pole involved the front bumper, grille, radiator, and hood (**Figures 2 and 3**). Direct damage began 36 centimeters [14.2 inches] inward from the front right bumper corner (actual metal bumper, not bumper fascia) and extended 54 centimeters [21.3 inches] inward, along the front bumper. Maximum crush was measured as 38 centimeters [14.9 inches] between C2 and C3. The wheelbase on the case vehicle's left side was shortened 2 centimeters [0.8 inches] while the right side remained unchanged. The front bumper, bumper fascia, grille, hood, and radiator were directly damaged and crushed rearward. The right and left fenders sustained induced damage. None of the case vehicle's tires were restricted or damaged and there was no glazing damage.

Based on the vehicle inspection, the CDC for the case vehicle was determined to be: **01-FDEW-2 (40)**. The WinSMASH reconstruction program, barrier algorithm, was used on the case vehicle's impact. The Total, Longitudinal, and

**Figure 2:** Front of case vehicle, straight on (case photo #07)

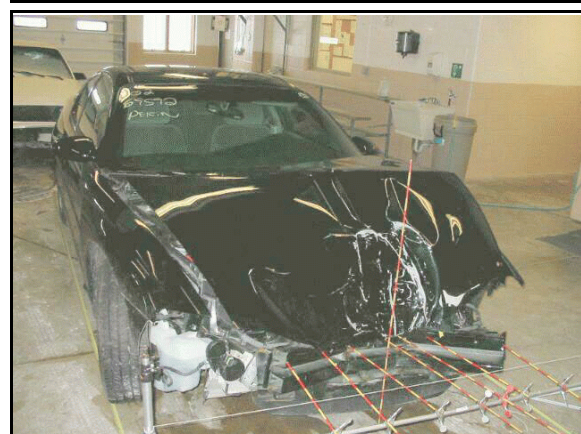
**Figure 3:** Front of case vehicle, elevated angle view from right (case photo #20)

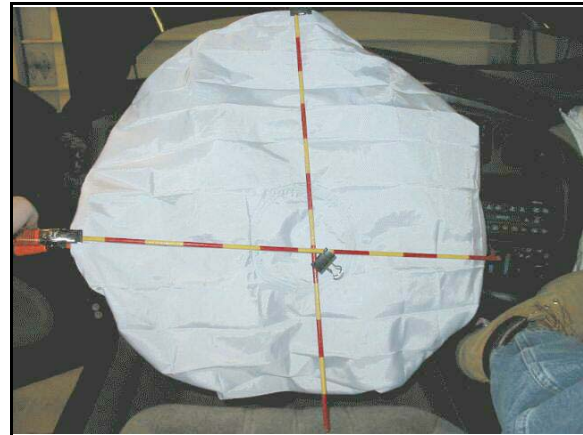
The case vehicle's driver air bag was located in the steering wheel hub (**Figure 4**). An inspection of the air bag module's cover flaps and air bag revealed that the cover flaps opened at the designated tear points, and there was no evidence of damage during the deployment to the air bag or the cover flaps. The driver's air bag was designed with four tethers, each 7.7 centimeters [3.0 inches] wide. The driver's air bag had two vent ports, approximately 3.5 centimeters [1.4 inches] in diameter, located at the 11 and 1 o'clock positions. The deployed driver's air bag was round with a diameter of 65 centimeters [25.6 inches]. There were routine deployment marks but no contact evidence readily apparent on the driver's air bag.

**Figure 4:** Front of driver air bag (case photo #34)

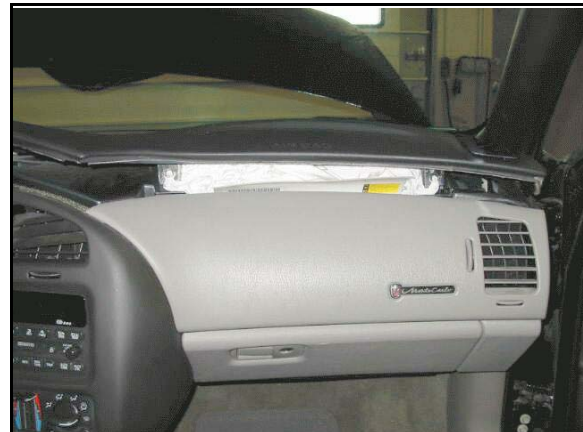
**Figure 5:** Raised top of active instrument panel, showing the opening through which the front right air bag deployed (case photo #41)

The front right passenger's air bag was located in the mid-mount position, on the front of the instrument panel, in a configuration that the manufacturer refers to as an "active instrument panel". There was no module cover flap as such. Rather, as the deploying air bag expands, it forces the top of the instrument panel upward, causing the points of attachment to break away and creating an opening between the horizontal top and the vertical front of the instrument panel. The air bag deploys through this opening (**Figures 5 and 6**). The deployed front right air bag was rectangular with a height of approximately 54 centimeters [21.3 inches] and a width of approximately 36 centimeters [14.2 inches] (**Figure 7**). The air bag was designed with one tether, which was 32 centimeters [12.6 inches] wide. The front right air bag had two vent ports, approximately 4.5 centimeters [1.8 inches] in diameter, located at the 9:30 and 2:30 clock positions. There was no contact evidence on the front right air bag.

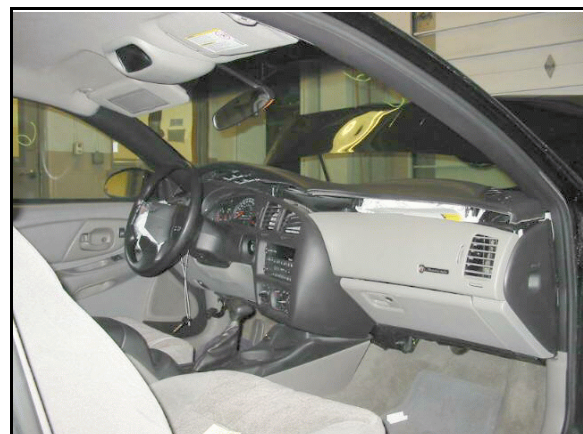
**Figure 6:** Active instrument panel raised across entire width (case photo #32)

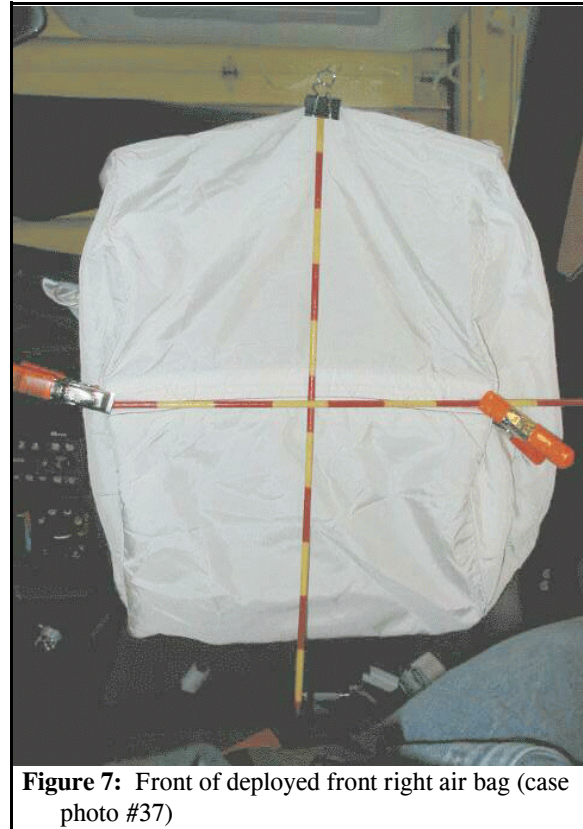
**Figure 7:** Front of deployed front right air bag (case photo #37)

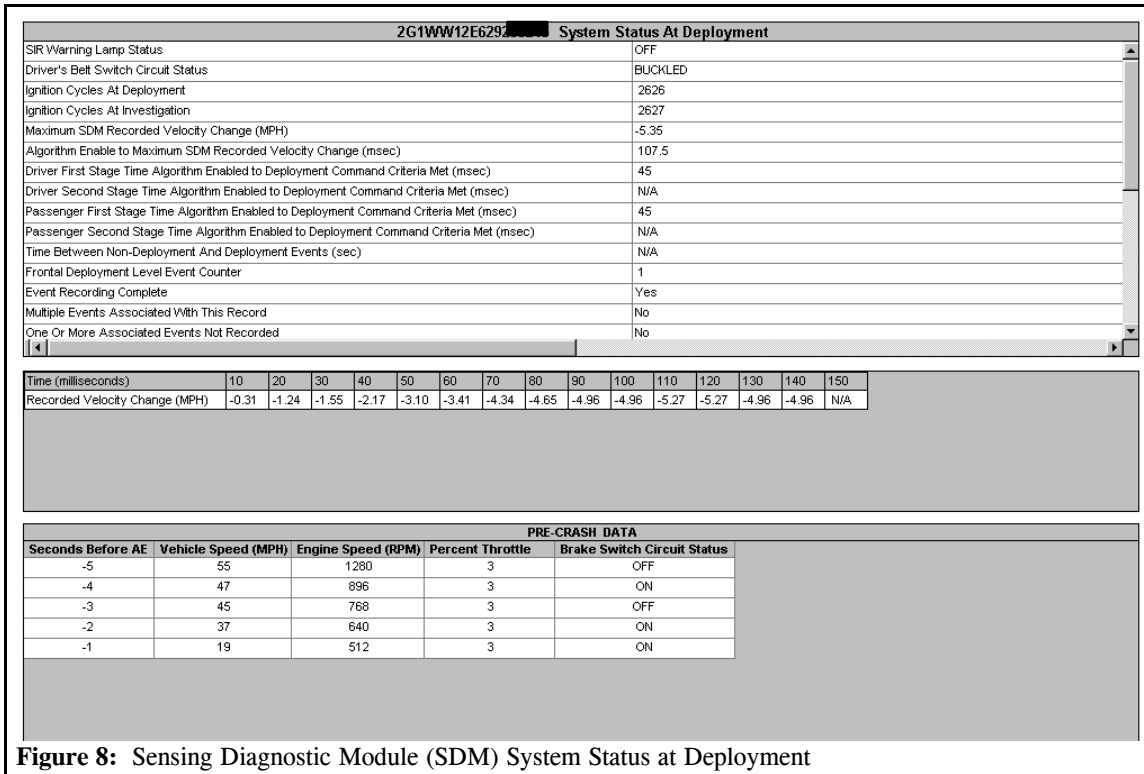
The case vehicle's Event Data Recorder (EDR) was successfully downloaded in the field via the diagnostic port (i.e., the vehicle's electrical system was functional). The Sensing Diagnostic Module (SDM) report is included as **Figures 8, 9** and **10**. The System Status Report shows that the Supplemental Inflatable Restraint (SIR) warning lamp was OFF indicating no error conditions in the automatic restraint system, the driver's seat belt was buckled and the deployment event occurred during ignition cycle 2,626 (**Figure 8**). The case vehicle was traveling approximately 89 km.p.h. [55 m.p.h.] with 3 percent throttle five seconds prior to the impact. The driver pumped the brakes on, off and on again over the next four seconds and the vehicle slowed to 31 km.p.h. [19 m.p.h.] at one second prior to the impact (**Figures 8** and **9**). The case vehicle driver and front right passenger air bags were equipped with multi-stage inflators. The SDM report indicates that the command for first stage deployment was issued at 45 milliseconds [0.045 seconds] after algorithm enable and the criteria for second stage deployment were not met (**Figure 8**). The SDM report indicates that the maximum recorded velocity change was -8.6 km.p.h. [-5.35 m.p.h.] at 107.5 milliseconds [0.1075 seconds] after algorithm enable (**Figure 8**). The velocity change data show deltaV accumulating gradually to the maximum at approximately 110 milliseconds following algorithm enable. Recording stopped at 140 milliseconds (**Figures 8** and **10**). The WinSMASH barrier algorithm calculated longitudinal deltaV for the case vehicle was -15.3 km.p.h. [-9.5 m.p.h.].

Figure 8: Sensing Diagnostic Module (SDM) System Status at Deployment

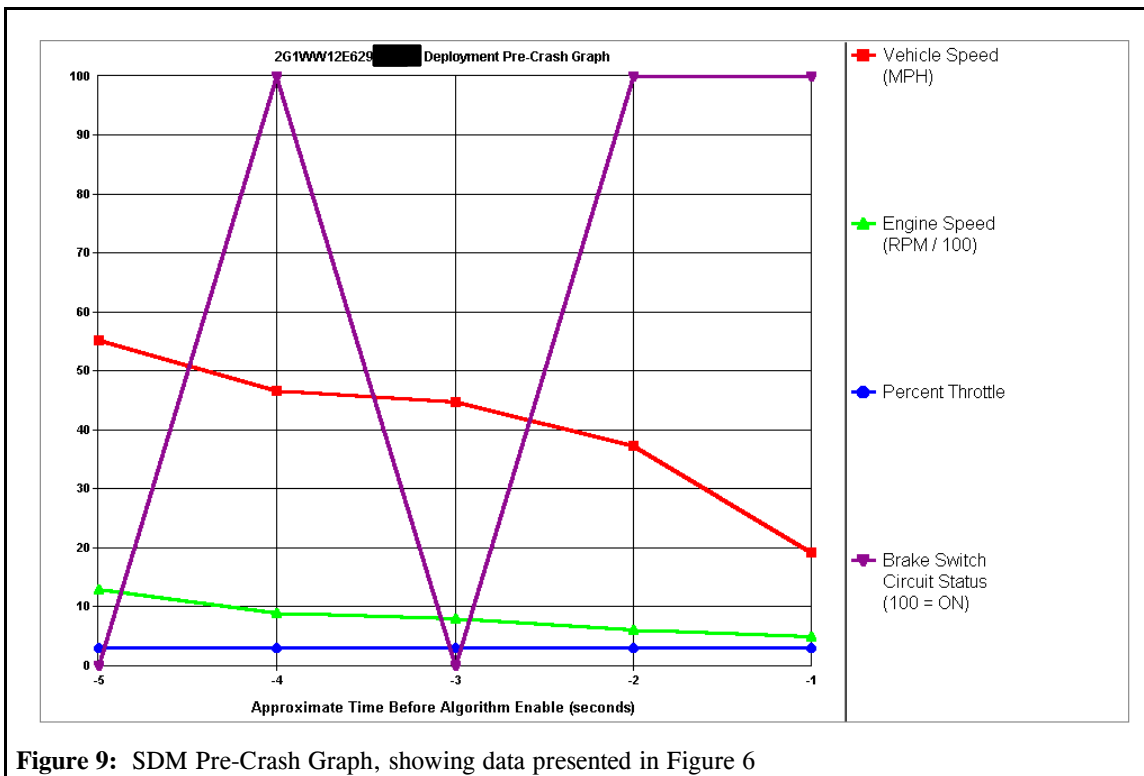
Figure 9: SDM Pre-Crash Graph, showing data presented in Figure 6

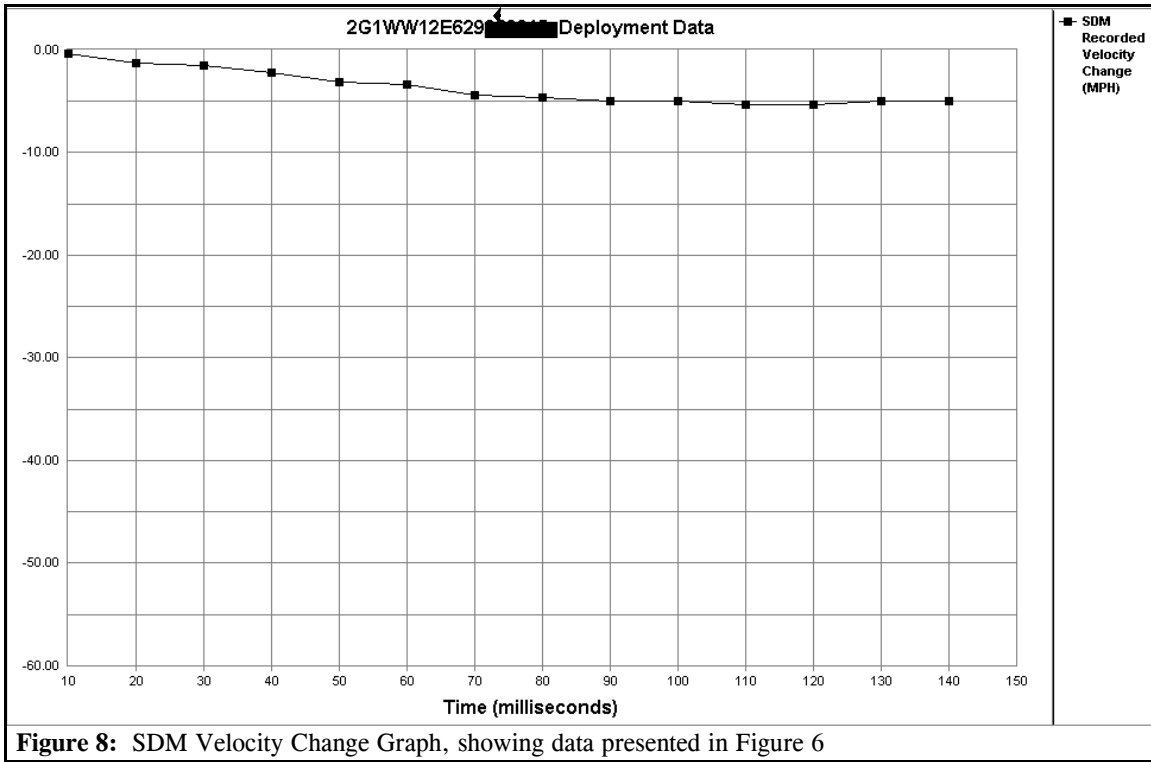
Figure 8: SDM Velocity Change Graph, showing data presented in Figure 6
