On-Site Passenger Air Bag Child Fatality Investigation / Vehicle to Vehicle
Dynamic Science, Inc. / Case Number: DS03016
2001 Kia Spectra
California
April, 2003

1. Report No. DS03016		2. Government Accession No.		3. Recipient Catalog No.	
4. Title and Subtitle Passenger Air Bag Child Fatality Investigation				5. Report Date

Dynamic Science, Inc.
Crash Investigation
Case Number: DS03016

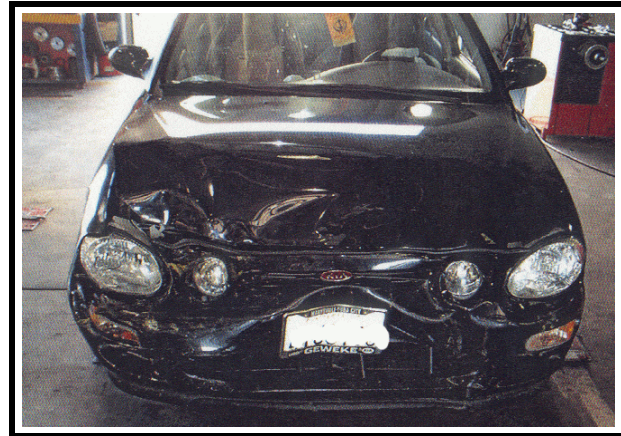
Figure 2. Front, case vehicle

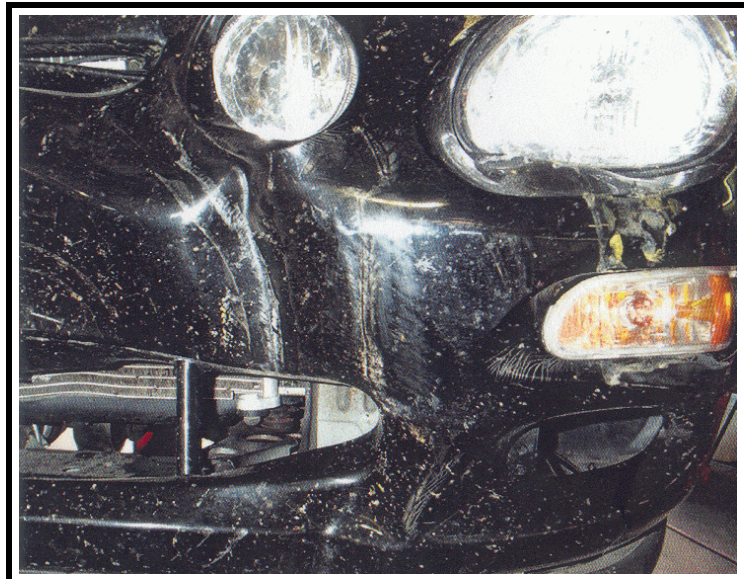
Figure 3. Close up, front bumper of case vehicle

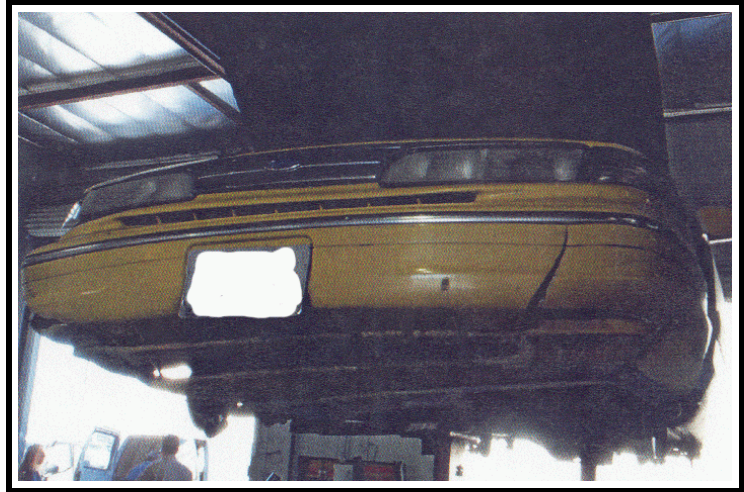
Figure 4. Front bumper of other vehicle (Crown Victoria)

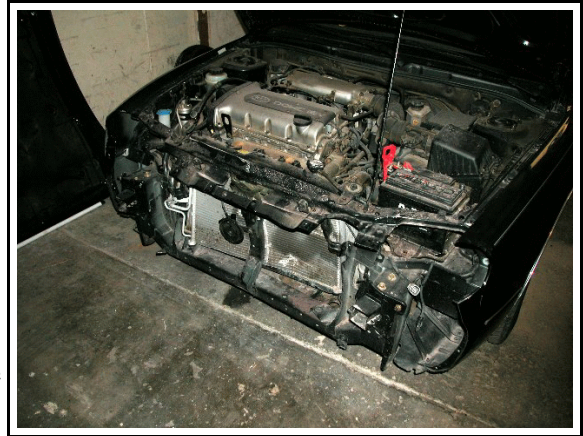
Damage Description:	Moderate front end damage. Bumper, backing bar, hood, radiator.	
CDC:	12FDEW1	
Delta V:	Total	19.0 km/h (11.8 mph)
	Longitudinal	-18.7 km/h (-11.6 mph)
	Latitudinal	3.3 km/h (2.1 mph)
	Energy	27,164 joules (20,035 ft-lbs)

The case vehicle had been partially dismantled prior to inspection. The vehicle sustained 134.0 cm (52.7 in) of direct contact across the full width of the hood. The principle direction of force was within the 12 o'clock sector and was an estimated 350 degrees. The impact energy was managed by the forward structures of the vehicle. The damaged components for this impact included the bumper fascia and reinforcement bar, upper and lower radiator supports, and hood. There was damage to the right side of the windshield from the passenger air bag module cover.

Figure 7. Front left, case vehicle

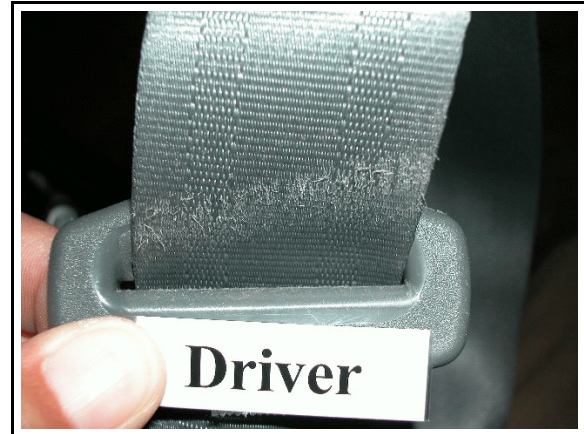
The Kia Spectra was configured with manual 3-point lap and shoulder belts with sliding latch plates for both front positions and the rear outboard positions. The front seat belts were equipped with B-pillar mounted pyrotechnic pretensioners. The right front seat and two rear outboard seats were equipped with switchable retractors. The driver's manual restraint was configured with an emergency locking retractor. Both front seat belts were in use at the time of the crash. The front right restraint was being used using with a child restraint at the time of the crash. The belt had been switched to the automatic locking mode. There were loading marks found on both the driver's and front right passenger seat belts. For the driver's belt, loading marks were located 21 cm (8.3 in) and 50 cm (19.7 in) from the stop button. For the front right passenger belt, loading marks were found 39 cm (36.6 in), 68 cm (26.8 in), and 145.0 cm (57.0) from the stop button. The pretensioners for both front seat belts actuated during the crash. The plastic covers for both B pillars were displaced by the pretensioned belts.

Figure 8. Loading marks to driver's seat belt

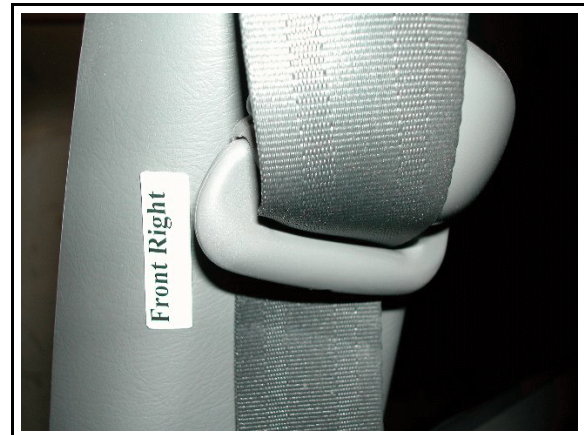
Figure 9. Loading marks to front right seat belt

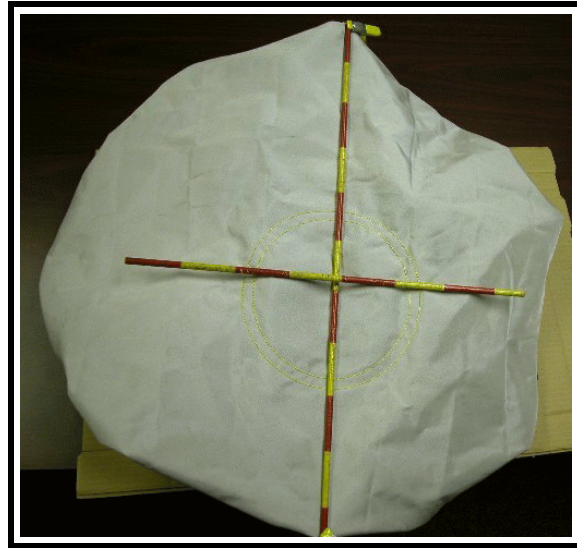
The driver and front right redesigned passenger air bags deployed and the front seat belt pretensioners actuated. The driver's air bag module had an "H" configuration and was located in the center hub of the steering wheel rim. The top flap measured 15 cm (5.9 in) wide and 12 cm (4.7 in) high. The bottom flap measured 15 cm (5.9 in) by 9 cm (1.9 in) high. The diameter of the air bag measured 54 cm (21.3 in) in its deflated state. There were two tethers and two vent ports. The ports were at the 11 and 1 o'clock positions.

Figure 10. Face of driver's air bag

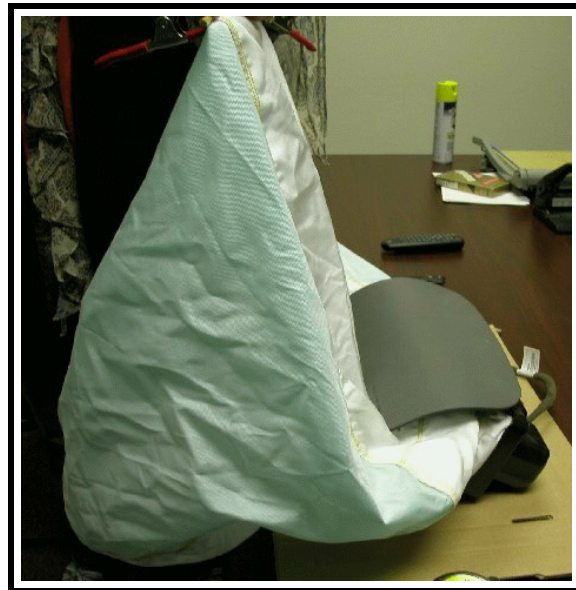
The front right passenger's air bag was a top mount design located in the right aspect of the instrument panel. The module consisted of a single flap. The flap measured 33.0 cm (12.9 in) wide by 19.5 cm (7.7 in) high. The deflated air bag measured 33.0 cm (12.9 in) wide by 61 cm (24.1 in) high. There were no vent ports. There was a single tether across the face of the air bag. There were no indications of occupant contact. There was scuffing on the air bag face from the module cover.

Figure 11. Front right passenger's air bag, side view

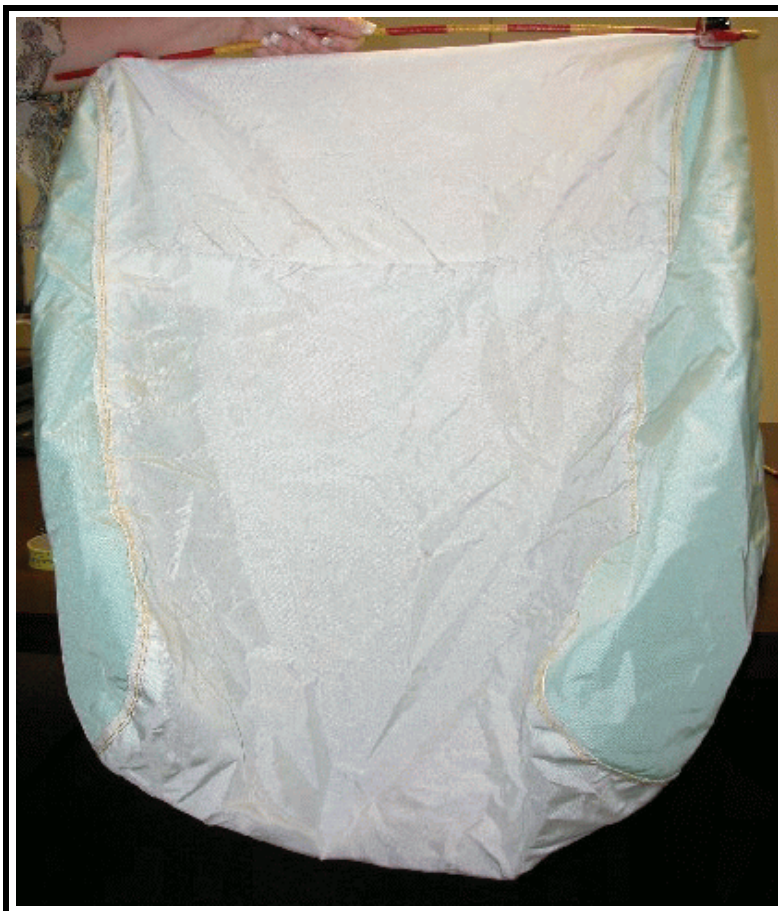
Figure 12. Face of front right passenger's air bag

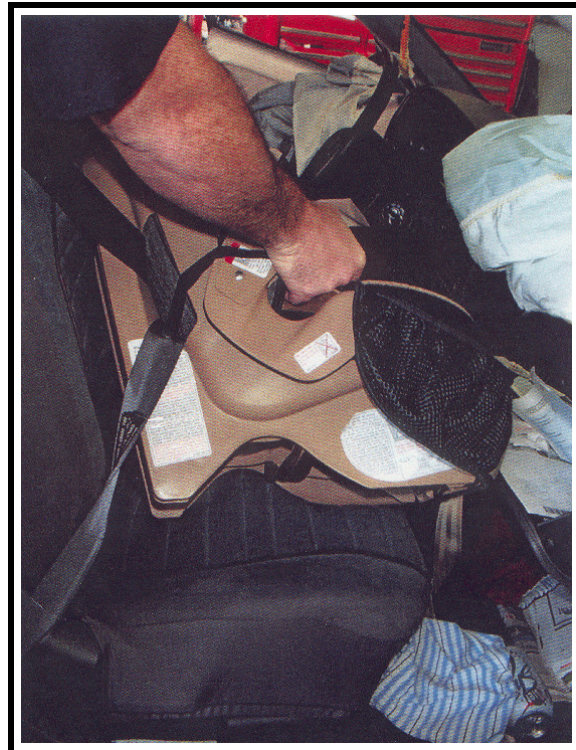
Figure 14. Child seat movement (police photo)

At impact, the front right passenger's air bag deployed and the seat belt pretensioners actuated. Though the pretensioner fired it does not appear that it was able to take in enough slack to anchor the child seat to the vehicle seat. As a result, the child seat pitched forward and the back end rose up to some unknown height. The front right occupant responded to the 12 o'clock direction of force by exhibiting a forward trajectory. As the child pitched forward she would not have been restrained to any significant degree by the child seat harness. She engaged the deploying air bag fully in the face. She sustained multiple superficial abrasions and contusions about the forehead, face, chin and anterior neck. Her head was forced backwards and she sustained a C2-C3 subluxation with a spinal cord injury that resulted in quadriplegia and ventilator dependency. There was also extensive hemorrhaging in the paraesophageal area, as well as to the anterior cervical spine. She was transported to an area hospital and died two days later.

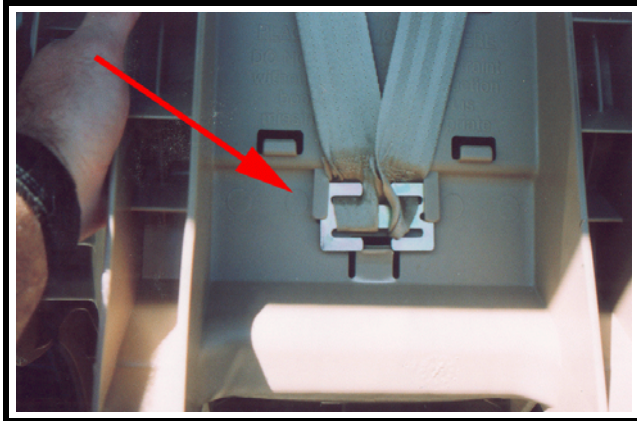
Figure 15. Back of child seat (harness attached to locking clip)

The 14-month-old female (79 cm/31 in, 14 kg/30 lbs) front right occupant was seated in a Cosco, "Eddie Bauer" high back booster seat, Model #02-880-MBP. The seat was equipped with a 5-point internal harness system. The harness was not attached to a fixed point on the child seat. The net effect of the attachment was that the harness was incapable of sustaining any load. The seat was anchored to the vehicle seat using the available lap and shoulder belt. However, the child seat was not tightly anchored to the vehicle seat. The fabric covered bucket seat was adjusted to a point between the middle and forward most track position. The leading edge of the seat cushion was 38.0 cm (14.9 in) rearward of the lower A pillar. The seat back was at a 68 degree angle from horizontal. The seat belt anchorage was in the full up position.

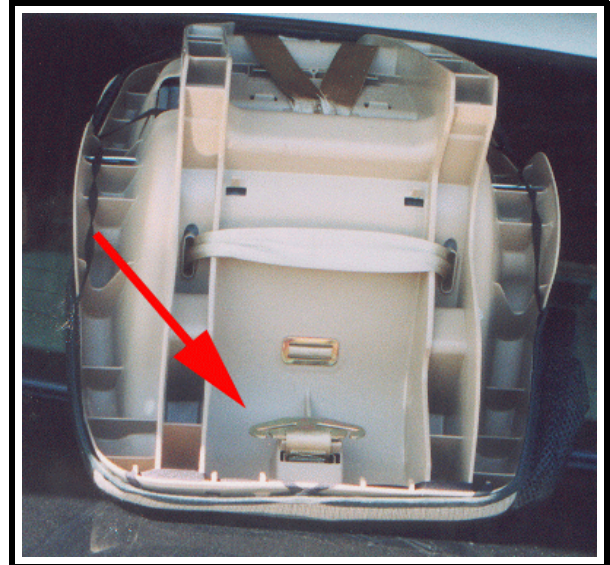
Figure 16. Bottom of child seat (actual attachment point for harness)

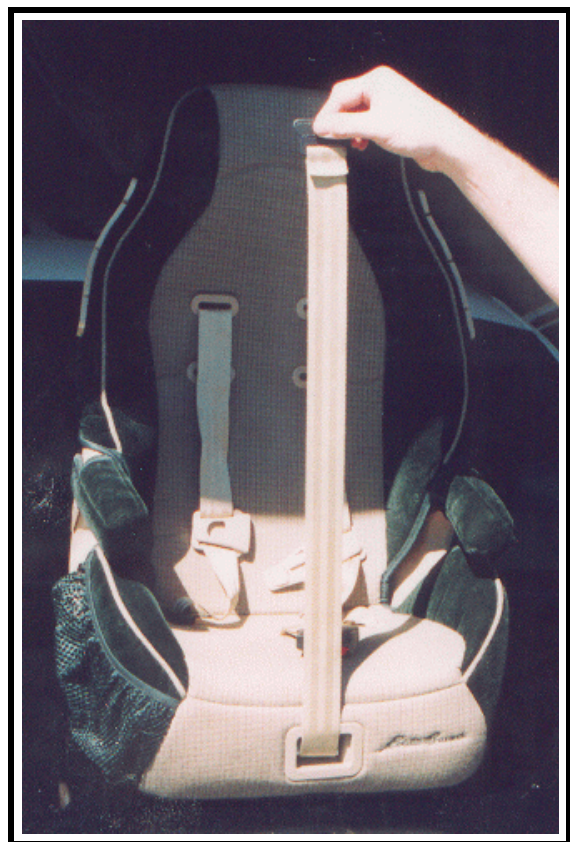
Cosco, “Eddie Bauer” high back booster seat, Model #02-880-MBP. It was manufactured on 06/06/2002. It was equipped with a 5-point internal harness system. The manufacturer recommends harness usage with children between 9.9-18.1 kg (22-40 lbs). When the child is heavier and the child’s shoulders are above the upper set of harness slots the seat is to be used as a belt-positioning booster for children between 13.6-36.2 kg (30-80 lbs). The vehicle seat belt was a 3-point lap and shoulder belt with a sliding latch plate and a switchable retractor. During the police inspection it was determined that the vehicle seat belt retractor was in the locked mode. The child seat was not anchored tightly in the vehicle and the seat could be moved several inches (see Figure 14). The harness straps were routed through upper slots. The straps were attached to a locking clip on the back side of seat instead of the splitter bar (see Figures 15-16). The locking clip was still stored in the factory storage location. Without the harness straps attached to the splitter bar, there was no way to adjust the harness system for snugness on the child occupant (Figure 17).

Figure 17. Front of child safety seat

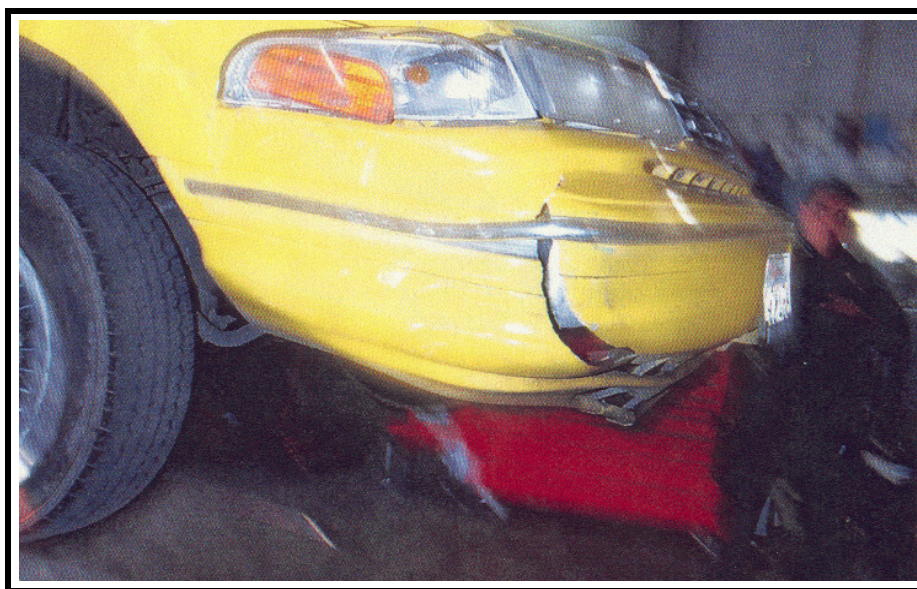
Description:	1997 Ford Crown Victoria four-door sedan	
VIN:	Unknown	
Odometer:	Unknown	
Engine:	Unknown	
Reported Defects:	Police inspected vehicle and did not find any significant mechanical deficiencies.	
Cargo:	None	
Damage Description:	Moderate crush to right fender. Contact to right front wheel. Face of bumper fascia cracked.	
CDC:	03RFEW2	
Delta V:	Total	12.0 km/h (7.5 mph)
	Longitudinal	-2.1 km/h (-1.3 mph)
	Latitudinal	-11.8 km/h (-7.3 mph)
	Energy	11,036 joules (8.,140 ft lbs)

Figure 18. Right bumper corner

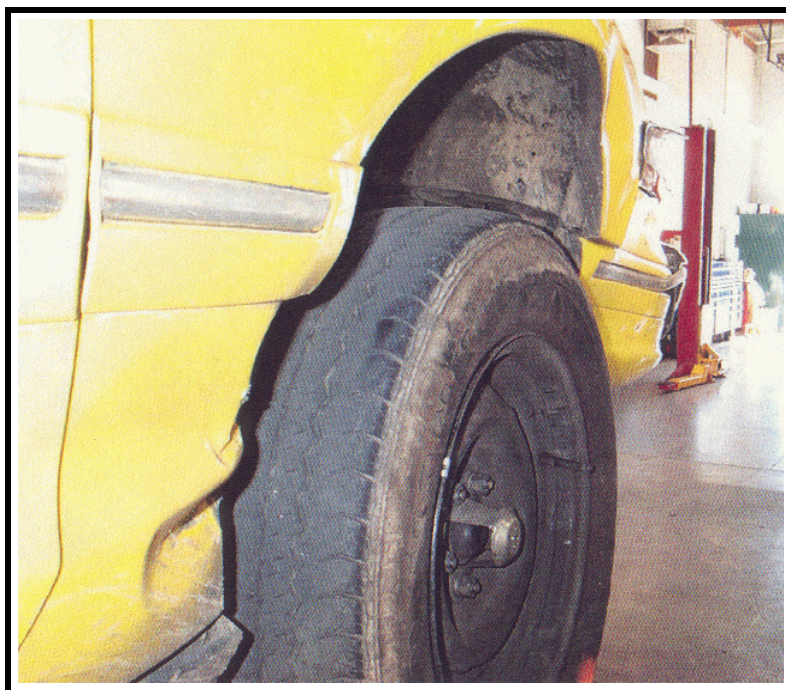
Figure 19. Right wheel/fender

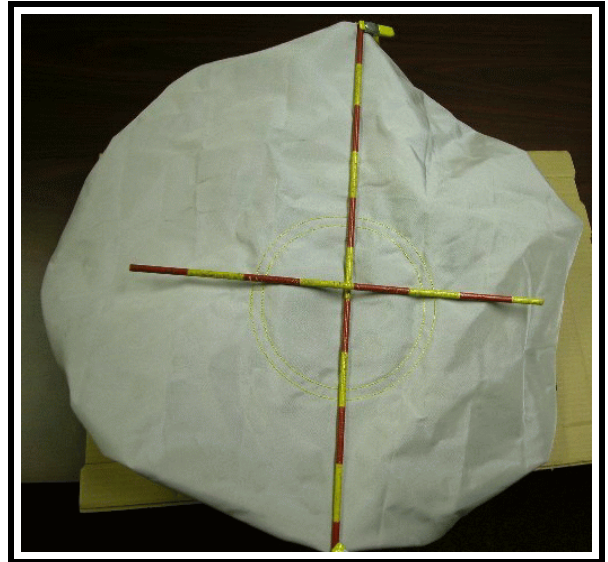
Figure 20. Driver's air bag

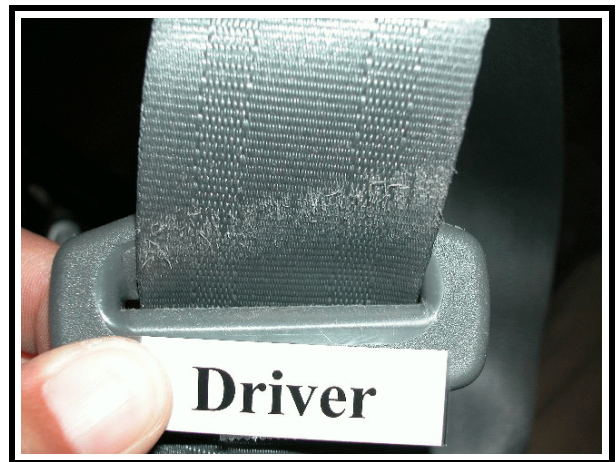
Figure 21. Loading to driver's seat belt
