**VERIDIAN ON-SITE ADULT AIR BAG RELATED FATALITY
INVESTIGATION**

VERIDIAN CASE NO. CA03-016

VEHICLE: 1996 MERCURY SABLE

CRASH DATE: FEBRUARY 2003

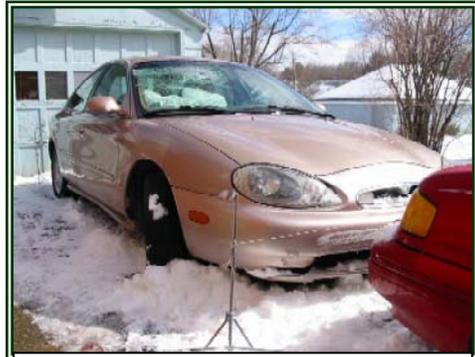
Figure 1. Front right view of the 1996 Mercury Sable

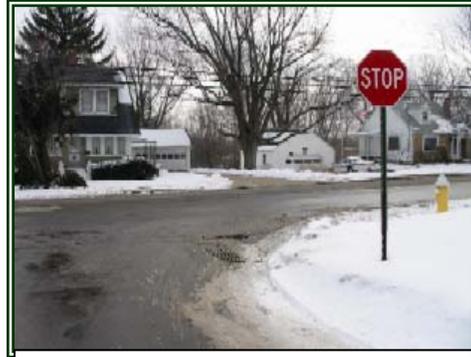
Figure 2. Overall view of the crash scene.

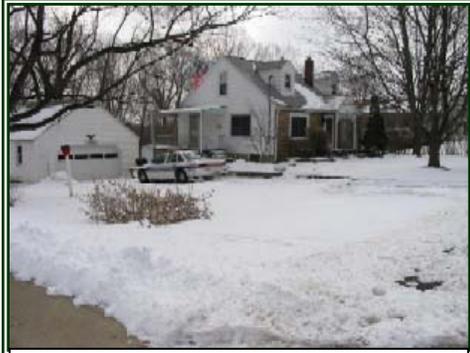
The front left area of the Mercury Sable impacted and overrode a large shrub that was located in the lawn area between two driveways (**Figure 3**). The shrub impact apparently resulted in a rapid air out of the left front tire. The Sable continued forward on a slight clockwise arc, traveling on a path that was nearly parallel to the intersecting street. The vehicle traversed another private driveway and impacted a retaining wall (**Figure 4**) that was constructed of 30x46x5 cm (12x18x2”) concrete blocks. The front center and right area of the Sable impacted the retaining wall that was approximately 20 cm (8.0”) in height.

Figure 3. Trajectory of the Mercury Sable and the struck shrub (Impact #1).

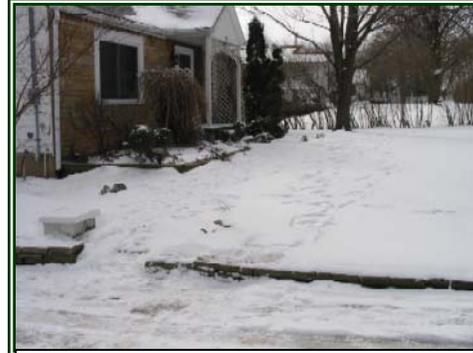
Figure 4. Struck retaining wall and sidewalk steps.

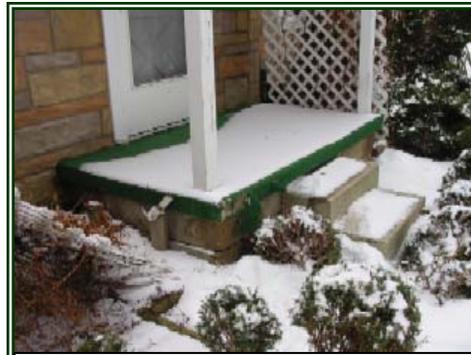
As the Sable began to mount the wall, the leading edge of the front left frame rail impacted the concrete steps that led to a paved sidewalk. The Sable continued forward, impacting a concrete marker that was 48 cm (19”) square and 28 cm (11.0”) in height with the front right area of the bumper. The impact fractured this marker and displaced the fragments across the front lawn of the private residence. The Sable continued forward and overrode a three-tier stack of landscape timbers that bordered the front of the house. As the Sable continued forward, the vehicle impacted two ornamental shrubs prior to impacting the concrete slab of the front porch (**Figure 5**).

Figure 5. Struck porch.

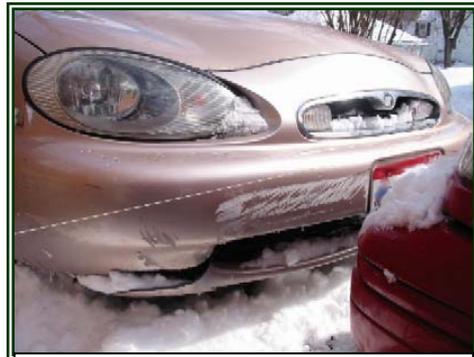
The lower air dam aspect of the bumper fascia (**Figure 6**) impacted the retaining wall that paralleled the private driveway. This impact, which abraded and fractured the composite component, began 29.2 cm (11.5") left of center and extended 90.2 cm (35.5") to the right. This impact was below the level of the bumper beam. The lower radiator support engaged the retaining wall as the Sable overrode the block wall, however, there was no residual crush.

Figure 6. Impact damage to the bumper fascia and air dam.

The left front tire and wheel of the Sable overrode the concrete stairs and the vehicle continued forward. The front right and center aspect of the front bumper impacted the square concrete decorative marker that was positioned beyond the retaining wall. The impact involved the bumper face and the structural beam of the bumper system. The direct contact damage began 2.5 cm (1.0") left of center and extended 48.3 cm (19.0") to the right, terminating inboard of the corner (**Figure 6**).

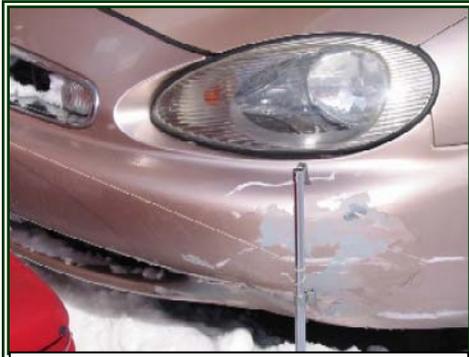
The front left corner (**Figure 7**) area of the Sable impacted the corner of the porch. The porch consisted of a concrete block foundation that was capped with a 10 cm (4") thick concrete slab that measured 127x236 cm (50x93"). The slab was covered with indoor/outdoor carpeting. The impact abraded the bumper fascia and chipped the paint from the corner area of the fascia as the fascia flexed and rebounded to its original form. The direct contact damage began 59.7 cm (22.5") left of center and extended 10.2 cm (5.0") to the corner. The leading edge of the front left frame rail was crushed rearward (**Figure 8**) to a maximum depth of (1.0").

Figure 7. Front left corner damage from porch impact.

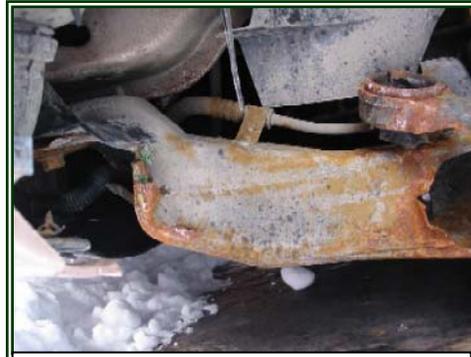
Figure 8. Crushed leading edge of the left frame rail and separation of the lower control arm.

The lower control arm separated (**Figure 8**) from the outboard aspect of the left frame rail. It appeared that rust and deterioration contributed to the separation. It was unknown if this separation occurred from the vehicle's impact with the sidewalk steps, or resulted from tire/wheel contact against the porch foundation.

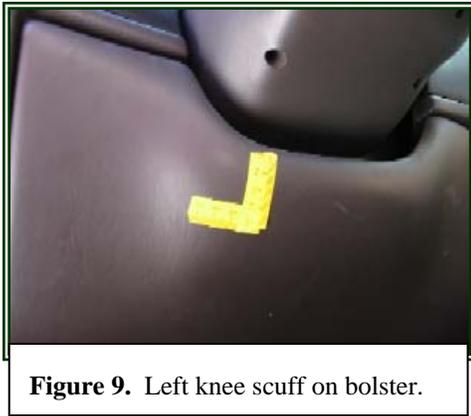
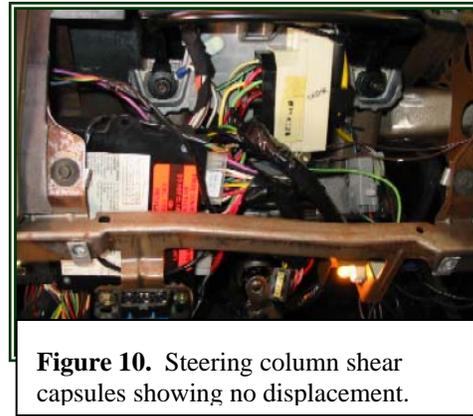
transfers were observed to the driver's air bag. These transfers resulted post-deployment as the driver came to rest slumped against the steering assembly. There was no damage to the four-spoke steering wheel rim or compression of the energy absorbing steering column. **Figure 10** is a view of the shear capsule brackets that show no displacement.

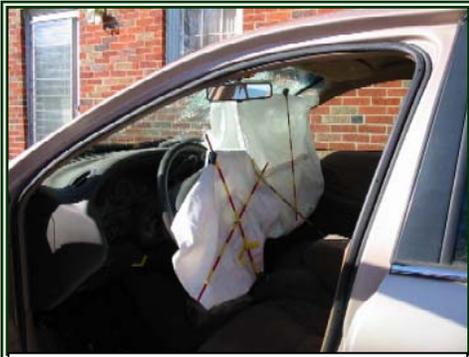
The Mercury Sable was equipped with a frontal air bag system for the driver and right passenger positions. The system consisted of two crash sensors that were mounted to the upper radiator support panel, a diagnostic control module that was mounted on the center tunnel under the mid instrument panel, the steering wheel mounted driver's module, and the front passenger module that was mounted in the top of the right instrument panel. The frontal air bag system probably deployed (**Figure 10**) as a result of the frontal impact with the porch.

Figure 10. Deployed frontal air bags.

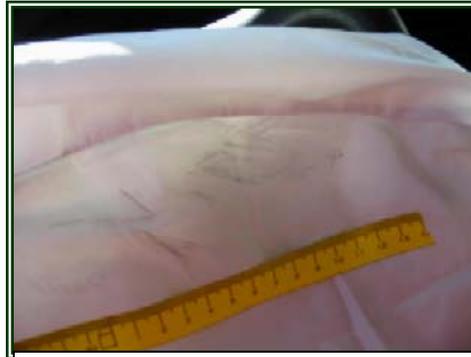
Figure 11. Expansion transfers on the bag membrane.

The air bag membrane did yield evidence of expansion transfers (**Figure 11**) from the inside surface of the module. A 15.8x5.1 cm (6.25x2.0") area of black striations was noted on the membrane at the 9 o'clock sector, forward of the peripheral seam. A second area of black striations was present on the bag at the 6 o'clock sector, extending in both directions of the peripheral seam. These transfers possibly resulted from an impeded

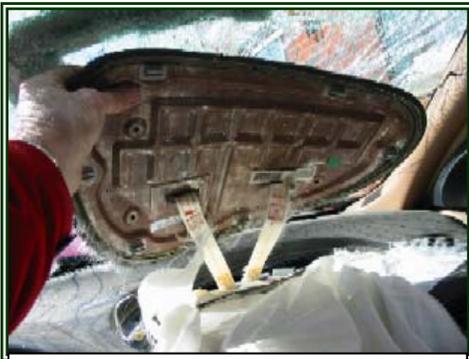
The front right passenger air bag was concealed by a single cover flap that was mounted to the top of the right instrument panel. The cover flap was reinforced with a sheet metal backer panel and was shaped in a tri-oval design. The maximum width of the flap was 43.8 cm (17.25") with a height of 29.2 cm (11.5"). The flap was tethered to the instrument panel by two 2.9 cm (1.125") wide tether straps that were 24.8 cm (9.75") in length (**Figure 12**). At deployment, the flap completely separated from the top right instrument panel and was restrained by the tethers. The flap impacted and fractured the right two-thirds (66 percent) of the windshield. In addition, the flap impact lacerated 21.6 cm (8.5") of the plastic laminate. The leading edge of the cover flap was abraded from the windshield contact.

Figure 12. Tethered front right air bag module cover flap.

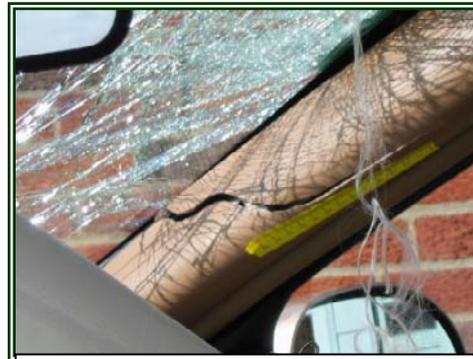
Figure 13. Fractured right A-pillar trim from air bag expansion.

The front right passenger air bag was folded into the module and wrapped with a band of bag material. At deployment, the expansion of the air bag membrane split the band to allow the deployment of the bag. This band material was fragmented with strands snagged in the right sun visor clip and headliner. The expanding air bag membrane, although not restricted, contacted and fractured the plastic trim (**Figure 13**) on the right upper A-pillar. The bag also expanded against the rear view mirror, fracturing the mirror glass and displacing the mirror to the left.

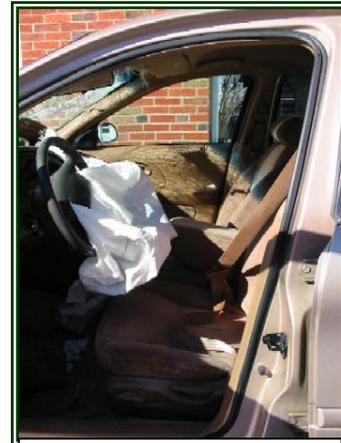
Figure 14. Driver's position and the deployed front left air bag.

The frontal air bag system deployed during the multiple event crash. The system probably deployed as result of the impact with the porch. At the time of deployment, the driver was probably slumped in a forward direction with his face in close proximity to the steering wheel mounted air bag module (**Figure 14**). As the air bag deployed, the expanding bag membrane impacted the driver's face resulting in abrasions of the nose, forehead, and a left periorbital contusion. The continued expansion of the bag against the driver's head produced a subdural hematoma, intracranial hemorrhage, and a small cerebral contusion of the right parietal lobe. The driver also sustained a right pneumothorax that probably resulted from air bag expansion against his chest. Although he would have initiated a forward trajectory in response to the frontal crash forces, there was no evidence of steering wheel deformation or compression of the energy absorbing steering column. A small scuff was noted to the left was aspect of the knee bolster. No injury occurred from this contact.

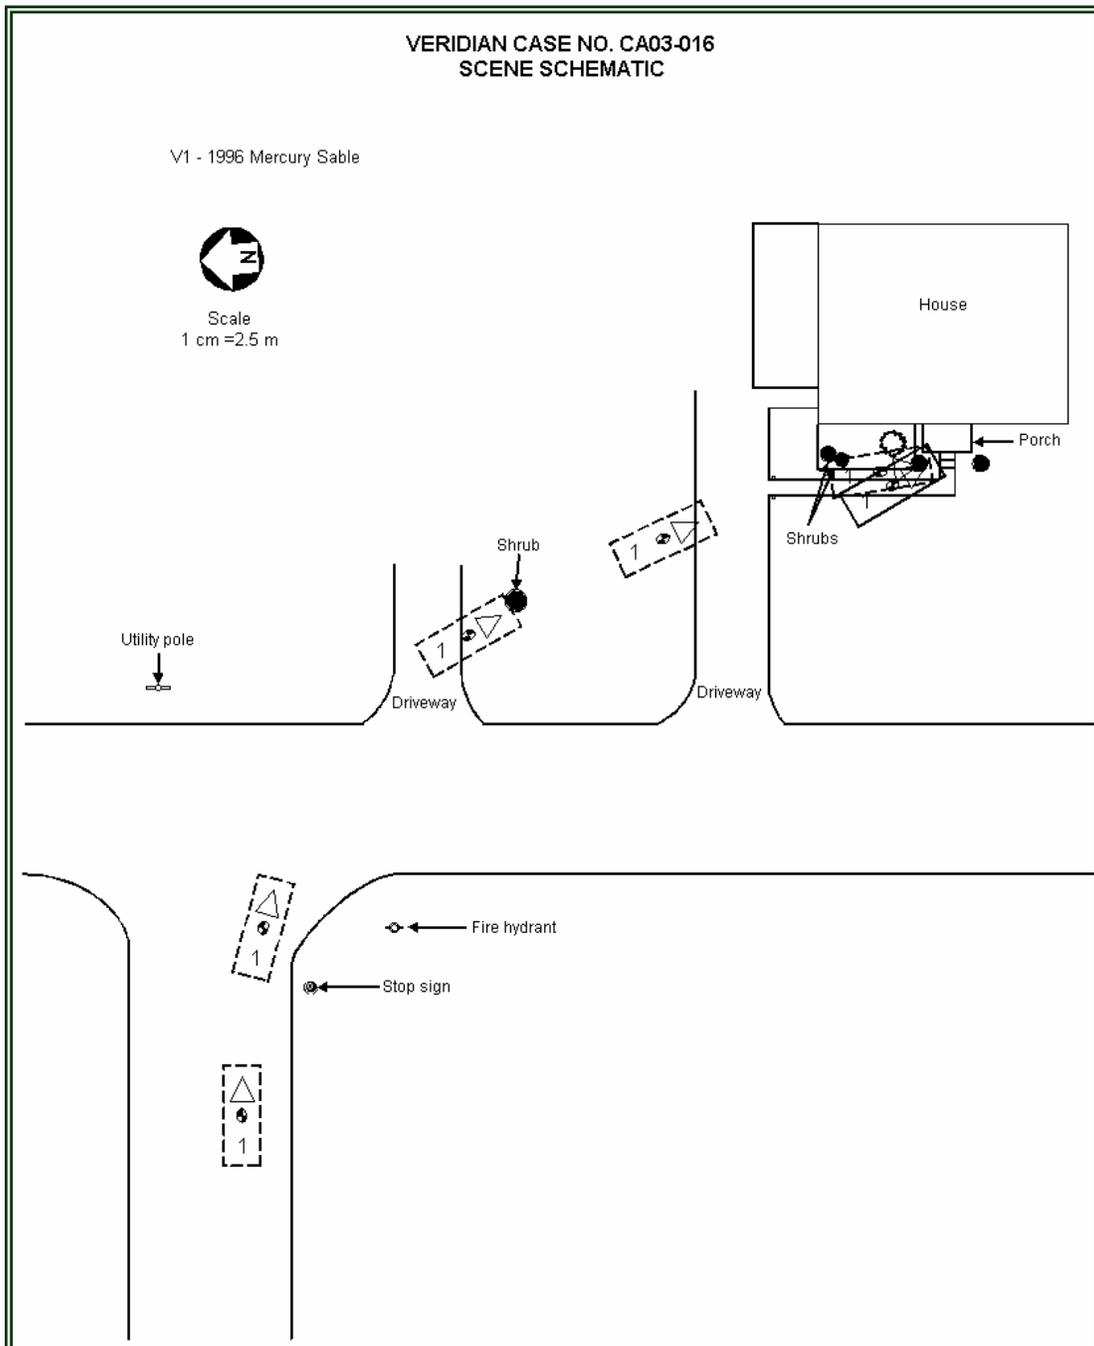
The driver initiated a wide right turn at the three-leg intersection and departed the east (left) edge of the intersecting street at a private driveway. The vehicle traversed the mouth of the driveway and entered a lawn area in a tracking mode. Light snow covered the grass and private driveways. The crash schematic is attached as **Figure 15**, Page 12.

Figure 15. Crash Schematic.
