**CALSPAN ON-SITE ADULT AIR BAG RELATED FATALITY  
INVESTIGATION**

**CASE NO: CA03-019**

**VEHICLE: 1995 MERCURY GRAND MARQUIS**

**CRASH DATE: FEBRUARY 2000**

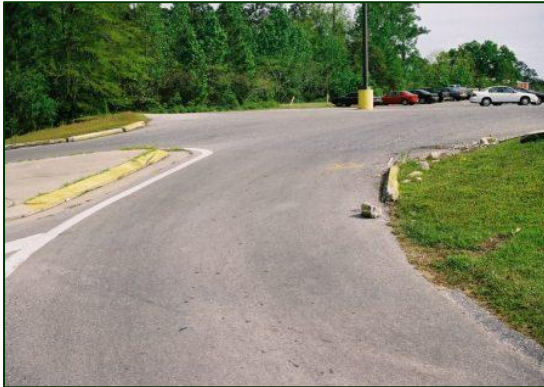
The crash occurred in a parking lot of a super market during daylight hours. The parking lot was delineated into a series of parking spaces with driving lanes separating the rows of parking spaces. The Mercury entered the parking lot from a two-lane state route in a posted 56 km/h (35 mph) sped zone. The north/southbound travel lanes were separated by a painted flush median that transitioned into a left turn lane for southbound traffic south of the parking lot entrance. A northbound right-turn lane channeled traffic into the parking lot (**Figure 2**). The state route was curved to the left with a slight negative grade relative to northbound traffic flow. A grassy drainage ditch separated the right turn lane

**Figure 2. Mercury's approach to the crash site.**

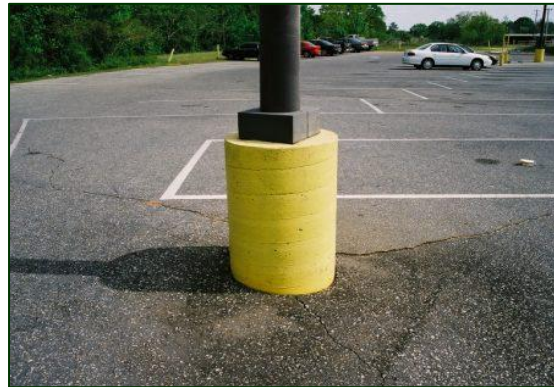
**Figure 3. Struck pole base.**

The aluminum light pole was mounted on-top of a poured concrete (**Figure 3**) base that was 61 cm (24") in diameter and 79 cm (31") in height, and was located 15.6 m (51.2') east of the gore and 24.3 m (79.7') east of the east road edge of the northbound travel lane. There was no damage reported to the pole or the concrete base. The Crash Schematic is included as **Figure 11** of this narrative report.

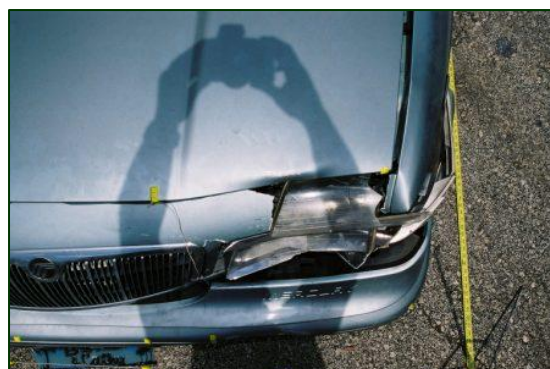
The front left bumper area of the 1995 Mercury Grand Marquis impacted the concrete base for the light pole (**Figure 4**). The impact resulted in a 12 o'clock direction of force and crushed the bumper beam to a maximum depth of 24 cm (9.5"). A damage algorithm of the WinSMASH program computed a total velocity change of 22 km/h (13.6 mph) with longitudinal and lateral components of -22 km/h (-13.6 mph) and 0 km/h, respectively. The impact with the concrete base deployed the Mercury's frontal air bag system.

**Figure 4. Overhead view of the frontal damage.**

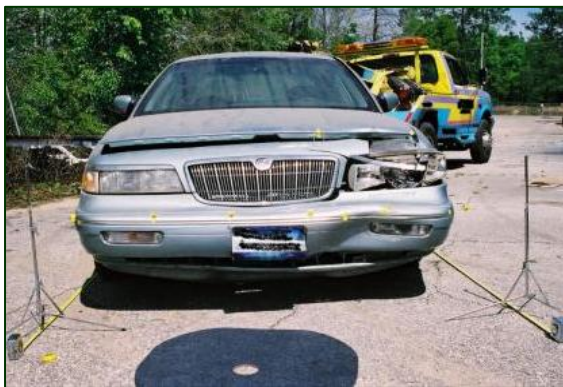
The front left aspect of the Grand Marquis impacted the concrete base of the light pole. The direct contact damage of the bumper fascia began 34 cm (13.2") left of center and extended 46 cm (18") to the left corner (**Figure 5**). The impact crushed the front bumper beam to a residual depth of 24 cm (9.5") located at the left corner of the bumper (**Figure 6**). At maximum engagement, the leading edge of the hood contacted the base which resulted in 1 cm (0.4") of sheet metal crush that was located 54 cm (21.4") left of center. The bumper fascia rebounded from the impact event; however, the aluminum bumper beam deformed resulting in a full-width damage pattern (Field L) of 160 cm (62.75"). The crush profile at the bumper beam was as follows: C1 = 24 cm (9.5"), C2 = 23 cm (9.2"), C3 = 18 cm (6.9"), C4 = 12 cm (4.75"), C5 = 8 cm (3.1"), C6 = 4 cm (1.75"). The left bumper energy absorbing device (EAD) compressed 4 cm (1.75") and punched through the leading edge of the frame rail. The right EAD did not exhibit compression. Both units had an original pre-crash length of 5 cm (2"). The Collision Deformation Classification (CDC) for this event was 12-FLEW-1.

**Figure 5. Front left damage to the Grand Marquis.**

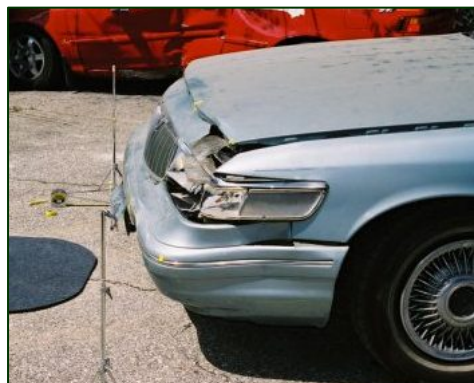
**Figure 6. Lateral view of the crush depth.**

Components damaged by the impact included the front bumper fascia, bumper beam, the left EAD and frame rail, header panel, left headlamp assembly, hood, the radiator support panel, and the left front fender. The left wheelbase was reduced in length by 4 cm (1.4”) while the right wheelbase was elongated by 1 cm (0.25”).

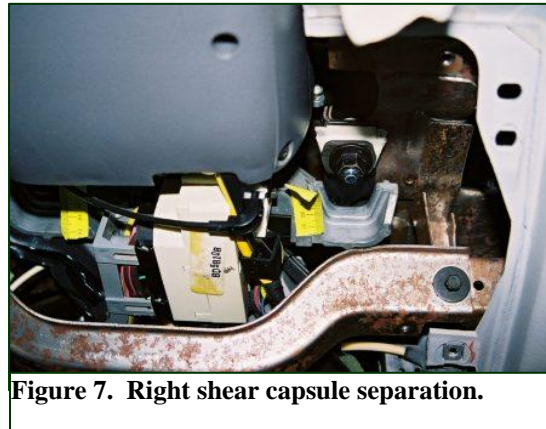
The interior of the Grand Marquis sustained minor damage that was associated with air bag deployment and occupant loading. The driver’s air bag expanded against the forward positioned driver as evidenced by fabric transfers on the bag membrane. These transfers are discussed in the *Frontal Air Bag System* section of this report. Air bag expansion against the out-of-position driver, in combination with the forward kinematic response of the driver to the crash forces, resulted in compression of the energy absorbing steering column. The shear capsules yielded separation values of 4 cm (1.6”) on the left and 3.8 cm (1.5”) on the right side (**Figure 7**). Both brackets were completely separated from the fixed blocks. There was no bending or deflection of the steering wheel rim.

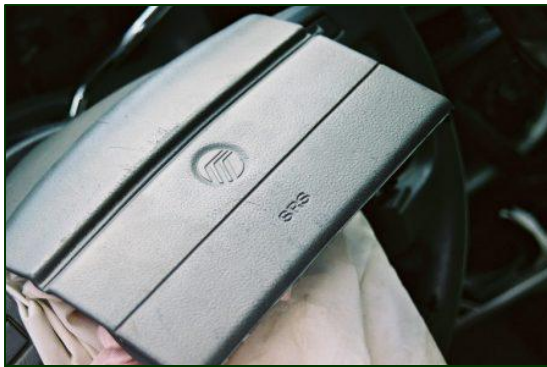
The driver's air bag module was mounted within the four-spoke steering wheel rim. The spokes were positioned at the 3/9 and 5/7 o'clock positions. The air bag module consisted of asymmetrical H-configuration module cover flaps that opened at the designated tear points. The large upper flap measured 20 cm (8") horizontally and 13 cm (5") vertically while the lower flap had respective measurements of 20 cm (8") and 4 cm (1.5"). There was no damage or contact evidence on the cover flaps (**Figure 8**). The lower flap was captured between the lower steering wheel spokes.

**Figure 8. Upper cover flap.**

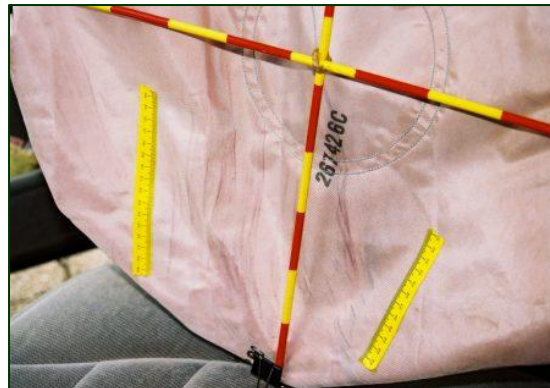
**Figure 9. Fabric transfers to the lower face of the driver's air bag.**

The driver air bag membrane contained two large fabric transfers that resulted from expansion against the out-of position driver's clothing (**Figure 9**). A large blue/green/red fabric transfer was located at the bottom aspect of the bag. The transfer was vertically oriented and began 6 cm (2.25") above the horizontal center line on the tether reinforcement and extended to the peripheral seam flaring to a width of 20 cm (8"). Several vertically oriented fabric transfers wrapped around the back side of the peripheral seam and extended 6 cm (2.5") onto the back side on the bag membrane. Scattered lateral and diagonally oriented fabric transfers extended from the peripheral seam at the 3

o'clock sector, continuing 13 cm (5") onto the face of the bag. There was no damage or tears to the bag membrane.

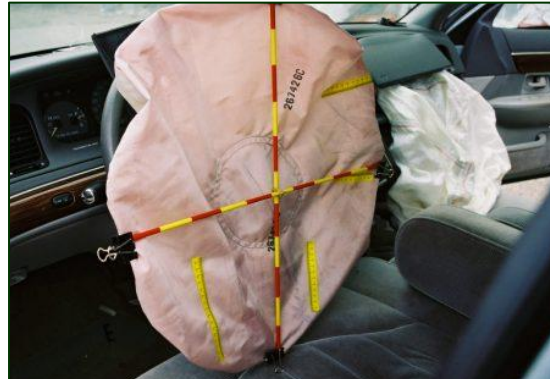
The air bag membrane expanded against the driver's chest, anterior neck, chin and lower face. The chest contact fractured the anterior and lateral aspects of the right 2-4 ribs and the lateral aspect of the left 6<sup>th</sup> rib. The continued expansion of the air bag resulted in abrasions of the chin and neck regions, a contusion and laceration of the lower lip and a contusion of the upper frenulum from lip compression against the teeth. The expanding air bag hyperextended the driver's neck which resulted in fractures of the petrous ridges of the base of the skull, a complete laceration of the basilar artery, and subarachnoid hemorrhage.

**Figure 10. Deployment of the driver's frontal air bag.**
