**VERIDIAN ON-SITE SCHOOL BUS INVESTIGATION  
SCI TECHNICAL SUMMARY REPORT**

**VERIDIAN CASE NO. CA03-020**

**VEHICLE: 1991 CARPENTER SCHOOL BUS**

**CRASH DATE: MARCH 2003**

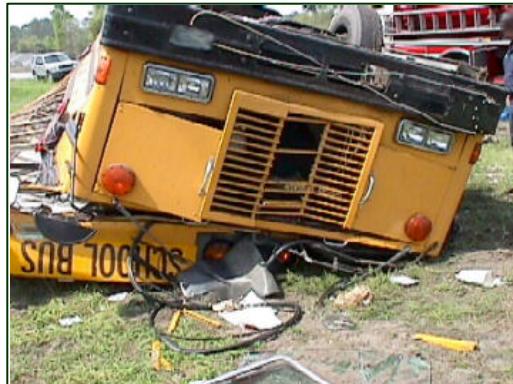
**Figure 2.** Collapsed roof of the 1991 Carpenter school bus.

The school bus sustained severe structural integrity loss during the rollover event that resulted in a near total collapse of the roof. The primary damage to the Carpenter body school bus was isolated to the greenhouse (beltline area and above) area of the vehicle. The roof collapse resulted in damage to all vertical pillars, multiple glazing damage, and damage to the right door and the rear emergency door. Damage below the greenhouse area was rated as moderate. **Figures 4 and 5** are overall views of the exterior damage.

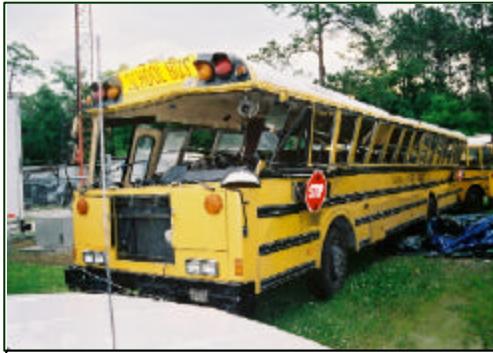
**Figure 4.** Front left view of the 1991 Carpenter school bus.

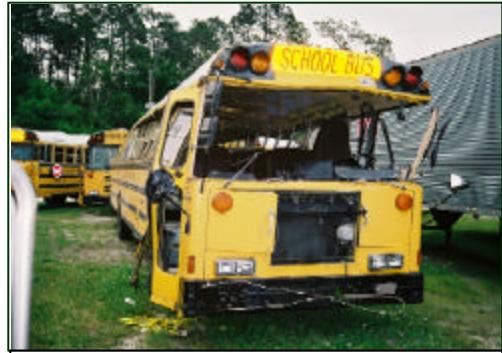
**Figure 5.** Front right view of the bus with the roof repositioned.

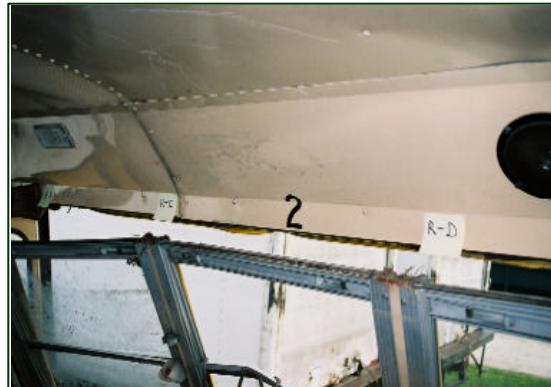
The construction of the bus at the roof side rail/pillar juncture contributed to the structural collapse of the roof. Although the pre-crash condition of the welded joints was unknown, the post-crash inspection and documentation of these joints, and the identification of numerous cracked welds on exemplar buses, the roof structure on this bus was probably weak. The downward and lateral forces applied to the right roof side rail area during the rollover event swayed the roof laterally left. As the forces were exerted on the welded joints, the joints failed due to poor quality welds and stress overload of the design.

The right A- through I-pillars completely separated at the welded joints to the side rail (**Figure 6**). The right J- through O-pillars sustained partial weld separations and/or tearing of the side surfaces of the pillar U channel. The left upper A-pillar separated completely at the side rail. The left B- through Q-pillars exhibited a combination of cracked welds, torn side surfaces, and near complete separation of the pillars from the fabricated side rails. As the side surfaces of the formed pillars failed due to the weld separations or stress overload, the face weld of the pillar acted as a hinge point as the roof was deflected laterally left.

**Figure 6.** Separation of the right A - through I-pillars.

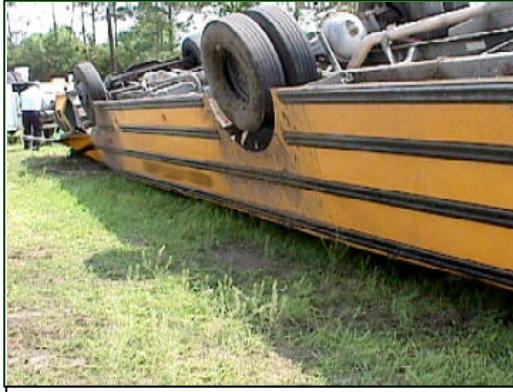
The upper pillar failures weakened the side structure of the bus body by defeating the structure's ability to distribute the lateral load through the roof bows and off-side. The loading initiated the lateral bending of the pillars at the beltline. Based on the on-scene images of the bus at final rest, all right side pillars deflected at the beltline, shifting the roof laterally left. The left pillars deflected outward at the beltline, decreasing in severity from front-to-back. The left rear corner area of the roof structure was minimally displaced. At final rest, the right beltline area of the bus was in near full contact with the ground. The left side of the bus roof was angled upward front-to-back supported by the deflected roof. **Figures 7 and 8** are on-scene images of the roof collapse.

**Figure 7.** On-scene image of the roof collapse at the right side.

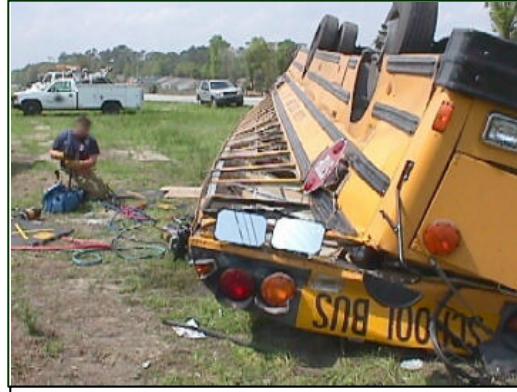
**Figure 8.** Left side roof collapse as viewed from the front of the Carpenter school bus.

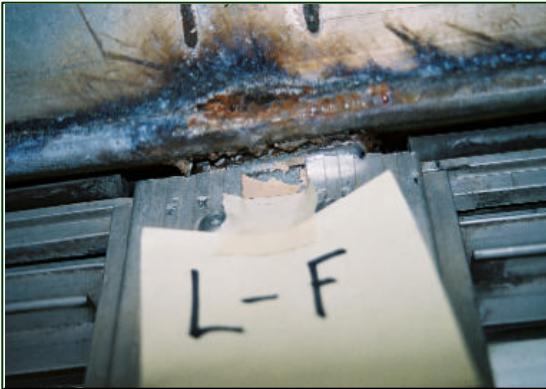
**Figure 9.** Crack at left F-pillar weld.

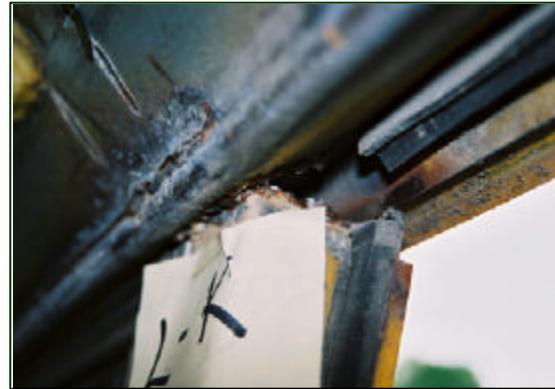
**Figure 10.** Tear and cracked welds at the left K-pillar

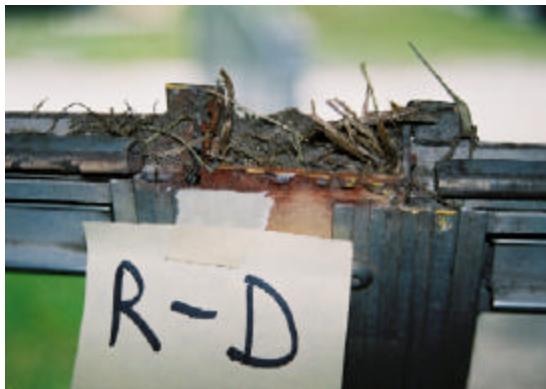
**Figure 11.** Separation of the right D-pillar.

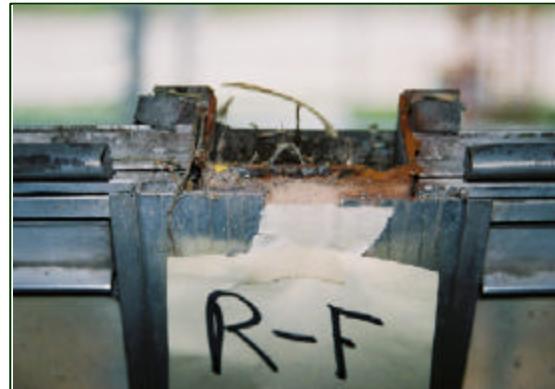
**Figure 12.** Separation of the right F-pillar.

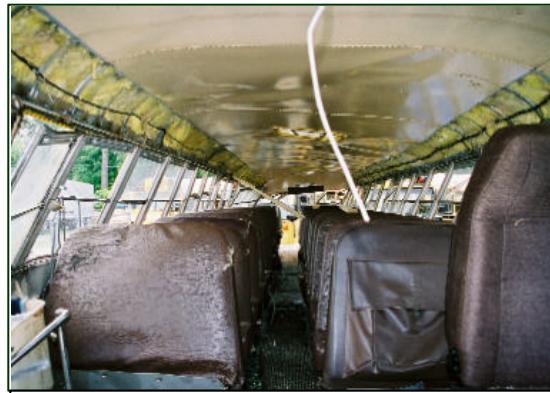
The interior of the school bus sustained moderate severity damage that resulted from the severe intrusion of the roof. The roof collapsed onto the driver's high-back (integral head restraint) seat back, deflecting the upper aspect of the seat back forward. The collapse of the roof structure resulted in contact of the right side widow units against the top aspect of the high-back seat backs. Numerous right side glazing panels were shattered and several seat backs were deflected rearward. The compression of the seat frames resulted in the complete separation of numerous seat cushions.

**Figure 13.** View looking rearward of the interior of the school bus.

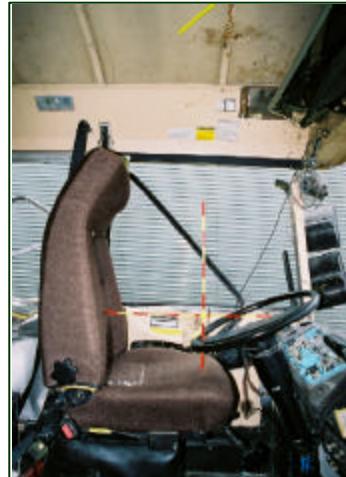
During the rollover, the driver loaded the manual 3-point lap and shoulder belt system. Although the belt system exhibited historical usage/wear indicators, there was no distinct loading evidence of the belt webbing or hardware components. The driver's loading of the belt system resulted in multiple rib fractures. Her left thigh loaded against the left side mounted two-way radio and/or the horizontally oriented steering wheel rim that resulted in a left femur fracture. As the roof of the bus collapsed, the driver's head contacted the intruding headliner/interior roof panel that resulted in a laceration of the driver's frontal scalp. She also sustained multiple contusions and noted that several contusions developed from medical intervention. **Figure 14** is an overall view of the driver seat back and her contact points.

**Figure 14.** Driver's seat and contact points.

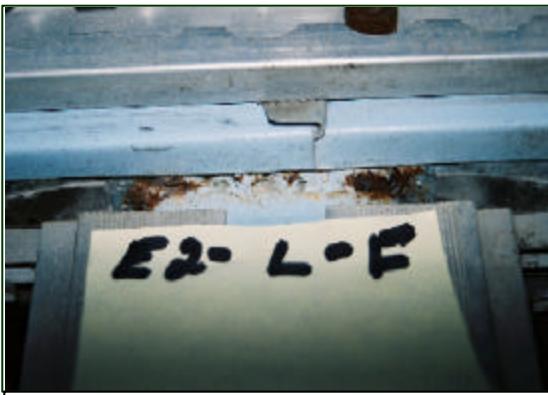
**Figure 16.** Left F-pillar of Exemplar Bus No. 2.

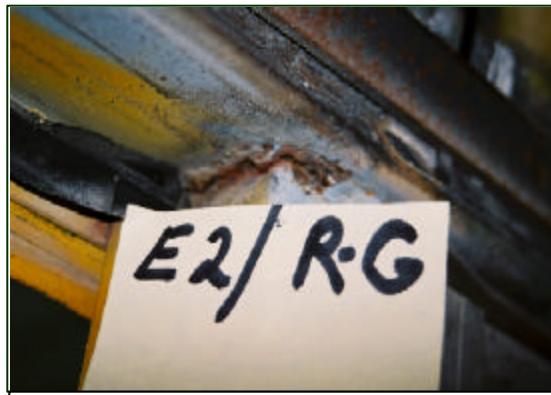
**Figure 17.** Cracked weld at the right G-pillar of Exemplar Bus No. 2.

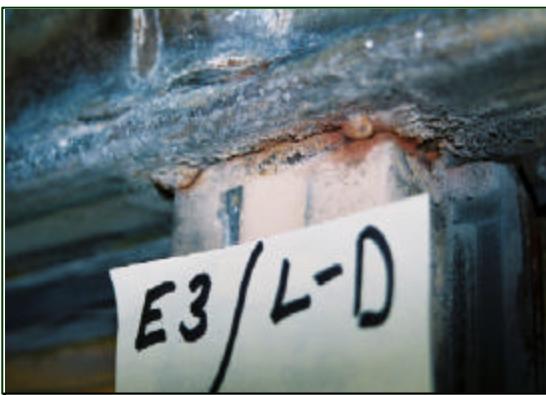
**Figure 18.** Cracked weld at the left D-pillar of Exemplar Bus No. 3.

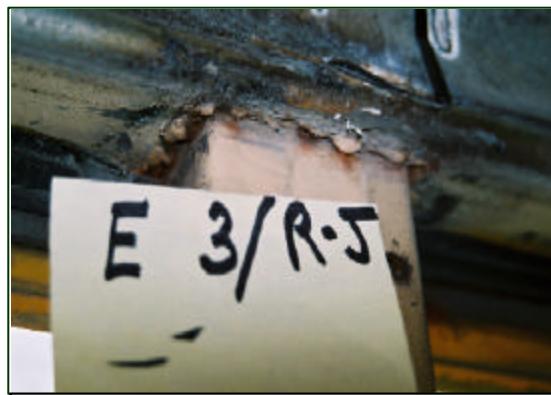
**Figure 19.** Cracked weld at the right J-pillar of Exemplar Bus No. 3.

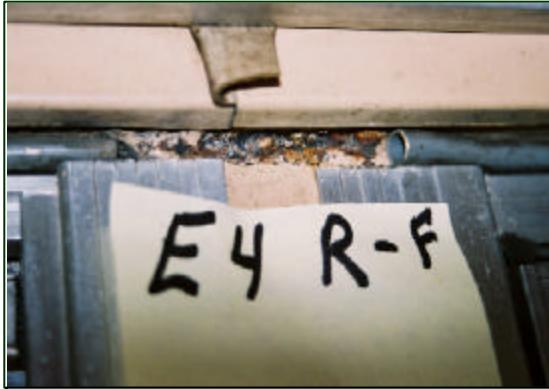
This exemplar conventional Carpenter school bus was equipped with a wheel chair lift and three designated wheel chair positions. The bus had a rated passenger capacity of 17. A visual inspection of the pillars was performed and there were no visible fractures of the pillar welds. The flux on the welds was cracked and was easily chipped off. It should be noted that the welds at the pillar/side rail junctures were poor quality welds as illustrated in **Figures 20 and 21**.

**Figure 20.** Right F-pillar of Exemplar Bus No. 4.

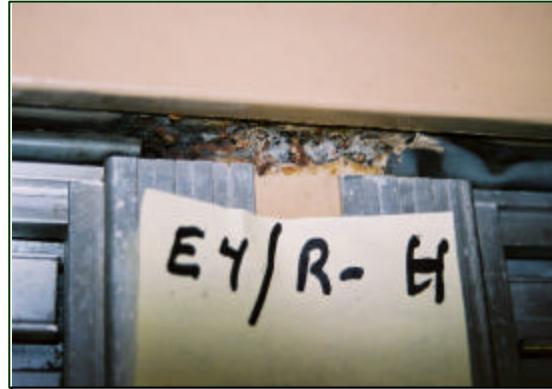
**Figure 21.** Right H-pillar of Exemplar Bus No. 4.

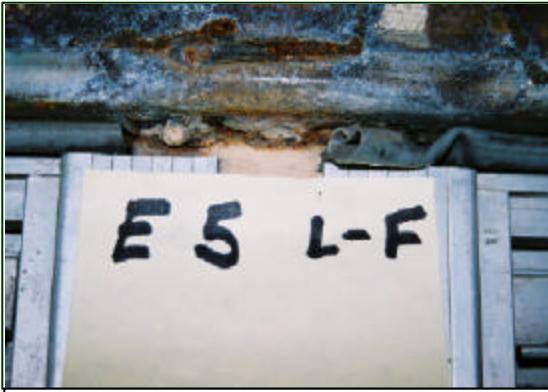
<i>Aspect/Location</i>	<i>Observation</i>
Left F-pillar	Weld cracked at the midpoint of face extending to the full width of the aft side surface ( <b>Figure 22</b> )
Left G-pillar	Weld intact
Left J-pillar	Weld intact; large weld, atypical of fleet
Left K-pillar	100 percent of weld cracked ( <b>Figure 23</b> )
Left L-pillar	Weld intact
All right side pillars	Welds intact

**Figure 22.** Cracked weld at left F-pillar of Exemplar Bus No. 5.

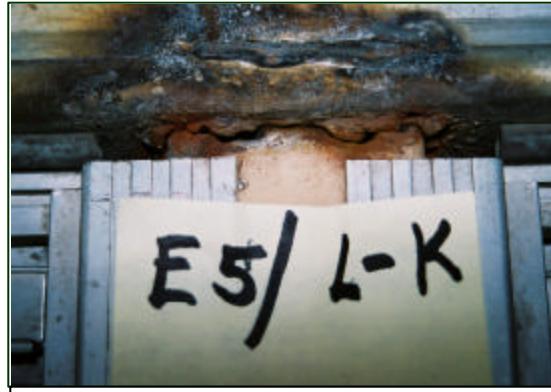
**Figure 23.** Complete crack of weld at left K-pillar of Exemplar Bus No. 5.

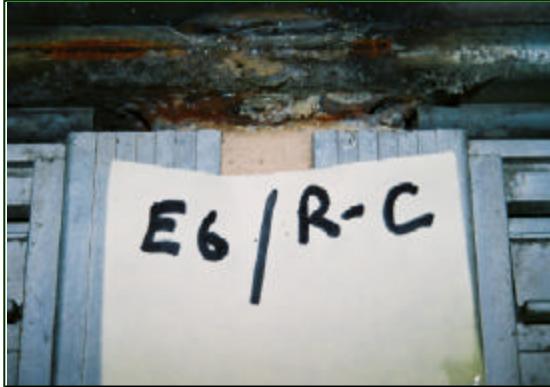
<i>Aspect/Location</i>	<i>Observations</i>
Left pillars	All welds appeared to be intact
Right B-pillar	Weld intact
Right C-pillar	Hairline crack through entire weld, all three surfaces ( <b>Figure 24</b> )
Right D-pillar	Hairline crack of both side welds, extending $\frac{1}{2}$ " on face weld at both sides; mid aspect of face weld intact ( <b>Figure 25</b> )
Right E- through Q-pillars	All welds appeared intact

**Figure 24.** Hairline crack at right C-pillar of Exemplar Bus No. 6.

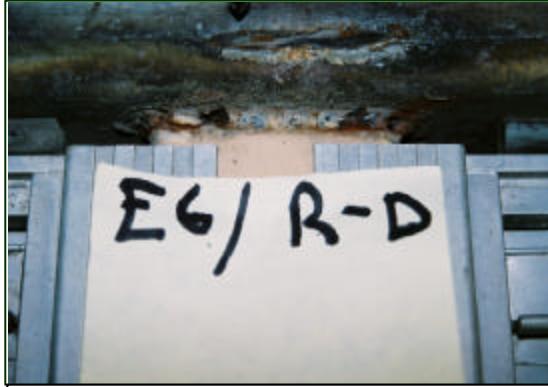
**Figure 25.** Crack side and face welds of right D-pillar of Exemplar Bus No. 6.
