ON-SITE CHILD SAFETY SEAT CRASH INVESTIGATION

VEHICLE: 2002 CHEVROLET VENTURE

CASE NO: CA03-022

CRASH DATE: FEBRUARY, 2003

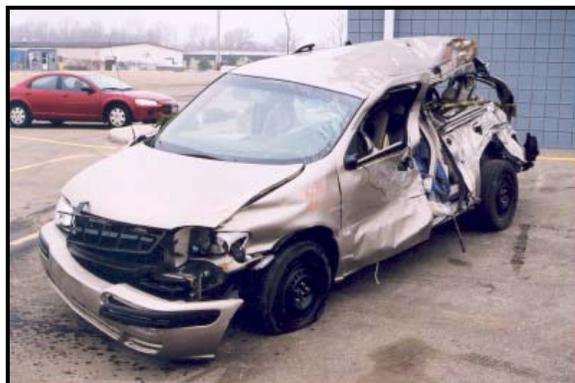
Figure 1: Left front view of the Chevrolet Venture.

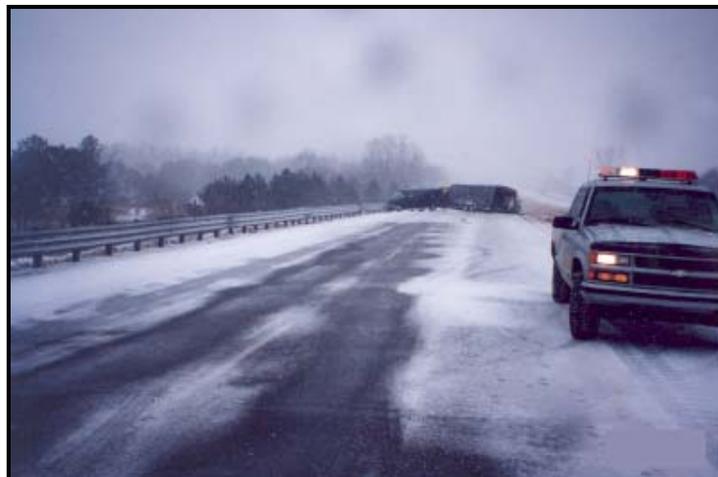
After separation with the Chevrolet, the front plane of the Ford struck and deformed the south guardrail, and came to rest blocking the eastbound travel lanes. **Figure 4** is a view looking west along the eastbound traffic lanes depicting the road conditions and the final rest position of the van and trailer. As a baseline analysis the WINSMASH model was used as a crash severity indicator. The total delta V's of the Chevrolet and Ford calculated by the Missing Vehicle Algorithm of the WINSMASH collision model were 52.0 km/h (32.3 mph) and 22.0 km/h (13.7 mph), respectively.

Figure 4: View looking west at the final rest position of the Ford and trailer in the eastbound lanes.

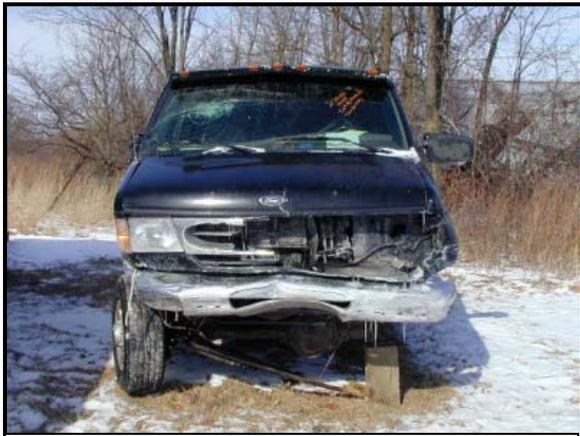
Figure 5: Front view of the Ford.

Analysis of the photographs indicated the front plane of the Ford sustained approximately 114 cm (45 in) of direct contact damage as a result of its impact to the Chevrolet and subsequent contact to the guardrail. The direct damage began approximately 30 cm (12 in) left of center and extended to the left corner. The estimated maximum crush was 15 cm (6 in) at the front left

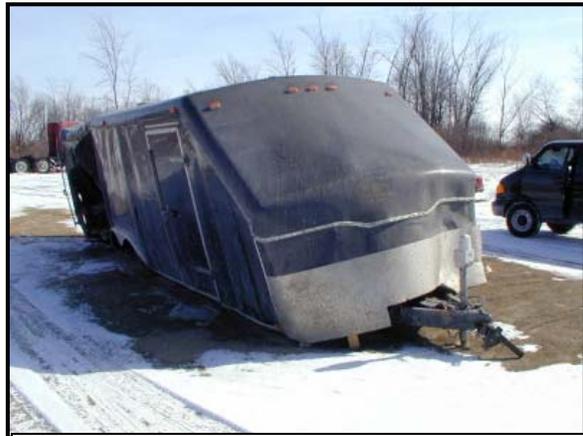
Figure 6: Left front view of the trailer.

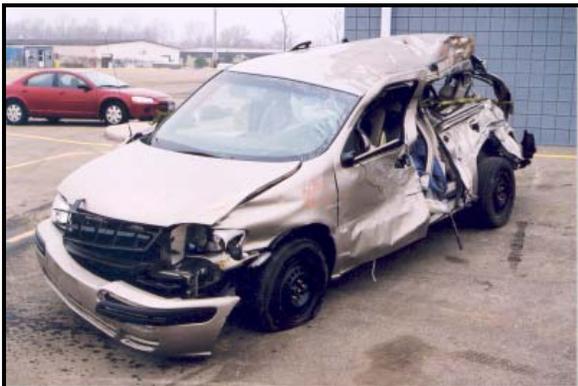
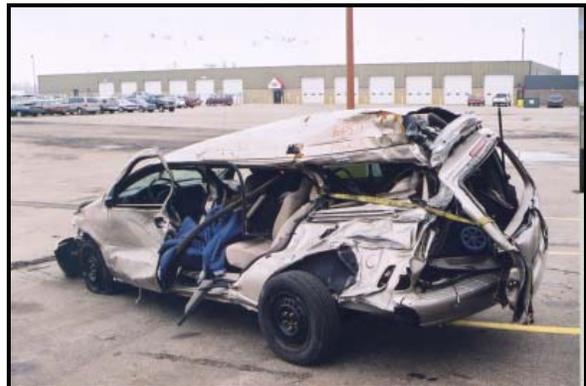
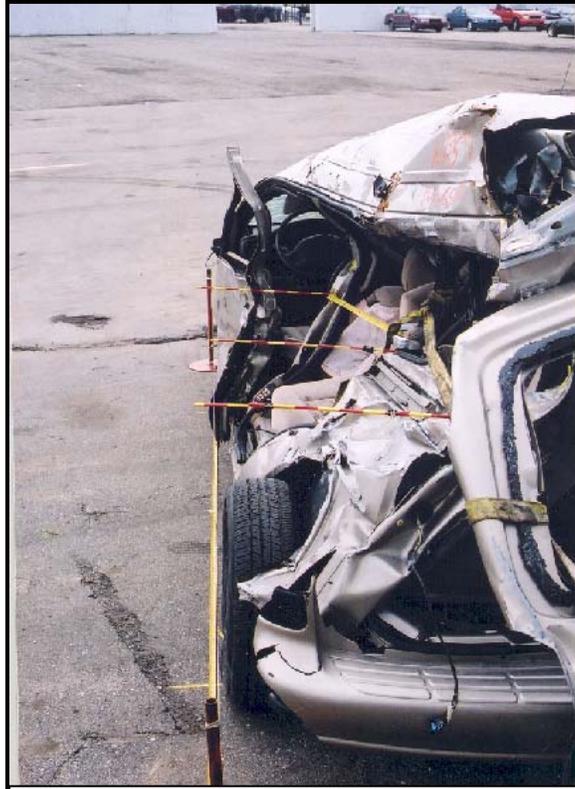
The Chevrolet Venture sustained severe left side damage as a result of the impact with the Ford van. **Figures 7 – 9** are the left front, left rear and rear longitudinal views of the Venture. The combined width of the direct and induced damage measured 340 cm (134 in). The induced damage began on the forward aspect of the left front door, 46 cm (18 in) rearward of the left front axle. The left side direct damage began 152 cm (60 in) aft of the left front axle at the location of the left B-pillar and extended through the D-pillar to the left rear corner. The width of the direct contact damage measured 234 cm (92 in). The principle direction of force was in the 10 o'clock sector. The direct contact deformed the left B-, C-, and D-pillars laterally and deformed the roof downward. The left sliding door separated from the vehicle at its hinges. The principle exterior damage was above the level of the sill and did not result in a measurable change in the left wheelbase dimension. The residual crush profile measured at the mid door height was as follows: C1 = 78.2 cm (30.8 in), C2 = 55.4 cm (21.8 in), C3 = 53.8 cm (21.2 in), C4 = 21.1 cm (20.1 in), C5 = 8.1 cm (3.2 in), C6 = 0. The delta V calculated by the Missing Vehicle Algorithm of the WINSMASH model was 52.0 km/h (32.3 mph). The longitudinal and lateral components of the delta V were -33.4 (-20.8 mph) and 39.8 km/h (24.7 mph), respectively. The Collision Deformation Classification (CDC) of the damage was 10-LZAW-5.

Figure 7: Left front view of the Chevrolet Venture.

Figure 8: Left rear view of the Venture.

Figure 9: Rear left longitudinal view of the Venture.

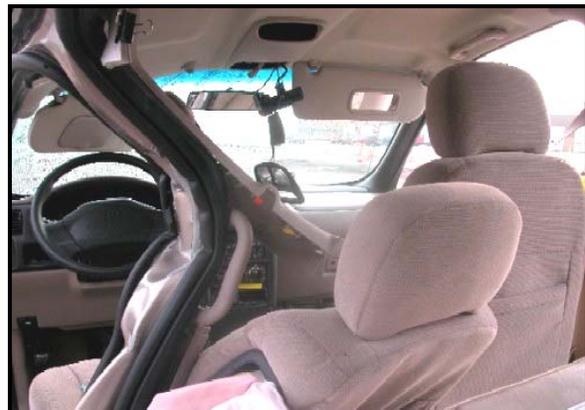
The front seating row consisted of manual bucket seats with adjustable head restraints. The driver seat, **Figure 10**, was adjusted to a full rear track position and was jammed in place by deformation. The head restraint was in its lowest position. The trim panel covering the left B-pillar was displaced from the deformed pillar at the belt line and was in contact with the driver seat back. The seat back was deformed to the right in partial contact with the right seat and had rotated counterclockwise. The seat back was laterally compressed approximately 8 cm (3 in). The interior panel of the left door immediately below the arm rest exhibited a 13 cm x 8 cm (5 in x 3 in) contact by the left flank of the driver. The front right seat was adjusted to a rear track position and measured 2.5 cm (1.0 in) forward of the full rear track position. The seat back was nearly upright and measured 5 degrees aft of vertical. The head restraint was in the lowest position.

Figure 10: Driver seat deformation and left B-pillar intrusion.

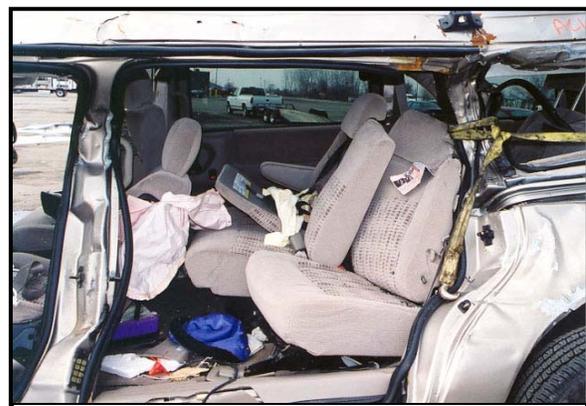
The second seating row consisted of a 60/40 split bench seat with folding seat backs. The seats were on an adjustable track and were independent of each other. The width of the left seat measured 46 cm (18 in). This seat was located in the area of direct contact and was impacted by the intruding left sliding door and C-pillar, **Figure 11**. The forward left anchor attaching the seat frame to the floor deformed and released by overload. The floor pan and mount exhibited corresponding damage. The seat deformed rearward and laterally to the right. The rearward displacement of the seat cushion and the lateral displacement of the seat back measured 23 cm (9 in) and 28 cm (11 in), respectively.

Figure 11 View of the second row seat deformation and intrusion.

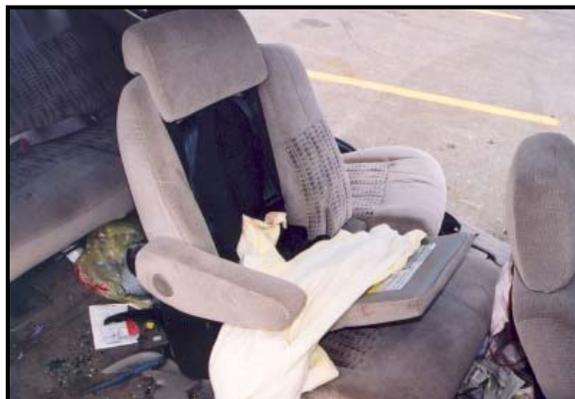
The second row right seat was not damaged in the impact, **Figure 12**. The seat was adjusted to a full rear track position. The adjustable head restraint was in the full down position. The seat back was reclined 22 degrees. The width of the seat cushion measured 61 cm (24 in). The OEM integrated Child Safety Seat (CSS) with a 5-point harness was located within this seat back. The seat was labeled for use by a child that weighed 10 to 18 kg (22 to 40 lb) and a height of 85.1 cm to 101.6 cm (33.5 in to 40.0 in). A 30 cm x 41 cm (12 in x 16 in) section of the seat back folded down and became the integrated CSS seat cushion. This cushion measured 4.6 cm (1.8 in) in thickness.

Figure 12: View of the integrated Child Safety Seat.

Initial observation of the 5-point harness revealed the right shoulder strap was cut during the removal of the child and the right crotch latch clip was missing. Examination of the straps and the hardware revealed evidence of historical use. The crotch straps exhibited slight creasing/roping at the latch clips that appeared to be more related to routine use than crash loading. There was no crash related evidence on the shoulder straps or harness retainer clip. The location of the clip measured 26.9 cm (10.6 in) below the entrance to the slot in the seat back. The driver reported that the child was restrained at the time of the crash and the retainer clip was located at the level of the child's arm pit. A blood stained yellow blanket located on the cushion was entangled in the harness straps. Reportedly, this blanket was used during the first aid efforts for the child and was originally located in a diaper bag on the floor at the time of the crash. SCI inspection of the integrated CSS determined the 33 month old child was restrained at the time of the crash.

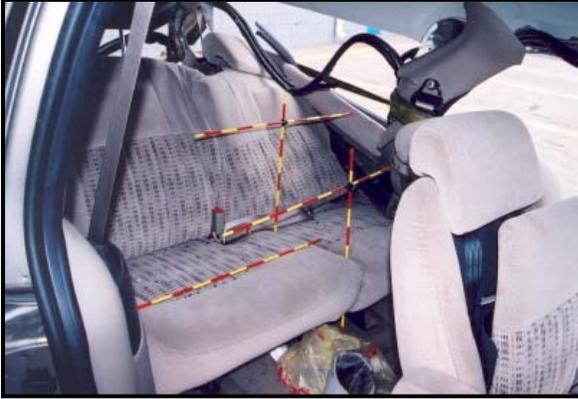
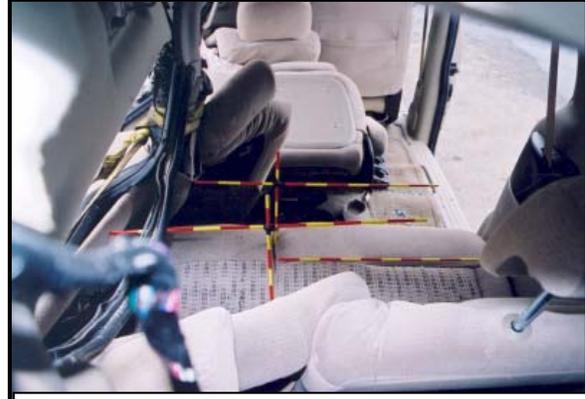
The left side wall and C-pillar were severely intruded into this region, **Figures 13 and 14**. The width of the right seat cushion measured 61 cm (24 in). This measurement was taken from the centerline of the seat to the right side wall. At the forward edge of the left seat cushion, the distance from the centerline to the residual location of the intruded C-pillar measured 20 cm (8 in). At the seat bight, the left lateral distance from the center to the residual position of the left side wall at the seat bight measured 30 cm (12 in). The left wall was in contact with the left seat back. This contact had displaced it to the right and had compressed the right seat back laterally approximately 10 cm (4 in).

Figure 13: Right view into the third row.

Figure 14: Forward view of the third row intrusion.

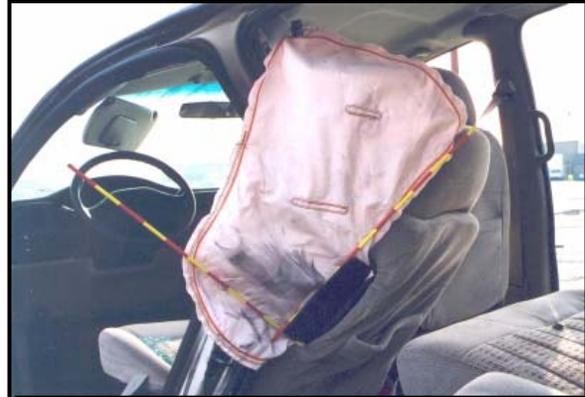
Figure 15 is a left view of the SAB. Note the position of the deployed air bag is aft and outside the left B-pillar. During the impact sequence, the B-pillar intrusion, and deformation/rotation of the driver's seat back caused the side impact air bag to deploy behind the pillar. The deployment of this SAB offered the driver no protection during this crash.

Figure 15: View of the deployed left SAB.

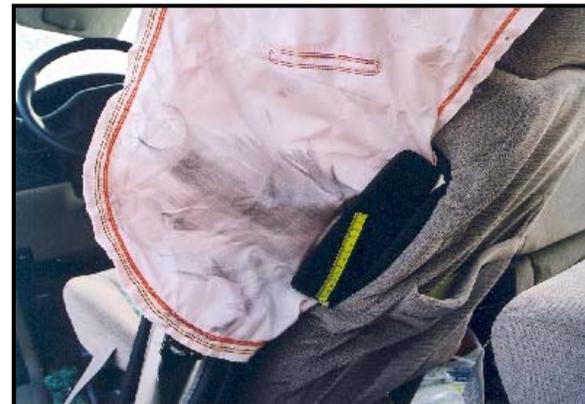
Close-inspection of the cover flap revealed a 13 cm (5 in) contact between the flap and the B-pillar trim panel, **Figure 16**. A corresponding vinyl transfer was identified on the trim panel (now in contact with the seat back). The outboard lower section of the side bag exhibited a heavy (8 in x 8 in) vinyl transfer caused by the impeded expansion of the bag. The inboard side of the bag exhibited a 23 cm x 10 cm (9 in x 4 in) transfer.

Figure 16: Close-up view of the impeded SAB.

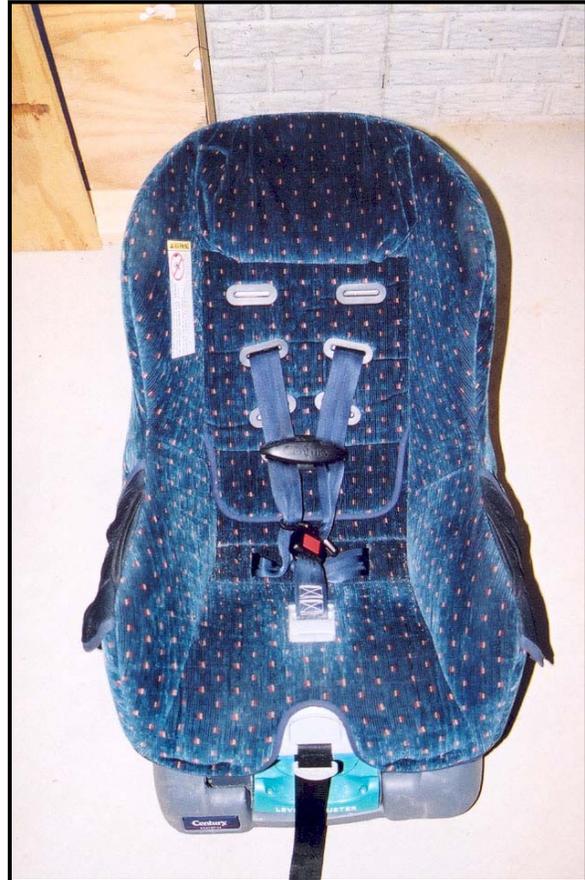
The 7 month old infant was restrained in a Century Bravo SE Convertible Child Safety Seat, **Figure 17**, that was identified by the Model No: 44622NYK and was manufactured on 10/09/2000. The convertible child restraint was installed in a rear-facing orientation in the third row of the Venture. Reportedly, the seat was purchased new for the family's first child in the later part of 2000. The driver reported that he had read the CSS manual.

Figure 17: Front view of the Century CSS.

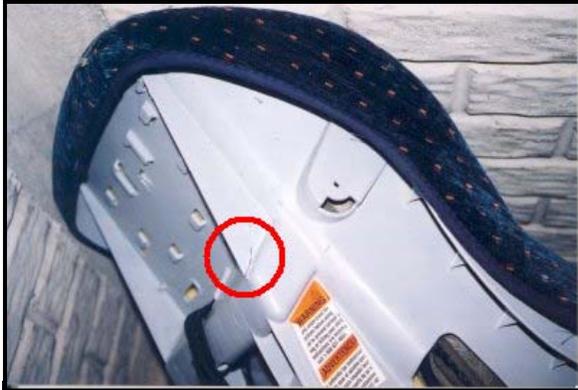
Examination of the shell identified two areas of crash related evidence. A contact to the upper right aspect of the shell from the intruding left side and C-pillar was identified, **Figure 18**. This contact resulted in a fracture to the plastic reinforcement on the back side of the shell. Corresponding stress marks were identified on the interior side of the seat back, **Figure 19**. The shell deformation was located in the region where the rear right aspect of the infant's head was probably located.

Figure 18: View of damage to the back of the CSS shell.

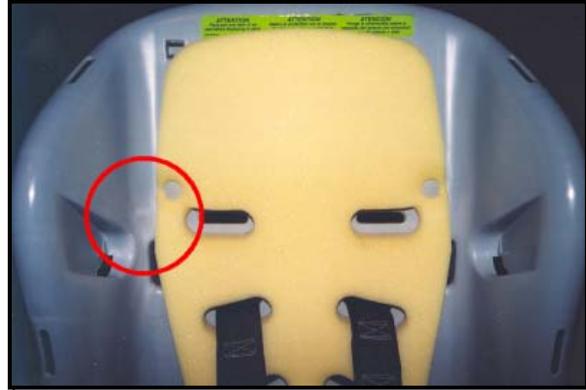
Figure 19: View of plastic stresses to the shell.

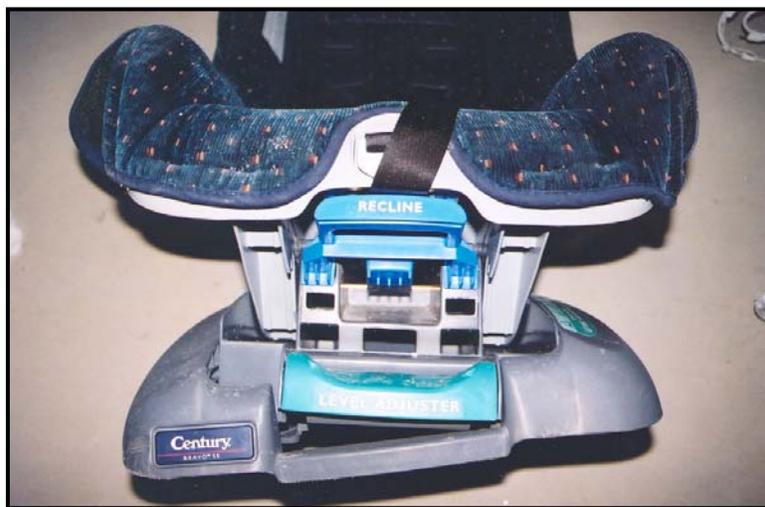
Inspection of the CSS also identified damage to the adjustable foot, **Figure 20**. The left side of the foot had collapsed due to overload. This occurred when the upper right rear aspect of the shell was impacted causing the CSS to rotate forward onto the foot.

Figure 20: View of the damage to the adjustable foot.

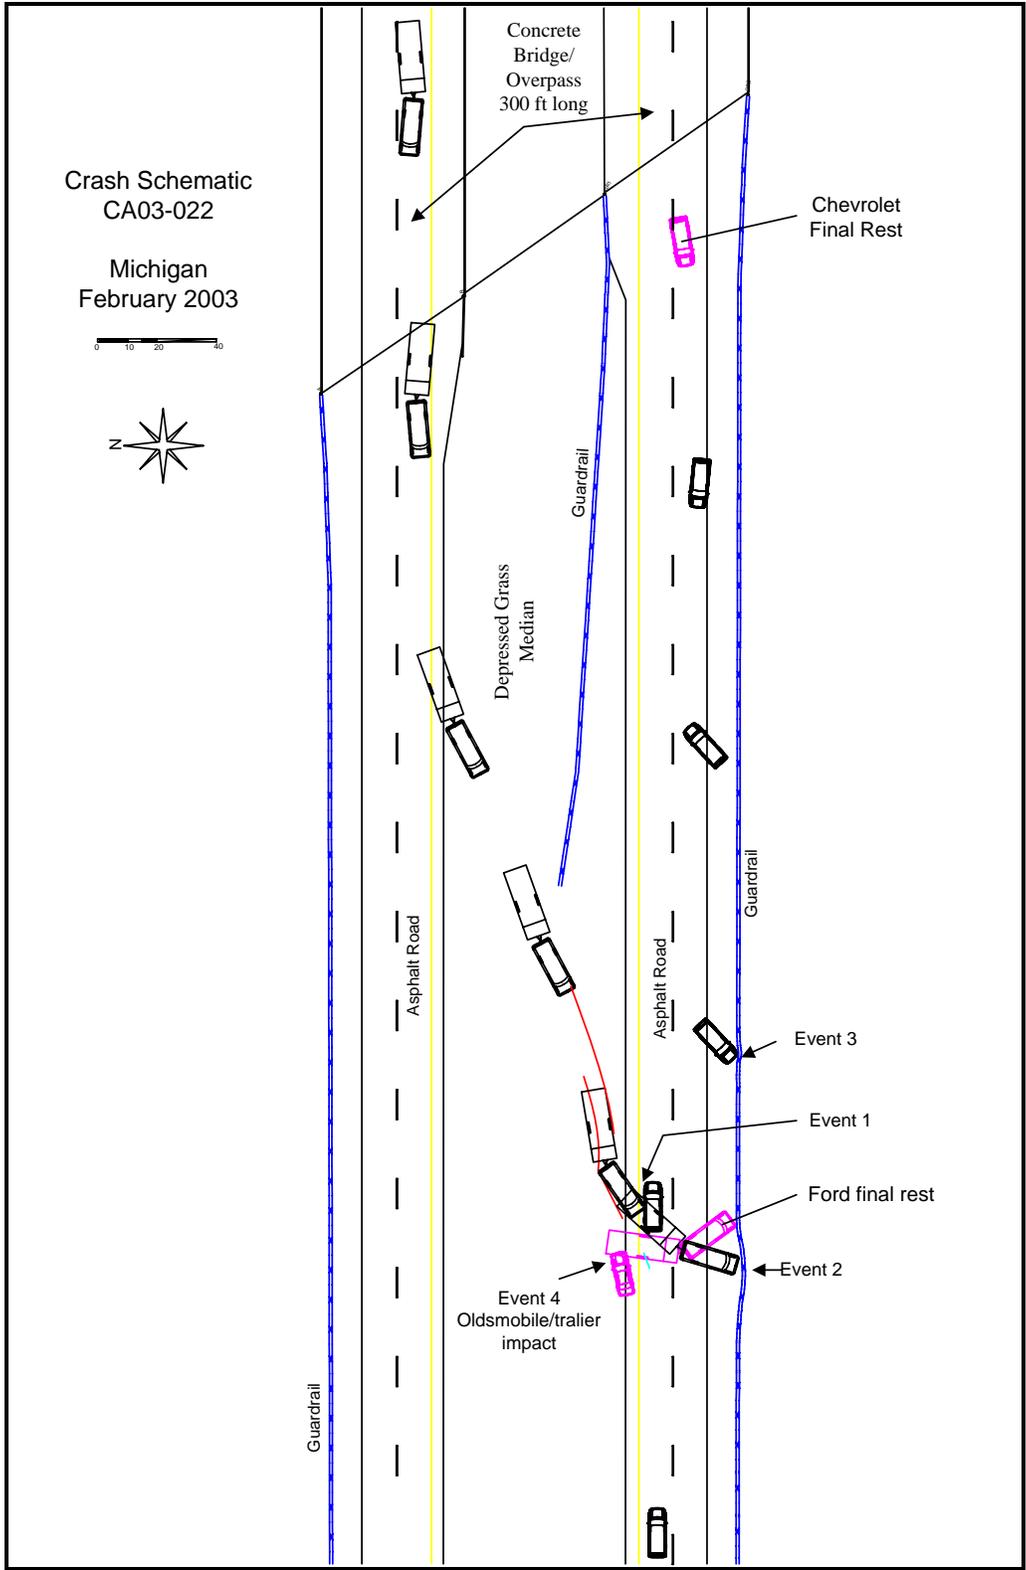
Figure 21: Crash Schematic

A schematic of the crash sequence is attached to the end of this report, **Figure 21**, Page 18. The crash occurred with the front left corner of the van impacting the left side of the Venture at its B-pillar. The directions of force were in the 10 and 1 o'clock sectors for the Chevrolet and Ford, respectively. The side impact air bag in the Chevrolet Venture deployed due to the force of the impact. The force of the impact rearward of the Chevrolet's center of gravity caused the Venture to rotate counterclockwise (CCW) and displaced the vehicle laterally. The Venture rotated approximately 200 degrees CCW and struck the W-beam guardrail bordering the south roadway edge with its front left corner. This guardrail impact was located 15 m (50 ft) east of the initial point of impact and was evidenced by a deflection in the guardrail. The Chevrolet then slid approximately 85 m (280 ft) eastward along the highway to rest, while rotating an additional 360 degrees. The Venture came to rest facing west in the outboard lane of the highway.
