**CALSPAN ADULT DRIVER AIR BAG RELATED FATALITY
INVESTIGATION**

CASE NO: CA03-023

VEHICLE: 1999 FORD TAURUS SE

CRASH DATE: APRIL 2001

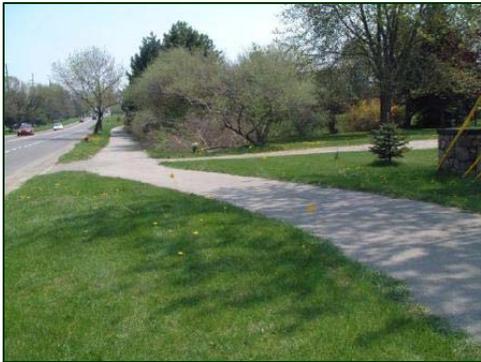
The 62-year old male driver of the Ford Taurus departed his residence to pick-up a pizza. While returning to his residence, he was traveling in an easterly direction. Reportedly, he stopped the Taurus behind several vehicles for a non-contact vehicle that was initiating a left turn at an intersection located west of the crash site. As traffic started to accelerate, the driver of the Taurus accelerated in an easterly direction on the four lane segment of the roadway. For an unknown reason, the driver of the Taurus allowed the vehicle to drift to the right as it departed the roadway in a tracking mode at the three-leg T-intersection. The Taurus overrode the barrier curb at an area of a storm receiver. At this location, the concrete road surface was tapered to the receiver which exposed a higher curb face. There was no evidence of undercarriage contact to the curb or storm receiver. The Taurus mounted the curb and departed the southeast quadrant of the intersection and traversed the lawn area in a slight, but tracking counterclockwise arc. The vehicle's trajectory was evidenced by rotating tire prints across the lawn area (**Figure 3**). The Taurus traversed a sidewalk and the stone driveway on a departure angle that was approximately 10 degrees from the south road edge. There was no scene evidence to support avoidance maneuvers. The Scene Schematic is included as **Figure 15** at the end of this narrative report.

Figure 3. Rotating tire prints across the lawn area.

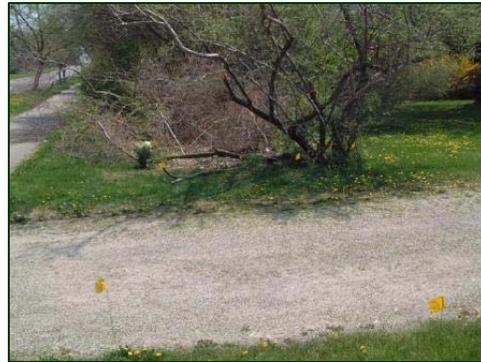
Figure 4. Struck shrub and continued trajectory of the Taurus.

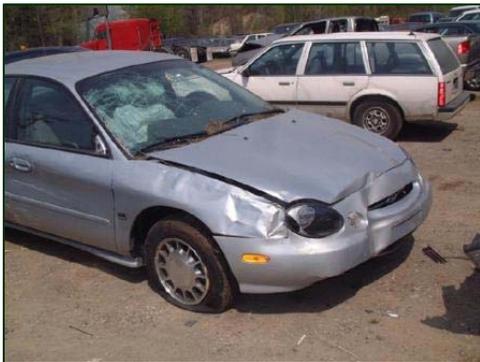
The front right area of the Taurus impacted a large overgrown shrub. The front bumper and hood edge impacted and fractured the trunk as the leading edge of the right front fender simultaneously impacted a second, diagonally oriented limb (**Figure 5**). The resultant directions of force were 12 o'clock for both impacts. This trunk impact resulted in 11 cm (4.3") of crush to the bumper, located approximately 33 cm (13") right of center (**Figure 6**). The bumper impact fractured the trunk from the shrub cluster. The Taurus continued forward as the right side of the vehicle remained engaged with the limb resulting in sideswipe-type damage to the entire length of the right side of the vehicle.

Figure 3. Frontal and right side damage to the Taurus.

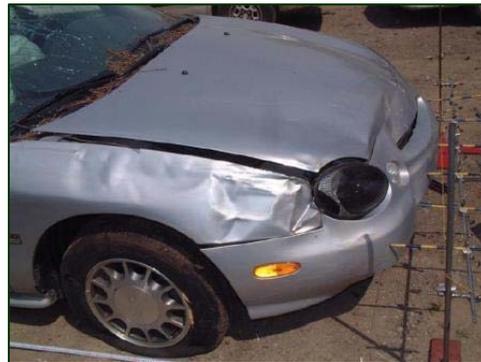
Figure 4. Lateral view depicting the depth of frontal crush.

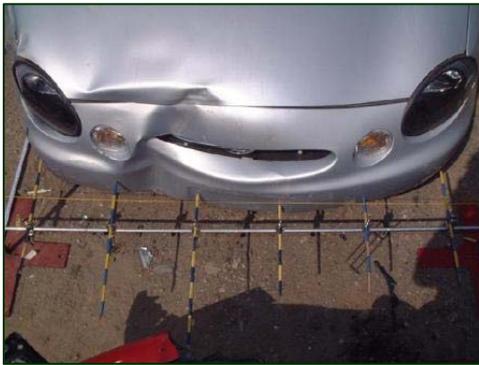
The initial impact with the trunk of the shrub resulted in damage to the front right bumper system. The area of deformation began approximately 13 cm (5") right of center and extended 38 cm (15") to the right turn signal assembly. The maximum crush from this impact was 11 cm (4.3"). The damage involved the fascia, bumper beam, and the hood edge (**Figure 7**). The crush profile at bumper level was as follows: C1 = 0 cm, C2 = 0 cm, C3 = 1 cm (0.4"), C4 = 5 cm (2"), C5 = 7 cm (3"), C6 = 1 cm (0.4"). This event was assigned a Collision Deformation Classification (CDC) of 12-FZEN-1.

Figure 7. Overhead view of the frontal crush depth.

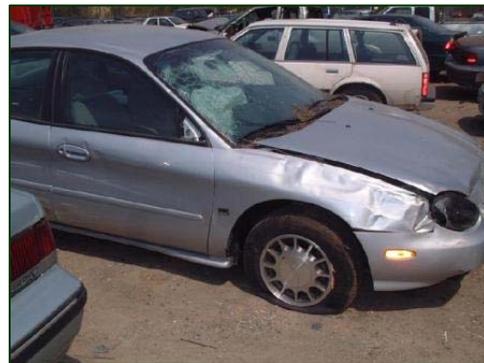
Figure 8. Right front fender sideswipe damage.

The Taurus' continuous engagement with the limb of the large shrub involved the right side area as the Taurus continued on a forward trajectory. This contact produced a series of dents to the top aspect of the fender with abrasions. The contact damage extended rearward and involved the upper right A-pillar, B-pillar, and the right side rear view mirror. The mirror was fractured from its mount. Abrasions and isolated dents were also noted to the right side surface of the Taurus that extended the full length of the vehicle (**Figure 8**). This continuous impact was assigned a CDC of 12-RDAS-9.

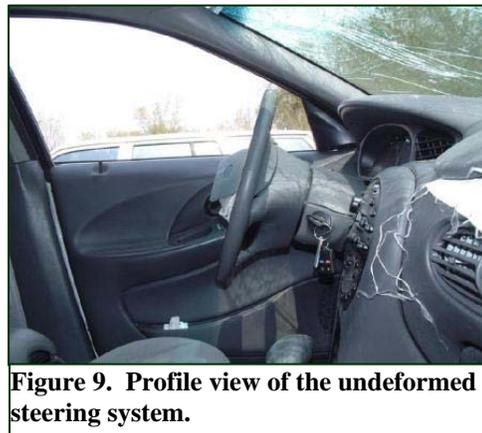
The driver was impacted by the expanding air bag membrane. Although he was presumed to be in close proximity to the air bag module at deployment, there was no apparent deflection of the upper steering wheel rim and no visible compression of the energy absorbing steering column (**Figure 9**).

Figure 9. Profile view of the undeformed steering system.

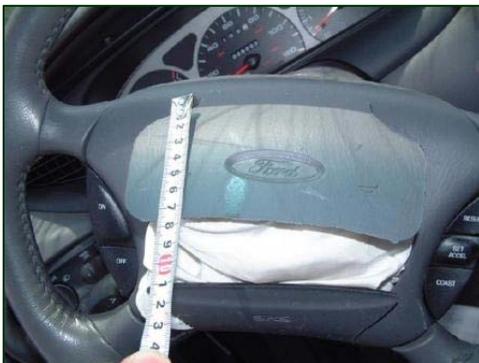
The driver air bag was concealed by asymmetrical H-configuration module cover flaps (**Figure 10**). The upper flap was approximately 8 cm (3") in height by 15 cm (6") in width at the horizontal tear seam. The deployed air bag membrane was tethered internally and was vented by two ports located at the 12 o'clock sector of the bag, forward of the peripheral seam. There was no damage to the air bag; however, several body fluid (blood) transfers were present on the face of the bag (**Figure 11**).

Figure 10. Driver air bag module cover flaps.

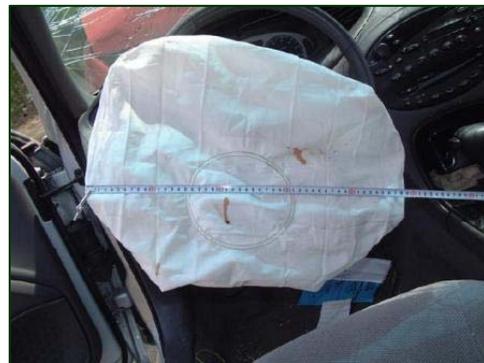
Figure 11. Deployed driver's redesigned frontal air bag.

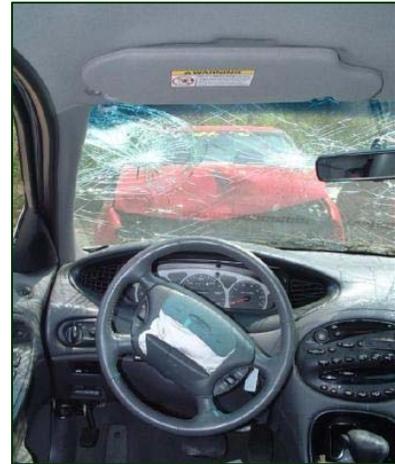
The 62-year old male driver of the 1999 Ford Taurus was seated in a rear track position and was not restrained by the manual 3-point lap and shoulder belt system. The lack of belt usage was supported by the vehicle inspection and from observations of the first responders to the crash site. Prior to impact, the driver possibly experienced a medical episode which could have resulted in his loss of directional control of the vehicle and the subsequent lateral drift off the right road edge. Additionally, the driver was out of position forward, within the deployment path of the expanding redesigned front left air bag (**Figure 12**). Based on injury data, the driver had both hands positioned on the steering wheel rim.

Figure 12. Initial trajectory of the unrestrained driver.

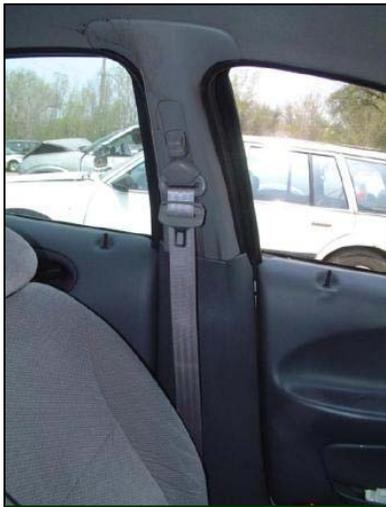
The driver's head and upper body was displaced upward and to the left with respect to the vehicle by the expanding air bag. A contact point attributed to the driver's head was noted at the upper aspect of the left B-pillar at its juncture with the roof side rail. This was evidenced by a bloody transfer; although, there was no associative damage to the plastic panel (**Figures 13 and 14**). The adjustable D-ring hardware that was located below plastic panel was free of contact evidence and damage as well.

Figure 13. Left B-pillar of the Ford Taurus.

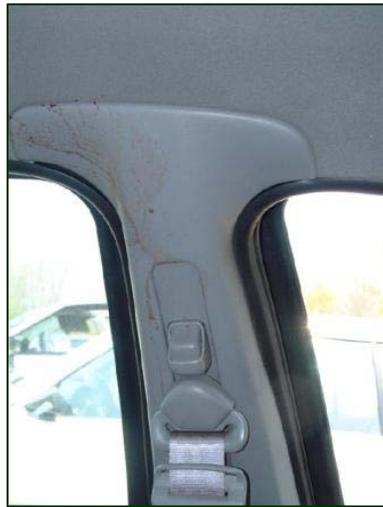
Figure 14. Head strike to the upper left B-pillar.

The driver sustained a horseshoe-shaped fracture of skull that involved a depressed left frontal skull fracture with a 3 cm basilar skull fracture, extending across the left and right sphenoid ridges. A fracture line was noted to originate in the left frontal region and extend anteriorly and inferiorly. These fractures resulted from the driver's head contact with the left B-pillar as he was displaced by the expanding air bag. Underlying injuries of the brain included uncal and tonsilar herniations, massive cerebral edema generalized subarachnoid hemorrhage, bilateral contusions, left and right intraventricular hemorrhage, and lacerations of the left temporal and frontal lobes.
