REMOTE CHILD AIR BAG-RELATED FATALITY INVESTIGATION

CASE NUMBER - IN-03-024
LOCATION - Missouri
VEHICLE - 1996 CHRYSLER CONCORDE
CRASH DATE - October 2001

Submitted:
August 25, 2004
Revised:
February 15, 2007

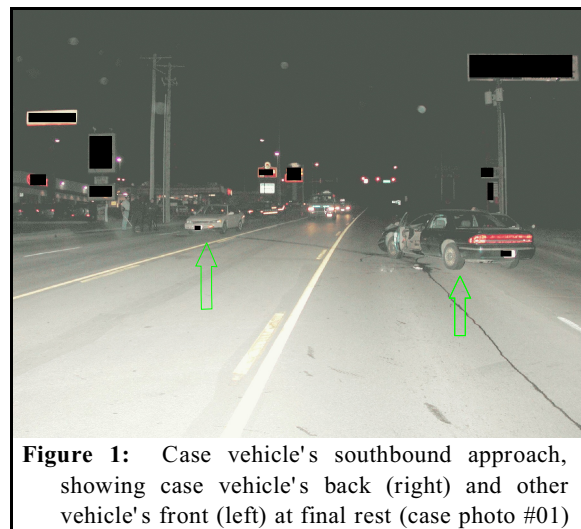
The case vehicle's front right area was impacted by the Nissan's front left, causing the case vehicle's driver and front right passenger air bags to deploy. The case vehicle moved backwards in a northwesterly direction approximately 15 meters [50 feet] and came to rest straddling the two southbound through lanes, heading southeastward (**Figure 1**). The case vehicle's driver stated that, immediately prior to the impact, she was trying to back her car out of the northbound lanes, and the case vehicle's transmission may have been in neutral or reverse at the time of the impact. The Nissan was redirected slightly clockwise and came to rest heading north in the inside northbound lane.

Figure 1: Case vehicle's southbound approach, showing case vehicle's back (right) and other vehicle's front (left) at final rest (case photo #01)

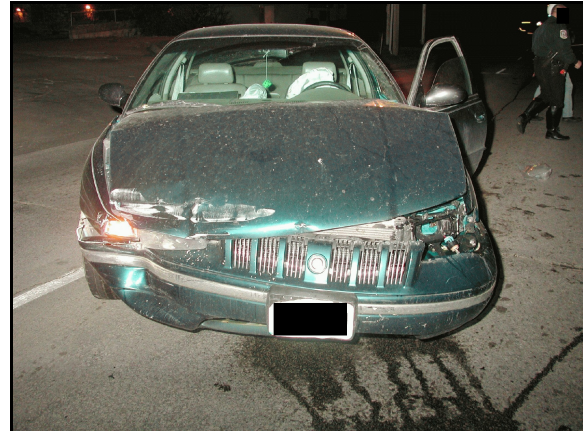
The case vehicle sustained direct contact at the apex of the front right corner, extending across the right third of the front and with some direct contact along the leading edge of the right fender. The engine hood was folded upward across the middle and downward in the front, and the right fender was displaced inward. The front bumper was pushed down across the entire width and displaced slightly leftward. The left headlamp/turn signal assembly was knocked loose and thrown free. There was substantial fluid leakage, suggesting that the radiator was damaged. None of the tires appeared to be deflated or restricted and there was no glazing damage.

The CDC for the case vehicle was estimated from photographs as **01-FZEW-1 (30)**. The WinSMASH reconstruction program, damage only algorithm based on the photo-estimated CDCs for the two vehicles, was used. The total, longitudinal and lateral delta Vs for the case vehicle are, respectively: 16.0 km.p.h. [9.9 m.p.h.], -13.9 km.p.h. [-8.6 m.p.h.] and -8.0 km.p.h. [-4.9 m.p.h.]. This is a borderline reconstruction, but the results appear reasonable. This was a crash of low severity (14-23 km.p.h. [9-14 m.p.h.]) for the case vehicle.

Figure 2: Front of case vehicle at final rest, showing moderate frontal damage (case photo #08)

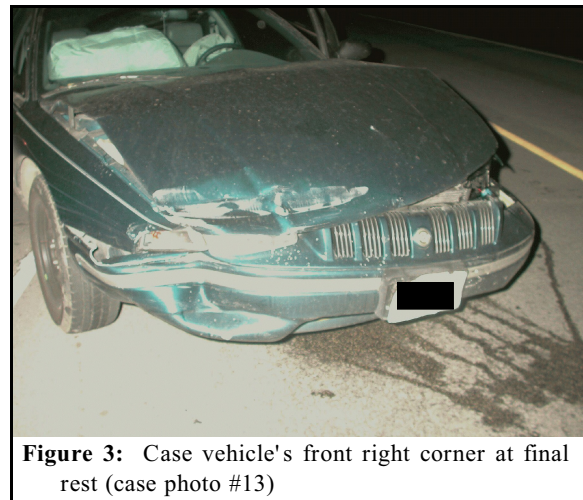
Figure 3: Case vehicle's front right corner at final rest (case photo #13)

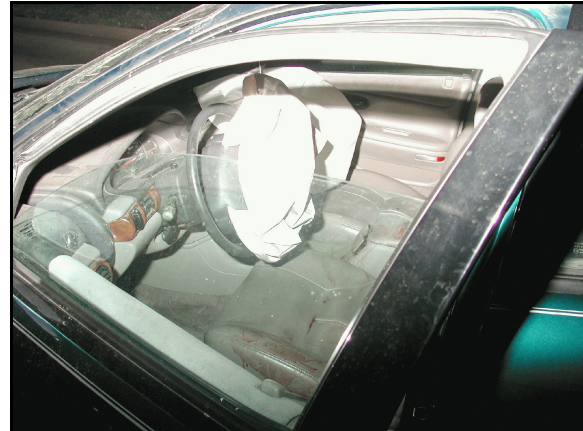
details are not completely visible in the available photographs). The deployed driver's air bag was round, with its diameter unknown. It is not known if the air bag had any vent ports or tethers. There is no visible evidence of contact on the driver's air bag fabric (**Figure 4**).

Figure 4: Deployed driver's air bag viewed from left (case photo #14)

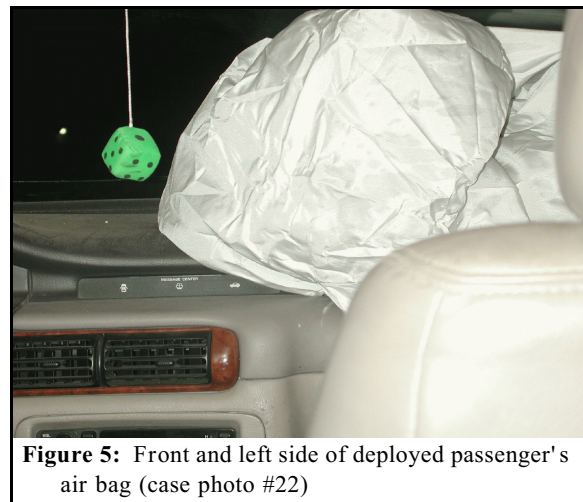
The front right passenger's air bag was located in the top of the right instrument panel. The configuration of the module cover flap(s) is not known. The cover flap(s) cannot be seen in the available photographs and it is not known if the module opened correctly. The shape of the air bag cannot be discerned in the available photographs, and its size is not known. It is not known if the air bag had any tethers or vent ports. There is no visible evidence of damage to the passenger's air bag, and no evidence of occupant contact can be seen in the available photographs (**Figures 5 and 6**).

Figure 5: Front and left side of deployed passenger's air bag (case photo #22)

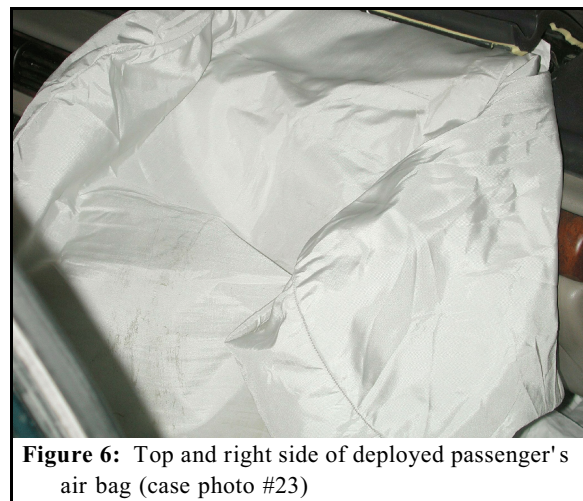
Figure 6: Top and right side of deployed passenger's air bag (case photo #23)

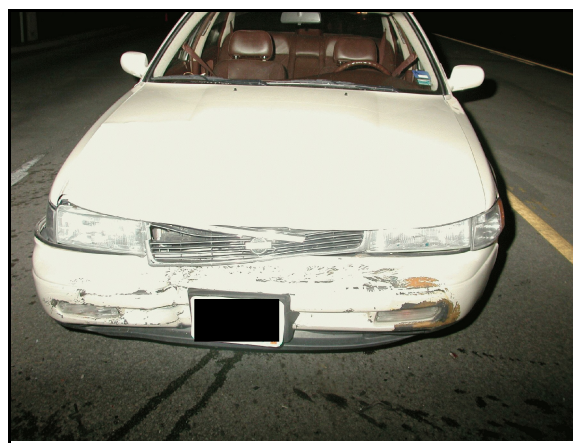
The Nissan sustained direct contact on its bumper and grille, primarily at the center and extending toward the left. The bumper and grille were crushed rearward slightly, with the bumper displaced slightly rightward. The engine hood was bent upward across the middle and slightly downward at the front. None of the tires were deflated or restricted and there was no glazing damage.

The CDC for the Nissan was estimated from photographs as **12-FYEW-1 (0)**. The WinSMASH reconstruction program, damage only algorithm based on the photo-estimated CDCs for

Figure 7: Nissan's front at final rest (case photo #27)

the two vehicles, was used. The total, longitudinal and lateral delta Vs for the Nissan are, respectively: 17.0 km.p.h. [10.6 m.p.h.], -17.0 km.p.h. [-10.6 m.p.h.] and 0 km.p.h. [0 m.p.h.]. This is a borderline reconstruction, but the results appear reasonable. This was a crash of low severity (14-23 km.p.h. [9-14 m.p.h.]) for the Nissan.
