VERIDIAN ON-SITE REAR IMPACT CRASH/FIRE INVESTIGATION

VERIDIAN CASE NO. CA03-025

VEHICLE: 2000 FORD CROWN VICTORIA POLICE INTERCEPTOR

CRASH DATE: MAY 2003

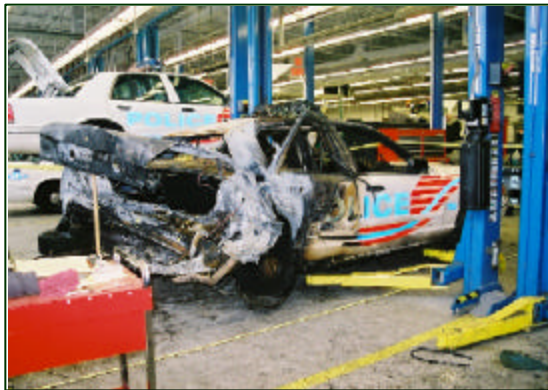
Figure 1. Right rear view of the crush pattern and resultant fire damage to the 2000 Ford Crown Victoria.

right rear areas of the Crown Victoria, resulting in severe damage to the police vehicle. The steel fuel tank of the Crown Victoria was punctured and a fire ensued which consumed the vehicle (**Figure 1**). The Crown Victoria was displaced forward by the crash. Two police officers who were standing in the roadway forward of the Police Interceptor were struck by the front of the Crown Victoria. One of the officers sustained bilateral leg fractures while the other sustained minor severity injuries. The Taurus subsequently struck the rear of the ambulance. The impact with the Crown Victoria deployed the Taurus' frontal air bag system. The unrestrained female driver of the Taurus was reportedly under the influence of a controlled substance at the time of the crash. She sustained police reported incapacitating injuries and was transported to a local hospital where she was admitted for treatment.

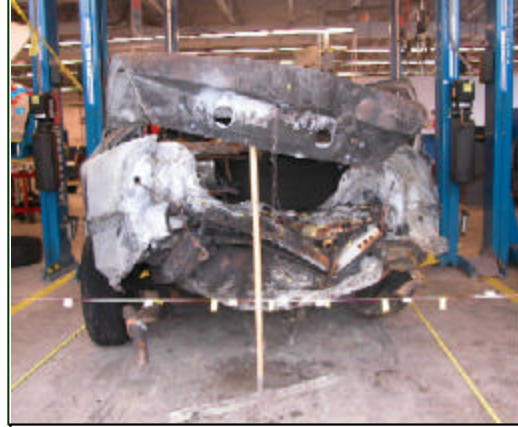
The 2000 Ford Crown Victoria sustained severe rear damage (**Figure 4**) as a result of the impact with the Ford Taurus. The direct contact damage began 8.6 cm (3.4”) left of the center of the face of the trunk lid and extended 94.6 cm (37.2”) to the rear right corner. The impact deformed the entire end width resulting in a combined direct and induced damage length that measured 89.2 cm (35.1”). The bumper beam was crushed forward and rotated upward 90 degrees. The maximum crush on the bumper beam measured 127.0 cm (50.0”) and was located 34.3 cm (13.5”) right of center. (The rear bumper fascia was consumed by the ensuing fire).

Figure 4. Rear view of the Crown Victoria.

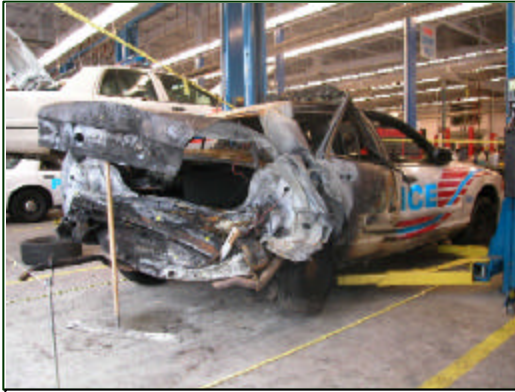
The trunk lid was buckled and displaced upward, and the entire trunk was crushed forward. The left frame rail was displaced laterally inward. The right frame rail was crushed forward and laterally over the rear axle and was bent at the apex of the axle. The frame rail crush measured 34.6 cm (13.6”) on the left rail and 104.8 cm (41.3”) on the right frame rail. The forward displacement of the rear axle resulted in the reduction of the right wheelbase by 33.3 cm (13.1”) and the elongation of the left wheelbase by 4.8 cm (1.9”). The alloy driveshaft was fractured forward of the differential yoke as a result of the forward displacement of the rear axle. Both rear quarter panels were crushed forward and the left quarter panel was pulled inward at the rear aspect due to the offset impact configuration. The longitudinal displacement at the left quarter panel measured 12.4 cm (4.9”) and the longitudinal crush on the right quarter panel measured 114.0 cm (44.9”). The forward displacement of the right rear quarter panel resulted in the restriction of the right rear wheel and tears in the sidewall of the right rear tire. The right rear quarter panel damage also resulted in the forward displacement of the bottom aspect of the right C-pillar and the separation of spot welds from the right rear inner fender to the right C-pillar. The total length of the weld separation measured 105.1 cm (41.4”) vertically from the sill. Six crush measurements were documented along the center aspect of the bumper beam and were as follows: C1 = 41.0 cm (16.1”), C2 = 66.0 cm (26.0”), C3 = 91.6 cm (36.1”), C4 = 118.1 cm (46.5”), C5 = 121.0 cm (47.6”), C6 = 112.9 cm (44.4”). Six additional crush measurements were documented along the bottom of the trunk lip. The Field-L along the trunk lip measured 134.9 (53.1”) and the crush measurements were as follows: C1 = 29.2 cm (11.5”), C2 = 61.9 cm (24.4”), C3 = 84.8 cm (33.4”), C4 = 120.7 cm (47.5”), C5 = 129.5 cm (51.0”), C6 = 130.8 cm (51.5”). The Collision Deformation Classification (CDC) for the rear impact was 06-BZEW-6. **Figures 5 and 6** document the rear damage pattern.

Figure 5. Right rear three-quarter view of the Crown Victoria.

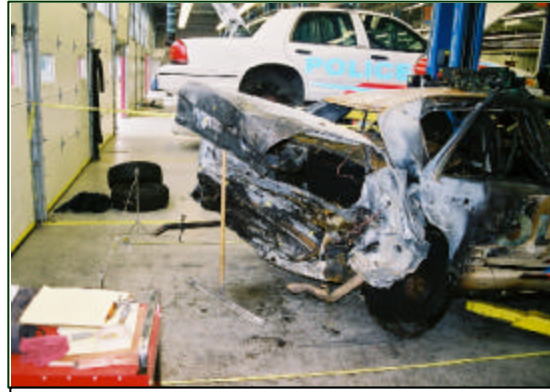
Figure 6. Lateral view documenting the extent of crush to the back plane.

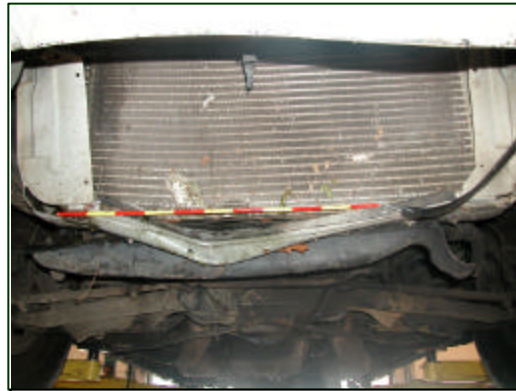
Figure 8. Lower radiator support impact damage.

The Crown Victoria also sustained frontal damage, possibly the result of an impact with a tree stump or log on the roadside. The bumper fascia exhibited abrasions and minor deformation along the entire width and the front left corner of the fascia was crushed rearward and fractured on the bottom aspect. The frontal damage was concentrated on the lower radiator support that was crushed rearward (**Figure 8**). The direct damage on the lower radiator support began at the centerline and extended 14.0 cm (5.5") to the right. The combined direct and induced damage measured 83.8 cm (33.0") across the lower radiator support. Both the lower radiator support and lower aspect of the radiator core

were crushed and abraded. Transfers that appeared to be from tree bark were present on the lower radiator support in the area of the direct damage. Four crush measurements were documented along the lower radiator support and were as follows: C1 = 8.3 cm (3.3”), C2 = 11.4 cm (4.5”), C3 = 23.5 cm (9.3”), C4 = 12.1 cm (4.8”). The CDC for this frontal impact was 12-FCLN-1.

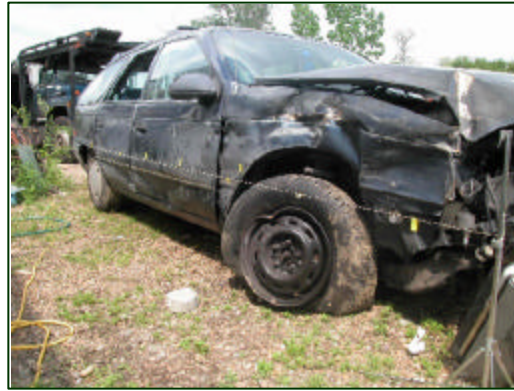
The 1990 Ford Taurus sustained moderate right side damage as a result of multiple impacts with the Cavalier (initial impact event) and the ambulance resulting in overlapping damage patterns (**Figure 9**). The direct damage began 92.1 cm (36.3”) forward of the right rear axle and extended forward 257.8 cm (101.5”) along the right side plane to the leading edge of the right front fender. Isolated dents were present on the front and rear right doors. A vertical dent and related abrasion was present on the roof side rail on above the forward aspect of the right rear door from direct contact with the right rear corner of the ambulance patient compartment. The right rear door glazing also disintegrated. The right front fender was abraded and deformed inward from direct contact. Due to masking damage from the multiple events, the specific crush profiles could not be separated, therefore a common profile was documented along the right side plane and was as follows: C1 = 0.0 cm, C2 = 0.0 cm, C3 = 0.0 cm, C4 = 7.0 cm (2.8”), C5 = 20.6 cm (8.1”), C6 = 13.0 cm (5.1”).

Figure 9. Right side damage to the Ford Taurus.

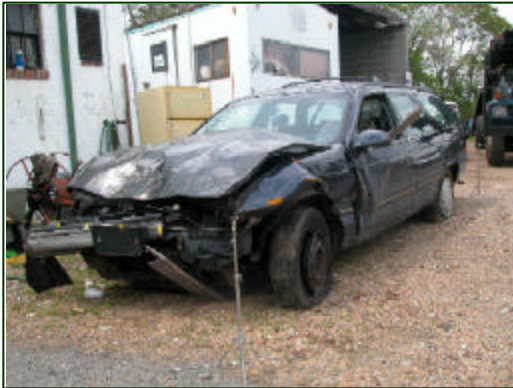
The 1990 Ford Taurus sustained moderate frontal damage as a result of the impact with the Ford Crown Victoria (**Figure 10**). The direct damage on the hood began 13.0 cm (5.1”) to the right of the centerline and extended across the hood to the front left corner. The direct damage on the bumper began 18.1 cm (7.1”) to the right of the centerline and extended 81.3 cm (32.0”) to the left corner. The fiberglass/plastic bumper beam was fractured near the left bumper mount/EAD. The left aspect of the bumper was fractured and separated. The combined direct and induced damage involved the entire frontal width of the Taurus and measured 130.8 cm (51.5”) across the bumper. The hood and front fenders were buckled rearward. The frontal damage resulted in the reduction of the right wheelbase by 10.5 cm (4.2”). Six crush measurements were documented across the front bumper and were as follows: C1 = 27.0 cm (10.6”), C2 = 29.2 cm (11.5”), C3 = 25.1 cm (9.9”), C4 = 16.8 cm (6.6”), C5 = 5.7 cm (2.3”), C6 = 7.3 cm (2.9”). **Figure 11** is a lateral view of the left side documenting the extent of frontal crush.

Figure 10. Frontal view of the resultant damage from the Crown Victoria impact.

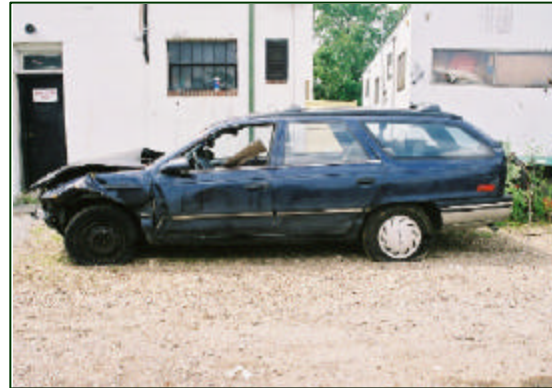
The lower radiator support also sustained direct contact damage from the frontal impact. The maximum crush on the lower radiator support measured 29.8 cm (11.8”). The Field-L on the lower radiator support measured 71.1 cm (28.0”) across its width. Four crush measurements were documented along the lower radiator support and were as follows: C1 = 19.7 cm (7.8”), C2 = 26.0 cm (10.3”), C3 = 20.3 cm (8.0”), C4 = 4.4 cm (1.8”). The Taurus CDC’s for the impact events are identified in the following table.

Figure 11. Lateral view documenting the extent of the frontal crush.

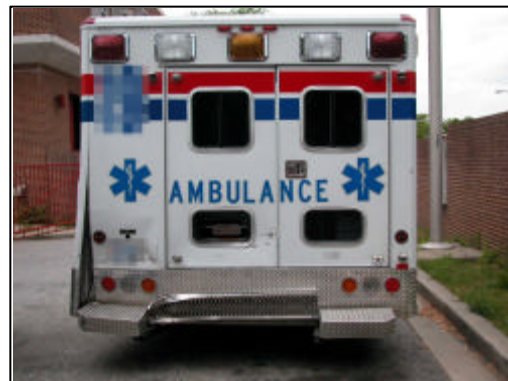
The 2002 Ford E-450 Type III Ambulance sustained minor damage to the rear aspect of the patient compartment (**Figure 12**) as a result of the impact by the Taurus. The Taurus initially impacted the left aspect of the step bumper and left corner area prior to side-slapping the full end width of the patient compartment. The overlapping impacts resulted in direct contact that measured 245.1 cm (96.5”). The left rear corner post of the patient compartment was deflected outward 9.3 cm (3.8”) at the base and separated to 124.5 cm (49.0”) above the rear step. The rear wall of the patient compartment was crushed 8.9 cm (3.5”) and the left rear step was deflected inward at the rear left corner. The lower window glazing on the left rear door disintegrated. The aluminum rear-folding step was rotated upward and crushed against the rear aspect of the patient compartment. The license plate was crushed 10.8 cm (4.3”) laterally to the left. Both door-keepers were deformed on the left aspect of the rear of the patient compartment. A dark scuff was present on the right rear corner of the patient compartment 142.2 cm (56.0”) above the ground that extended 5.7 cm (2.3”) vertically from the right rear door and roof side rail of the Taurus. Fractured tempered glazing was also present on the right rear side gutter over

Figure 12. Damage to the back of the parked ambulance.

the compartment door. The CDC for the initial impact was 03-BYEW-1 with a sideslap CDC of 06-BZEW-1.

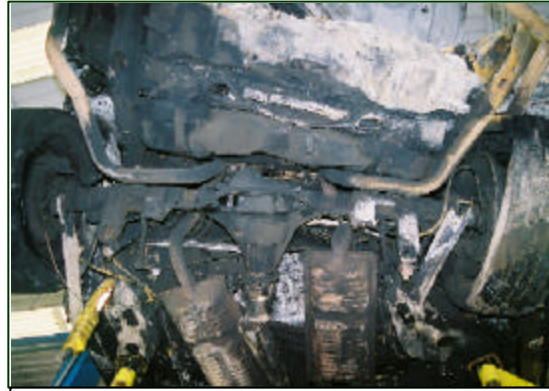
A Field Service Campaign (02B02) was announced by Ford in September 2002, to install a retrofit shield kit to the rear axle and fuel tank straps. The kit included two fiberglass reinforced shields that cover the shock and sway-bar mounting brackets, a rubberized shield that protects the differential cover, rubber boot-type shields that protect the bottom attachment point of the fuel tank straps, and the installation of three rivets to the leading edge of the rear mounted vapor recovery system mounting bracket. **Figure 13** is a view of an exemplar vehicle with the retrofit kit installed. An authorized Ford technician demonstrated and supervised the installation of these kits to the police maintenance technicians. The kits were subsequently installed by the police maintenance technicians on all vehicles within this police fleet. The kit was installed on the crash-involved Crown Victoria on March 15, 2003. Following the crash and fire, the kit remained intact, with moderate fire-related damage (**Figure 14**), and appeared to have been installed properly to Ford's specifications.

Figure 14. Shield kit of the Subject Crown Victoria.

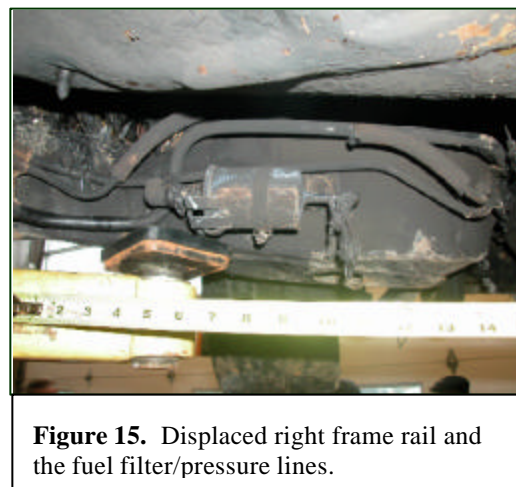
The fuel system was inspected in its post-crash state. All fuel supply, vent, and recovery lines were basically intact, allowing the investigators to trace the lines for signs of suspected ruptures/failures. The right frame rail was displaced laterally left (inboard) approximately 20.0 cm (8.0") at the location of the right C-pillar. The fuel filter was attached to the frame at this location. The fuel supply pressure line was burned at the aft segment of the filter; however, the manufactured loop in the supply line aft of the filter provided sufficient flex in the line to prevent line separation at this point (**Figure 15**).

Figure 15. Displaced right frame rail and the fuel filter/pressure lines.

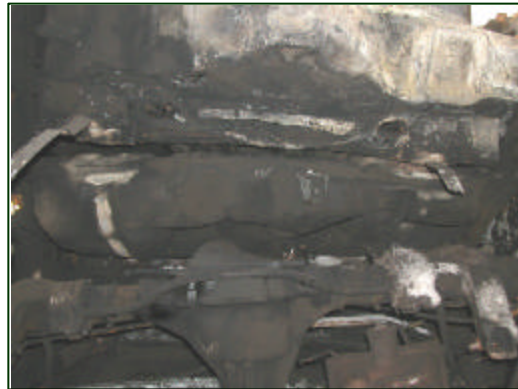
The forward and side surfaces of the fuel tank were visually inspected for signs of penetration and/or ruptures. These surfaces appeared to be free of punctures (**Figure 16**). With the approval of Fleet Management, the decision was made to remove the tank from the vehicle to allow for inspection of the top and aft surfaces of the tank. Several police automotive technicians conducted the tank removal process with assistance provided by the SCI investigators.

Figure 16. Deformed fuel tank prior to removal

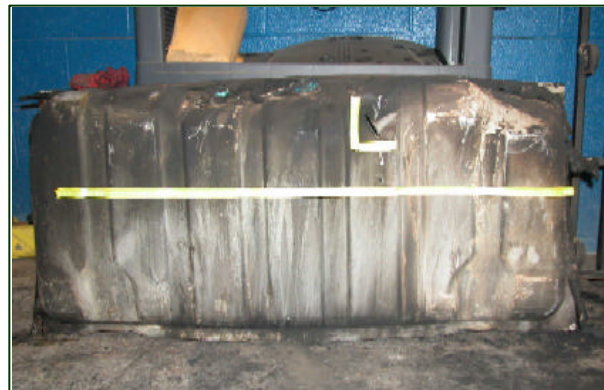
Figure 18. Rear aspect of the fuel tank with puncture outline with calibrated tape.

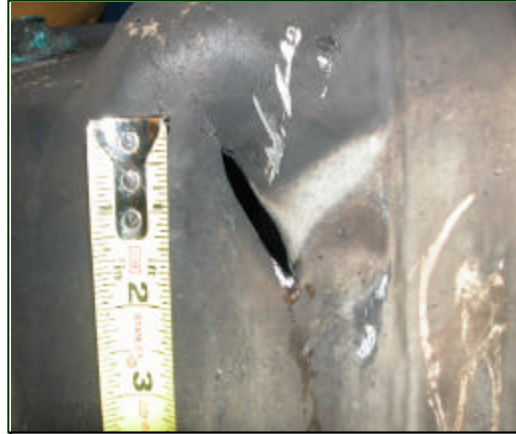
As the tank was removed from the Crown Victoria, a large puncture (**Figure 19**) was noted to the back-side of the tank (side adjacent to the trunk), near the top surface. The puncture was located 12.7-15.2 cm (5.0-6.0") right of the tank's vertical centerline and extended 5.7-9.9 cm (2.25-3.9") below the top surface of the tank. The puncture measured 6.4 mm (0.25") in maximum width. A burn pattern, which indicated extreme heat, extended from the puncture site, oriented up and to the right of the puncture location. This pattern was white in color against the blackened fuel tank and extended 5.1 cm (2.0") outward from the puncture. The triangular shaped pattern was 2.5 cm (1.0") wide at the site of the puncture. As viewed from the rear of the tank, the burn pattern extended in a clock direction of 2-2:30.

Figure 19. Puncture to the upper aspect of the fuel tank with adjacent burn.

1. The steel OEM fuel tank was punctured on the back wall of the tank, opposite of the rear axle and differential.
2. A burn pattern demonstrating extreme heat was present at the location of the puncture, supporting the theory that the fire was fuel related.
3. A mating puncture of the forward wall of the trunk was located in the exact area of the tank puncture and was of the same size and shape as the fuel tank puncture.
4. All components of the trunk were removed and inspected as potential sources of the puncture.
5. All trunk items were ruled out as potential sources of the puncture with the exception of the hold-down bracket washer for the spare tire.

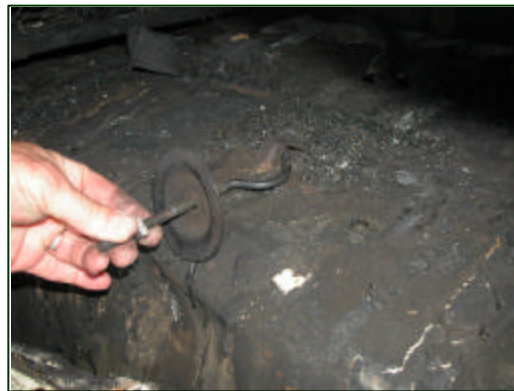
The spare tire was positioned in its designated position on the top shelf of the trunk, lying horizontally, right of center and fully forward against the rear seat area. The wheel was positioned in a face-up attitude with the outside surface of the tire and wheel facing upward. In this position, approximately 25 percent of the tire and wheel protruded over the rear edge of the shelf. The tire was charred with minimal burn-through which resulted in the loss of tire pressure. A pry bar was used to separate the tire from the steel floor of the trunk. As the tire was slid rearward, the spare tire hold-down bracket and washer fell to the floor of the trunk. This hold-down bracket was lying loose under the wheel toward the center point of the vehicle. The bracket and washer (**Figure 20**) were retrieved as the tire was removed from the trunk. It should be noted that the tire contained a significant amount of water that was used by the firefighters to cool the vehicle following the suppression of the fire.

Figure 20. Spare tire hold-down bracket and anchor loop.

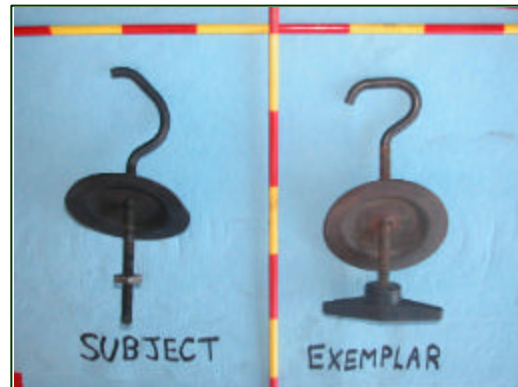
The spare tire hold-down bracket and retainer washer were examined and compared to an exemplar unit (**Figure 21**). The hook aspect of the treaded rod was elongated, or opened to the extent of 3.5 cm (1.375"). This indicated a stress load was placed on this bracket as it was engaged with the floor mounted anchor loop. The loop was closely examined and it was noted to be loaded in a rearward direction, with deflection from left to right. It appeared that the hold-down bracket was engaged with the anchor loop and inserted into the loop from the right side.

Figure 21. Subject vehicle hold-down bracket compared to an exemplar

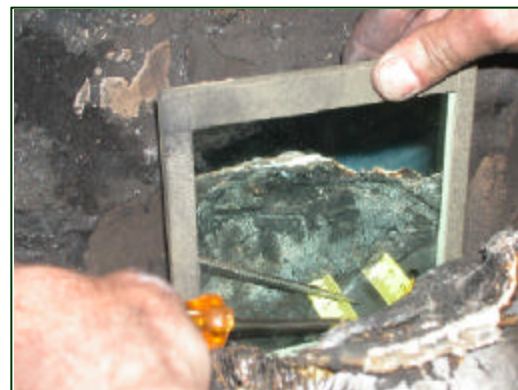
This washer, with minimal circumferential deformation, was positioned in the puncture of the trunk wall and the fuel tank puncture site. As the washer was rotated in the puncture sites, the deflection of the washer surface aligned near perfectly with the slight vertical contour of the punctures. An inspection mirror was utilized to examine the intruding back wall of the trunk. At maximum engagement, the dynamic crush displaced the rear wall of the trunk fully forward against the forward wall at the spare tire location. A superficial, vertically oriented crease (**Figure 22**) was present in the rear wall of the trunk, nearly directly opposite of the trunk wall puncture site. This evidence verified that the fuel tank was punctured by an object within the trunk, apparently the spare tire hold-down bracket washer.

Figure 22. Crease to the back wall of the trunk from washer engagement.

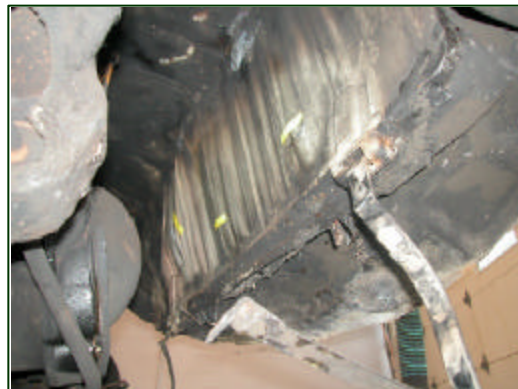
It should be noted that none of these items recovered from the trunk, had the characteristics, shape, or location of the puncture to the trunk wall and fuel tank. The pry-end of the crowbar did penetrate the deformed trunk floor left of center at the aft aspect of the trunk. Three distinct outward dents (**Figure 23**) were noted to the forward wall of the trunk, adjacent to the location of the fuel tank. The OEM jack dented the left side of the trunk wall, 8.3-10.8 cm (3.25-4.25") inboard of the left tank strap and 8.9-11.4 cm (3.5-4.5") above the trunk floor. On the center aspect of the wall, a small round shaped dent was noted 29.2 cm (11.5") inboard of the right tank strap and 8.9 cm (3.5") above the floor of the trunk. This dent probably resulted from the OEM lug wrench. The third outward dent (two clustered) was located 7.6-10.2 cm (3.0-4.0") inboard of the right tank strap and 15.2-19.7 cm (6.0-7.75") above the trunk floor. These dents probably resulted from the hook portion of the crowbar.

Figure 23. Outward dents on the forward wall of the trunk toward fuel tank from trunk contents .

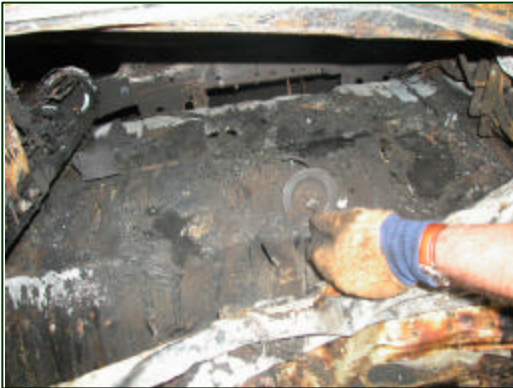
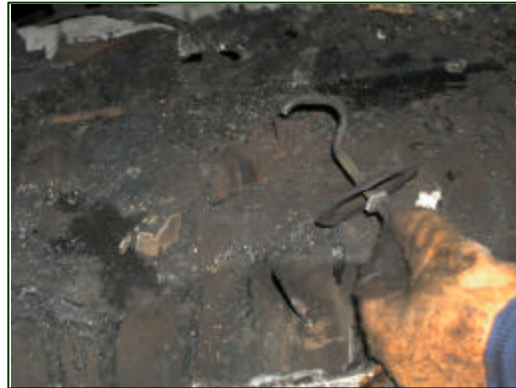
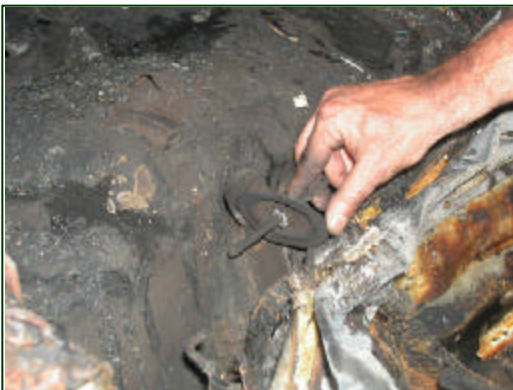
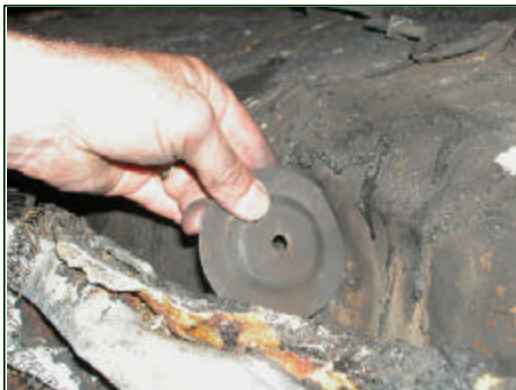
As the 1990 Ford Taurus impacted the rear of the parked Ford Crown Victoria, the rear aspect of the Crown Victoria began to crush. During this event, the Crown Victoria was accelerated forward. The spare tire essentially remained in position in space as the vehicle was displaced forward. (The spare tire was displaced rearward with respect to the vehicle). The forward aspect of the wheel rim of the spare engaged the retainer washer of the hold-down bracket. This was evident by the load induced bending of the hook aspect of the hold-down bracket. During this loading event, the hook aspect of the hold-down bracket deformed the floor mounted anchor bracket. As the 6.4 mm (0.25") diameter hold-down bracket deformed under load by the spare tire, the hook aspect disengaged from the anchor bracket. During the loading and disengagement, the retainer washer rotated approximately 90 degrees in a clockwise direction with respect to the vehicle. The hold-down bracket was free-floating as it was contacted and compressed against the forward wall of the trunk by the intruding back wall of the trunk. This compression resulted in the edge of the retainer washer penetrating, in a knife-like manner, the back wall of the trunk and the adjacent fuel tank. The tank puncture was 5.1 cm (2.0") vertically and 6.4 mm (0.25") in width. As the vehicle continued to crush, the hold-down bracket was displaced vertically, coming to rest on the shelf under the spare tire.

The fuel tank was full at the time of the crash with an estimated 64-68 liters (17-18 gallons) of gasoline present in the tank. The tank was compressed against the tank straps and the tailpipes that reduced its volume. Fuel was forced from the puncture and subsequently ignited immediately, resulting in the vehicle fire. The source of ignition could not be determined. There were no distinct impacts to the undercarriage (i.e., curb, pavement) in the area of the fuel leakage. **Figures 24-27** are simulated images of the spare tire hold down bracket engagement by the spare tire, the subsequent separation and rotation of the unit, and the puncture of the trunk and fuel tank.

Figure 24. Initial position and engagement of the spare tire hold-down bracket.

Figure 25. Loading, elongation, and separation of the bracket from the anchor loop.

Figure 26. CW rotation of the bracket and engagement against the trunk wall.

Figure 27. Penetration of the bracket washer through the trunk wall and into the back of the fuel tank.
