***ON-SITE AIR BAG RELATED CHILD PASSENGER SERIOUS INJURY  
INVESTIGATION***

**GENERAL DYNAMICS CASE NO: CA03-026**

***VEHICLE: 1996 DOGE CARAVAN***

**CRASH DATE: MAY, 2003**

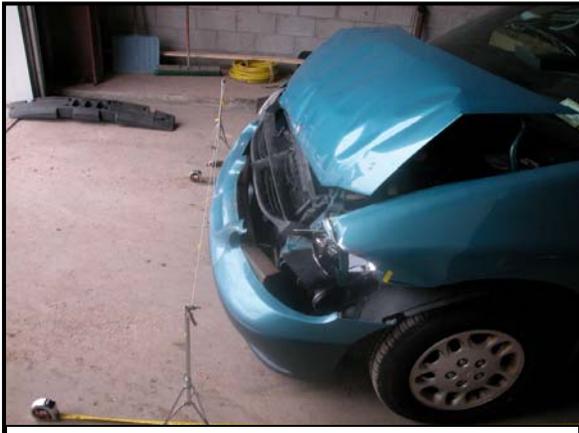
The front plane of the Caravan sustained 132.6 cm (52.2 in) of direct contact damage as a result of the impact with the 2002 Caravan. The direct contact began 54.4 cm (21.4 in) right of center and extended to the left corner. The combined with of the direct and induced damage extended across the entire 156.4 cm (61.6 in) end width of the vehicle. The nature and profile of the impact damage was indicative of an underride. **Figure 3** is a left lateral view of the damage. There was no measurable residual crush at the elevation of the front bumper. Minor abrasions were observed on the vertical face of the bumper fascia that wrapped onto the fascia's horizontal face. This contact pattern then transitioned into direct impact damage to the center grille area. All the residual impact damage was above the elevation of the front bumper with the greatest crush located along the upper radiator support and leading edge of the hood. The severity of the impact was determined by an averaged residual crush profile as an input to the Damage Algorithm of the WINSMASH model. This averaged profile was: C1 = 0, C2 = 11 cm (4.3 in), C3 = 12 cm (4.7 in), C4 = 11 cm (4.3 in), C5 = 0, C6 = 0. There was no reduction in the vehicle's wheelbase measurements and all the doors remained operational. The calculated total delta V was 16.1 km/h (10.0 mph). The longitudinal and lateral components of the delta V were -16.1 km/h (10.0 mph) and 0 km/h, respectively. The Collision Deformation Classification (CDC) for the impact was 12-FDMW-1.

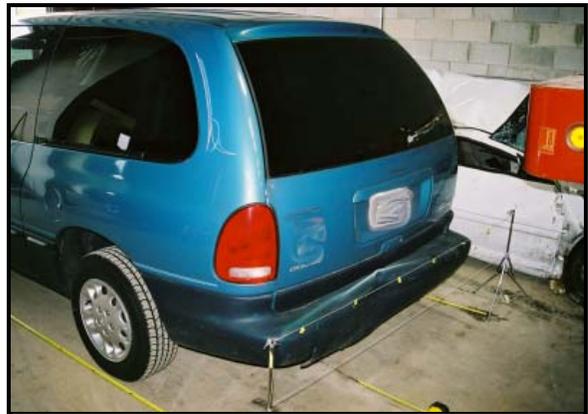
The rear bumper of the Caravan sustained minor damage as a result of a secondary impact from the Ford Taurus, **Figure 4**. The residual crush profile of the rear bumper reinforcement was as follows: C1 = 7.0 cm (2.8 in), C2 = 8.0 cm (3.1 in), C3 = 16.0 cm (6.3 in), C4 = 7.0 cm (2.8 in), C5 = 5.0 cm (2.0 in), C6 = 3.0 cm (1.2 in). The rear hatch remained closed and was operational. However, its operation was restricted by the deformation of the rear bumper fascia. The delta V of the rear impact was approximately 14.5 km/h (9.0 mph). The CDC was 06-BDEW-1.

**Figure 4: Rear bumper deformation.**

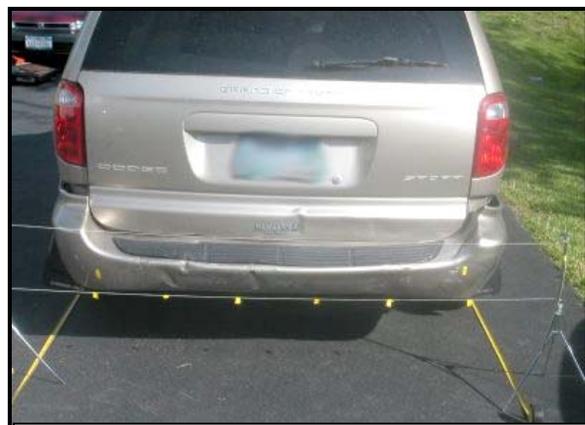
**Figure 6** is rear view of the rear bumper damage. The rear bumper system of the Dodge sustained minor impact damage as a result of the crash. The width of the direct damage measured 138.5 cm (54.5 in). The direct contact began 55.9 cm (22.0 in) left of center and extended to the right rear corner. The width of the direct and induced damage extended across the entire 165.1 cm (65.0 in) undeformed end width. The deformation of the vehicle was confined to the structures of the rear bumper system; there was no visible damage to the vehicle's rear uni-body structure. The residual crush profile of the rear bumper reinforcement was as follows: C1 = 0, C2 = 4.0 cm (1.6 in), C3 = 4.0 cm (1.6 in), C4 = 5.0 cm (2.0 in), C5 = 9.0 cm (3.5 in), C6 = 10.0 cm (3.9 in). The electronic rear hatch was not damaged in the crash and was still operational. There were no glazing fractures and the wheelbase dimensions were unchanged. The delta V calculated by the Damage Algorithm of the WINSMASH model was 16.3 km/h (10.1 mph). The CDC was 06-BDEW-1.

**Figure 6: Rear view of the 2002 Caravan.**

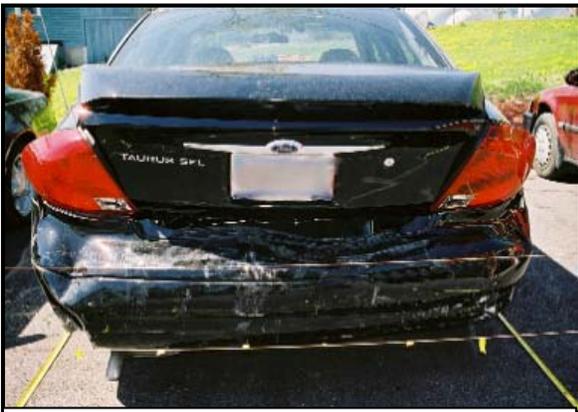
**Figures 7 and 8** are views of the Ford's rear bumper and trunk damage. The rear bumper of the Ford sustained 157 cm (62 in) of direct contact damage that extended across the entire end width of the vehicle as a result of the impact from the Chevrolet. The crush of the bumper reinforcement was uniform and directed longitudinally forward. The force of the crash collapsed the trunk space capturing the vehicle's spare tire that was housed within the trunk's lower section. The residual crush profile of the rear bumper reinforcement was as follows: C1 = 20.0 cm (7.9 in), C2 = 28.0 cm (11.0 in), C3 = 32.0 cm (12.6 in), C4 = 29.0 cm (11.4 in), C5 = 26.0 cm (10.2 in), C6 = 22.0 cm (8.7 in). The CDC of this impact was 06-BDEW-3. The delta V calculated by the Missing Vehicle Algorithm of the WINSMASH model was approximately 23.7 km/h (14.7 mph).

**Figure 5: Rear view of the Taurus.**

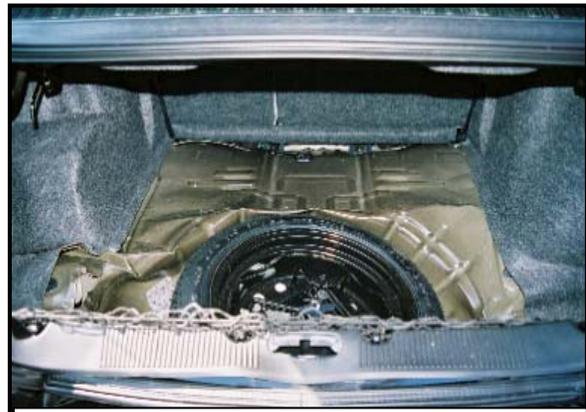
**Figure 6: View of the trunk collapse.**

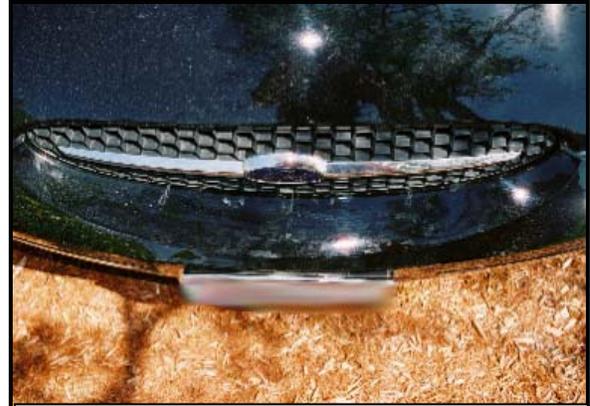
Figure 9. The abrasions resulted from frictional contact between the fascia and the lower surface of the center grille. The minor nature of the frontal impact did not warrant deployment of the Taurus's safety systems given that both front occupants were restrained by the 3-point manual lap and shoulder belt.

**Figure 8: Abrasions to the center section of the fascia.**

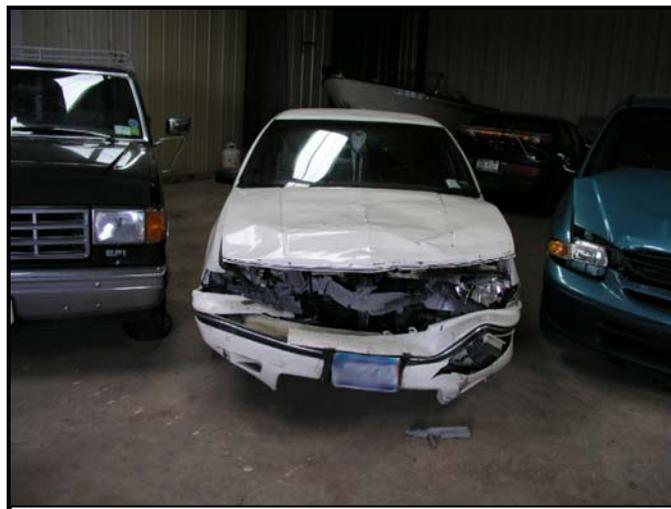
The 1990 Chevrolet Lumina was not available for inspection. A review of the police photographs indicated the vehicle sustained moderate frontal damage as a result of its impact with the rear bumper of the Ford, **Figure 11**. The collision damage extended across the vehicle's front end width and was uniform. The estimated crush was approximately 25 cm (10 in). The vehicle was equipped with 3-point lap and shoulder belts for the front occupants. It was not equipped with a Supplemental Restraint System.

**Figure 9: Front view of the Chevrolet Lumina.**

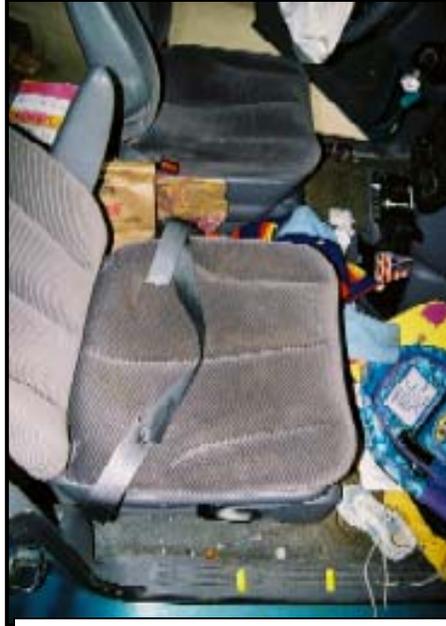
The six year old child passenger was restrained only by the lap portion of the restraint at the time of the crash. The shoulder portion of the belt was behind her back. The webbing of the front right manual restraint was cut above the floor anchor and above the latch plate by the EMS responders. In this manner, the restraint could be removed without moving the child. As a result the restraint was in three sections. A 44.4 cm (17.5 in) section of webbing was attached to the outboard floor anchor and a 50.8 cm (20.0 in) webbing section was found in the right foot-well. The balance of the webbing was allowed to spool back into the retractor and it was not inspected. **Figure 12** is a view of the front right restraint in a reconstructed position. The cinching latch plate was found on the seat cushion. Examination of the plate revealed evidence of historical use. There was no evidence of loading identified on the latch plate hardware or on the D-ring surface. The D-ring was noted to be in its lowest adjustment.

**Figure 10: Front right restraint webbing.**

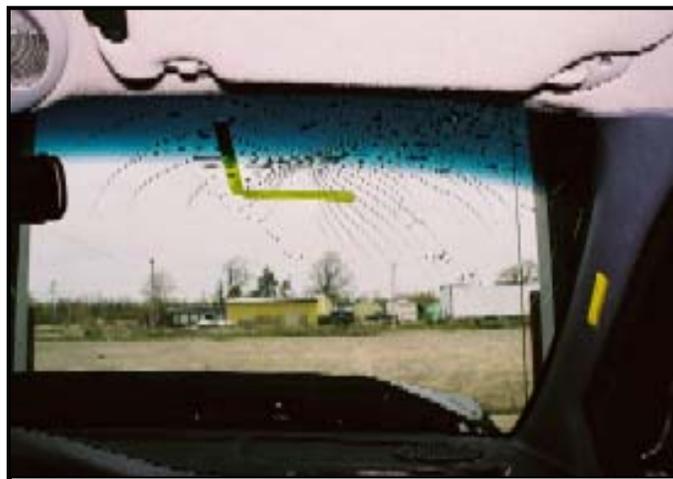
The right aspect of the windshield was fractured forward of the front right seat position, **Figure 13**. The center of the fracture site located 15.7 cm (6.2 in) below the header and 37.6 cm (14.8 in) inboard of the right A-pillar. The fracture was caused by the altered deployment of the front right passenger air bag. Air bag contact scuffs that measured 5 cm (2 in) in length were observed on the interior surface of the laminate adjacent to the fracture site. The air bag also contacted and abraded the right A-pillar trim. The abrasion measured 5.6 cm (2.2 in) in length and began 33 cm (13 in) above the surface of the instrument panel.

**Figure 11: View of the windshield fracture and abraded A-pillar trim.**

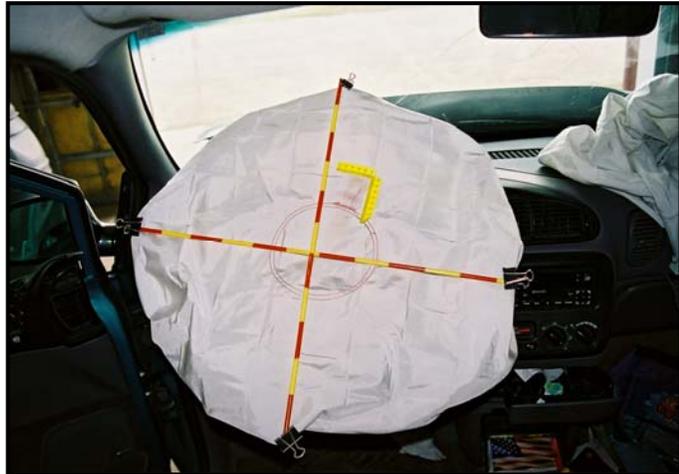
The driver contacted the 6 o'clock sector of the deployed air bag. The physical nature and position of the contact evidence was consistent with the driver contacting the deployed bag in this orientation (i.e. with the steering wheel rotated). The driver contact evidence consisted of a pair of lip stick contacts and a 3.3 cm (1.3 in) diameter area of blood tinged fluid. This area was probably expelled from her nose. The lower lip lipstick contact measured 3.3 cm (1.3 in) in length and was located 8.4 cm (3.3 in) from the center of the bag. The upper lipstick contact measured 5 cm (2 in) in length and was located 9.7 cm (3.8 in) from the center of the bag. The area of fluids was located 13 cm (5 in) from the bag's center.

**Figure 12: Driver air bag. Note, the steering wheel is rotated 180 degrees.**

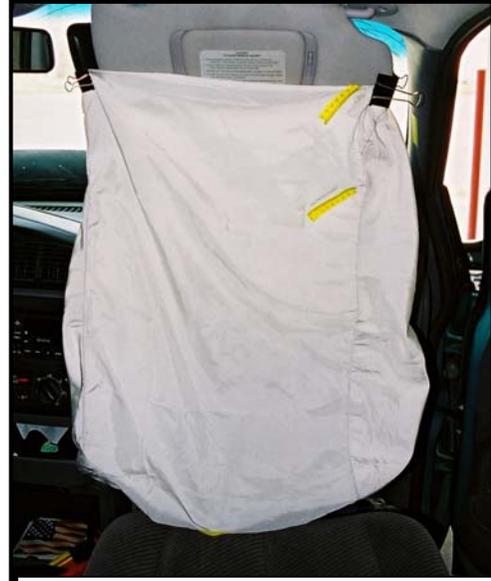
The face of the deployed front right passenger air bag measured 46 cm by 61 cm (18 in by 24 in), width by height, **Figure 15**. The rearward excursion of the bag measured 46 cm (18 in) from the vertical face of the instrument panel. The only contact evidence to the face of the air bag consisted of gray transfers to the fabric of the bag. These transfers measured approximately 5

cm (2 in) and 13 cm (5 in), respectively and were located in the upper outboard aspect of the bag's face and extended to its perimeter. These transfers were consistent with the contact evidence identified on the right A-pillar trim.

**Figure 135: View of the face of the PAB.**

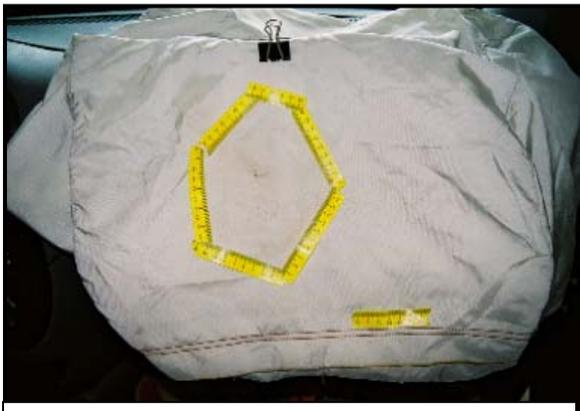
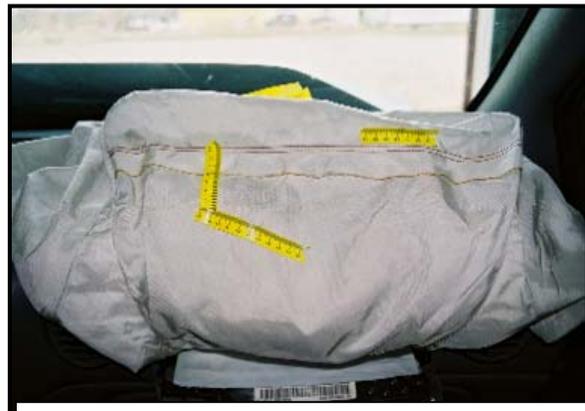
Examination of the bottom section of the air bag revealed three regions of occupant contact. **Figure 16** is a view of the 46 cm by 30 cm (18 in by 12 in) section of the air bag immediately below the bag's face. The section formed the bottom of the bag during normal inflation. This section exhibited two areas of occupant contact. An elliptical region measuring approximately 8 cm by 15 cm (3 in by 6 in), width by height was identified in the center aspect of the bag. The center of this region was located approximately 15 cm (6 in) above the fabric construction seam used as a reference. Remnants of tissue and possible makeup were identified through the region. A 6.4 cm by 5 cm (2.5 in by 2 in) red/brown transfer was located 18 cm (7 in) left of the outboard edge of the bag and 3.8 cm (1.5 in) above the seam. The third contact region was located 3.8 cm (1.5 in) below the fabric seam and 10 cm to 18 cm (4 in to 7 in) right of the inboard edge of the bag, **Figure 17**. This region measured 7.6 cm by 4.6 cm (3.0 in by 1.8 in), width by height and was gray/black in color. These three regions were indicative of direct occupant contact very early in the deployment sequence.

**Figure 16: Contact to the bottom surface of the PAB.**

**Figure 17: Contact to the bottom surface of the PAB.**

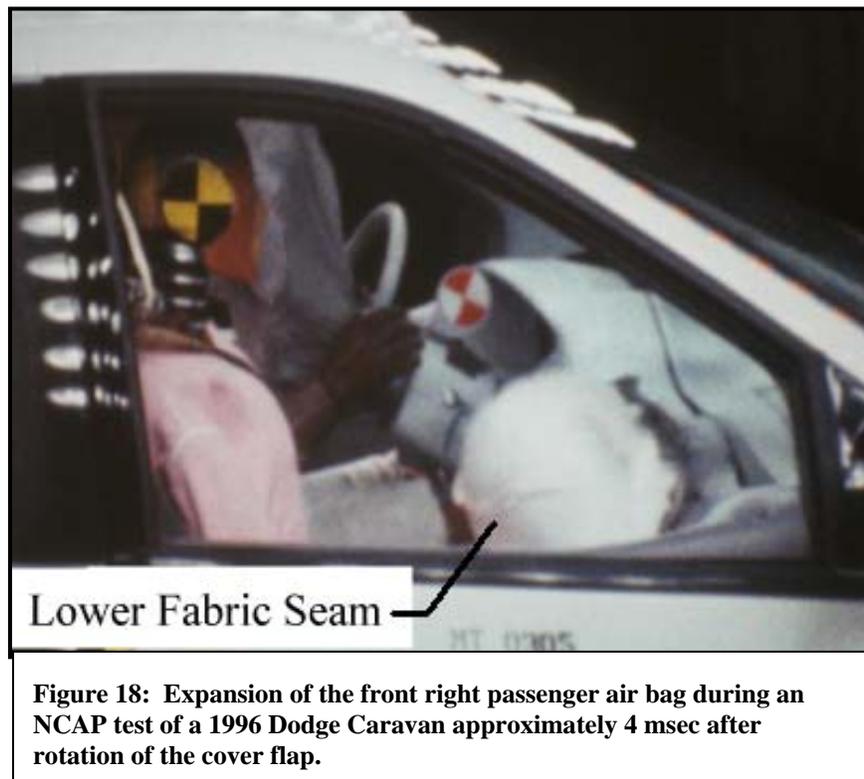
**Figure 18** is a frame of the high speed film depicting the inflating front right passenger air bag early in the deployment sequence and by-way of reference the lower seam of the bag is identified. This stop-action frame occurred approximately 4 milliseconds after initiation of the deployment sequence (i.e. the initial rotation of the cover flaps). By comparing the location of the contact evidence in Figures 15 to Figure 17, it is clear that the occupant was contacted by the inflating air bag very early in the deployment sequence and her forward position impeded its normal expansion.
