**TRANSPORTATION SCIENCES
CRASH DATA RESEARCH CENTER**

**GENERAL DYNAMICS ON-SITE REAR IMPACT CRASH/FIRE
INVESTIGATION
SCI 1 CASE NO: CA03-028
VEHICLE: 2003 FORD CROWN VICTORIA POLICE INTERCEPTOR
LOCATION: MISSOURI
CRASH DATE: MAY 2003**

Contract No. DTNH22-01-C-17002

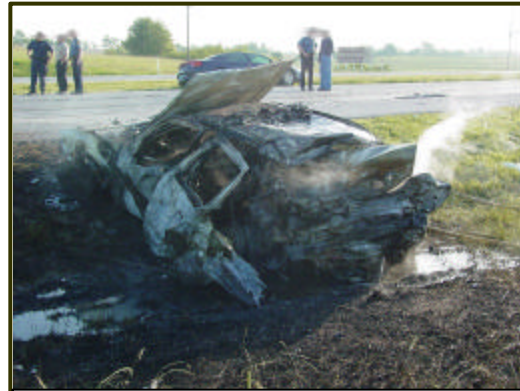
Figure 1. Left rear view of the CVPI at final rest at the crash site.

suspected that both occupants of the CVPI were unrestrained. A 2001 Ford F-350 was traveling in the outboard lane in a easterly direction on the interstate roadway. In the vicinity of the impending crash site, the police reported a site distance of approximately 1.6 km (1.0 mile) for eastbound traffic. The driver of the F-350 was reportedly distracted as he attempted to reach for his sunglasses that were on the right instrument panel. As he reached for the glasses, he applied an inadvertent steering input that directed the F-350 onto the right shoulder. The frontal area of the truck impacted the rear of the parked CVPI that resulted in severe damage to the CVPI. As a result of the crush, the CVPI's fuel tank filler tube was severed which resulted in fuel leakage and a subsequent fire (**Figure 1**).

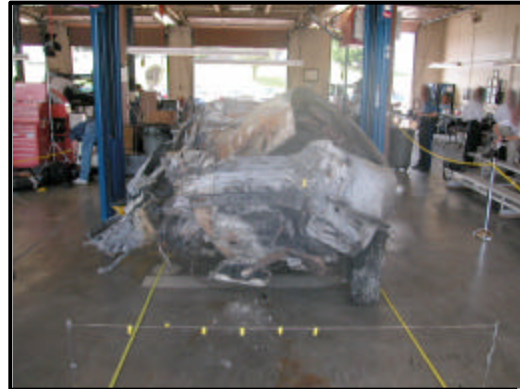
Figure 6. Rear view of the CVPI.

The longitudinal displacement (crush) of the left and right EAD's measured 111.8 cm (44.0") and 50.5 cm (19.9"), respectively. The left EAD compressed its entire 3.5 cm (1.375") length and was jammed. There was no compression of the right EAD. The rear damage profile of the CVPI was documented along the rear wall of the trunk and was as follows: C1 = 120.0 cm (47.2"), C2 = 92.0 cm (36.2"), C3 = 82.0 cm (32.3"), C4 = 73.0 cm (28.7"), C5 = 57.0 cm (22.4"), C6 = 53.0 cm (20.9"). The trunk latch released during the impact and the trunk lid was displaced forward through the backlight and into contact with the roof and backlight header. The displacement of the upper left and right corners of the roof measured 19.6 cm (7.7") and 8.6 cm (3.4"), respectively. The left wheelbase was reduced in length by 59.9 cm (23.6"). The right wheelbase was elongated 8.6 cm (3.4 in) due to displacement of the rear axle. The Collision Deformation Classification (CDC) was 06-BYEW-6.

The direct contact damage was biased to the left side indicative of the offset impact configuration. The force of the offset impact separated the exterior sheet metal of the left rear quarter panel and C-pillar from the inner fender and side rail. The deformed sheet metal was attached to the deformed left rear door by the latch/striker post engagement. The separation then continued forward approximately 151.1 cm (59.5") along the left floor pan to the left A-pillar location. The left doors of the vehicle became a free-floating section, attached to the vehicle at the A-pillar door hinge and by the upper B-pillar connection to the left roof rail. During this deformation and separation, the fuel tank filler tube was cut 15.2 cm (6.0") outboard of the fuel tank. The upper end of the filler neck became entrapped in the deformed left rear quarter panel sheet metal. The in-tank end of the filler tube remained in the tank. Refer to the *Filler Tube Damage - CVPI* section of this report for greater detail on the filler tube separation. The left side separation created a direct path for the fire to enter the occupant compartment.

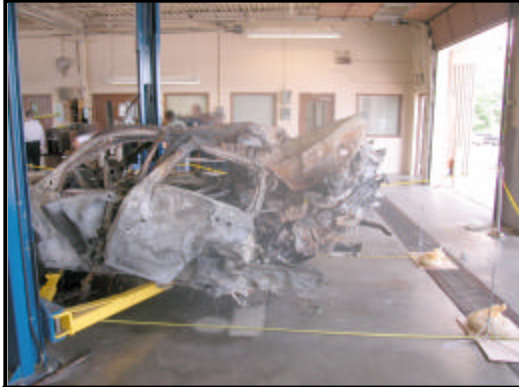
The left front door was jammed closed by the exterior deformation. The left rear door remained engaged to the C-pillar; however, the pillar was separated by the damage resulting in integrity loss due to structural failure. The right front door remained closed during the impact and was initially operational. The passing motorist opened this door in

Figure 7. Left view of the CVPI

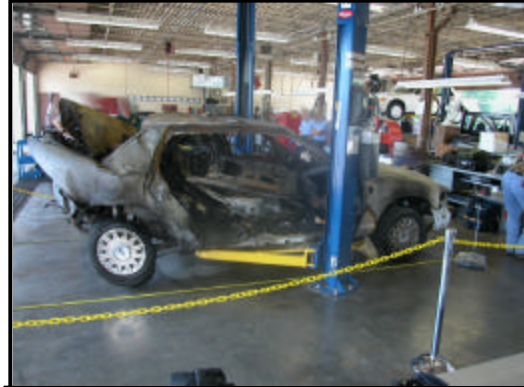
order to remove the front right occupant. Presumably, it closed after his removal and was then rendered inoperative by the fire. As depicted in **Figure 8**, both right doors and the right B-pillar were removed by rescue personnel in order to extricate the body of the Trooper.

Figure 8. Right view of the CVPI.

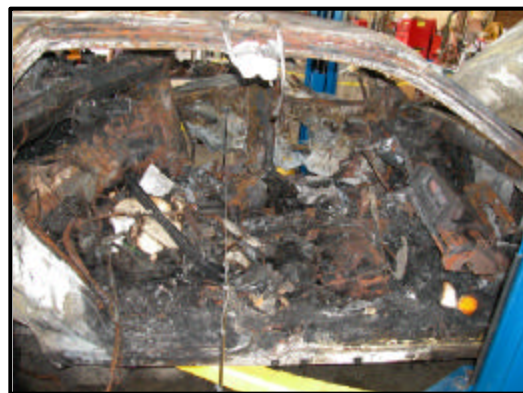
Figure 9 is a right interior view of the CVPI. The interior compartment was completely burned by the crash-induced fire. During the process of extricating the driver, fire department personnel removed the right doors and cut the right B-pillar from the CVPI to gain access to the compartment. In order to access the driver, the front right seat back, center console and driver seat back were cut. There was no deformation of the seat backs upon examination. The adjustable front seats were estimated to be in a full rear track position. The CVPI was not equipped with a

Figure 9. Right interior view of the CVPI.

It should be noted that under the dynamic conditions of the impact, the rear intrusion would have been greater than documented. As such, the dynamic rear left intrusion was probably in-close proximity to the driver's seat back.

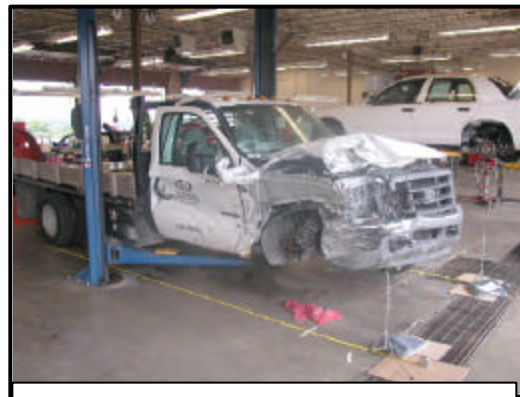
Figure 10. Right front view of the Ford F350.

The frontal damage pattern wrapped around the front right corner and extended along the right side of the cab to the leading edge of the cargo body and integrated tool box. This contact pattern occurred as the pickup drove through the impact sequence, remaining

The exterior sheet metal of the right fender was deflected rearward to the right A-pillar. The lower right aspect of the windshield was fractured from direct contact. The leading edge of the flat bed body protruded 13.5 cm (5.3") outboard of the cab and exhibited direct contact damage. The flat bed was shifted approximately 2.5 cm (1.0") rearward on the right side. The right door remained closed during the crash and was jammed closed post-crash. The right front axle spindle fractured across its threaded end and the right front tire and wheel assembly separated which fractured the brake rotor. The right front tire was deboned and the sidewall was cut. The rim was deformed over a 20x5 cm (8x2") region. The right wheelbase was reduced in length by 17.5 cm (6.9"). There was no measurable change in the left wheelbase dimension.

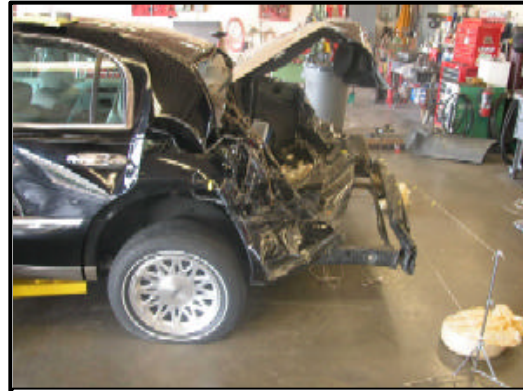
Figure 11 is a left lateral view of the Lincoln. The frontal area of the CVPI initially impacted the rear bumper of the Lincoln and overrode the bumper, engaging the sheet metal area of the trunk. The rear bumper fascia was torn and partially separated from the vehicle, exposing the bumper beam. The direct contact extended across the vehicle's full 156.2 cm (61.5") end width. The residual deformation of the Lincoln was measured along the bumper reinforcement beam and at the rear wall of the trunk. Maximum crush was 69.8 cm (27.1") located at the rear left corner of the trunk wall. The crush depth at the left corner of the rear bumper beam was 13.0 cm (5.1"). The documented crush profile at the level of the trunk wall was as follows: C1 = 69.8 cm (27.1"), C2 = 68.3 cm (26.9"), C3 = 55.6 cm (21.9"), C4 = 47.2 cm (18.6"), C5 = 35.8 cm (14.1"), C6 = 22.2 cm (8.75"). The averaged residual crush profile, based on bumper and trunk wall crush was as follows: C1 = 40.9 cm (16.1 in), C2 = 45.0 cm (17.7"), C3 = 38.0 cm (15.0"), C4 = 30.0 cm (11.8"), C5 = 24.0 cm (9.4"), C6 = 13.0 cm (5.1"). The CDC for this impact was 06-BDEW-4.

Figure 11. Left lateral view of the Lincoln's crush profile.

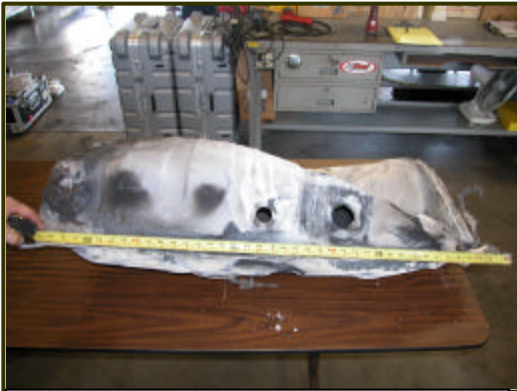
The top aspect of the tank contained three valves that were secured to the tank with rubber grommets (**Figure 14**). The left and center valves were completely consumed by the ensuing fire. The rubberized grommet for the valve mounted on the left side of the tank was severely charred with fragments of the valve resting on the top surface of the tank. The center valve unit was completely incinerated. The valve on the right side of the tank was melted by the fire and heat; however, the valve remained intact to close off the tank opening for this unit. The fuel return line that serviced this valve was melted to the right side of the fuel tank.

Figure 14. Top view of the fuel tank.

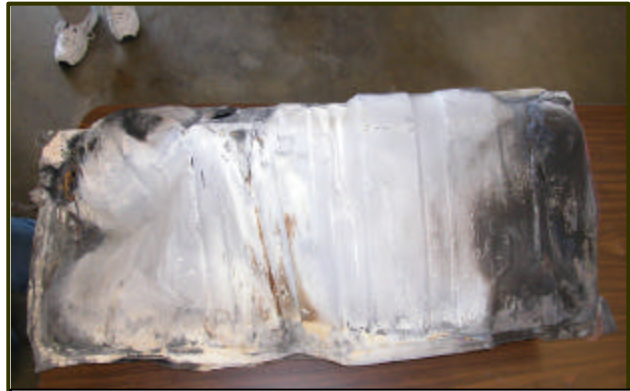
Figure 15. Rear aspect of the CVPI's fuel tank.

The tank was crushed as described above in the *In-Vehicle Observations* section of this report. The left lower rear quadrant of the fuel tank was crushed to near full thickness between the intruding trunk wall and the left frame rail and tailpipe (**Figure 15**). A square area of deformation that measured 17.8 cm (7.0”) laterally and 10.8 cm (4.25”) in depth was noted to the lower left aspect of the rear wall of the tank. This near full thickness crushing of the tank resulted from compression of the trunk and the left side mounted police radio cluster. The radio cluster did not penetrate the tank or the trunk wall.

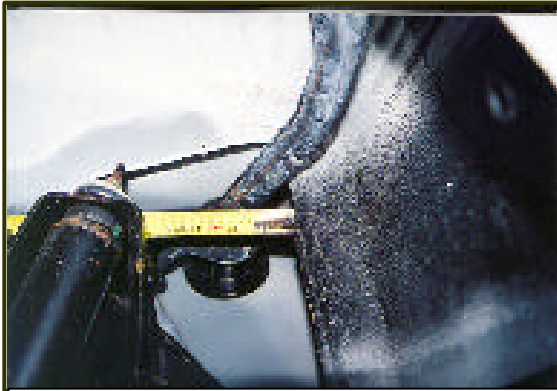
aft aspect of the filler tube. The formed inner fender edge extended 22.9 cm (9.0") vertically and protruded 2.2 cm (0.875") forward of the forward trunk wall. Based on the inspection of an exemplar vehicle, the air gap between this inner fender edge and the filler tube was 0.6 cm (0.25"). **Figures 16 and 17** are views of the inner fender edge and filler tube location on an exemplar 2003 CVPI.

Figure 16. Filler tube position in relation to the inner fender on an exemplar 2003 CVPI.

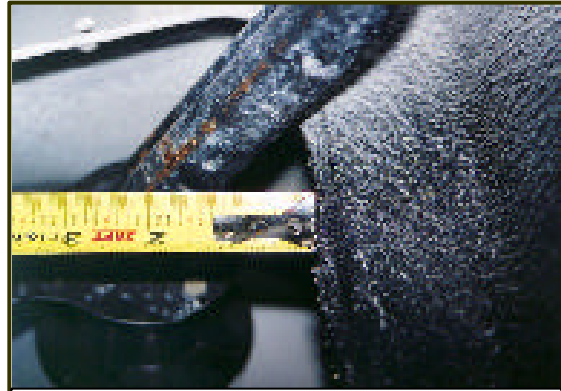
Figure 17. Close-up view of the proximity of the filler tube to the inner fender edge.

The inboard aspect of the sheet metal inner fender was formed to an edge that was the thickness of the sheet metal. This horizontally oriented edge extended 15.2 cm (6.0") forward of the apex of the edge of the vertical seam. The centerline of the filler tube was located 2.5 cm (1.0") forward of the vertical seam edge and 5.1 cm (2.0") below the horizontal seam edge.

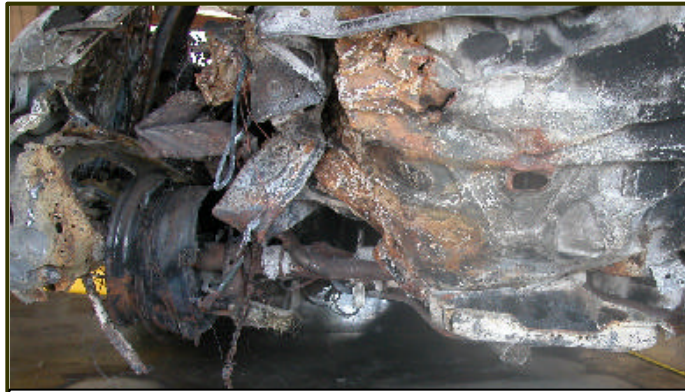
During the initial visual inspection of the 2003 Ford CVPI, it was noted that the filler tube had separated from the fuel tank, as the upper end remained engaged to the left quarter panel (**Figure 18**). As previously noted, the left rear quarter panel and C-pillar of the CVPI were completely separated from the vehicle's body. These components remained attached to the vehicle solely by the engagement of the left rear door latch and

C-pillar mounted striker post. Closer inspection of the downstream end of the filler tube revealed that the filler tube sheared during the impact. The fuel tank end of the filler tube remained in the tank; however, the grommet was completely consumed by the fire.

Figure 18. Separated filler tube and left rear quarter panel at lower left corner of image.

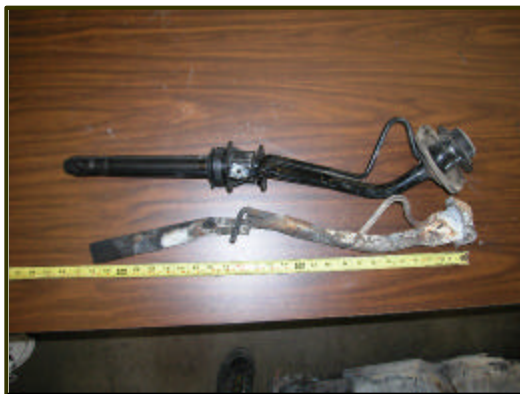
The tube was partially cut 26.7 cm (10.5”) upstream of the tank-end of the filler tube. This segment of the filler tube was dented 17.1-22.9 cm (6.75-9.0”) above the tank-end, the area that is originally located at the tank grommet and above (external to the tank). Located upstream of this dent, was a crease in the steel tube that extended 19.1-25.4 cm (7.5-10.0”) above the tank-end. This crease was located in the area of the tube that was reduced in diameter from 3.5 cm (1.375”) to 3.2 cm (1.25”). The upper end of the filler tube had a mating cut/tear that was located 38.1 cm (15.0”) downstream of the filler cap location. **Figures 19 and 20** are views of the separated filler tube verses an exemplar filler tube.

Figure 19. The damaged and separated filler tube in relation to an exemplar tube.

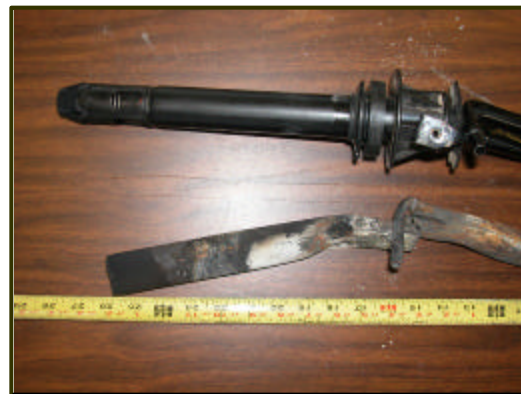
valve was missing from the filler tube). This dent resulted from the tube engaging against either the forward wall of the tank due to crushing of the tank, or impacting the back wall of the tank due to forward displacement of the upper end of the filler tube, thus rotating the downstream end of the tube rearward. This dent also supported the probability that the check valve was damaged or fractured during this in-tank contact event.

Figure 20. Close-up view of the separation location of the filler tube.

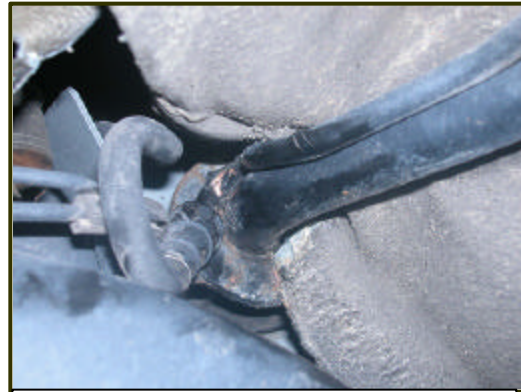
During the inspection process of the Lincoln, it was observed that the fuel tank filler tube was contacted and partially crushed by the forward displacement of the vertical seam edge of the inner fender. The aft aspect of the tube was crushed outboard of the positioning bracket. The inner fender edge was deformed in a concave configuration from the engagement against the filler tube. At this point, the crush to the Lincoln ceased as maximum engagement occurred. Slight restitution of the inner fender was noted aft of the filler tube. There was no fuel leakage associated with this engagement. **Figures 21 and 22** are views of the deformation from engagement of the Lincoln’s inner fender edge against the filler tube.

Figure 22. Deformation of the filler tube and inner fender edge from engagement during crash.
