REMOTE AIR BAG DEPLOYMENT REPORT

CASE NUMBER - IN-03-028

VEHICLE - 1996 Mercury Cougar XR7

CRASH DATE - March 2001

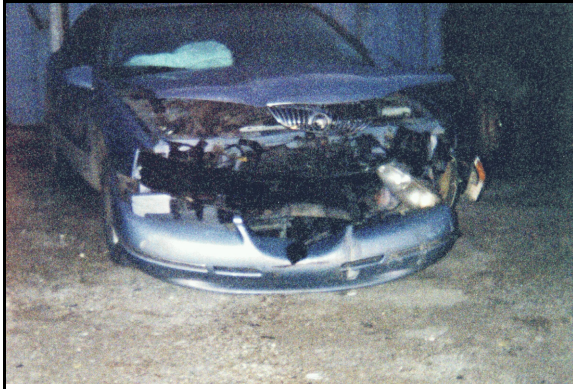
Figure 2: Front-right view of case vehicle's frontal damage (case photo #11)

The case vehicle sustained direct contact across the entire front. The bumper cover was torn off and the steel bumper was crushed rearward, more so on the left. The grille and both headlamp/turn signal assemblies were shattered and broken away, and the radiator support bracket was bent rearward. The engine hood was displaced and bent slightly down in the front (**Figures 2 and 3**). The windshield was cracked and there was no other glazing damage. None of the tires were deflated or restricted.

The CDC for the case vehicle's single impact was estimated from photographs as **12-FDEW-1 (350)**. The WinSMASH reconstruction program, damage-only algorithm based on photo-estimated CDCs for the two vehicles, was used. The total, longitudinal and lateral delta-Vs for the case vehicle are, respectively: 17.0 km.p.h. [10.6 m.p.h.], -16.7 km.p.h. [-10.4 m.p.h.], and + 3.0 km.p.h. [+ 1.9 m.p.h.]. This is a borderline reconstruction, but the results appear reasonable. This was a crash of low severity for the case vehicle.

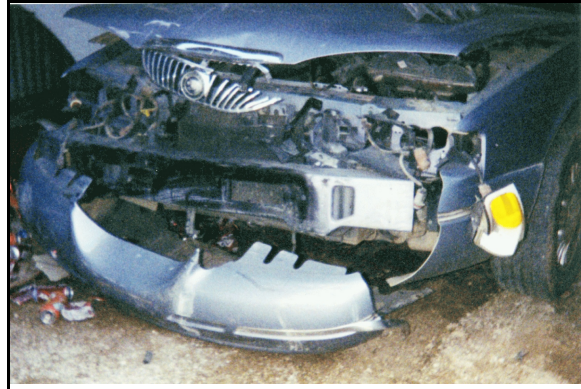
Figure 3: Front-left view of case vehicle's frontal damage (case photo #05)

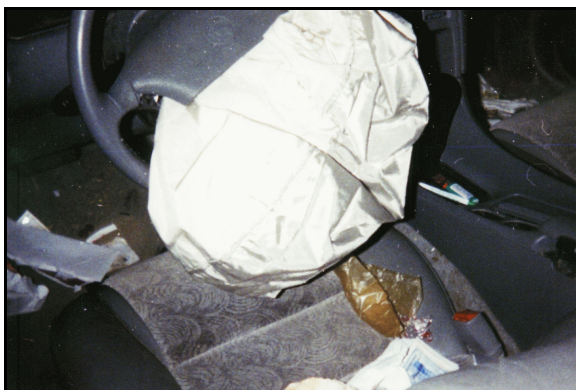
The driver's air bag was located in the steering wheel hub with the module cover flaps in the "H" configuration. The one available photograph (**Figure 4**) does not show any evidence of damage to the cover flaps or the air bag. The driver's air bag was round, with its diameter unknown. It is not known if this air bag had any tether(s) or vent port(s). There is no visible evidence of contact on the air bag's fabric.

Figure 4: Driver's air bag, steering wheel and seat area (case photo #13)

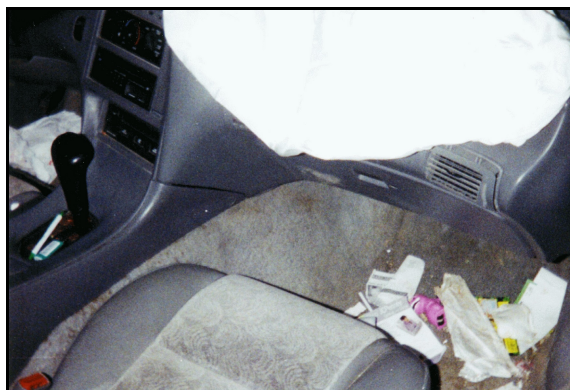
The front right passenger's air bag was located in the middle position on the right side of the instrument panel. The module cover flap(s) cannot be seen in any of the available photographs

and the flap configuration is not known. It is not known whether the flap(s) were damaged during the deployment. The air bag's shape and size are not known, and it is not known whether it had any tether(s) or vent port(s). There is no evidence of occupant contact visible in the available photographs (**Figure 5**).

Figure 5: Front right seat area and partial view of front right passenger's air bag (case photo #14)

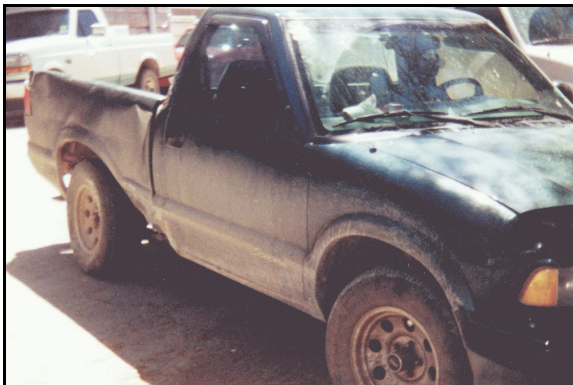
Figure 6: Other vehicle's entire right side, showing damage in right rear wheel area (case photo #17)

The GMC pickup sustained direct contact damage along the right side, beginning at the base of the right B-pillar and extending rearward to the trailing edge of the right rear wheel well (**Figures 6 and 7**). The lower end of the B-pillar had slight crushing and scraping, the exterior body panel on the forward portion of the cargo bed was scraped and crushed inward, and the wheel/tire assembly sustained direct contact but with no apparent damage other than scuffing. There was very minor crush and scraping above the wheel well from contact by the case vehicle's hood. There was no glazing damage and none of the tires were deflated or restricted. The GMC pickup was equipped with a driver-only air bag that did not deploy.

The CDC for the GMC pickup's single impact was estimated from photographs as **03-RZEW-2 (80)**. The WinSMASH reconstruction program, damage-only algorithm based on photo-estimated CDCs for the two vehicles, was used. The total, longitudinal and lateral delta-Vs for the GMC are, respectively: 20.0 km.p.h. [12.4 m.p.h.], -3.5 km.p.h. [-2.2 m.p.h.], and -19.7 km.p.h. [-12.2 m.p.h.]. This is a borderline reconstruction but the results appear reasonable. This was a crash of low severity for the GMC pickup.

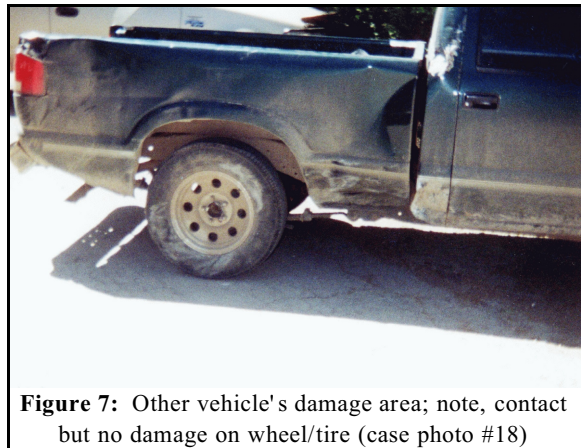
Figure 7: Other vehicle's damage area; note, contact but no damage on wheel/tire (case photo #18)
