## REMOTE CHILD AIR BAG-RELATED FATALITY INVESTIGATION

CASE NUMBER - IN-03-030  
LOCATION - New York  
VEHICLE - 1995 FORD ESCORT  
CRASH DATE - June 2001

Submitted:  
May 19, 2004  
Revised:  
February 20, 2008

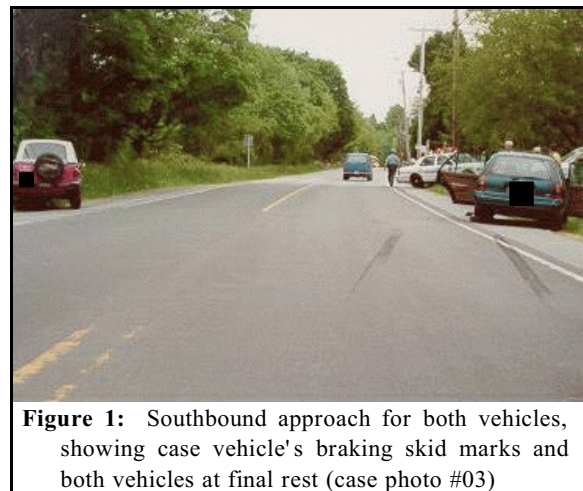
The case vehicle's front left corner impacted the other vehicle's back right corner, causing the case vehicle's driver and front right passenger air bags to deploy. The case vehicle was deflected to the right and came to rest on the right (west) shoulder a short distance from the point of impact. The other vehicle was pushed slightly forward and leftward and the driver drove beyond the intersection and brought the Geo to a controlled stop on the left (east) shoulder (**Figure 1**).

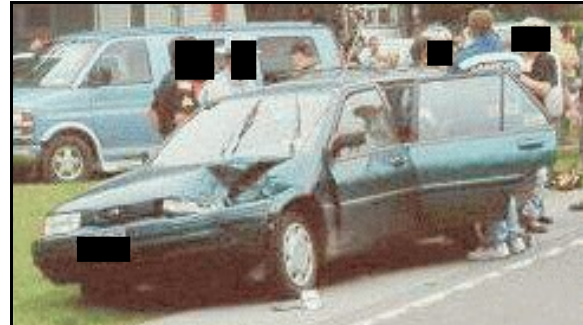
The case vehicle sustained narrow direct contact damage at the front left corner (**Figures 2 and 3**), with crushing above the bumper and relatively light scraping on the bumper yielding a front underride damage configuration. The left headlight lens was fractured and the headlamp/turn signal assembly was displaced but not broken away. The left fender was crushed rearward and slightly inward, and the leading edge of the hood was crushed rearward and downward. The left fender showed induced buckling rearward of the wheel well. The left front wheel was restricted due to the crushed fender being pressed against it, but with no obvious damage to the tire and no damage or restriction on any other wheel or tire. There were cracks in the lower center windshield glazing and no other glazing damage.

**Figure 2:** Case vehicle's front and left side, at final rest (case photo #10)

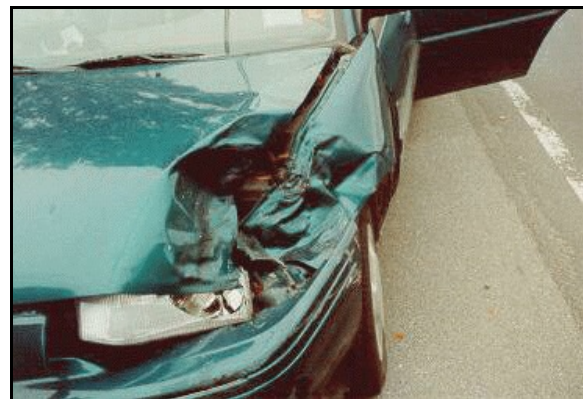
**Figure 3:** Case vehicle's direct damage at front left corner (case photo #11)

The CDC for the case vehicle's single impact was estimated from photographs as **12-FLEE-2 (350)**. The WinSMASH reconstruction program, damage algorithm with CDC only for both vehicles, was used. The total, longitudinal and lateral delta Vs are, respectively: 13.0 km.p.h. [8.1 m.p.h.], -12.8 km.p.h. [-7.9 m.p.h.], + 2.3 km.p.h. [+ 1.4 m.p.h.]. This is a borderline reconstruction and the results appear somewhat low but reasonable. This was a crash of low severity (14-23 km.p.h. [9-14 m.p.h.]) for the case vehicle.

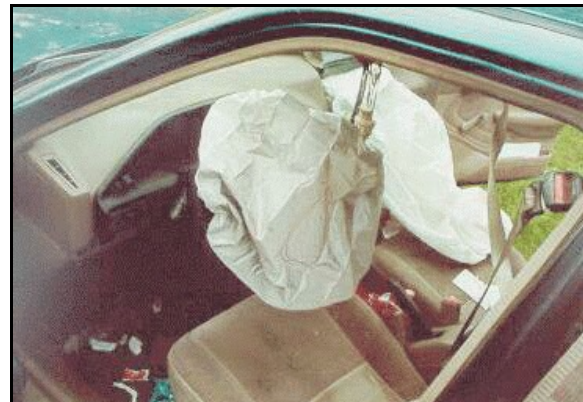
The driver's air bag was located in the steering wheel hub with cover flap(s) in an unknown configuration. The deployed air bag was round with the diameter not known (**Figure 4**). It is not known if the driver's air bag was designed with any tether(s) or vent port(s). There was no obvious damage to the air bag, and there was no evidence of occupant contact visible in the available photographs.

**Figure 4:** Driver's air bag and automatic shoulder belt (case photo #16)

The driver's automatic safety belt consisted of a shoulder belt attached to a retractor in the center console and a latch attached to a buckle that moves via a motorized track along the upper door frame. The available photographs show the case vehicle with the driver's door open but with the buckle in the closed position, indicating a possible malfunction of the motorized component of the automatic safety belt system (**Figure 4**). It is not known whether this possible malfunction was a result of the crash. The safety belt webbing appears to be correctly retracted into its center console retractor.

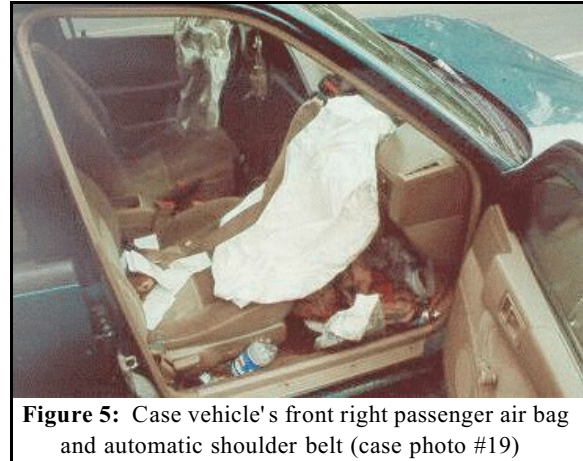
The front right passenger's air bag was located in the top of the right instrument panel with a single cover flap. The deployed air bag was probably rectangular, with unknown dimensions (**Figure 5**). It is not known if the front right passenger's air bag was designed with any tether(s) or vent port(s). There was no obvious damage to the air bag, and no evidence of occupant contact visible in the available photographs.

**Figure 5:** Case vehicle's front right passenger air bag and automatic shoulder belt (case photo #19)

The front right passenger's automatic safety belt consisted of the same components as the driver's automatic safety belt. The available photographs show the case vehicle with the front right passenger's door open and with the motorized buckle in the forward position (**Figure 5**). The safety belt webbing is twisted, indicating that it had been disconnected and incorrectly reconnected. The webbing also shows a substantial amount of slack, indicating that the retractor in the center console was not functioning properly or a twist in the belt at the retractor may have prevented full retraction of the belt. It is not known if the incorrect configuration of the webbing and the possibly malfunctioning retractor were a result of the crash, but the police crash report notes that there was no evidence of loading stress on any component of the front right passenger's automatic safety belt system.

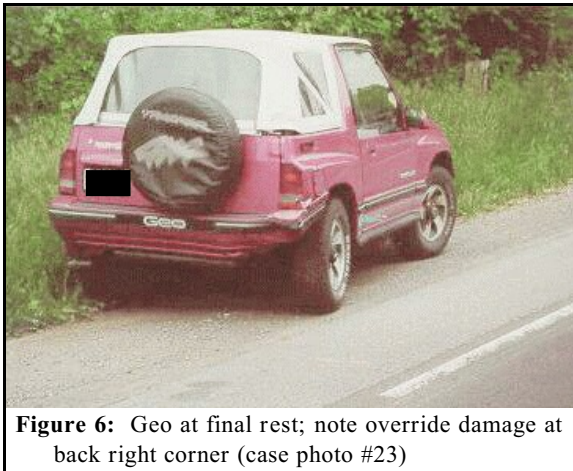
The Geo sustained narrow direct contact damage on the bumper at the back right corner that exhibited the features of a classic rear override impact (**Figures 6 and 7**). The bumper was abraded and displaced forward. The right rear wheel assembly was pushed forward and inward at the front, suggesting that the rear axle may have been bent. The available photos do not indicate whether the right rear wheel was restricted. The right rear tail light lens was cracked but not broken away. There was minor deformation of the right rear quarter panel.

**Figure 6:** Geo at final rest; note override damage at back right corner (case photo #23)

The CDC for the Geo's single impact was estimated from photographs as **06-BRLE-2 (180)**. The WinSMASH reconstruction program, damage algorithm with CDC only for both vehicles, was used. The total, longitudinal and lateral delta Vs for the Geo are, respectively: 14.0 km.p.h. [8.7 m.p.h.], + 14.0 km.p.h. [+ 8.7 m.p.h.], 0 km.p.h. [0 m.p.h.]. This is a borderline reconstruction and the results appear somewhat low but reasonable. This was a crash of low severity (14-23 km.p.h. [9-14 m.p.h.]) for the Geo.

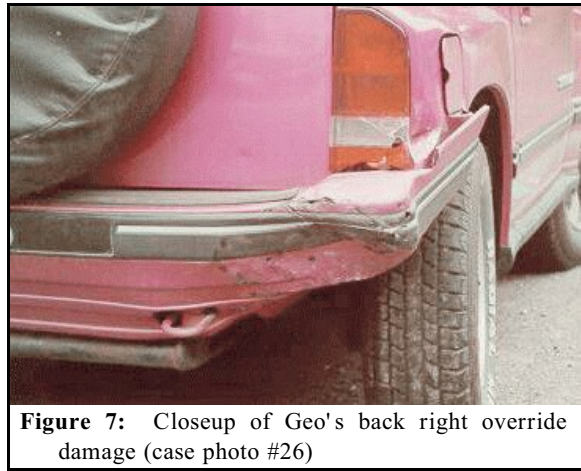
**Figure 7:** Closeup of Geo's back right override damage (case photo #26)
