Inflatable Side Air Curtain Investigation / Vehicle to Object
Dynamic Science, Inc. / Case Number: DS03030
2003 Mini Cooper S three-door hatchback
Colorado
August, 2003

1. Report No. DS03030		2. Government Accession No.		3. Recipient Catalog No.	
4. Title and Subtitle Inflatable Side Air Curtain Investigation				5. Report Date August 5, 2004

**Dynamic Science, Inc.
Accident Investigation
Case Number: DS03030**

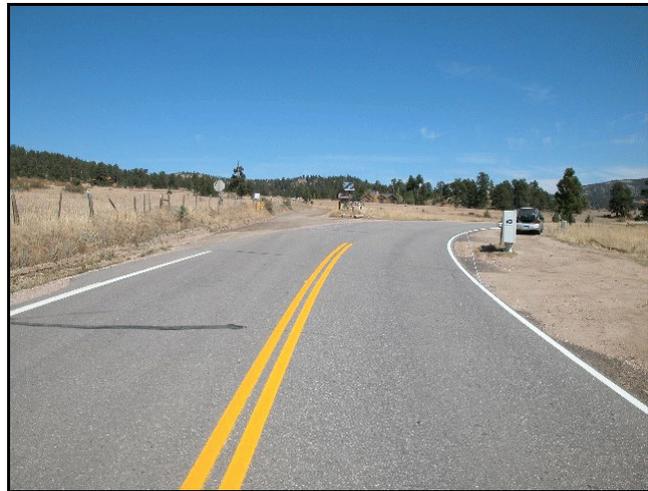
Figure 1. Approach, case vehicle (north)

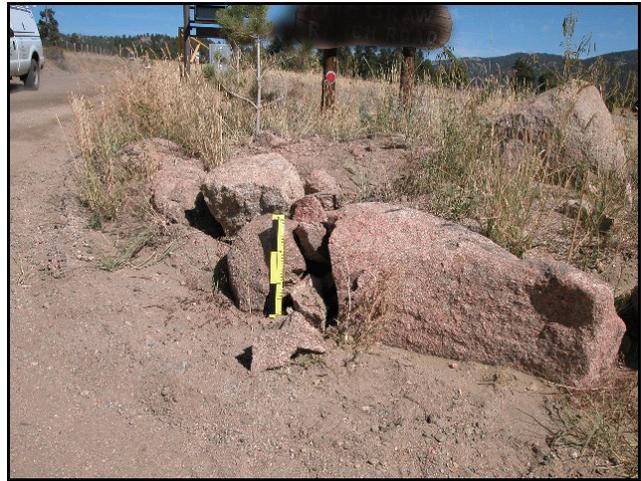
The case vehicle was initially traveling straight on the northbound roadway. The driver indicated that he had been blinded by the bright lights of an oncoming vehicle. As the case vehicle entered the curve the driver failed to make the turn. The case vehicle departed the roadway on the left. There were no skid marks or indications of braking. The case vehicle struck a large rock with its right front end (12FRLE2). The right portion of the bumper reinforcement bar rotated rearward and the vehicle engaged the rock with its front right tire/rim. The rock cracked and was displaced. The case vehicle wheelbase was shortened by 23.0 cm (9.0 in). The driver and front right passenger air bags likely deployed at this point. Both front seat belt pretensioners actuated. The vehicle ramped when engaging the rock and began to both pitch to the left and to rotate clockwise. The vehicle pitched over and overturned two quarter rolls—impacting the ground with the right roof rail and roof area (00TDZO2). The right side air curtain and front right seat back mounted side air bag deployed at this time. The right side of the case vehicle then struck the left side of the other vehicle (00RBEW1). The case vehicle continued overturning until it had completed one full roll and came to rest on its wheels 52 m (172 ft) south of the intersection area.

Figure 2. Rock(s) struck by case vehicle

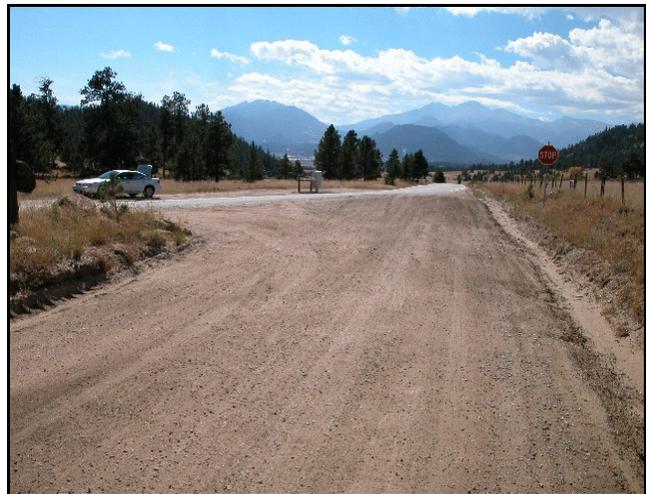
Figure 3. Overview of southbound approach to area of impact

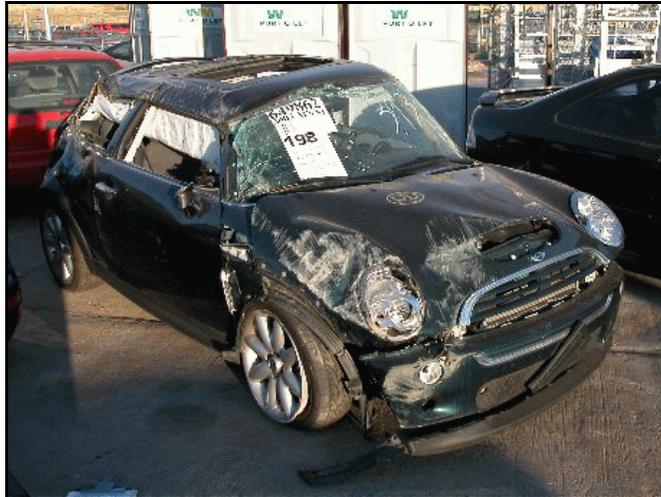
Figure 4. Front right, case vehicle

The case vehicle sustained 31.0 cm (12.2 in) of direct contact to the front bumper from the initial impact. The residual crush measured along the bumper was as follows: C1=0 cm (0 in), C2=0 cm (0 in), C3=0 cm (0 in), C4=0 cm (0 in), C5=2.0 cm (0.8 in), C6=9.0 cm (3.5 in). The maximum crush was at C6. The principle direction of force was within the 12 o'clock sector and was an estimated 0 degrees. The damaged components included the bumper fascia and reinforcement bar. The wheelbase was shortened by 23.0 cm (9.0 in).

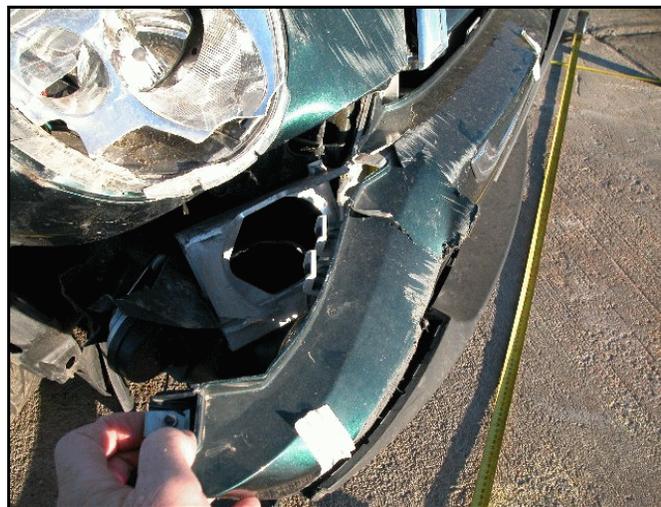
Figure 5. Close up view of reinforcement bar movement

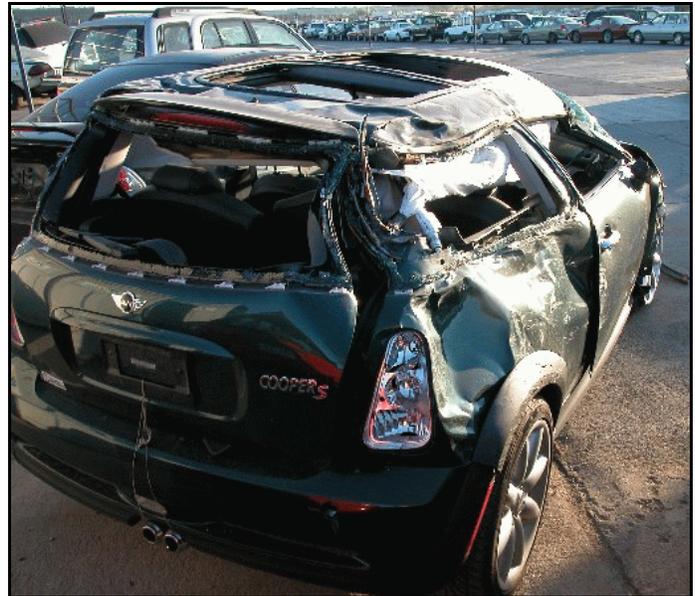
During the subsequent rollover the vehicle sustained direct contact damage to the hood, roof, and both sides. The maximum crush was at the right A pillar and measured 22.0 cm (8.7 in) vertically. All the side windows, roof windows, and the backlight glass disintegrated during the crash. The latch failed on the rear hatch and the hatch came open at some point.

The vehicle sustained 59.0 cm (23.2 in) of direct contact to the right side from the impact with the other vehicle. The case vehicle was essentially upside down when this damage occurred.

Figure 7. Right rear view showing rollover damage and contact to other vehicle

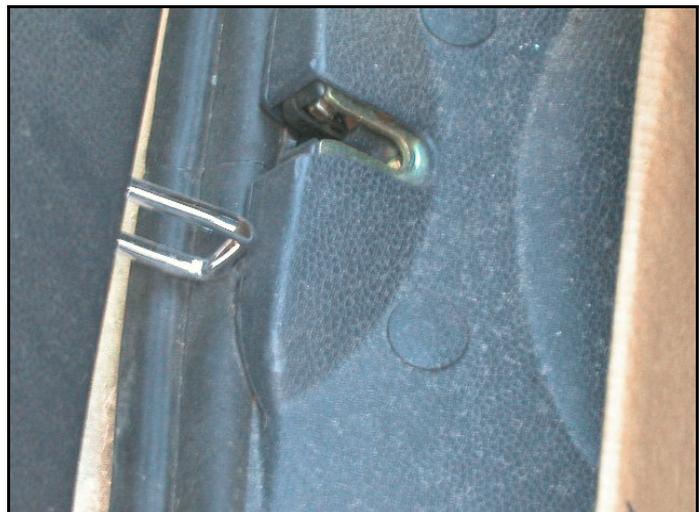
Figure 9. Rear latch failure

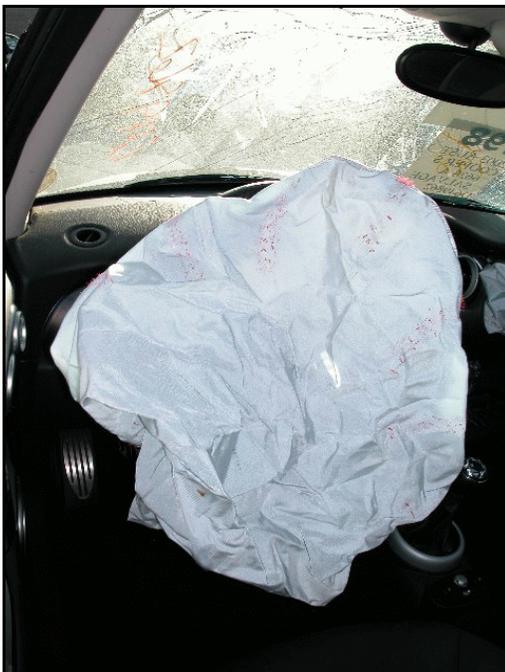
Figure 11. Driver's air bag

The driver's air bag was mounted in the steering column. It measured 50.0 cm (19.7 in) in diameter in its deflated state. It was equipped with one vent port at the 9 o'clock position. It was equipped with 10 force limiting type tethers. The tethers were arranged in a fan shape along the top half of the air bag. They ranged in length from 6.0 cm (2.4 in) at the 9 o'clock position to 14.0 cm (5.5 in) at the 12 o'clock position. The air bag module cover was 11.0 cm (4.3 in) in diameter. It was held in place by two 9.0 cm (3.5 in) long tethers. There was no damage to the cover.

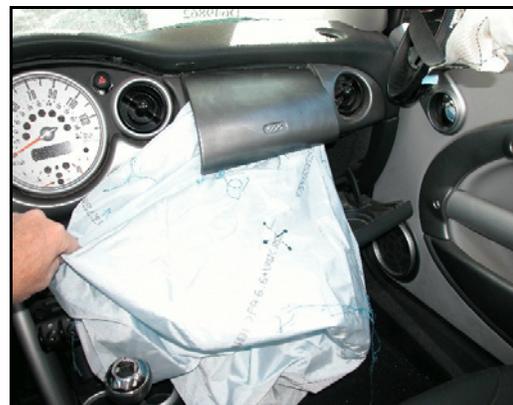
Figure 12. Front right passenger air bag

The front right passenger air bag had a mid mount installation. It measured 43.0 cm (16.9 in) wide seam to seam and 70.0 cm (27.5 in) high. There were two “X” cut vent ports at the 3 and 9 o’clock positions. The module cover was generally rectangular in shape and measured 25.0 cm (9.8 in) wide by 17.0 cm (6.7 in) high. There were no indications of any damage or contact to either the air bag or the module cover.

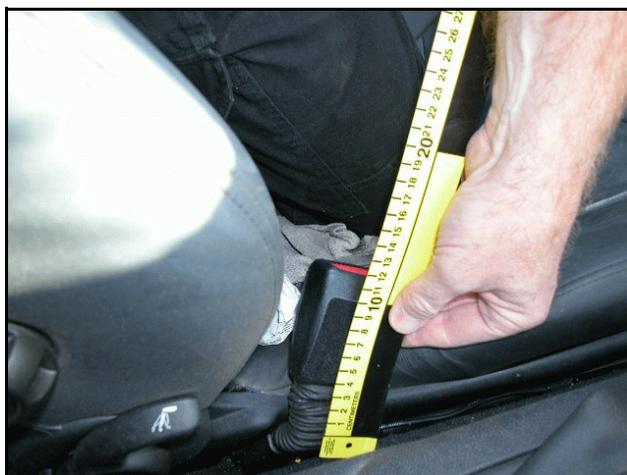
Figure 13. Driver’s buckle mounted seat belt pretensioner

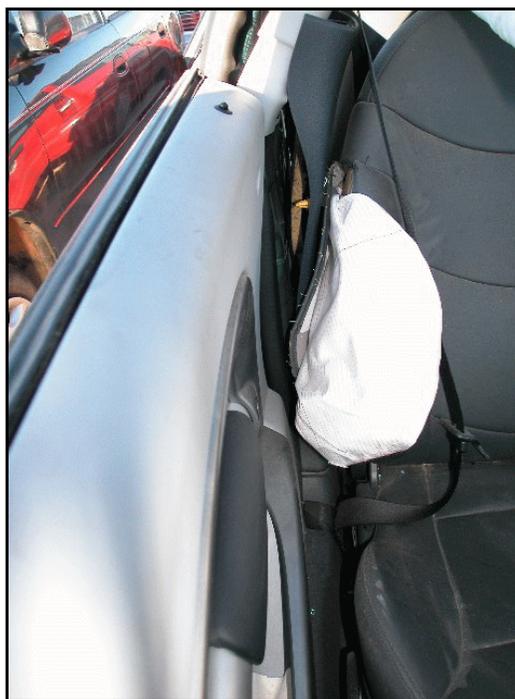
The seat back mounted side air bag measured 32.0 cm (12.6 in) long by 22.0 cm (8.7 in) high. The right side air bag deployed during the rollover sequence. There was no damage to the air bag or to the 9.0 cm (3.5 in) high cover flap.

Figure 14. Seat back mounted right side air bag

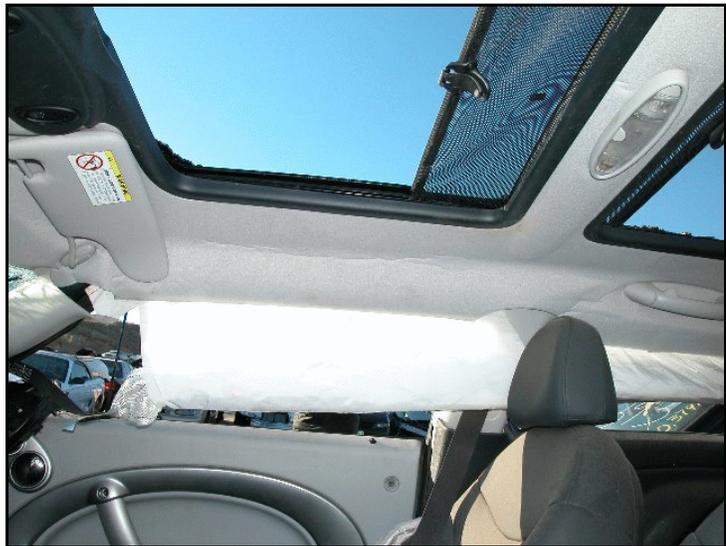
The right side air curtain measured 140.0 cm (55.1 in) end to end. The inflatable portion of the curtain is sheathed by a 22.0 cm (8.7 in) high covering. The front end is secured to the A pillar by a 32.0 cm (12.6 in) long tether. The rear end is secured to the C pillar by an 11.0 cm (4.3 in) tether on the top and a 16.0 cm (6.3 in) tether on the bottom. The inflator is in the C pillar. Prior to deployment, the entire curtain in enclosed in the roof rail cladding. The right side air curtain deployed during the rollover sequence of this crash. There was no damage to the curtain. The front right occupant contacted the curtain with his face—leaving a skin transfer.

Figure 15. Right side air curtain

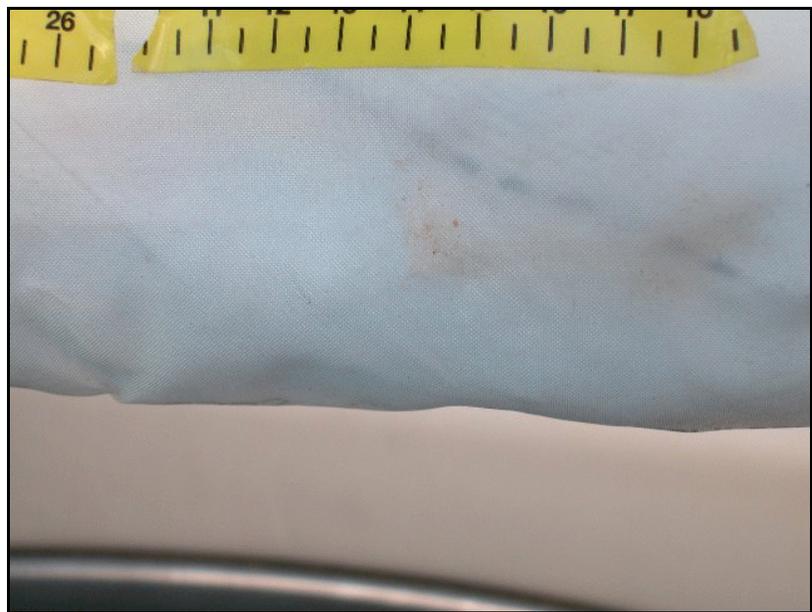
Figure 16. Skin contact to side air curtain

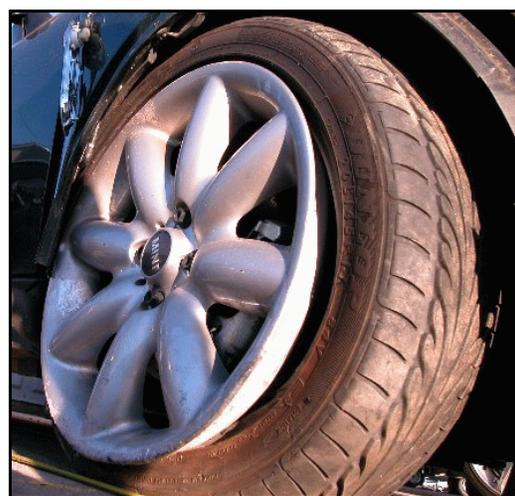
Because of these capabilities, if a DSST tire loses its inflation pressure, the driver may not be aware of such a loss and may continue driving for extended distances at high speeds. The vehicle is equipped with sensors that will warn the driver if inflation has been lost. In this case the front right tire sustained a complete air out due to the impact, but appears to have retained some measure of vehicle support.

Figure 17. Front right tire, case vehicle

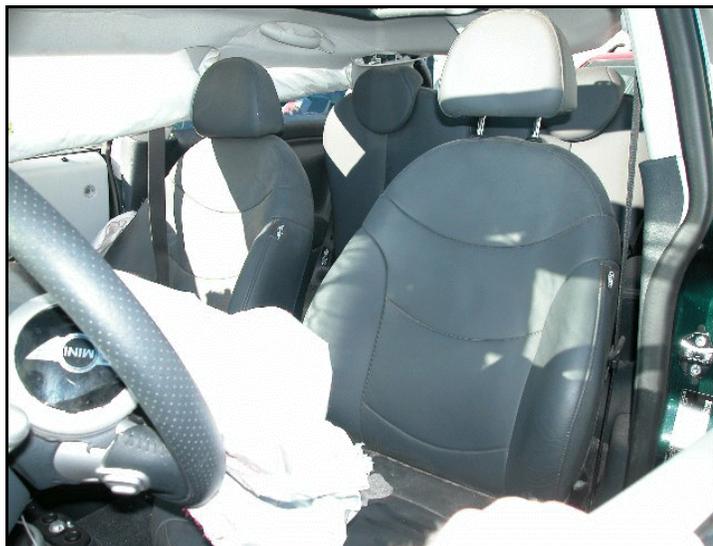
Figure 19. Driver's seated area

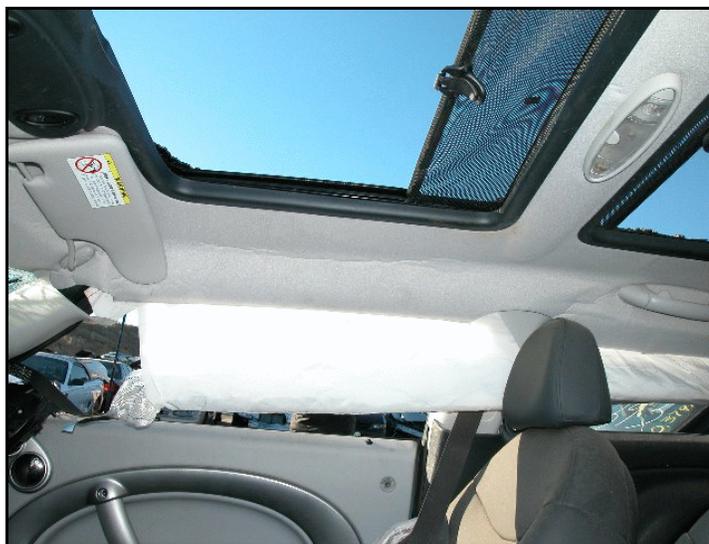
Figure 20. Front right seat area—shows contacted side air curtain
