GENERAL DYNAMICS ON-SITE CHILD SAFETY SEAT INVESTIGATION

GENERAL DYNAMICS CASE NO: CA03-035

VEHICLE: 1997 MERCURY SABLE

CRASH DATE: JUNE 2003

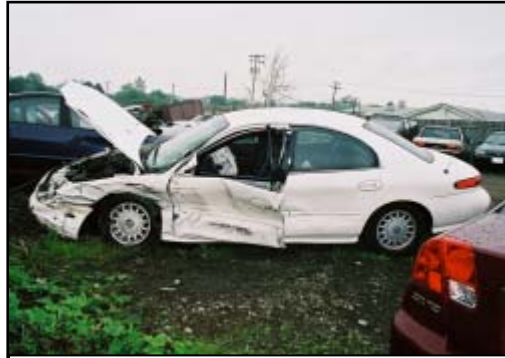
Figure 1. View of damaged Mercury Sable

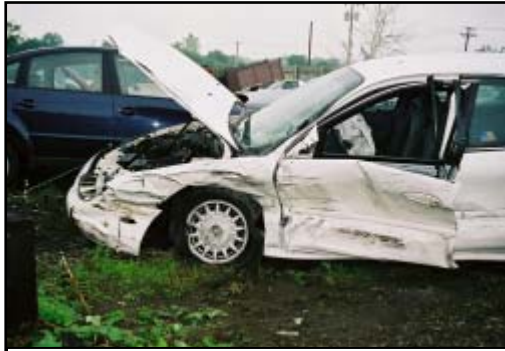
The 1997 Mercury Sable sustained moderate left side damage as a result of the impact with the Volkswagen Passat (**Figure 5**). The direct contact damage began at the left front bumper corner and extended 323.8 cm (127.5") rearward, where it terminated 36.2 cm (14.25") forward of the left rear axle. Both left side doors were crushed laterally and sustained contact abrasions from the bumper of the Passat. The rear aspect of the left front door was deformed rearward as a result of the longitudinal crush. The windshield was fractured with scattered stress fractures at the lower A-pillar area from contact with hood edge. The left front wheel was separated from the suspension components and restricted against the rear of the left front fender. The side and rear glazing were not damaged. The left front door was jammed closed by damage and pried open for extrication of the driver. The damage from rescue personnel's attempts to extricate the driver consisted of pry marks to the latch and striker area of the left front door. The left rear and both right side doors remained closed during the crash and were operational post-crash. The Collision Deformation Classification for the impact with the Passat was 11-LYEW-2. Six crush measurements were documented at the mid-door level: C1 = 0.0 cm, C2 = 11.4 cm (4.5"), C3 = 20.3 cm (8.0"), C4 = 22.8 cm (9.0"), C5 = 21.9 cm (8.6"), C6 = 14.0 cm (5.6"). Maximum crush was located 7.6 cm (3.0") forward of the rear edge of left front fender and measured 22.8 cm (9.0").

Figure 5. Front left damage to Sable.

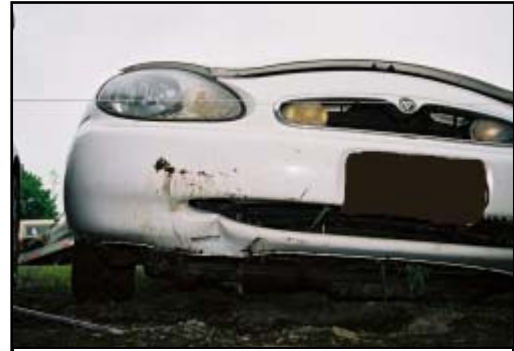
The front right area of the bumper fascia had sustained damage from the impact to the embankment. The damage consisted of dirt scuffs and a dent to the lower fascia below the air dam. There was no structural involvement; however, the bumper fascia was deformed to a depth of 2.5 cm (1.0") (**Figure 6**). The Collision Deformation Classification for the impact with the embankment is 12-FRLW-1.

Figure 6. Damage to Sable from Embankment.

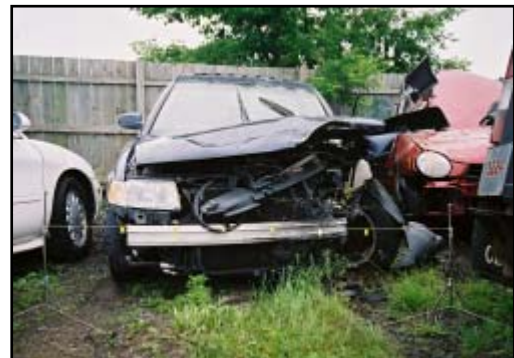
The 1999 Volkswagen Passat sustained moderate frontal damage as a result of the impact with the Sable (**Figure 7**). The direct contact damage on the bumper fascia, which separated from the vehicle, began 8.0 cm (3.1”) left of center and extended 72.0 cm (28.3”) to the left front corner. The leading edge of the hood was abraded from direct contact and buckled rearward. The left headlamp and grille trim were disintegrated. The left end of the bumper beam was crushed rearward. The left front fender was buckled rearward. The bumper and front structure sustained left lateral end shifting as a result of the Sable’s forward momentum during the crash. The left corner of the upper radiator support was displaced rearward 42.3 cm (16.6”). Six crush measurements were documented along the front bumper beam and were as follows: C1 = 29.0 cm (11.4”), C2 = 25.5 cm (10.0”), C3 = 17.0 cm (6.8”), C4 = 11.0 cm (4.2”), C5 = 5.5 cm (1.9”), C6 = 0.0 cm (0.0”). The CDC for the frontal impact with the Sable was 01-FYEW-1.

Figure 7. Front damage to the Passat.

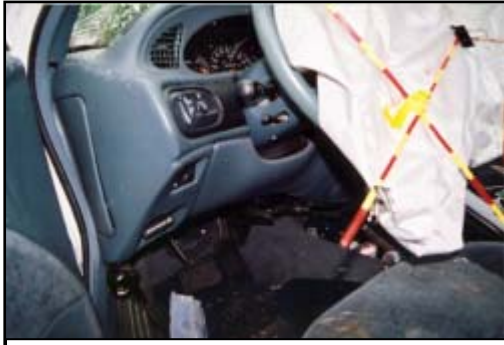
Interior damage to the 1997 Mercury Sable was minor and attributed to passenger compartment intrusion and occupant contact (**Figure 8**). The left side panel forward of the A-pillar was intruded laterally 5.0 cm (2.0”). A cluster of the driver’s hair was located on the front left seat cushion and a possible contact was found to the upper B-pillar where strands of hair were adhered to the B-pillar (**Figure 9**). At impact, the driver initiated a forward and left trajectory into the path of the deploying air bag. The driver loaded the air bag and compressed the steering column and displaced the shear capsules. The left shear bracket was displaced 0.6 cm (0.25”) (**Figure 10**) and the right shear bracket was displaced 0.3 cm (0.125”) (**Figure 11**).

Figure 8. View of intrusion to the Sable's side panel forward of A-pillar.

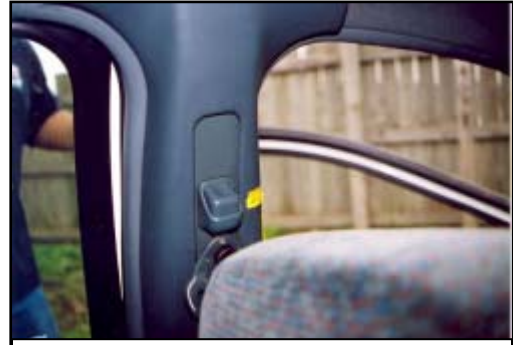
Figure 9. Driver contact to left B-pillar of the Sable. Note* D-ring cover

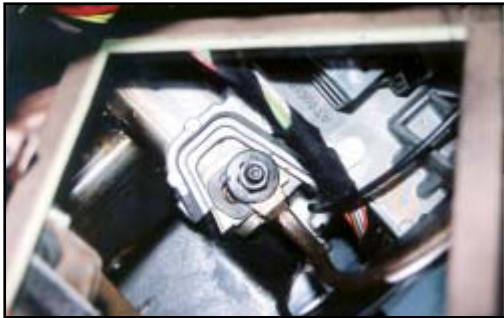
Figure 10. Left shear bracket displacement of the Sable.

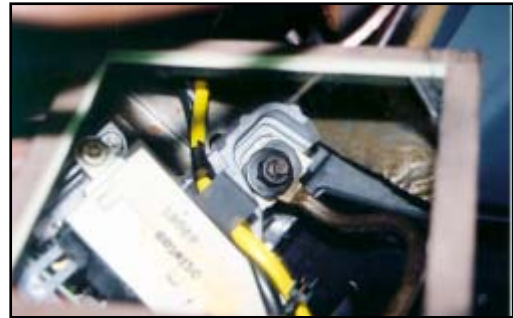
Figure 11. Right shear bracket displacement of the Sable.

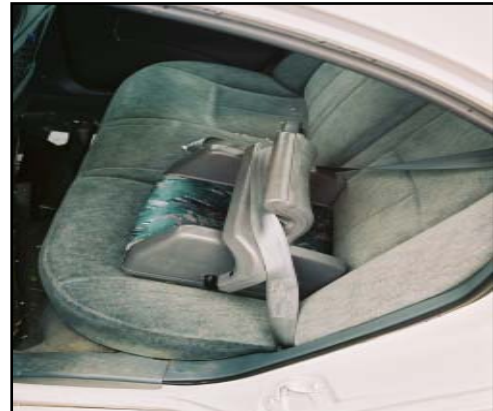
A Cosco Explorer shield booster seat was positioned in the rear center of the Sable. At the time of the inspection, the CSS was found in the rear left position (**Figure 14**). However, the driver stated to the SCI investigator that the CSS was installed in the rear center position and was restrained by the lap belt portion of the safety belt system. The CSS displayed a Manufacture Date of 08/16/94 and a Model Number of 022399EMF. The CSS was constructed of plastic with a plastic abdominal shield that hinged on the left side. The abdominal shield padding was not present at the time of inspection. The instructions and informational labels were not present on the CSS. The lap portion of the safety belt was positioned across the designated belt path on the face of the shield. The shoulder belt was not used with the CSS. The CSS displayed no evidence of failure or damage associated with the crash.

Figure 14. CSS found in rear left position at inspection.
