**GENERAL DYNAMICS ON-SITE CERTIFIED ADVANCED 208-COMPLIANT
VEHICLE CRASH INVESTIGATION
SCI TECHNICAL SUMMARY REPORT**

CASE NO. CA03-041

VEHICLE – 2003 ACURA MDX

CRASH DATE – JULY 2003

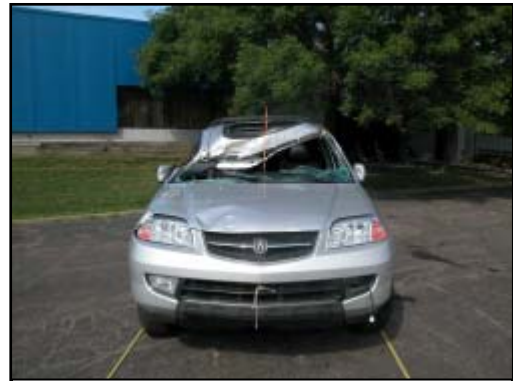
Figure 1. Damaged 2003 Acura MDX

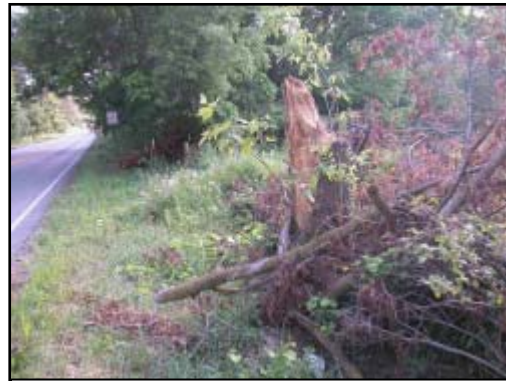
The 34-year-old male was operating the Acura MDX in a southbound direction on the two-lane roadway (**Figure 3**). The driver stated that the vehicle was traveling approximately 81 km/h (50 mph) prior to the impact. As the vehicle approached the crash site, he observed a large tree limb fracture and fall onto the roadway. The driver applied the brakes as the MDX approached the tree limb in the roadway. The tree trunk that measured 45.7 cm (18.0”) in diameter fractured 134.6 cm (53.0”) above the base (**Figure 4**) and began to fall at this point in time.

Figure 4. View of the base of the fractured tree

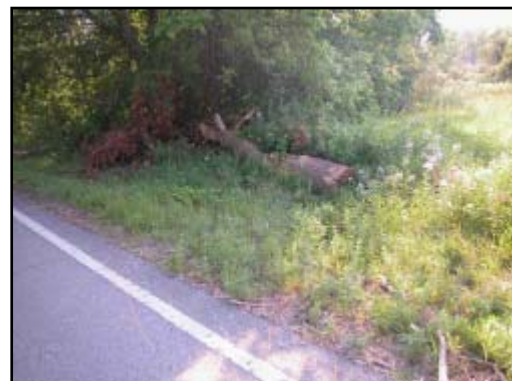
Figure 5. View of the final rest position of the fractured tree

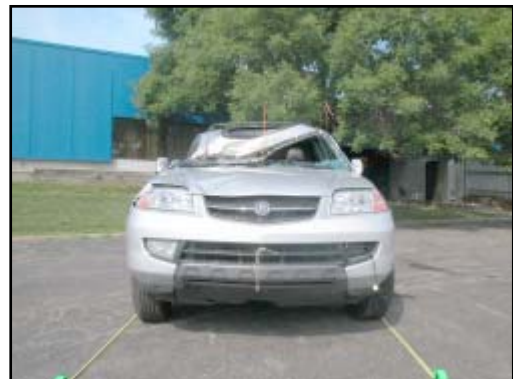
The 2003 Acura MDX sustained minor lower front bumper fascia damage as a result of the initial impact (Figure 6) with the tree limb. There was no residual crush, and the direct contact abrasions began at the centerline and extended 53.3 cm (21.0") to the right. The combined direct and induced damage across the bottom of the plastic fascia began at the centerline and extended 76.2 cm (30.0") to the right. The Collision Deformation Classification (CDC) for the impact with the tree limb was 12-FZEW-1.

Figure 6. Frontal view showing minor lower bumper fascia damage

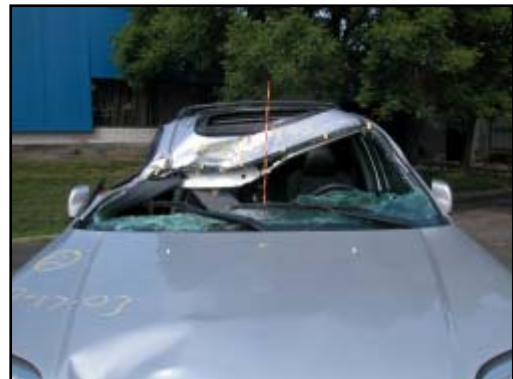
The MDX sustained moderate green house damage as a result of the impact with the fractured tree trunk (Figure 7). The direct damage began on the right A-pillar, 19.1 cm (7.5") above the belt line, and extended 48.9 cm (19.3") upward along the right A-pillar. The direct damage extended laterally across the entire width of the windshield, windshield header, forward aspect of the roof, and the right roof side rail. The windshield header and right A-pillar were crushed vertically approximately 25 cm (10") from their original position. The maximum longitudinal crush on the windshield header measured 26.0 cm (10.3") and was located 31.1 cm (12.3") to the right of the centerline. The right roof side rail was crushed vertically from the right B-pillar forward, and the windshield was fractured and holed. A semi-circular damage pattern on the right A-pillar that measured 45.7 cm (18.0") in diameter was located 22.9 cm (9.0") above the belt line from direct contact with the tree (Figure 8). The combined direct and induced damage measured 132.1 cm (52.0") across the windshield header. Six longitudinal crush measurements were documented along the windshield header and were as follows: C1 = 0.6 cm (0.3"), C2 = 4.2 cm (1.7"), C3 = 15.2 cm (6.0"), C4 = 24.1 cm

Figure 7. Frontal view of green house damage to the MDX

(9.5”), C5 = 20.1 cm (7.9”), C6 = 10.8 cm (4.3”). The right aspect of the hood was slightly deformed as a result the deflection of the tree from the vehicle onto the roadside. The CDC for the impact with the fallen tree trunk was 00-TPDW-4.

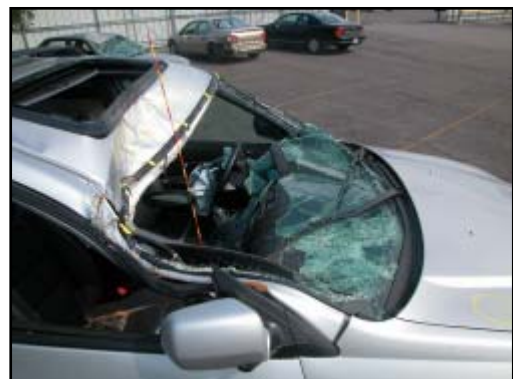
Figure 8. Lateral view showing direct damage from the tree

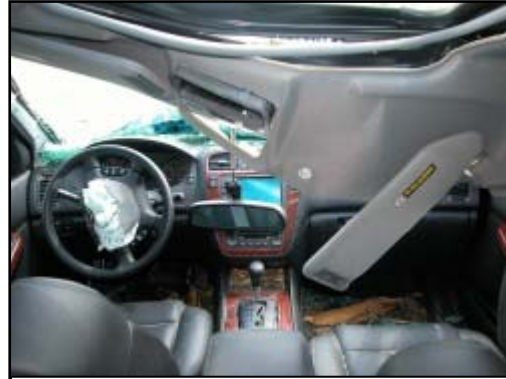
Figure 10. Interior view showing passenger compartment intrusions

The 2003 Acura MDX sustained moderate interior damage as a result of passenger compartment intrusion (**Figure 10**). Numerous tree fragments were present in the vehicle. The windshield was fractured and holed from direct contact with the tree. The right front window, right rear window (cargo area), and the sunroof glazing disintegrated as a result of the impact. Fractured glazing was present throughout the vehicle. A scuff mark was present on the rear outboard aspect of the plastic trim on the rear of the driver’s seat cushion from engagement against the safety belt webbing. The scuff mark measured 6.4 cm (2.5”) in width and was diagonally oriented. The headliner fabric was torn adjacent to the right sun visor arm and was separated along the width of the windshield header. The rear view mirror was separated. Multiple intrusions were documented as follows:

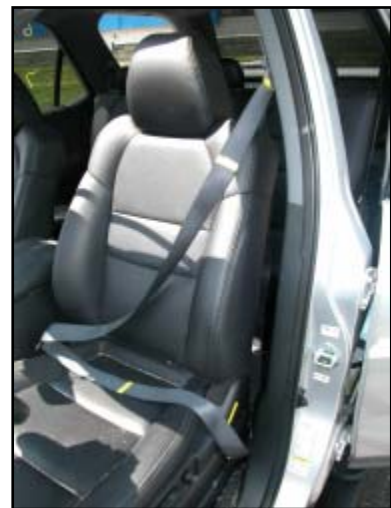
The 2003 Acura MDX was configured with manual 3-point lap and shoulder belts for the front seating positions. The driver's safety belt was equipped with an Emergency Locking Retractor (ELR) with a load limiter, a sliding latch plate, and an adjustable D-ring that was adjusted to the full-up position. The front right passenger's safety belt was equipped with a switchable/Automatic Locking Retractor (ALR) with a load limiter, and a sliding latch plate. The plastic-coated D-rings were configured with a metallic finish on the bottom aspect of the opening that engaged with the safety belt webbing. The driver's safety belt webbing was restricted in the used position (**Figure 11**). The total webbing that was exposed between the B-pillar trim and the anchor measured 192.4 cm (75.8") in length. The webbing exhibited stretching as a result of occupant loading that began 56.5 cm (22.3") from the anchor and extended 97.8 cm (38.5") upward along the lap and shoulder aspects. A full-width plastic transfer was located 18.4 cm (7.5") above the anchor from engagement against the plastic trim on the outboard aspect of the driver's seat cushion. The plastic-coated latch plate was abraded as a result of occupant loading, and the D-ring exhibited minor scuffing on the forward aspect of the plastic.

Figure 11. View of restricted driver's lap and shoulder

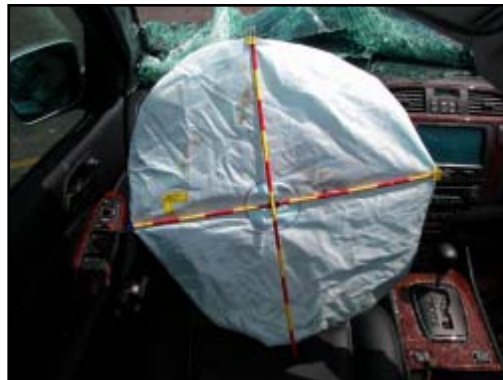
The driver's air bag deployed as a result of the impact with the fallen tree. The driver's air bag (**Figure 12**) deployed from the steering wheel hub and was designed with symmetrical H-configuration cover flaps. The flaps measured 7.6 cm (3.0") in height and 15.6 cm (6.1") in width at the tear seam. The deployed air bag measured 61.0 cm (24.0") in diameter. The air bag was vented by two circular ports that measured 3.8 cm (1.5") in diameter and were located at the 1 and 11 o'clock positions on the rear of the air bag. The air bag was tethered by three internal straps that measured 6.4 cm (2.5") in width and were located at the 12, 4, and 8 o'clock aspects around the center of the air bag. A small light colored fabric transfer that measured 1.0 x 1.0 cm (0.4 x 0.4") was located 17.1 cm (6.8") above the horizontal centerline and 1.6 cm (0.6") to the right of the vertical centerline. Small amounts of body fluid were present on the upper right quadrant of the air bag face. Two additional small light colored fabric transfers were present on the 2 o'clock aspect of the rear of the air bag.

Figure 12. Deployed driver's air bag
