TRANSPORTATION RESEARCH CENTER

REMOTE CERTIFIED ADVANCED 208-COMPLIANT VEHICLE INVESTIGATION

CASE NUMBER - IN-03-043
LOCATION - Texas
VEHICLE - 2003 Honda Odyssey
CRASH DATE - September 2003

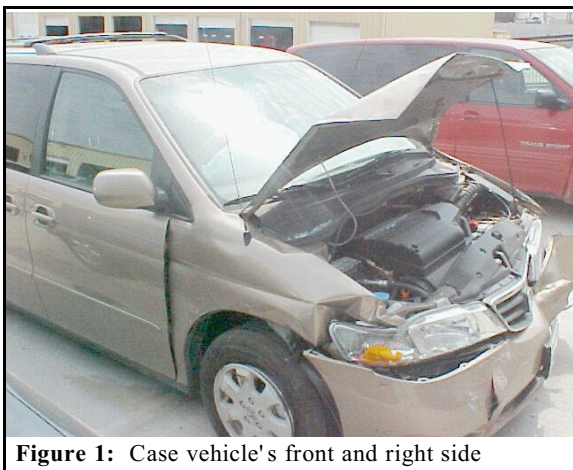
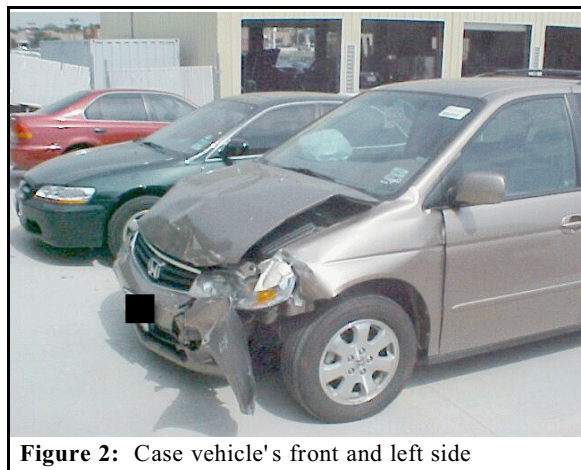
Figure 1: Case vehicle's front and right side

Figure 2: Case vehicle's front and left side

The case vehicle sustained direct contact damage at the front left corner area (**Figures 1 and 2**) from the impact with the traffic signal control box (event #1). The left headlamp/turn signal assembly was shattered and displaced rearward, the leading edge of the left fender was crushed and the entire fender was distorted and displaced rearward, the radiator and engine components on the left side were displaced, the hood was distorted, and the bumper cover was torn and displaced. The available photos do not show any visible damage that can be attributed to the impact with the shrubbery (event #2). The left outside rearview mirror lens was broken out. The impact with the parked Toyota (event #3) resulted in direct contact across the entire front bumper, with induced damage to the right fender and the right side of the engine hood. The two frontal impacts involved overlapping damage that cannot be separated with the information available.

The CDCs were estimated from the available photographs. For the impact with the traffic signal control box (event #1), the estimated CDC is **12-FLEW-1 (0 degrees)**. With no damage visible in the available photographs, the CDC for the shrubbery impact (event #2) is not known. Based on the police scene diagram, this was a swiping-type engagement along the left side and a partial CDC for event #2 is estimated as **12-L999-9 (0 degrees)**.

For the impact with the parked Toyota, the case vehicle's CDC is estimated as **12-FDEW-1 (0 degrees)**. The WinSMASH reconstruction program, missing vehicle algorithm based on the

case vehicle's photo-estimated CDC, was used on event #3, which was the deployment event. The total, longitudinal and lateral delta Vs for the case vehicle are, respectively: 21.0 km.p.h [13.0 m.p.h.], -21.0 km.p.h. [-13.0 m.p.h.] and 0 km.p.h [0 m.p.h.]. This is a borderline reconstruction but the results appear reasonable. Event #3 was of low severity (14-23 km.p.h. [9-14 m.p.h.]) for the case vehicle.

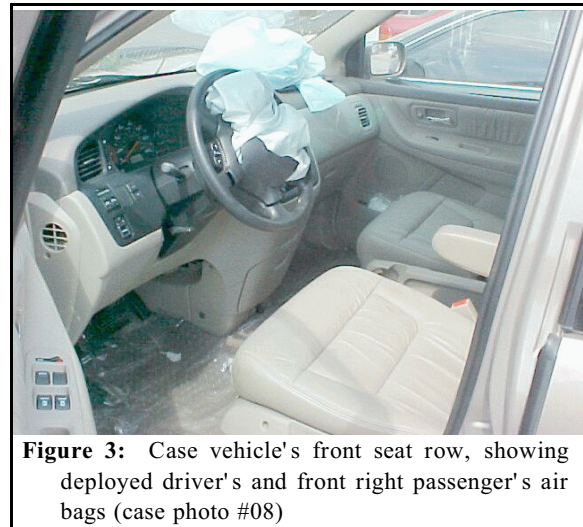
The case vehicle was equipped with dual-stage frontal air bags and seat back-mounted side impact air bags for the two front seat positions, for a total of four air bags. The two frontal air bags deployed while the two side impact air bags did not (**Figure 3**).

The driver's air bag was mounted in the steering wheel hub, with the module cover flap(s) in an unknown configuration. The air bag's size and shape are unknown, and it is not known if the air bag had any tether(s) or vent port(s). There is no obvious damage nor any evidence of occupant contact visible in the one photo that shows the air bags.

Figure 3: Case vehicle's front seat row, showing deployed driver's and front right passenger's air bags (case photo #08)

The front right passenger's air bag was located in the top of the right instrument panel, with the module cover flap(s) in an unknown configuration. The air bag's size and shape are unknown, and it is not known if the air bag had any tether(s) or vent port(s). There is no obvious damage nor any evidence of occupant contact visible in the one photo that shows the air bags.
