**CALSPAN ON-SITE SIDE IMPACT AIR BAG DEPLOYMENT INVESTIGATION
SCI TECHNICAL SUMMARY REPORT**

CASE NO. CA03-050

VEHICLE – 2003 HYUNDAI SANTA FE

CRASH DATE – AUGUST 2003

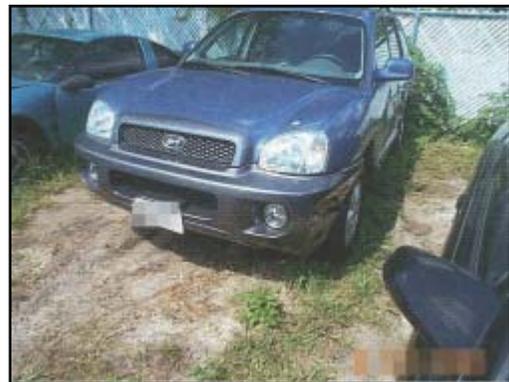
Figure 1. Post-crash photograph of damaged 2003 Hyundai Santa Fe

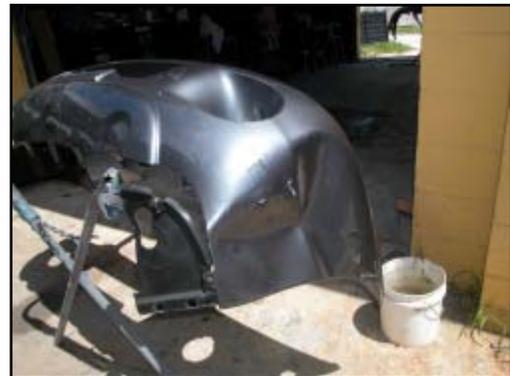
The direct damage on the left front aspect included white paint transfers and minor crush damage on the bumper fascia. The direct damage began at the left front corner of the bumper fascia and extended 35.6 cm (14.0") rearward to the left rear edge of the fascia (**Figure 4**). The maximum crush on the left aspect of the fascia was located 19.1 cm (7.5") rear of the left front corner and measured 3.8 cm (1.5"). The left front corner of the bumper fascia was slightly displaced from the initial contact and subsequent snagging as a result of the secondary sideslap event. The left corner of the metal bumper beam was deflected slightly forward as a result of the initial contact and rotation of the vehicles. The Collision Deformation Classification (CDC) for the initial impact was 10-LFEE-1.

Figure 4. Left front view of damaged bumper fascia

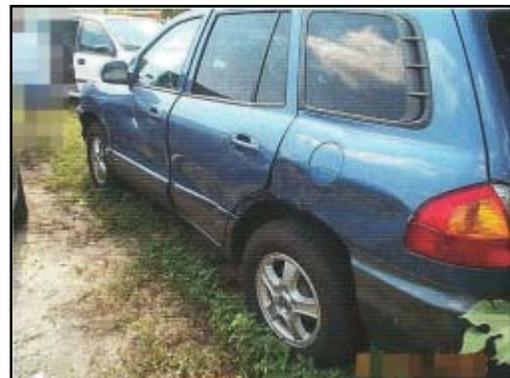
The secondary sideslap event resulted in minor damage to the left side aspect of the Santa Fe (**Figure 5**). The direct damage began at the leading edge of the left front door and extended 289.0 cm (113.7") rearward.

Figure 5. View of left side sideslap damage

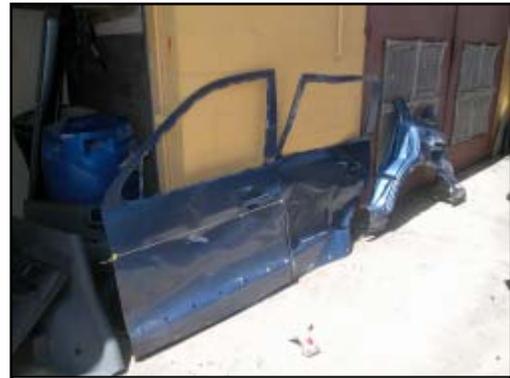
White paint transfers were present on the driver's door and were located 40.6 cm (16.0") aft of the leading edge of the left front door and 24.1 cm (9.5") below the beltline. The transfer measured 7.0 cm (2.8") in height and 10.2 cm (4.0") in width. Additional light paint transfers were located on the center aspect of the left rear door. A white paint transfer and rubber transfer from the right rear tire of the Camaro was located on the aft edge of the Santa Fe's left rear door below the door handle, which measured 10.2 cm (4.0") in length. White paint transfers were also present along the contour of the left rear wheel on the left rear quarter panel. As illustrated in **Figure 6**, lateral deformation and minor crush was present on both left side doors and the left rear quarter panel from direct contact with the Camaro.

Figure 6. View of deformation to both removed left side doors and left quarter panel

The combined direct and induced damage began at the left front axle and extended 343.0 cm (135.0") rearward to the left rear bumper corner. The maximum crush on the driver's door that resulted from the sideslap was located in the area of the white paint transfer, 43.1 cm (17.0") aft of the leading edge of the left front door and 24.1 cm (9.5") below the beltline. The maximum lateral crush on the left front door measured 3.8 cm (1.5"). The removed status of the left side components negated any significant crush measurements, as additional deformation was incurred by the removal process. There was no damage to the door structures. Six crush measurements were estimated from photographs provided from the insurance company, and were as follows: C1 = 0.0 cm, C2 = 3.0 cm (1.2"), C3 = 3.0 cm (1.2"), C4 = 1.0 cm (0.4"), C5 = 3.0 cm (1.2"), C6 = 0.0 cm. The CDC for the sideslap event was 09-LDEW-1.

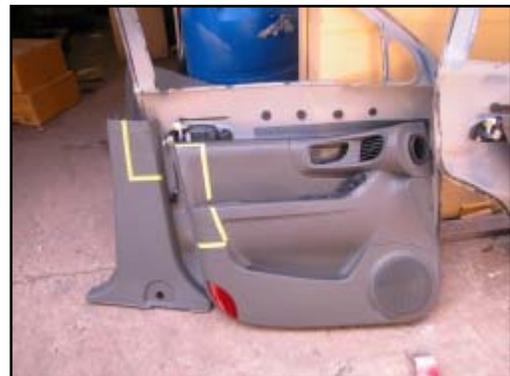
Figure 7 illustrates the interior damage to the left front door and left B-pillar trim. The forward aspect of the plastic B-pillar trim was scuffed and fractured at the beltline. The lower panel was removed from the vehicle at the time of the inspection. The top forward aspect of the removed panel was fractured. The fracture measured 7.0 cm (2.8") in height and radiated forward 3.2 cm (1.3"). The scuffed area around the fracture measured 17.8 cm (7.0") in height and 8.9 cm (3.5") in width.

Figure 7. Damaged interior left front door panel and left B-pillar trim

The rear aspect of the left front door interior and armrest was also scuffed from interaction with the left side impact air bag. The aft edge above the armrest was scuffed, heavier near the beltline. The scuff mark measured 16.5 cm (6.5”) in height and 7.6 cm (3.0”) in width at the beltline, and measured 2.5 cm (1.0”) in width at the bottom aspect. The distance between the beltline and the top aspect of the armrest measured 19.1 cm (7.5”) in height. A second scuff mark was located below the top plane of the armrest. The scuff mark began at the top of the armrest and extended downward 11.1 cm (4.4”). The scuff mark measured 10.2 cm (4.0”) in width.

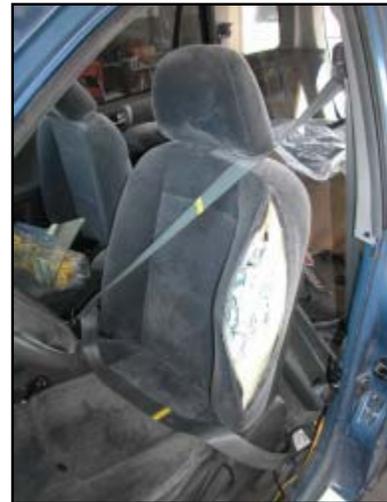
Figure 8. Driver's safety belt

The Santa Fe was configured with manual 3-point lap and shoulder belts for each front seat position. The driver’s safety belt (**Figure 8**) was configured with a sliding latch plate and an Emergency Locking Retractor (ELR) and the front right passenger’s safety belt was configured with a sliding latch plate and a switchable/Automatic Locking Retractor (ALR). At the time of the inspection, the lower anchor on the driver’s safety belt had been disconnected from the vehicle in anticipation of replacement. The driver’s adjustable D-ring was located one detent, or 2.5 cm (1.0”), below the full-up position. The plastic-coated D-ring and plastic-coated latch plate cover did not exhibit any abrasions. Minor historical use abrasions were present on the latch plate. The driver’s safety belt exhibited faint stretching from occupant loading that began 66.0 cm (26.0”) above the anchor and extended 78.7 cm (31.0”) upward along the webbing.

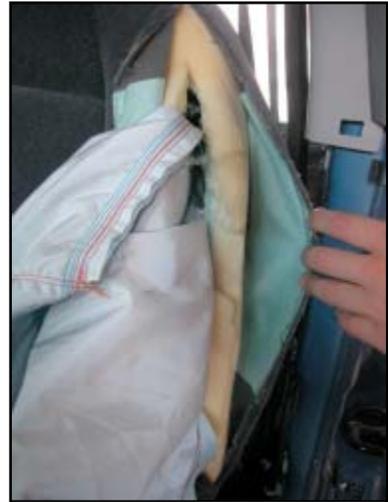
The driver's side impact air bag probably deployed as a result of the secondary sideslap event. The air bag tear seam on the outboard aspect of the seat back measured 40.6 cm (16.0") in length and began at the top aspect of the seat back. The module in the seat back measured 20.3 cm (8.0") in height. The bottom of the module was located 20.3 cm (8.0") above the seat cushion and the top of the module was located 12.1 cm (4.8") below the top of the seat back. A Styrofoam layer was present between the exterior seat fabric and the air bag module. The foam thickness on the outboard aspect of the seat measured 3.8 cm (1.5") in thickness and the foam on the inboard/forward aspect measured 2.5 cm (1.0") in thickness. The vertical tear in the foam measured 25.4 cm (10.0"). A clear plastic sleeve surrounded the air bag module, and measured 22.9 cm (9.0") in height, 10.2 cm (4.0") in depth at the inboard aspect, and 5.1 cm (2.0") in depth on the outboard aspect. The interior aspect of the seat fabric adjacent to the air bag module was lined with rectangular air bag fabric. The liners were stitched at the front and rear aspects to the interior aspect of the seat fabric. Both liners were located 8.3 cm (3.5") below the top aspect of the seat back and measured 28.6 cm (11.3") in height. The inboard liner measured 15.2 cm (6.0") in depth and the outboard liner measured 12.7 cm (5.0") in depth. The liners ensured a smooth deployment out of the seat back and prevented the air bag from snagging on the seat back tear seam as it expanded. **Figure 11** illustrates the tear seam, foam, and liners on the outboard aspect of the driver's seat back.

Figure 11. View of the outboard seat back and tear seam showing foam and interior liners

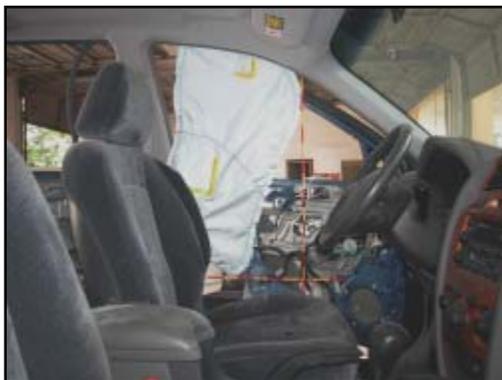
The air bag (**Figures 12 and 13**) deployed forward and upward from the outboard aspect of the seat back. The driver's side impact air bag measured 72.4 cm (28.5") in height, 44.5 cm (17.5") in width at the top aspect, and 16.5 cm (6.5") in width at the bottom aspect. The air bag extended vertically to the roof side rail and exhibited stitching along the entire perimeter located 1.9 cm (0.8") from the edge of the air bag. A full-width angular horizontal line of stitching was located 34.3 cm (13.0") below the top aspect of the air bag. A single 5.1 cm (2.0") vertical vent port in the air bag fabric was located on the outboard panel 47.0 cm (18.5") from the top of the air bag and 30.5 cm (12.0") aft of the forward aspect of the air bag.

Figure 12. Inboard view of deployed driver's side impact air bag

The inboard panel of the driver's side impact air bag exhibited faint scuff marks that resulted from contact with the seat fabric during the deployment. The scuffed area measured 8.9 cm (3.5") in width, 11.4 cm (4.5") in height, and was located 29.2 cm (11.5") above the bottom aspect of the air bag and 6.4 cm (2.5") forward of the rear seam. A square area of dark transfers that measured 5.1 cm (2.0") in length and width was located on the top inboard aspect of the air bag, 17.8 cm (7.0") rear of the forward aspect. The dark transfers appeared to be from post-crash handling of the air bag. There was no occupant contact evidence present on the air bag.

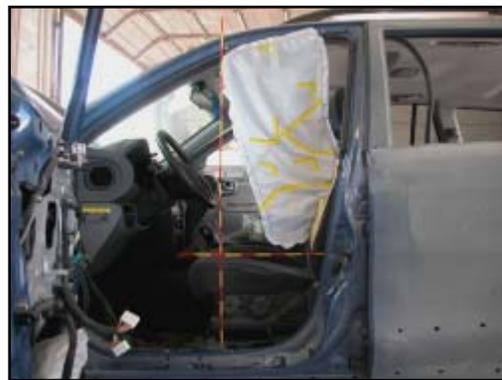
Figure 13. Outboard view of deployed driver's side impact air bag

Faint scuff marks were present on the bottom outboard aspect from contact with the interior aspect of the seat back during the deployment and contact with the interior panel and armrest of the left front door. The area of scuffing on the bottom of the air bag measured 22.9 cm (9.0") in width and 15.2 cm (6.0") in height. A triangular area of scuffing was present on the rear outboard aspect and located 25.4 cm (10.0") below the top aspect of the air bag. The area of scuff marks measured 18.1 cm (7.1") in height and 15.9 cm (6.3") in width and resulted from contact with the interior lower B-pillar trim, evidenced by corresponding scuff marks and fractured plastic. Two additional small faint scuff marks were present on the outboard panel from contact with the top aspect of the left front door interior. The scuff marks were located 6.4 cm (2.5") and 16.5 cm (6.5") aft of the forward seam of the air bag, and 44.5 cm (17.5") and 47.0 cm (18.5") from the top of the air bag, respectively. A square scuff mark was located on the forward aspect of the outboard panel that measured 8.9 cm (3.5") in height and width. The scuff mark was located 7.6 cm (3.0") aft of the forward seam and 17.9 cm (11.0") from the top aspect of the air bag. It appeared to be from contact with the seat back during the deployment. A 5.1 cm (2.0") square scuff mark was present on the aft aspect of the outboard panel above the module. It was located 17.8 cm (7.0") below the top of the air bag and 11.4 cm (4.5") forward of the rear aspect. The scuff mark was from contact with the interior door frame adjacent to the window. A 3.8 cm (1.5") square scuff mark was also located on the top center aspect of the outboard panel from contact with the roof side rail.
