**CALSPAN REMOTE SCHOOL BUS ROLLOVER CRASH INVESTIGATION**

**CASE NO: CA03-062**

**VEHICLE: 1993 BLUE BIRD 3800-SERIES SCHOOL BUS**

**LOCATION: OHIO**

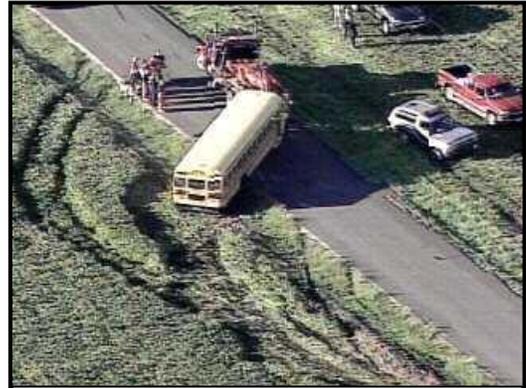
**Figure 1 - Overhead image of crash scene.**

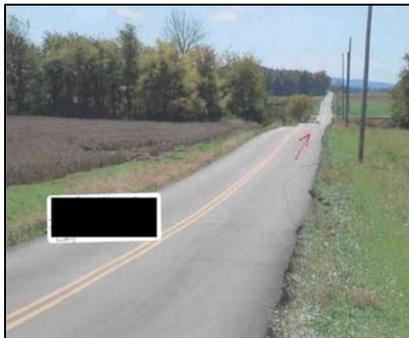
The 45-year old driver of the 1993 Blue Bird 3800 school bus was operating the vehicle in a southbound direction on a two-lane rural roadway and was negotiating a slight left curve (**Figure 2**). The driver, believing that she was partially in the northbound lane, steered right allowing a northbound vehicle to pass. As the driver steered right, she straddled the road edge until the front right wheel dropped off and crushed the unsupported asphalt road edge (**Figure 3**). Realizing that a right side road departure was occurring, the driver overcorrected by steering left and crossed the roadway’s centerline and then departed the left roadside (**Figure 4**).

**Figure 2 - southbound approach of 1993 Blue Bird**

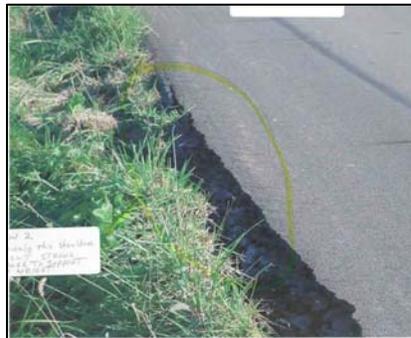
**Figure 3 - Fractured road edge.**

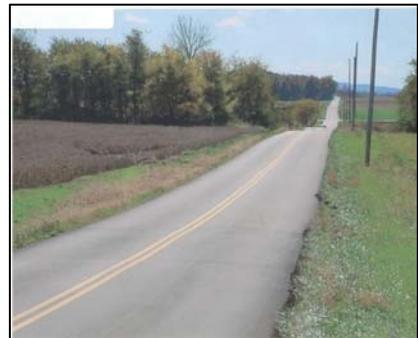
**Figure 4 - Area of left roadside departure and rollover.**

As the vehicle departed the left roadside, the left side wheels entered a ditch approximately 30 cm (12”) in depth and the driver applied a right steering input. The combination of the steering input and the listing of the bus to the left led to a left side leading one-quarter turn rollover. The vehicle came to rest on its left side in a soybean field facing in a southwest direction.

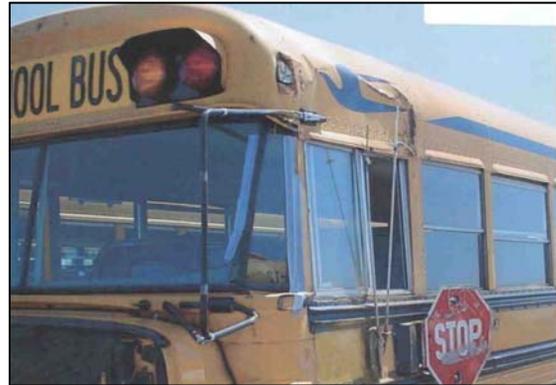
The 1993 Blue Bird 3800 school bus sustained minor structural damage to its left side due to the crash (**Figure 5**). There was no formal SCI inspection on the bus and this report is based mostly on 18 photographs taken by the school district following the crash. Damage is present on the front left roof area above the driver's window and side rail. This damage is approximately 50 cm (20") in length and the crush is approximately 10 cm (4") in depth. The side rail was bowed from the A- to C-pillars on the left side and the entire roof shifted to the right approximately 8 cm (3"). An 8 cm (3") gap is present separating the left aspect of the gasket-style windshield from the left A-pillar (**Figure 6**). The two warning lamps on the front right roof area were also displaced from their housing. Stress cracks were also present on the right aspect of the windshield caused by a translation of force from the roof shift.

**Figure 5 - Left roof area of 1993 Blue Bird 3800.**

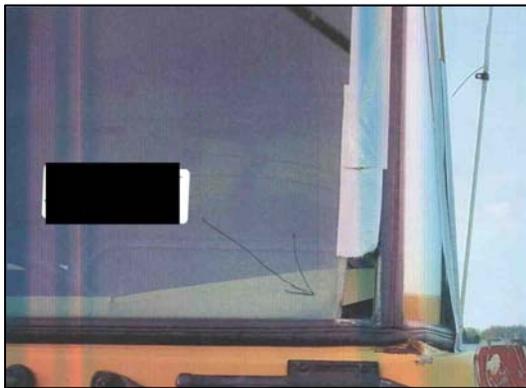
**Figure 6 - Gap between windshield and A-pillar.**

lines, brakes, body condition, doors, glazing, stop arm, bumper, and exterior mirrors. They found the brake lines and brakes to be in working order. The report indicated that the top of the entire body shifted to the right. The entry door was jammed and the windshield was both shifted to the right and fractured on the right aspect. The report further stated that the extending stop arm sustained heavy damage, the left side of the front bumper was deformed rearward, and that the left side rear view mirror and its bracket had been fractured.

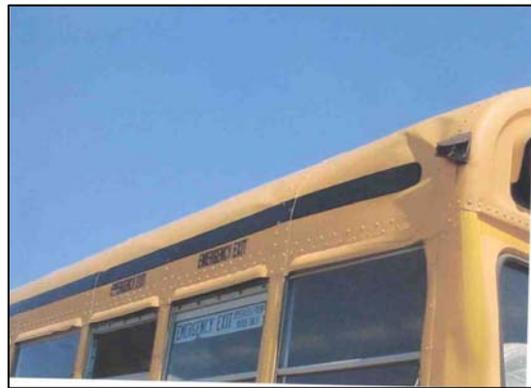
Minor damage was present on the left rear corner of the roof area above the exit row window frame at the K-pillar (**Figure 7**). The damage was approximately 25 cm (10") in length and the crush was approximately 8 cm (3") in depth. The left extending stop arm was also deformed due to impacting the ground during the rollover.

**Figure 7 - Damage to the left rear of 1993 Blue Bird 3800.**

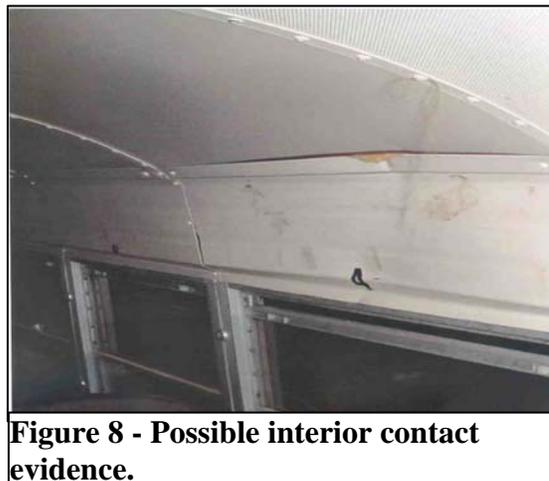
The interior of the 1993 Blue Bird 3800 school bus appeared to have sustained minor damage during the crash. The district provided photographs of the interior consisted only of three grainy images; therefore analysis of the interior was limited in scope. A possible body fluid transfer was present in the vicinity of the fourth and fifth rows on the roof panel above the side rail (**Figure 8**). Also, what appears to be a clump of hair is present fixed to the fourth bolt along the roof (**Figure 8**). No further discernable contact points or intrusions could be identified.

**Figure 8 - Possible interior contact evidence.**
