**GENERAL DYNAMICS ON-SITE ADAPTIVE CONTROL VEHICLE**

**DEFECT INVESTIGATION**

**SCI 1 CASE NO: CA03-063**

**VEHICLE: 2000 DODGE GRAND CARAVAN SPORT**

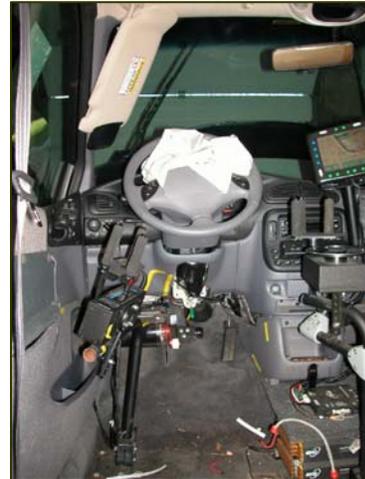
This on-site crash investigation focused on an alleged open throttle issue in an adaptive control (**Figure 1**) 2000 Dodge Grand Caravan Sport. The vehicle was operated by a 23-year old male with a C5 spinal cord injury that resulted in paralysis of the lower extremities and limited upper extremity mobility. The Caravan was adapted with remote electronic hand controls for the steering, brake, and throttle functions. The driver operated the vehicle from his motorized wheelchair that was restrained by a floor mounted EZ Lock electro-mechanical locking system. His body was essentially unrestrained by an improperly mounted and adjusted manual belt system. While traveling on a rural state route, the driver experienced an alleged throttle issue that resulted in constant acceleration. He attempted to control the Caravan by braking; however, the front brakes over-heated and became ineffective. The driver operated the Caravan for approximately 23 km (14 miles) in this condition. As he was ascending a steep hillcrest, he encountered a slower moving dump truck that was traveling ahead of his position. The driver steered rapidly in a clockwise direction into a farm field to avoid a front-to-rear crash with the dump truck. The driver traversed the cross slope of the field that had a changing grade and an overall negative grade from the road. Additionally, the field curved to the left, dictated by two wide rows of corn that bordered the field. The Caravan traveled a distance of 760 m (2,500') across the field. Located at the back left corner of the field was a row of six large 1.5 m (5.0') diameter round hay bales. The driver steered into the bales with the assumption that the bales would stop the vehicle. The Caravan experienced a full frontal impact with the bales. The impact displaced several of the bales and deflected the vehicle to its left. The Caravan travel 10 m (33') and impacted a 30 cm (12") diameter tree cluster located at the corner of a tree line. The vehicle came to rest against the struck tree. As a result of the frontal impact, the frontal air bag system deployed. The driver was displaced from his wheelchair onto the floor of the Caravan with his left shoulder and head resting on the leading edge of the chair cushion. He expired on the evening of the crash due to hypothermia. Prior to his death, the driver typed a brief chronology of the pre-crash events into a palm computer that was recovered by the investigating officer. Following a three-day air and land search for the driver, the crash site was located approximately 51 hours later, due to the remote location of the vehicle. The subsequent SCI inspection revealed a frayed throttle cable at the location of the servo motor unit for

**Figure 1.** Interior view of the adaptive controls.

the adaptive throttle and brake controller. This frayed cable prevented closure of the throttle.

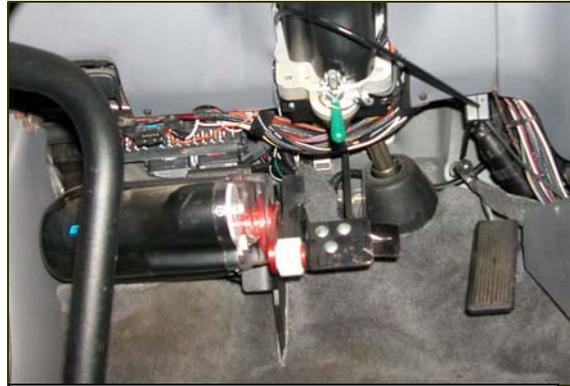
**Figure 4.** Servo motor and cable routed to the OEM accelerator pedal.

A servo motor control unit was mounted under the left side of the lower left instrument panel/knee bolster (**Figure 4**). This unit provided the mechanical action to operate the throttle and brake systems following input from the hand controller (DL-001). The throttle was activated by a conventional steel sleeved cable that was routed from a cam arm on the left side of the servo motor unit. This cam arm was 7.6 cm (3.0") in length and was in a horizontal position when the throttle was closed. The arm rotated downward approximately 90 degrees to the full open throttle position. This arm motion pulled on the cable to open the throttle while the OEM throttle return spring closed the throttle unit. The steel sleeved cable was apparently cut to length by the contractor that installed the adaptive controls. The cut end of the cable sleeve was not equipped with an end treatment to prevent cable abrasion from contact with the cut edge of the steel coil sleeve.

The cable was mounted in a vertical position above the cam arm and was routed in a 90 degree loop rearward, crossing the aft aspect of the steering column below the knee bolster. The cable continued to a block clamp that was mounted on the right aspect of the lower instrument panel, above the position of the OEM accelerator pedal. The cable continued forward and was attached to the upper end of the OEM accelerator pedal linkage, above the mid pivot point (**Figure 4**). Throttle input of the hand control would activate the servo, thus rotating the cam arm and pulling the cable. The cable would operate the OEM accelerator pedal that would then activate the throttle using the OEM cable system to the engine compartment.

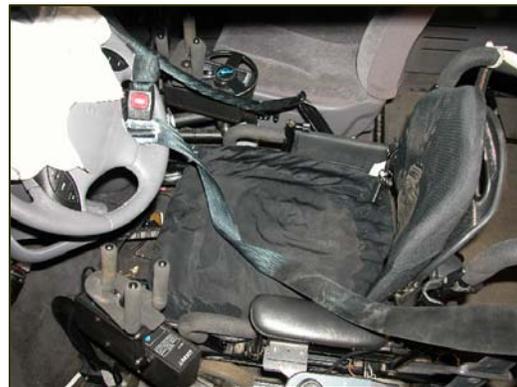
The retrofitted safety belt system that was installed in the Caravan for this driver did not appear to properly restrain him. Although designed as a three-point lap and shoulder belt system, the system was installed as a two-point combination manual/passive restraint system. That is, the system was designed to remain buckled and positioned (when not in use) on the steering wheel. The driver was to position his wheelchair under the belt and place the belt across his body once locked into the EZ Lock system. He apparently did not have the upper arm strength/range of motion to adjust the belt slack. Therefore, the belt was simply placed across his lap and over the arms of the motorized wheelchair as a means of restraint. **Figure 7** is a view of the adjusted position of the retrofitted safety belt with respect to the driver’s position within his chair and the steering wheel rim.

**Figure 3.** Retrofitted safety belt system in the adjusted positioned worn by the driver.

The inboard aspect of the retrofitted belt system was attached to a stalk that was attached to the floor track that extended laterally across the drop floor at the aft aspect of the B-pillars. The stalk was a steel strap that measured 3.8 cm (1.5”) in width x 3.2 mm (0.125”) in thickness x 65.4 cm (25.75”) in length. A 9 mm (3/8”) diameter Grade 5 bolt secured the belt to the stalk. The belt webbing was attached to the upper end of the stalk with a plastic wire tie. This tie held the upright position of the webbing, which allowed the driver to reach the belt webbing from his wheelchair. The belt webbing length was 128.9 cm (50.75”) from the floor anchor point, terminating at a conventional sewn-on buckle. The outboard aspect of the belt system was attached to the outboard aspect of the left D-ring. This length of belt webbing contained a latch plate and a loop at the lower end to form a 3-point system. The lower loop was to be mounted to the track system adjacent to the left B-pillar. This loop was not attached and did not exhibit evidence that it was ever attached to the vehicle. The latch plate was fastened to the buckle and the free end of the lap belt was knotted around the buckle to fix the adjustment length. In addition to the knot, the inboard aspect of the belt webbing was twisted (three complete twists). In this configuration, this belt system formed a two-point, fixed length shoulder

belt. The overall length of the B-pillar mounted webbing was 102.9 cm (40.5") that formed a shoulder belt that was 231.8 cm (91.25") in length. It should be noted that during the removal of the driver's body, the shoulder belt webbing was cut 9.5 cm (3.75") below the D-ring attachment point.

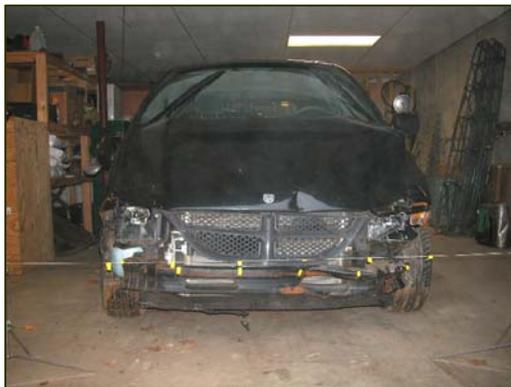
The full frontal width of the Caravan sustained superficial abrasions from the initial impact with the large diameter hale bales. The hood face was dented full width from contact with the bales. This impact displaced several of the bales and deflected the Caravan laterally to its left. The right front fender and right door sideswiped the bales as the vehicle continued on a trajectory to impact with the tree. The left side engagement resulted in superficial abrasions and deformation of the sheet metal fender and door panel. The Collision Deformation Classification (CDC) for this impact was 12-FDEW-1.

**Figure 10.** Frontal damage to the Dodge Caravan.

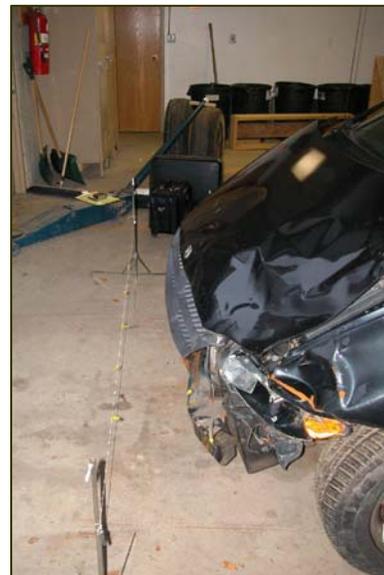
**Figure 11.** Lateral view of the crush profile.

The front left area of the Caravan impacted a tree cluster that was located at the back corner of the field within the tree line. The impact resulted in 25 cm (9.75") of maximum crush located on the bumper beam, 18 cm (7.0") left of the centerline. The cluster

consisted of three branches that spread from a 31cm (12.0”) diameter trunk. The direct contact damage began 15 cm (6.0”) left of center and extended 68.6 cm (27.0”) to the left corner (**Figure 10**). The frontal impacts separated the fascia from the bumper beam. The tree impact deformed the full width of the bumper fascia resulting in a combined induced and direct damage (Field L) length of 131 cm (51.75”). Six crush measurements were documented at the level of the bumper beam (**Figure 11**) and were as follows: C1 = 11 cm (4.5”), C2 = 10 cm (4.1”), C3 = 15 cm (6.0”), C4 = 10 cm (3.875”), C5 = 4 cm (1.75”), C6 = 5 cm (2.0”). It should be noted that the bumper beam crush profile was the result of the tree and hay bale impacts. The CDC for this tree cluster impact was 12-FYEW-1.

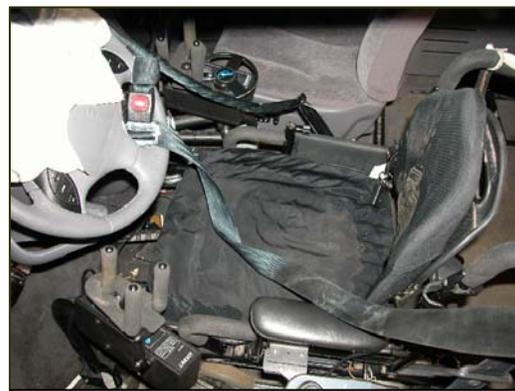
Due to the lack of proper restraint (**Figure 12**), the driver responded to the frontal crash forces and moved forward. His torso and face loaded the deployed air bag as his pelvic region began to submerge the steering column and the retrofit shoulder belt system. There was no contact evidence on the deployed air bag and no deformation of the steering wheel rim and/or energy absorbing column. The driver sustained multiple abrasions and contusions from probable contact with the adaptive hand controls and instrument panel. He sustained an abrasion of the postero-lateral aspect of the right arm adjacent to the axially apex from contact with the retrofitted shoulder belt as he submarined the steering assembly. The driver sustained

**Figure 12.** Driver’s seated position and the adjusted position of the retrofitted safety belt.

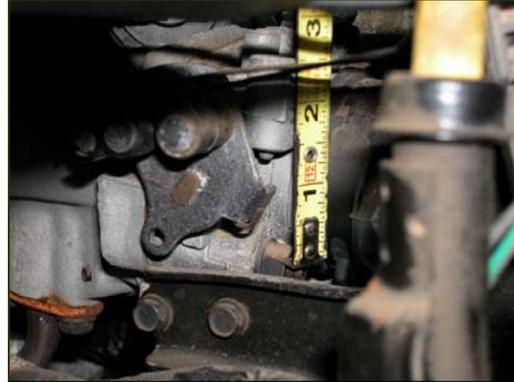
A Pennsylvania State Trooper with expertise in vehicle mechanical systems was summoned to the scene of the crash to provide an initial assessment of the vehicle. He opened the hood of the Dodge Caravan and observed the throttle plate was opened approximately 1.3 cm (0.5”) from its closed position. He further noted that the battery was ajar from its OEM position, resting against the air intake duct. As he attempted to reposition the battery, the throttle plate retracted to the closed position. He did not pursue further investigation of the throttle system due to the complexity of the adaptive controls.

**Figure 13.** Open throttle position resulting from the frayed cable.

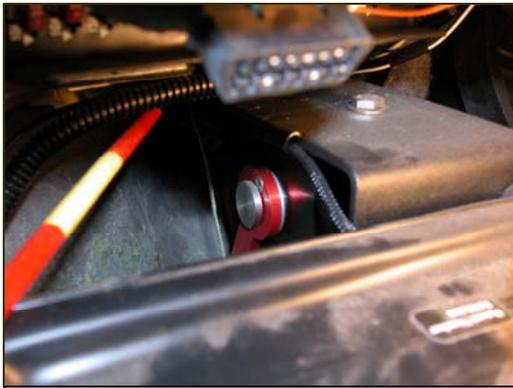
The passenger compartment components of the throttle assembly were inspected. These components included the OEM pedal, pivot, and cable; the servo motor assembly and the cable that translated the hand control inputs from the servo motor unit to the OEM gas pedal.

**Figure 14.** Cable and servo motor cam arm centered in image.

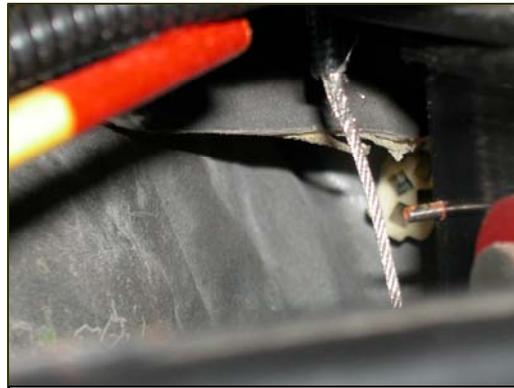
**Figure 15.** Frayed adaptive control throttle cable.

The retro fitted steel sleeved cable that connected the cam arm on the servo unit to the OEM gas pedal was looped at the downstream end, between the sleeve and the cam arm. The cam arm was rotated downward to extend the cable (**Figure 14**) and open the throttle. As this step was initiated, the loop was straightened and the cable extended from the sleeve. Upon release of the cam arm, the cable failed to retract within the sleeve. It was observed that the cable was frayed (**Figure 15**) over a 1.3 cm (0.5”) length. The frayed segment of cable partially engaged within the sleeve, but snagged at the cut end of the sleeve, which prevented the throttle from fully closing. This process was repeated several times during this investigation with the same results. All other components associated with the throttle system appeared to be fully operational. It should be noted that there were no attempts to start the engine of the Caravan during this investigation.

Based of the observations of the frayed throttle cable that extended from the adaptive throttle servo motor unit, this frayed cable prevented the throttle from closing during vehicle operation. The driver experienced an open throttle issue and attempted to override the open throttle by prolonged application of the service brakes. He could not stop the vehicle as the brakes became over-heated. He intentionally steered off-road to avoid an impact with the dump truck and traveled 0.8 km (0.5 mile) off-road to the impacts with the hay bales and the tree. He ultimately succumbed to the elements due to his remote final rest position. Furthermore, the driver did not receive emergency driving training for this vehicle as he continued to drive the adaptive Caravan with a stuck throttle for a distance of 22+ km (14+ miles).

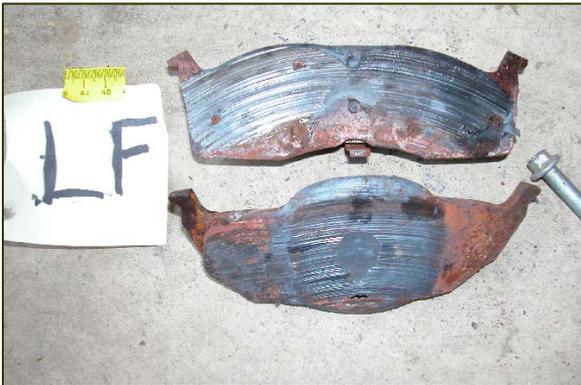
The 10 mm bolts were removed that fastened the calipers to the steering spindle castings. Due to the extreme heat that was generated during the prolonged braking, the calipers were seized to the mounting brackets. A long pry-bar was used to free the calipers from the spindle assemblies.

As the front calipers were removed, the riveted brake pads were inspected and removed from the calipers. The outboard pads were worn to the rivet heads and sustained severe degradation due to heat. The riveted linings and rivet heads in the area of the caliper pistons were completely worn away to the backer plate (**Figure 16**). The backer plates were bowed inboard with brake lining remaining on the winged sections of the plates. The piston side of the backer plates were eroded from engagement with the piston. The alloy caliper pistons were melted (**Figure 17**) at the engagement points with the brake pad. The heat that was generate by this prolonged braking melted the caliper piston boot (seal), the boots for the caliper slides, the lower ball joint boots, the outer tie rod boots, with minimal burn evidence visible on the ABS wheel sensors. Due to the piston boot damage, brake fluid was leaking from the calipers during this inspection process.

**Figure 16.** Left front disc brake pads. Note deflection of lower (piston side) backer plate.

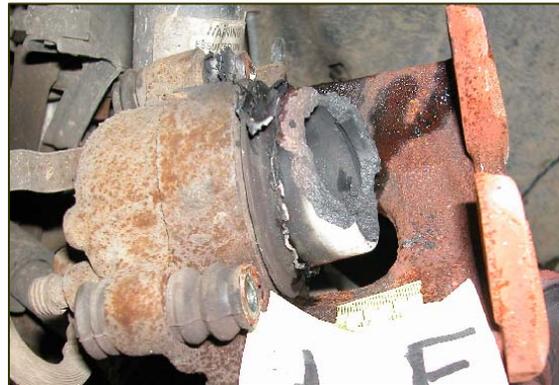
The driver noted that he applied the brakes and could smell the brakes burning prior to his intentional road departure. The mechanical inspector for the PA State Police removed the front wheels during his inspection of the vehicle and noted the front brakes had overheated to a point where the backer plate for the inboard disc brake pad had deformed. He further noted heat-related damage to the lower ball joint boots and to the ABS wheel sensors.

**Figure 17.** Deteriorated left front brake caliper piston and boot seal.
