CALSPAN ON-SITE CHILD SAFETY SEAT INVESTIGATION

CASE NO.: CA03-068

VEHICLE: 1999 DODGE GRAND CARAVAN

CRASH DATE: DECEMBER 2003

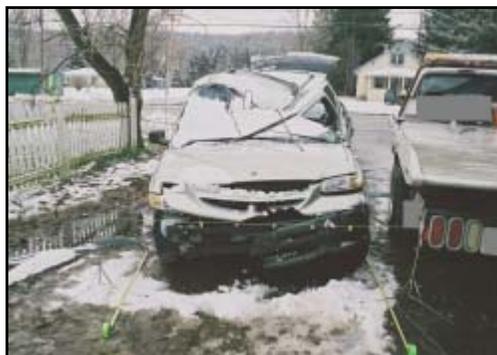
Figure 1. Damaged 1999 Dodge Grand Caravan

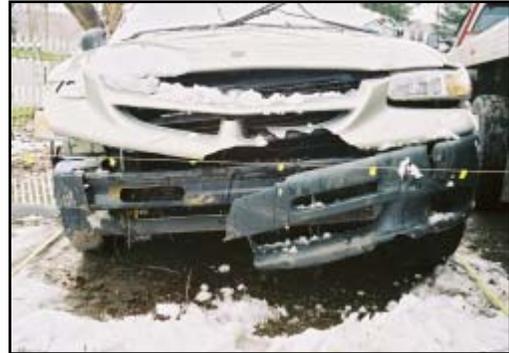
The 1999 Dodge Grand Caravan sustained minor front right damage as a result of the initial impact with the ditch. The front bumper fascia was fractured at the centerline and the right half of the fascia was separated from the vehicle at the time of inspection. The direct damage involved the entire width of the front bumper and measured 129.5 cm (51.0”) in width. The left aspects of the bumper fascia and bumper beam exhibited scuff marks. The grille was fractured and partially separated. The Collision Deformation Classification (CDC) for the initial impact with the ditch was 11-FDEW-1. Six crush measurements were documented along the front bumper beam and were as follows: C1 = 6.2 cm (2.4”), C2 = 5.1 cm (2.0”), C3 = 2.0 cm (0.8”), C4 = 1.7 cm (0.7”), C5 = 3.3 cm (1.3”), C6 = 5.1 cm (2.0”). Due to the yielding object, no Winsmash reconstruction could be completed.

Figure 4. Close up of frontal damage to the Grand Caravan

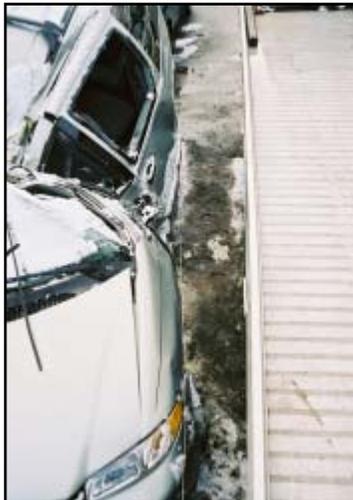
Figure 5. View of left side damage to the Grand Caravan

The Grand Caravan sustained severe left side and roof damage as a result of the left side impact with the tree (**Figures 5 and 6**). The direct contact damage began 36.2 cm (14.3”) aft of the left front axle and extended 34.3 cm (13.5”) rearward along the left side plane. The maximum crush was located 30.5 cm (12.0”) forward of the aft edge of the left front door and measured 48.3 cm (19.0”) at the mid-door level. The maximum lateral crush at the same longitudinal location on left roof side rail measured 56.5 cm (22.5”). The direct contact and crush extended vertically from the left sill to the roof side rail and extended laterally 119.4 cm (47.0”) from the left roof

side rail across the roof. Pocketing was present along the entire height of the left front door from direct engagement with the tree. The left A-pillar and left roof side rail were displaced laterally inward and crushed downward. The windshield header and roof were crushed downward and buckled. The lateral combined direct and induced damage began 19.1 cm (7.5”) forward of the left front axle and extended 238.8 cm (94.0”) rearward along the left side plane. The left front fender was deflected inward at the rear aspect, and the left rear sliding door was deflected inward at the forward aspect. Although the roof sustained direct contact damage and vertical displacement, the left side plane was the area of primary contact, which necessitated a CDC of 00-LPAN-5. Six crush measurements were documented along the left side at the mid-door level and were as follows: C1 = 0.0 cm, C2 = 2.9 cm (1.1”), C3 = 18.4 cm (7.3”), C4 = 25.4 cm (10.0”), C5 = 12.7 cm (5.0”), C6 = 0.0 cm. The non-horizontal impact was outside the scope of the Winsmash reconstruction program.

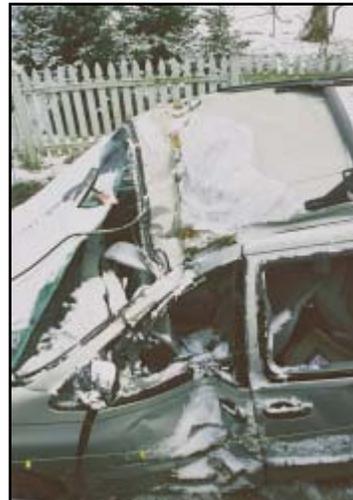
Figure 6. Close-up of direct damage from the tree

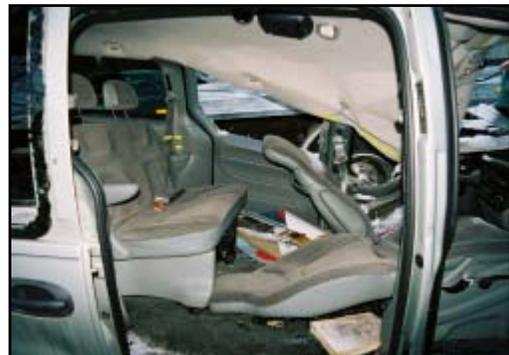
Interior damage to the Dodge Grand Caravan was severe and attributed to passenger compartment intrusion (**Figure 7**) and occupant contact. The vertical intrusion of the left A-pillar compressed the top aspect of the steering wheel rim forward approximately 90 degrees. The distance between the driver’s seat cushion and the intruded roof and left roof side rail measured 30.5 cm (12.0”). Intruded components included the following: windshield header, roof, left roof side rail, left A-pillar, left B-pillar, left front door, and the left C-pillar. The extent of the intrusion of these components is documented in the table that follows.

Figure 7. View from right side showing intrusions into front and second row seat positions

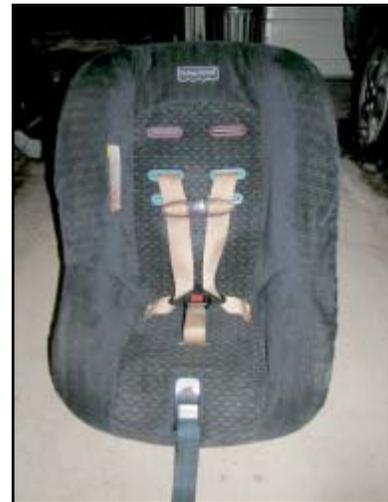
Figure 1. Fisher-Price Safe Embrace Convertible CSS

The convertible CSS sustained minor two small circular stress marks on the right side aspect.

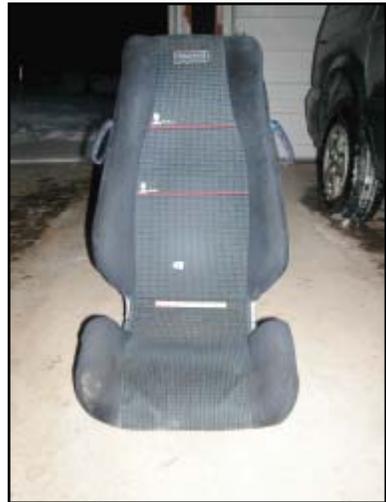
Figure 2. Fisher-Price Safe Embrace BPB

Both plastic shoulder belt positioners exhibited stress marks. A stress mark was present on the top interior aspect of the right positioner from probable loading from the shoulder belt. A light stress mark was also present on the bottom aspect. The left positioner exhibited two minor stress marks on the top aspect that were most likely not a result of this crash. There was no additional damage to the BPB.
