**CALSPAN REMOTE CERTIFIED ADVANCED 208-COMPLIANT  
VEHICLE CRASH INVESTIGATION**

**CASE NO: 2004-02-041A**

**VEHICLE: 2004 GMC YUKON XL**

**CRASH DATE: MARCH 2004**

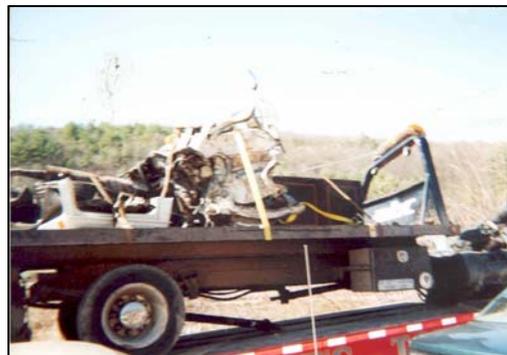
**Figure 3 - 1999 International 4700 series truck.**

The truck sustained severe front-end damage as a result of the impact with the Yukon and was towed from the scene. The majority of the cab components were fractured and placed on the flatbed prior to removing the vehicle from the scene.

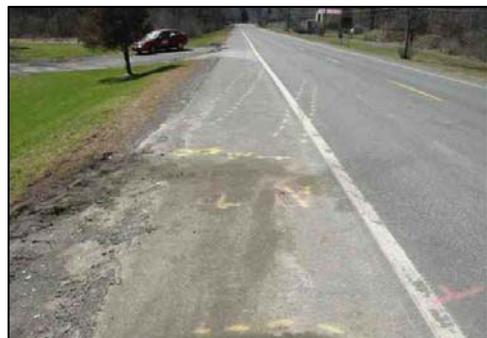
The entire front end of the Yukon impacted the front and undercarriage of the straight truck on the southbound shoulder of the roadway (**Figure 5**). The direction of force was 1 o'clock for the Yukon and 12 o'clock for the truck. The impact to the Yukon encompassed the entire front end. The area of maximum crush at the bumper level was at the front left corner with a depth of 133.0 cm (52.4"). During the impact, the truck overrode the Yukon's front end and contacted the Yukon's windshield, header, and left A-pillar partially intruding into the passenger compartment prior to disengaging. The barrier-only algorithm of the

**Figure 5 - Point of impact.**

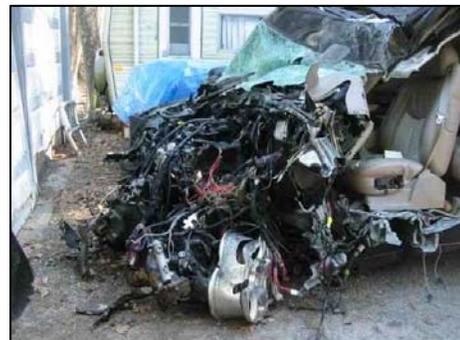
The 2004 GMC Yukon XL sustained severe damage as a result of the impact with the 1999 International 4700 Series flatbed truck (**Figure 6**). The NASS-CDS investigation reported the maximum crush at the bumper level to be 133 cm (52.3”), located at the front left corner. The direct contact damage was reported to extend from the left bumper corner to the right bumper corner, which measured 170 cm. (66.9”). The Field L measurement was also 170 cm (66.9”). The crush profile measured at the level of the bumper beam was as follows: C1 = 133 cm (52.3”), C2 = 89 cm (35.0”), C3 = 78 cm (30.7”), C4 = 74 cm (29.1”),

**Figure 6 - Frontal damage to the 2004 GMC Yukon XL.**

C5 = 69 cm (27.2”), C6 = 81 cm (31.9”). The Collision Deformation Classification (CDC) for this impact was incremented to include the lateral left end shift and was an SCI revised 81-FDEW-5.

After the initial impact, the straight truck partially overrode the front end of the Yukon and the truck’s front bumper contacted the windshield, the header, and the front left A-pillar before intruding into the passenger compartment. The roof was crushed vertically along the windshield header roughly 30 cm (11.8”). The vertical roof crush resulted from interaction between it and the undercarriage of the striking truck before they disengaged.

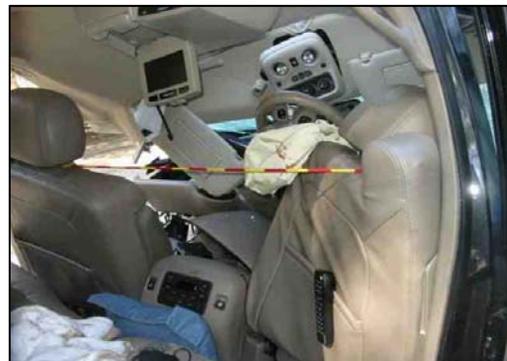
The interior of the subject Yukon sustained severe damage that was associated with exterior deformation, passenger compartment intrusion, and occupant contact. The area of greatest intrusion occurred in the driver’s seating position (**Figure 7**); the steering assembly intruded 60 cm (23.6”) laterally, 45 cm (17.7”) vertically, and 15 – 30 cm (6 – 12”) longitudinally. The steering assembly rotated upward and to the right as the cowl of the vehicle intruded rearward. The driver loaded the steering assembly and the deploying air bag during the impact and traveled upward into the roof as the crush intruded into the Yukon. The steering assembly was found in the second seat at the time of the NASS inspection. The rescue personnel likely separated it from the column. The driver rebounded into the left seat and deformed the seat back and center console. The SCI revised intrusions initially identified during the NASS-CDS inspection are listed by their magnitude in the following table:

**Figure 7 - Frontal view of interior - intrusion and front right seat back.**

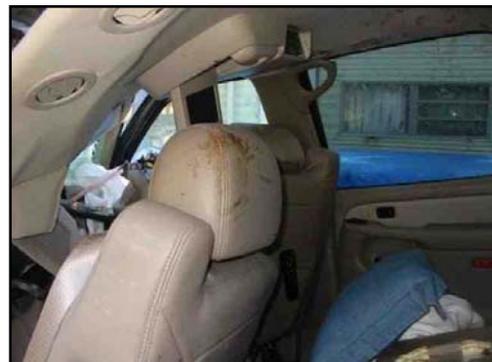
**Figure 8 - DVD player protruding from the roof.**

protruding from the roof (**Figure 8**). The front right seat back was deformed forward and to the right approximately 15 – 20 cm (6 - 8”). Direct contact to the seat back was limited to the left half evidenced by deep gouging and scuff patterns. After disengaging from the seat back, the rear right occupant rebounded into the middle-left of the second row evidenced by heavy blood and tissue transfers near the seat bight at that location. The kinematics surrounding all four occupants is discussed in greater detail in the Occupant Kinematics section of this report.

The NASS team identified a contact point on the DVD player, supported by heavy tissue and blood transfer on the unit. As a result of this contact, the occupant sustained interior basilar skull fracture, a vault skull fracture, left and right cerebrum lacerations with partial tissue avulsions, left and right subarachnoid hemorrhage, a pituitary gland laceration, and fractures to the maxilla, mandible, nose, and left and right eye orbits. The front right seat (**Figure 13**) was compressed left to right

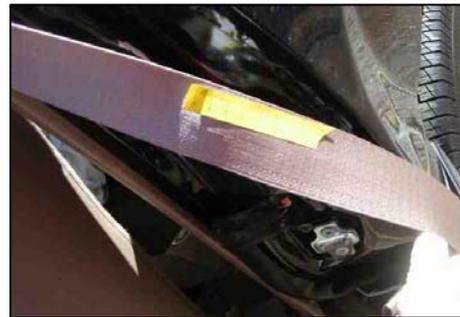
**Figure 9 - Scuffmark on rear left safety belt.**

The rear left passenger was reportedly restrained by the 3-point lap and shoulder belt system. Belt usage was supported by a scuff pattern on the lap belt webbing (**Figure 9**). The rear right occupant did not wear the safety belt system at the time of the crash. The lack of belt usage was supported by his trajectory

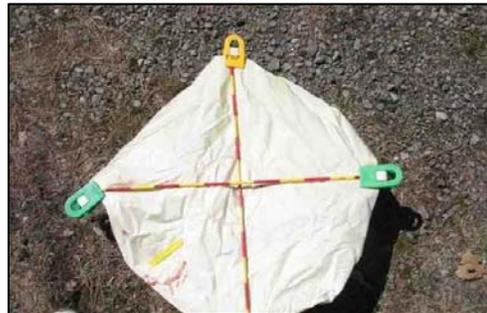
**Figure 10 - Driver's frontal air bag.**

The driver's air bag deployed through symmetrical I-configuration module cover flaps. Each flap was 7 cm (2.8") in width and 12 cm (4.7") in length. The cover flaps opened at the designated tear points. The driver's air bag measured 60 cm (23.6") in diameter in its deflated state (**Figure 10**) and contained two internal tether straps. Two ports located at the 11 and 1 o'clock sectors vented the bag. The steering assembly was found in the second seat at the time of the NASS inspection. The rescue personnel likely separated it from the column.

A faint blood transfer was present on the backside of the bag and measured approximately 1 cm (0.4") and was located 5 cm (2.0") inboard of the bag's peripheral seam. The backside of the bag also had several small tears as a result of contact with the windshield.

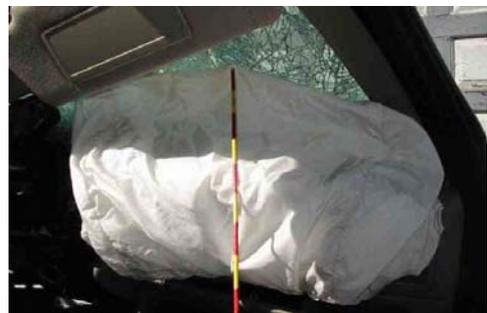
**Figure 11 - Right front passenger air bag.**

The deployed front right air bag (**Figure 11**) measured 54 cm (21.3”) in width and 50 cm (20.0”) in length. The bag was vented by two ports located at the lateral aspects of the bag in the 3 and 9 o’clock positions. The bag was not tethered. The front right seat was occupied; as such, the sensor in the seat reported this condition to the EDR and the EDR properly deployed the air bag at a stage 2 level. Both front row seats were equipped with side air bags located in their respective seat back. The side air bags did not deploy during the crash sequence.

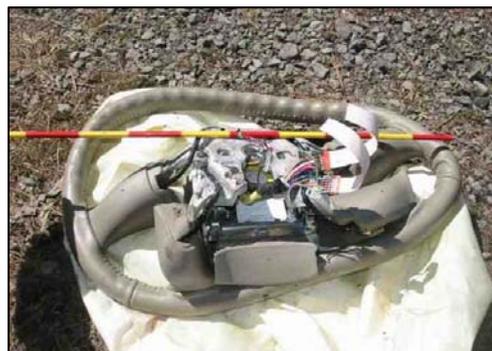
**Figure 12 - Steering wheel hub and spoke.**

assembly intruded vertically and laterally due to severe rearward displacement of the engine components through the cow. The driver's loading deformed the wheel rim and spokes in all quadrants (**Figure 12**). Due to the contact with the steering assembly, the driver sustained a major spleen laceration, six fractured ribs (bilateral fractures of three unspecified ribs on each side of the cage), bilateral lung contusions, a sternum fracture, multiple liver lacerations extending down the right lobe, a thoracic spine fracture, a right adrenal gland laceration, and multiple soft-tissue injuries to the face and chest.

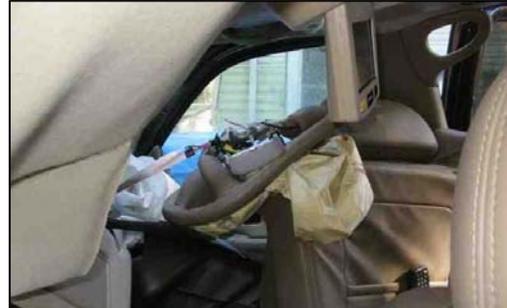
**Figure 13 - Steering assembly and compressed front right seat.**

laterally and also forward. Direct contact to the seat back was limited to the left half evidenced by deep gouging and scuff patterns. Resultant injuries from loading the seat back include a myocardium laceration perforation and contusion, a Grade V complex liver laceration, bilateral lung contusions, lacerations to the spleen and kidney, a rib fracture, and multiple soft-tissue injuries to the chest and right upper extremity. As this occupant was loading the seat back, his left leg contacted the center console and he sustained a left knee contusion and an abrasion to his lower left leg.
