GENERAL DYNAMICS REMOTE CHILD SAFETY SEAT INVESTIGATION

NASS/SCI COMBO CASE NO: 04-04-069B

VEHICLE: 1999 VOLKSWAGEN PASSAT

CRASH DATE: JULY 2004

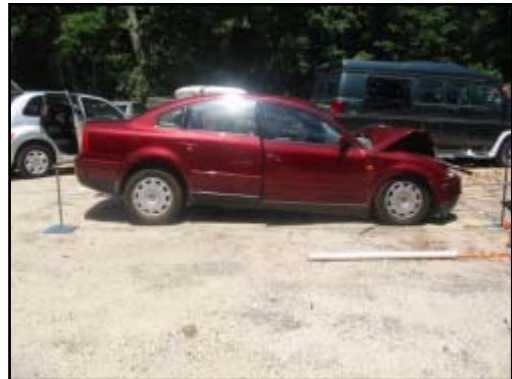
Figure 1. Subject vehicle 1999 Volkswagen Passat.

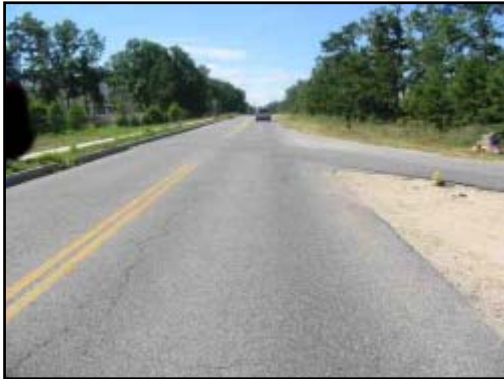
Figure 2. Volkswagen's westbound approach.

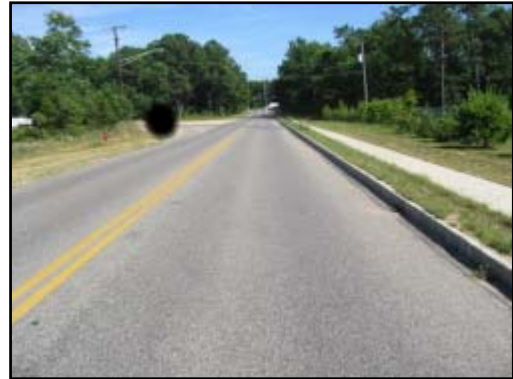
Figure 3. Dodge's eastbound approach.

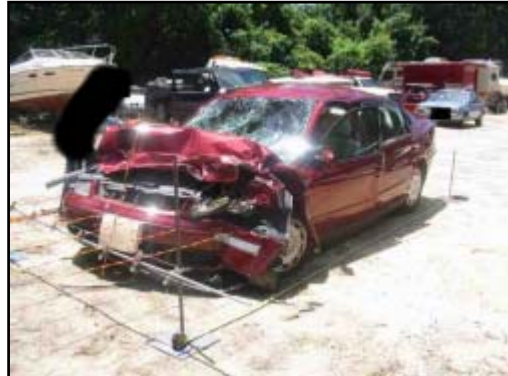
The 1999 Volkswagen Passat sustained severe severity frontal damage as a result of the impact with the Dodge (**Figure 4**). The direct contact damage began at the front left bumper corner and extended 140.0 cm (55.1”) to the front right bumper corner. The maximum crush was located at the front left bumper corner and measured 68.0 cm (26.8”). The damage resulted in the longitudinal displacement of the frontal components. The NASS researcher used six equidistant measurements to document the crush at the bumper level using a combined direct and induced damage width of 140.0 cm (55.5”) and were as follows: C1 = 68.0 cm (26.8”), C2 = 53.0 cm (20.9”), C3 = 41.0 cm (16.1”), C4 = 30.0 cm (11.8”), C5 = 23.0 cm (9.1”), C6 = 27.0 cm (10.6”). The Collision Deformation Classification (CDC) for this impact was 12-FDEW-3.

Figure 4. Resultant frontal damage to the Volkswagen.

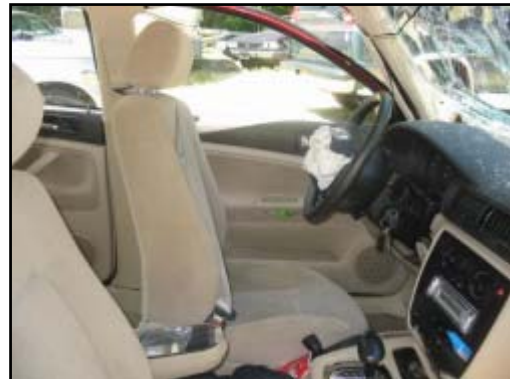
The 1999 Volkswagen Passat sustained moderate damage as a result of occupant contacts. At impact with the Dodge, the frontal air bags deployed. The air bag deployment resulted in the displacement of the driver’s left arm. As a result of this displacement, the driver’s upper left arm contacted the front left window frame which was evidenced by hair. The driver’s lower left arm contacted the door panel mounted power mirror control that was fractured. The NASS researcher noted a scuffmark to the knee bolster from contact with the driver’s left knee. Also noted was stretching to the lap belt portion of the safety belt from the driver’s abdomen loading the safety belt.

Figure 5. Overall view of the driver's area.

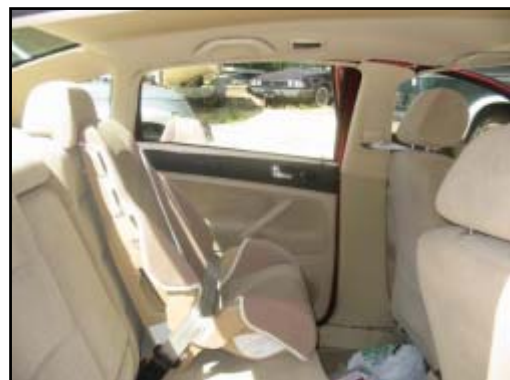
The 3-year-old female rear left passenger was seated in a belt-positioning booster at the time of the crash. At impact with the Dodge, she initiated a forward trajectory and loaded the shoulder portion of the manual 3-point lap and shoulder belt. The NASS researcher noted stretching and scratching to the safety belt webbing from the occupant contact/loading. **Figures 5 and 6** are overall views of the left side first and second rows.

Figure 6. Overall view of the second row left side.

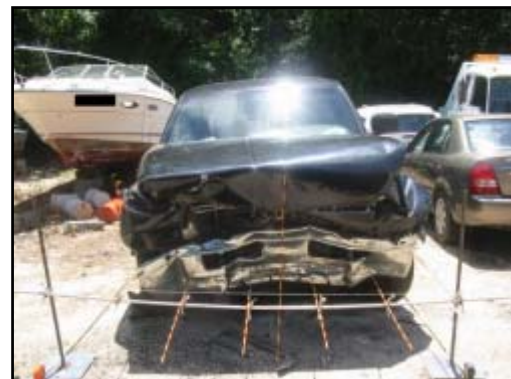
The 1999 Dodge Ram pickup truck sustained severe frontal damage as a result of the impact with the Volkswagen (**Figures 7**). The direct damage began at the front left bumper corner and extended 185.0 cm (72.8") to the right bumper corner. The maximum crush was located at the center of the frontal bumper and measured 65.0 cm (25.6"). Six crush measurements were used to document the crush along the frontal plane at the bumper level using a combined direct and induced damage width of 185.0 cm (72.8") and were as follows: C1 = 53.0 cm (20.8"), C2 = 62.0 cm (24.4"), C3 = 65.0 cm (25.6"), C4 = 64.0 cm (25.2"), C5 = 49.0 cm (19.3"), C6 = 34.0 cm (13.4"). The CDC for this impact was 12-FDEW-3.

Figure 7. Crush profile for the 1999 Dodge Ram.

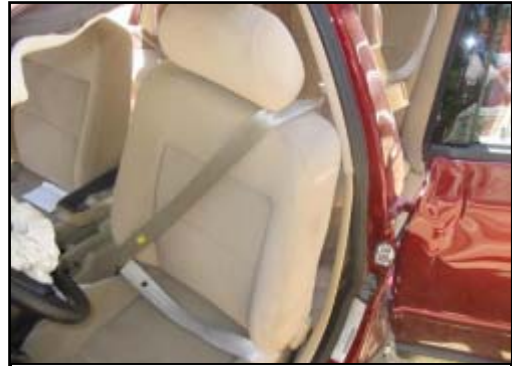
The 1999 Volkswagen Passat was configured with manual 3-point lap and shoulder belts for the four outboard seating positions. The driver's safety belt (**Figure 8**) was configured with continuous loop webbing, sliding latch plate, height adjustable D-ring that was in the lower position at the time of the NASS inspection, Emergency Locking Retractor (ELR), and a retractor pretensioner that fired as a result of the crash. The stretching to the lap belt portion of the safety belt resulted from the driver's pelvic region loading the safety belt. Minimal occupant contacts and the fired status of the pretensioner supported the safety belt usage for the driver. The front right safety belt was configured with a sliding latch plate, height adjustable D-ring that was in the lower position at the time of the NASS inspection, switchable ELR/Automatic Locking Retractor (ALR), and a retractor pretensioner that did not fire.

Figure 8. Driver's safety belt.

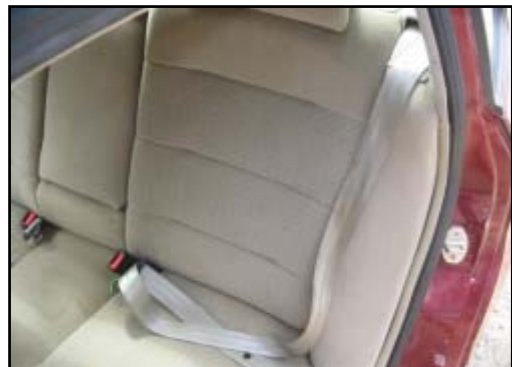
The second row outboard safety belts were configured with sliding latch plates, switchable ELR/Automatic Locking Retractor (ALR), and retractor pretensioners that fired as a result of the crash. The rear left safety belt (**Figure 9**) was used with a high back belt-positioning booster seat which was supported by the stretching and scratching to the safety belt from the occupant contact/loading and fired retractor pretensioner. The rear right safety belt was used to restrain an unoccupied belt positioning booster seat at the time of the crash, which was evidenced by the fired retractor pretensioner. The rear center safety belt was a 2-point manual lap belt that was configured with a sliding latch plate and an ALR.

Figure 9. Rear left safety belt with fired pretensioner.

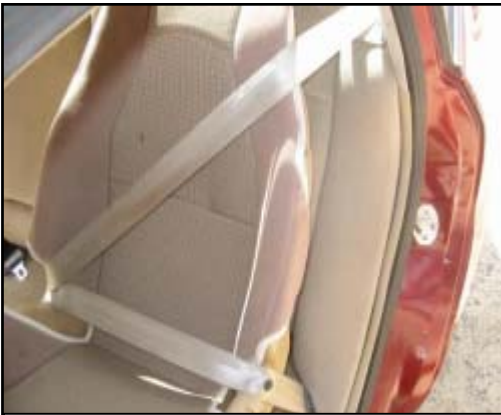
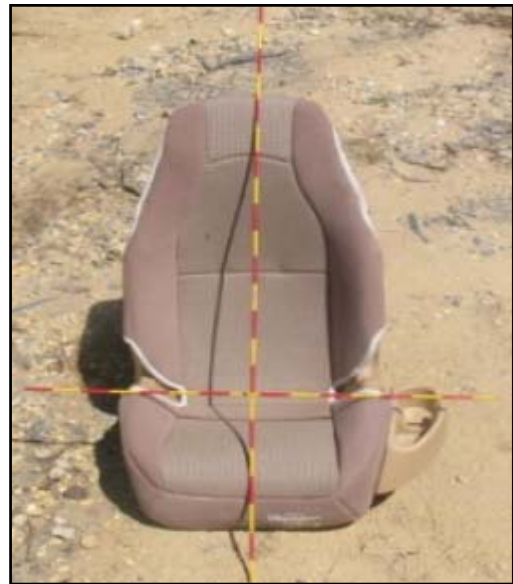
The Cosco Complete Voyager high-back Belt-Positioning Booster (BPB) seat (**Figures 10 and 11**) was identified by the Model Number: 22-210-TIM. The date of manufacture was March 5, 2004. The BPB was configured with three shoulder belt positioning slots on the upper outboard aspects. It was not known what position the shoulder belt was placed. It should be noted that use of the shoulder belt positioners could not be confirmed. The NASS researcher noted a stress crease on the rear aspect of the right side panel of the of BPB. Also noted was a spot of body fluid on the upper right side of the seatback and a scuff to the lower right side of the cushion. The manual 3-point lap and shoulder belt was used to restrain the child in the rear left seat of the vehicle. The vehicle's safety belt system was equipped with a retractor pretensioner that fired as a result of the crash. The safety belt was found restricted in the used position which was as result of the fired pretensioner. The BPB was used to position the 3-year-old child to ensure a proper

Figure 10. BPB in the vehicle's rear left position.

Figure 11. Overall view of BPB.

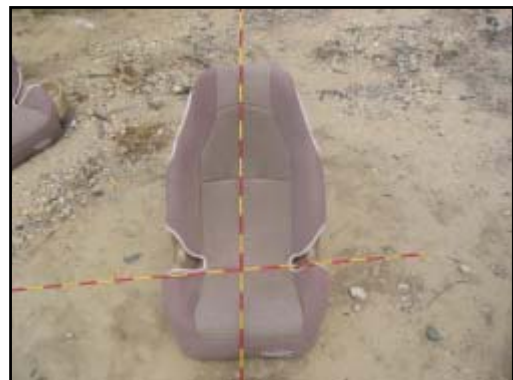
The NASS researcher noted a second BPB (**Figure 12**) in the rear right position of the Volkswagen. This BPB was not occupied at the time of the crash. The BPB was a Cosco Complete Voyager with a model number of 22-210-TM. The date of manufacture for this BPB was November 13, 2003. The BPB was found with the manual 3-point lap and shoulder belt in the used position. This was supported by the fired retractor pretensioner.

Figure 12. Unoccupied BPB.

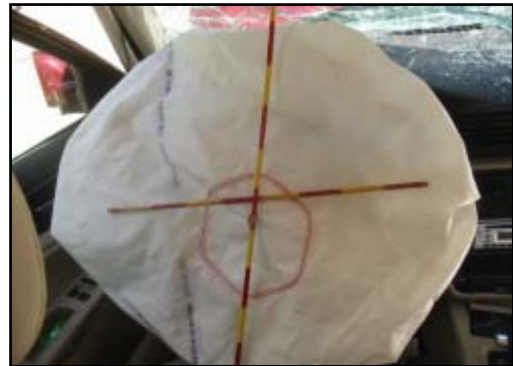
The driver's air bag module consisted of two H-configuration cover flaps. The top cover flap measured 17.0 cm (6.7") in width and 9.0 cm (3.5") in height. The lower cover flap measured 17.0 cm (6.7") in width and 7.0 cm (2.8") in height. The driver's air bag measured 72.0 cm (28.3") in diameter in its deflated state and contained two tethers. A single vent port that was located at the 12 o'clock position on the rear aspect vented the air bag. The NASS researcher noted no occupant contacts or failures to the driver's air bag. **Figure 13** is an overall view of the deployed driver's frontal air bag.

Figure 13. Deployed driver's frontal air bag.

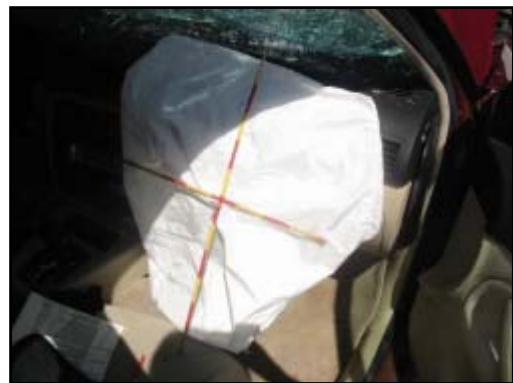
The front right air bag (**Figure 14**) module consisted of a single cover flap configuration that measured 34.0 cm (13.4") in width and 20.0 cm (7.9") in height. The air bag membrane measured 70.0 cm (27.8") in width and 85.0 cm (33.5") in height and was not tethered. A single vent port that was located at the 11 o'clock position on the rear aspect of the top panel vented the air bag. No occupant contacts or failures were noted to the front right air bag.

Figure 14. Deployed front right air bag.

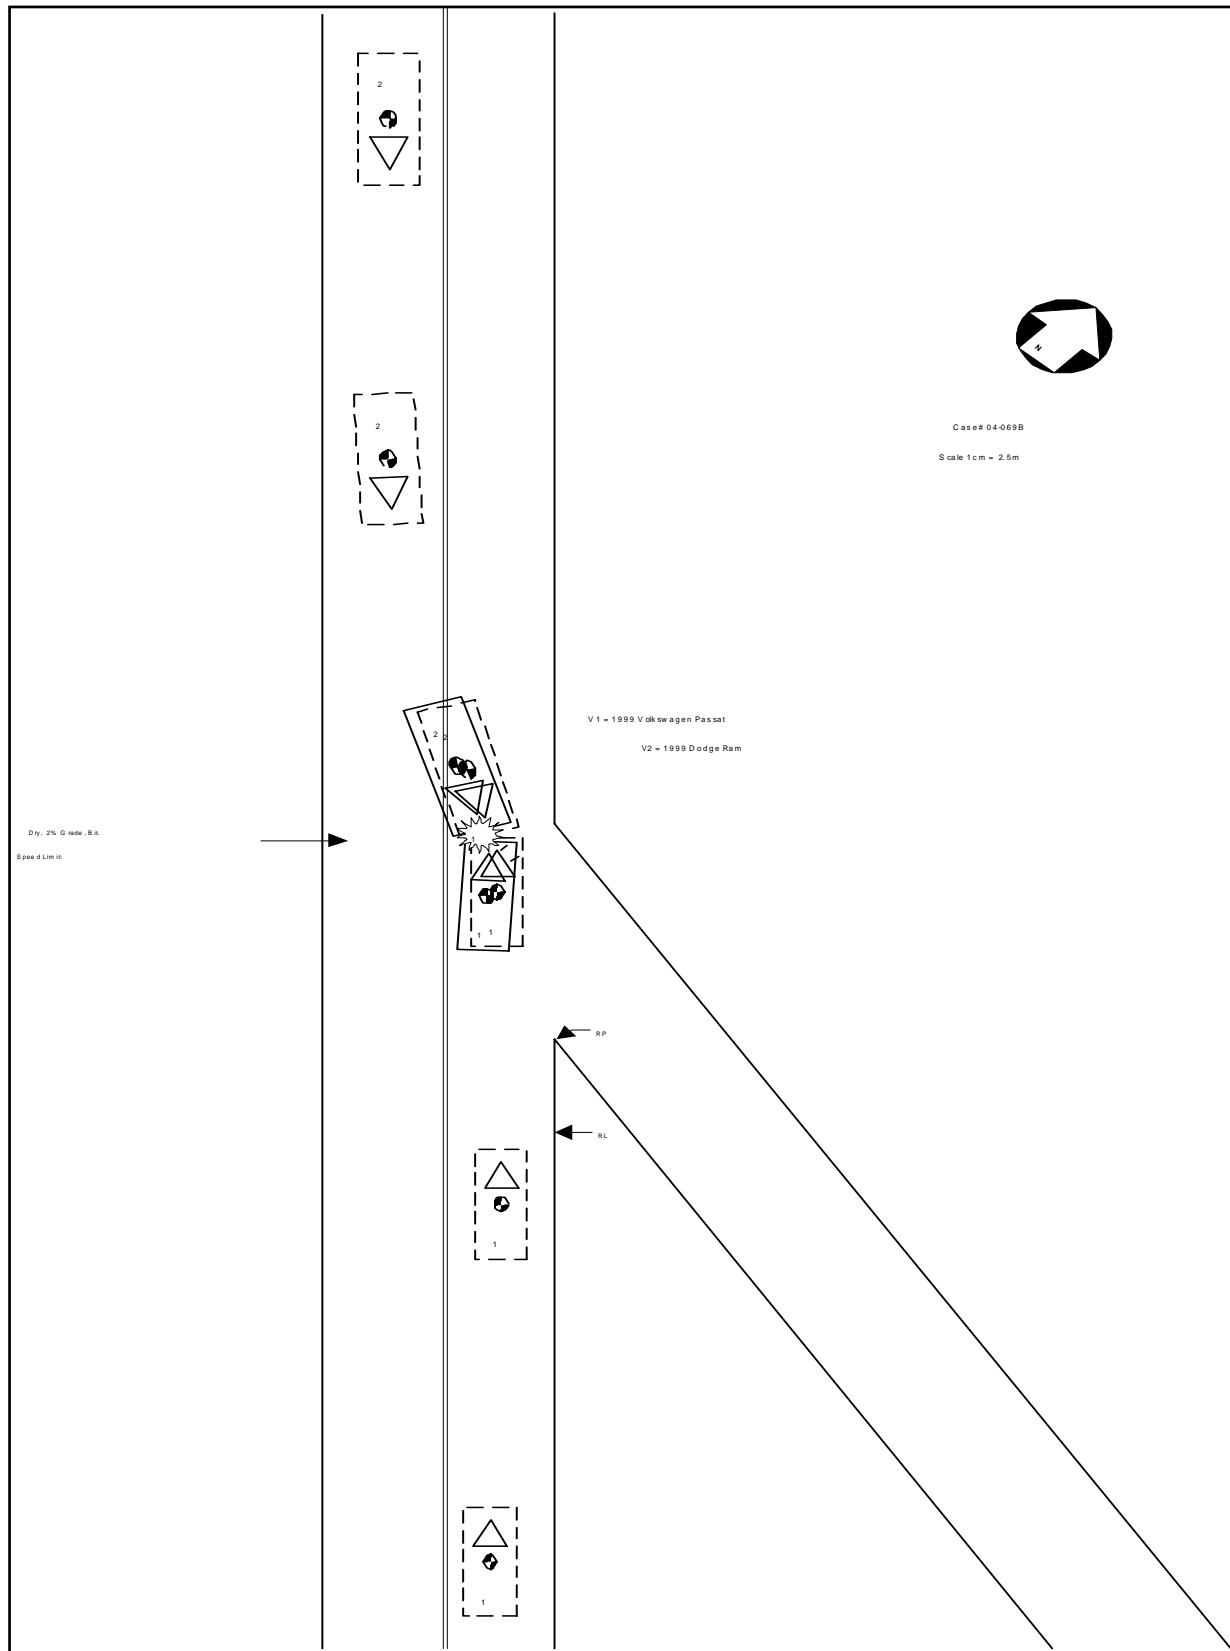
Figure 15. Scene Schematic

This intersection crash occurred during the evening hours of July 2004. At the time of the crash, it was daylight and the asphalt road surface was dry. The crash occurred at an angled three-leg intersection. The east/westbound roadway was configured with one travel lane in each direction and was delineated by a double yellow centerline. A concrete barrier curb bordered the south road edge. The intersecting roadway was configured with two travel lanes that were not delineated. Traffic flow through the intersection was not controlled. The posted speed limit for

the east/westbound roadway was 80 km/h (50 mph). The NASS scene schematic is included as **(Figure 15)** of this report.
