**CALSPAN REMOTE CERTIFIED ADVANCED 208-COMPLIANT
VEHICLE CRASH INVESTIGATION**

NASS/SCI CASE NO: 2004-47-043C

VEHICLE: 2004 GMC SIERRA PICUP TRUCK

CRASH DATE: APRIL 2004

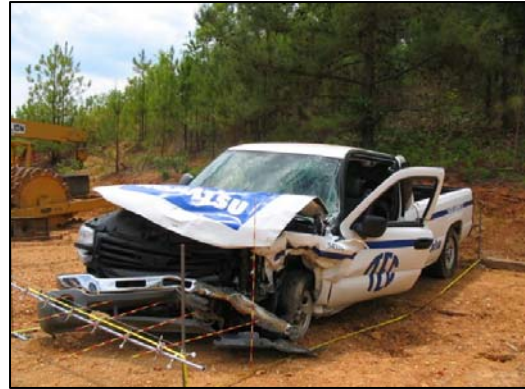
This remote investigation focused on the Certified Advanced 208-Complaint (CAC) safety system that was present in a 2004 GMC Sierra pickup truck (**Figure 1**). The manufacturer of this vehicle certified that it meets the requirements of the Advanced 208 Federal Motor Vehicle Safety Standard (FMVSS). The CAC system consisted of dual-stage frontal air bags for the driver and front right passenger positions, seat track position sensors, front safety belt buckle switches, a front right occupant detection sensor, and an Event Data Recorder (EDR). A restrained 40-

Figure 1 - Damaged 2004 GMC Sierra.

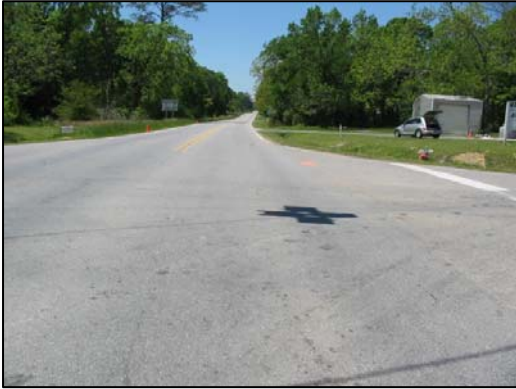
Figure 2 - Westbound approach of 2004 GMC Sierra.

The 40-year-old male driver of the 2004 GMC Sierra was westbound and had just traversed the intersection through the illuminated yellow blinking signal (**Figure 2**). A 19-year-old male, operating the 1993 Chevrolet 1500 pickup truck, was traveling eastbound on the same roadway and was intending to turn left (**Figure 3**). An uninvolved vehicle was stopped the westbound lane at the intersection and was in the process of turning left. As the Sierra passed the turning vehicle and traversed the intersection, the operator of the 1993 Chevrolet 1500 pickup truck either failed to recognize the Sierra or misjudged the gap distance and entered the westbound travel lane in an attempt to execute a sharp left turn. The driver of the Sierra reported that he did not initiate any avoidance actions during the NASS interview.

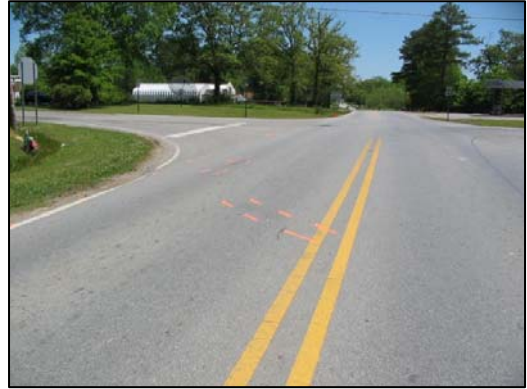
Figure 3 - Eastbound approach of 1993 Chevrolet C1500.

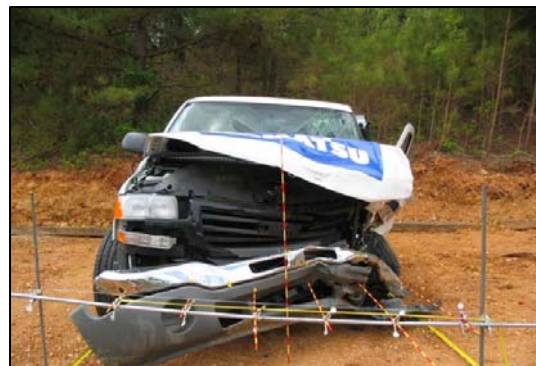
The 2004 GMC Sierra pickup truck sustained severe frontal damage as a result of the impact with the 1993 Chevrolet C1500 (**Figure 4**). The NASS vehicle inspection revealed that the direct contact damage began at the front left bumper corner and extended 124 cm (48.8”) to the right. The maximum crush was located at the front left bumper corner and measured 70 cm (27.6”) in depth. The combined direct and induced damage extended the entire width of the bumper and measured 151 cm (59.4”) in width. The Collision Deformation Classification (CDC) for this frontal impact was 12-FDEW-3. Six equidistant crush measurements were documented across the full width of the chrome bumper and were as follows: C1 = 70 cm (27.6”), C2 = 48 cm (18.9”), C3 = 43 cm (16.9”), C4 = 18 cm (7.1”), C5 = 7 cm (2.8”), C6 = 0 cm.

Figure 4 - 2004 GMC Sierra crush profile.

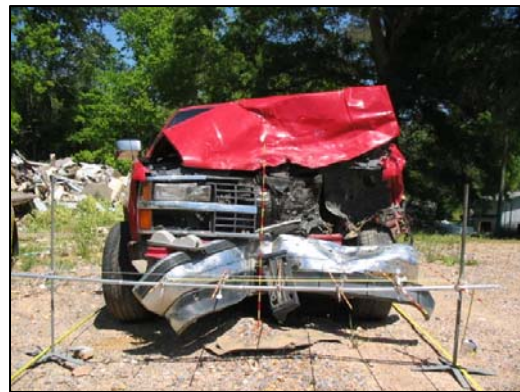
The 1993 Chevrolet C1500 sustained severe frontal damage as a result of the impact with the 2004 GMC Sierra (**Figure 5**). The direct contact damage involved the entire frontal width of the pickup and measured 141 cm (55.5”). The combined direct and induced damage was also 141 cm (55.5”). The maximum crush was located at the front left bumper corner and measured 50 cm (19.7”) in depth. The front of the vehicle was canted slightly to the left; however, it did not exceed the 10 cm (4”) threshold and therefore was not incremented as end-shift. The hood was deformed rearward and the front left fender buckled outward. The left front wheel was compressed rearward and reduced the wheelbase by 21 cm (8.3”). The front left door was deformed but remained operational. The CDC for this frontal impact was 01-FDEW-2. Six equidistant crush measurements were documented along the front bumper and were as follows: C1 = 50 cm (19.7”), C2 = 47 cm (18.5”), C3 = 44 cm (17.3”), C4 = 42 cm (16.5”), C5 = 13 cm (5.1”), C6 = 0 cm.

Figure 5 - Damaged 1993 Chevrolet C1500.

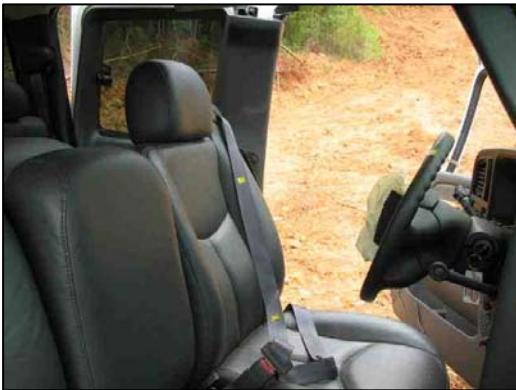
usage; measurements of the safety belt's components were not taken; however, many close-up images of the belt components were included. **Figures 6 and 7** below illustrate the stretched belt webbing and slight abrasions on the latch plate, indicative of belt usage. The front right restraint was equipped with a sliding latch plate and a switchable ELR/Automatic Locking Retractor (ALR). No additional occupants were present in the vehicle; close examinations of remaining restraints were limited in scope.

Figure 6 - Loaded front left seat belt and deformed steering wheel rim.

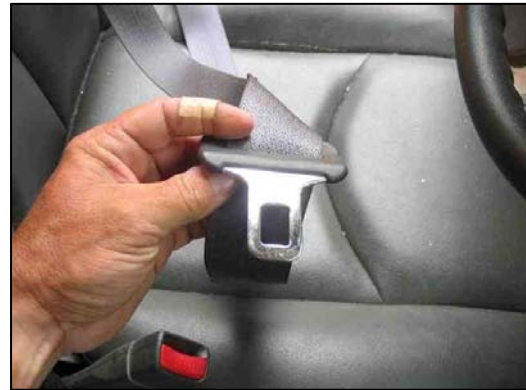
Figure 7 - Front left safety belt latch plate.

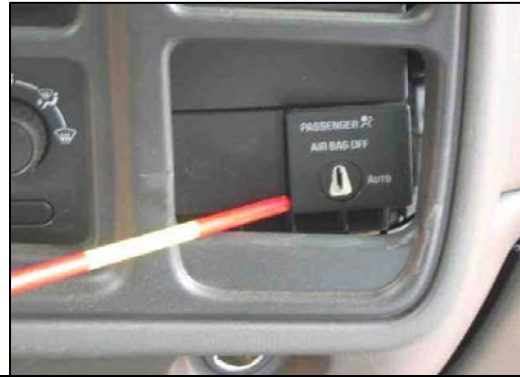
Figure 8 - Air bag cutoff switch.

panel and placing in the ‘off’ position. The air bag was manually suppressed at the time of the NASS vehicle inspection and did not deploy (**Figure 8**). Both front seat positions were also equipped with seat track position sensors, which adjusted the air bag deployment level if the seat was in the forward position.

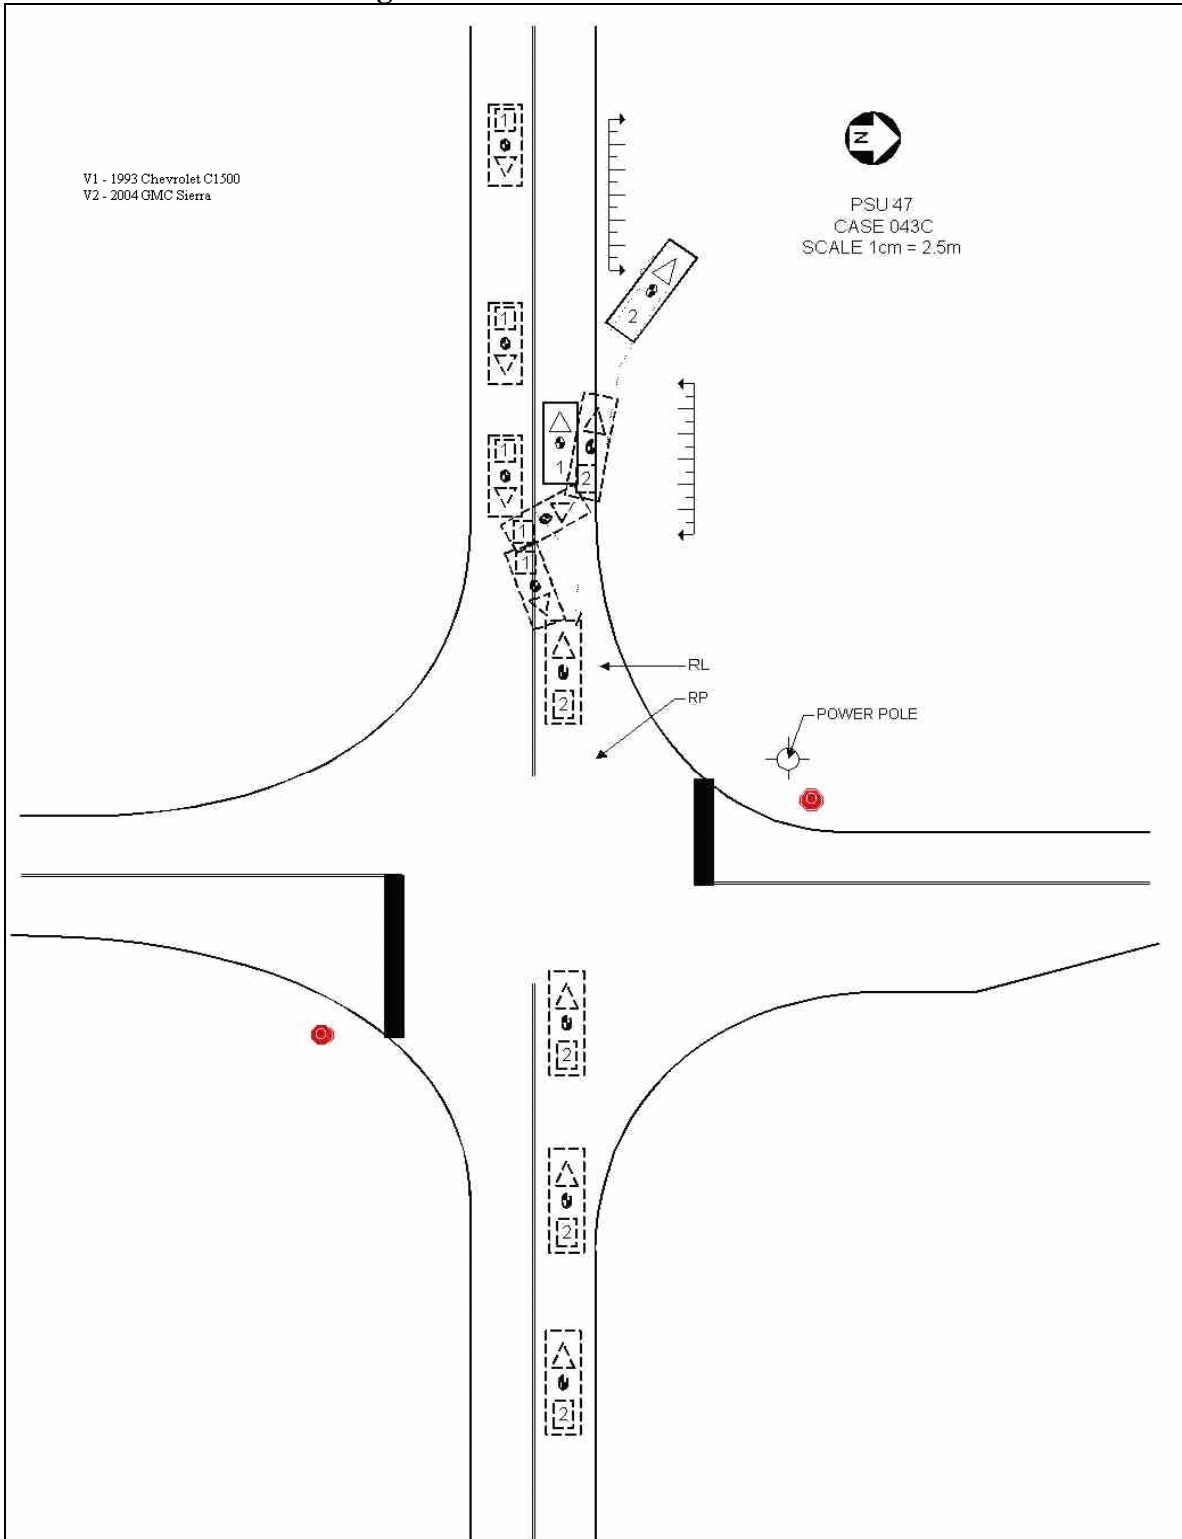
Figure 9 – NASS Scene Schematic

The off-set frontal crash occurred in the westbound lane approximately 10 m (33') west of the intersection. The directions of force for the 2004 Sierra and 1993 Chevrolet were in the 12 o'clock and 1 o'clock sectors, respectively. The impact resulted in severe damage to both vehicles and was sufficient to deploy the driver's frontal air bag. The EDR-reported the maximum velocity change of -31 km/h (-19.5 mph) for the Sierra that occurred 97.5 milliseconds from Algorithm Enable (AE). The damage-only routine of the WinSMASH program calculated a total delta-V of 43 km/h (26.7 mph), based on the frontal crush profiles of the two vehicles. Following the initial impact, the Sierra was deflected laterally to the right and came to final rest in a ditch approximately 5 m (16') north of the right roadside. The front of the Sierra contacted the ditch resulting in minor damage and no residual crush. The 1993 Chevrolet rotated counterclockwise (CCW) approximately 90 degrees and came to rest facing a northwesterly direction in the westbound lane.

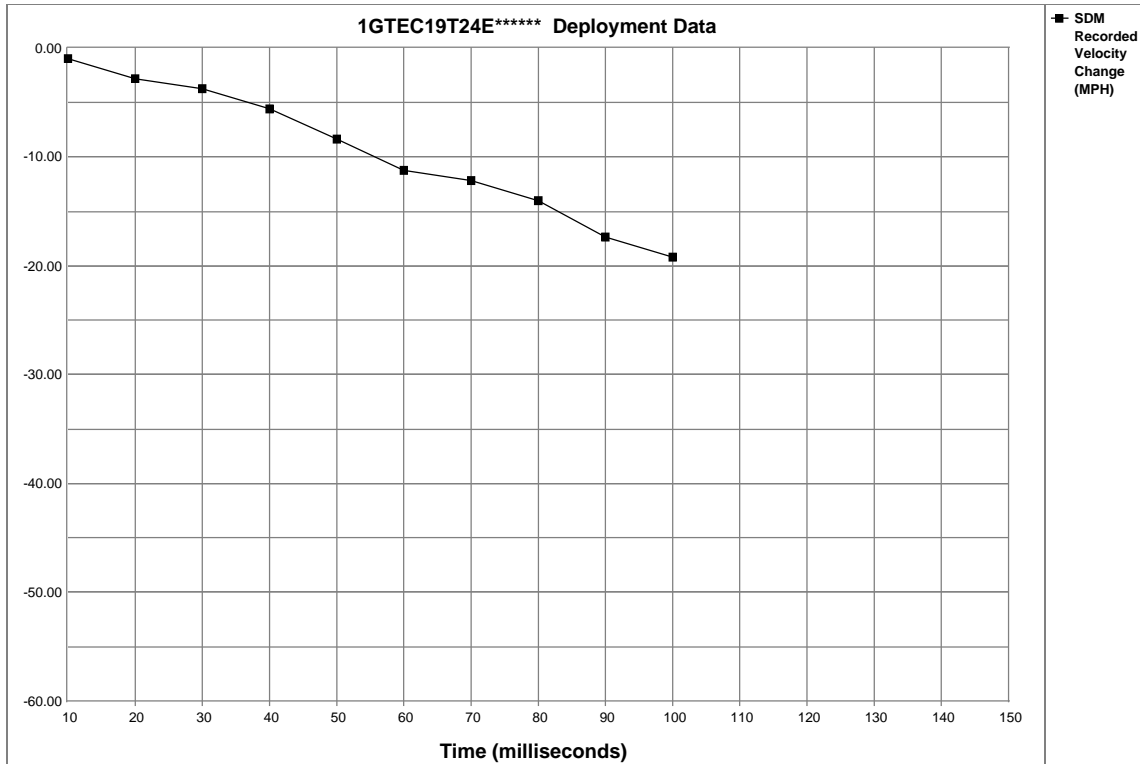
Time (milliseconds)	10	20	30	40	50	60	70	80	90	100	110	120	130	140	150
Recorded Velocity Change (MPH)	-0.93	-2.79	-3.72	-5.58	-8.37	-11.16	-12.09	-13.95	-17.36	-19.22	N/A	N/A	N/A	N/A	N/A

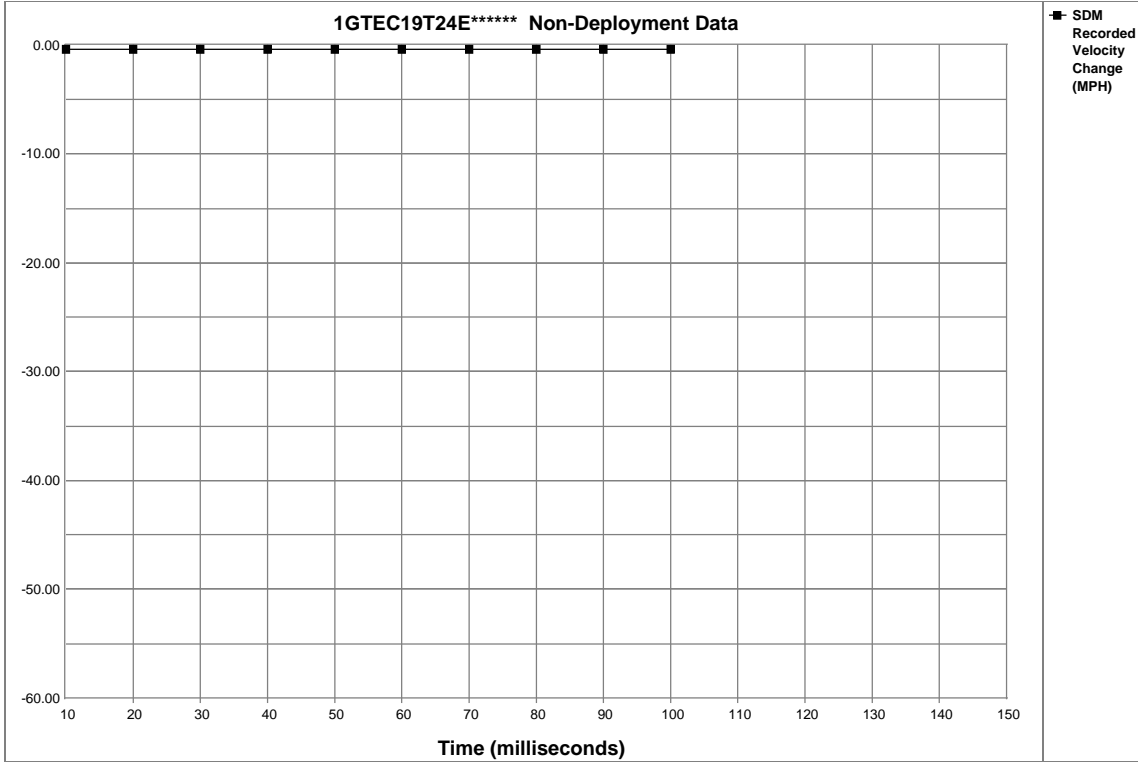
Time (milliseconds)	10	20	30	40	50	60	70	80	90	100	110	120	130	140	150
Recorded Velocity Change (MPH)	-0.31	-0.31	-0.31	-0.31	-0.31	-0.31	-0.31	-0.31	-0.31	-0.31	N/A	N/A	N/A	N/A	N/A
