SCI/NASS COMBINATION SIDE AIR BAG INVESTIGATION

CASE NUMBER - NASS-2004-49-221J
LOCATION - Texas
VEHICLE - 2004 MAZDA RX-8
CRASH DATE - July 2004

1. <i>Report No.</i> NASS-2004-49-221J		2. <i>Government Accession No.</i>		3. <i>Recipient's Catalog No.</i>	
4. <i>Title and Subtitle</i> SCI/NASS Combination Side Air Bag Investigation Vehicle - 2004 Mazda RX-8 Location - Texas			5. <i>Report Date:</i> April 5, 2005

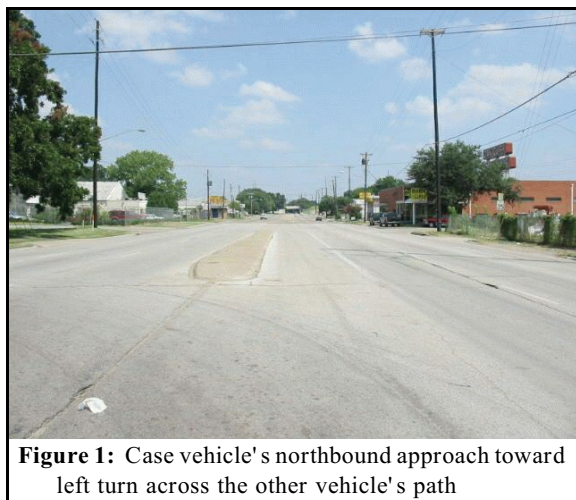
Figure 1: Case vehicle's northbound approach toward left turn across the other vehicle's path

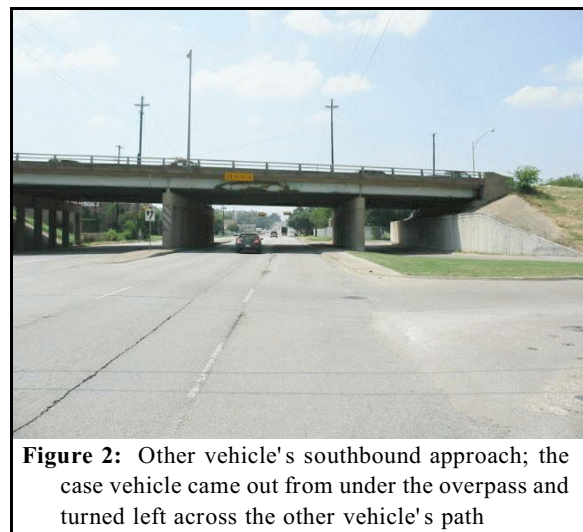
Figure 2: Other vehicle's southbound approach; the case vehicle came out from under the overpass and turned left across the other vehicle's path

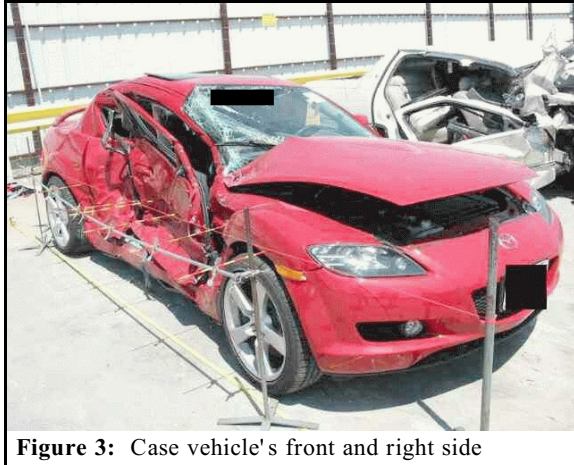
Figure 3: Case vehicle's front and right side

The case vehicle sustained heavy direct contact along the right side as a result of the first impact, extending from the A-pillar to the C-pillar, with induced damage extending slightly forward of the front axle and slightly rearward of the rear axle (**Figure 3**). The A-pillar, front door, back door and the C-pillar all sustained direct contact and were crushed inward. The glazing in the two right side windows was shattered. The right A-pillar sustained direct contact above the belt line and the windshield was heavily cracked and separated from its mounting along the right side. There was no other glazing damage. The engine hood was sprung open and displaced. The right roof rail was bent downward and inward. The length of direct plus induced damage was measured as 288 centimeters [113.4 inches]. Maximum crush was measured as 34 centimeters [13.4 inches], on the rearward portion of the front door.

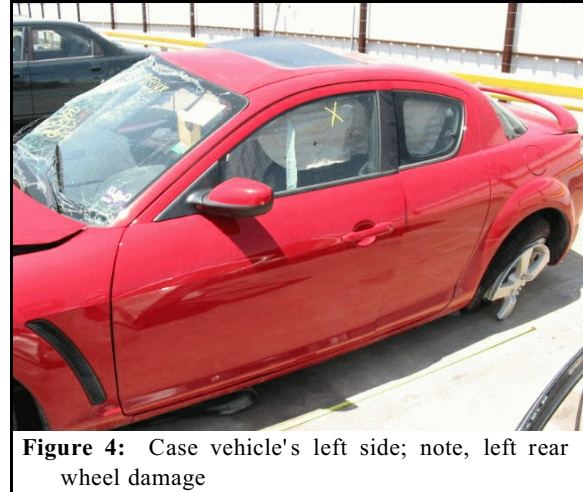
Figure 4: Case vehicle's left side; note, left rear wheel damage

After the first impact, the case vehicle was pushed and slid with the left side leading and the left rear wheel impacted a curb. The wheel was made of a brittle alloy and shattered, leaving the left rear tire dismantled and heavily damaged (**Figure 4**). None of the other wheel/tire assemblies were damaged.

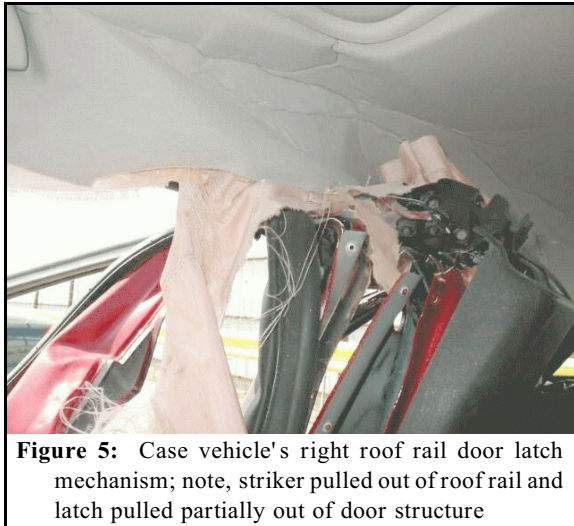
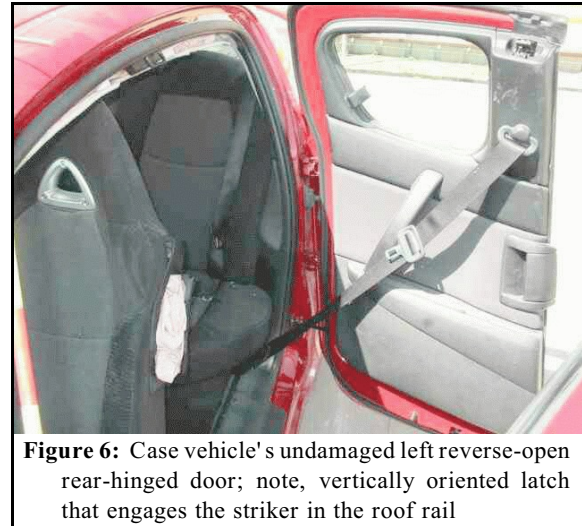
The reverse-open rear-hinged back doors had vertically oriented upper and lower latch-and-striker mechanisms in the leading edge of the back door, with the latches in the door and the strikers in the roof rail (**Figure 6**) and sill, respectively. The right upper latch mechanism was torn out of the door structure and separated from the upper striker, with the door structure intruding laterally (**Figure 5**). Note, there is no B-pillar as such in this arrangement.

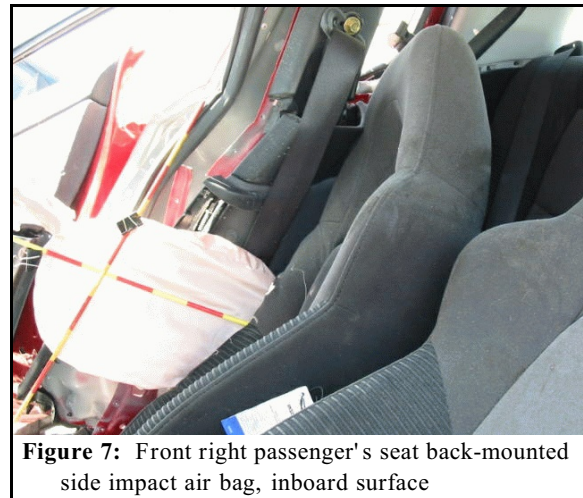
The front right passenger's seat back-mounted side impact air bag was installed behind a trim panel in the outboard edge of the front right seat back. The single air bag module cover flap was centered in this panel. The cover flap measured 20 centimeters [7.9 inches] vertically and 7 centimeters [2.6 inches] horizontally. The front right seat back was deformed and partially obscured by the intruding components but it appears that the module cover flap opened along the tear points and was not damaged during the deployment. The deployed air bag was approximately oval in shape (**Figure 7**), measuring 27 centimeters [10.6 inches] vertically and 30 centimeters [11.8 inches] horizontally. There was a single vent port, of unknown diameter, located near the forward edge on the outboard surface, and no tether. There was no evidence of occupant contact on the air bag, but the outboard surface showed scuffing from the intruding front door panel. There was no evidence of damage to the front right passenger's seat back-mounted side impact air bag.

Figure 7: Front right passenger's seat back-mounted side impact air bag, inboard surface

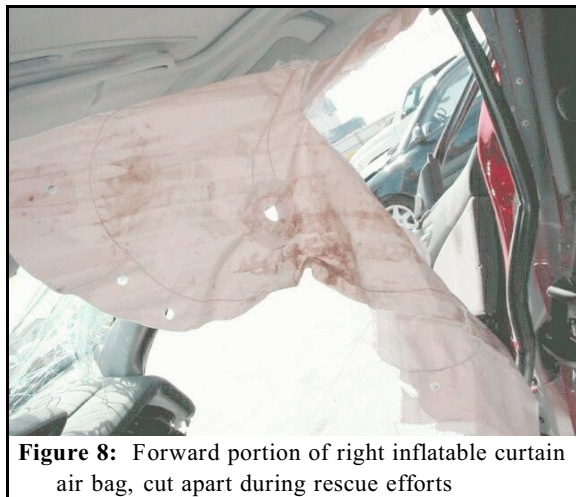
Figure 8: Forward portion of right inflatable curtain air bag, cut apart during rescue efforts

The right roof rail-mounted inflatable curtain air bag was installed along the junction where the headliner meets the roof rail and provides inflatable protection for the front and back seat positions (**Figures 8** and **9**). There is no cover flap as such. Rather, as the inflatable curtain air bag expands it causes the headliner joint to separate and the air bag emerges through this opening.

The entire vertical profile of the case vehicle's right side was heavily damaged and the right inflatable curtain air bag was cut apart during rescue operations such that it was not possible to measure the deployed air bag or otherwise evaluate the tattered remains. The left inflatable curtain air bag also deployed and was undamaged (see **Figures 10 - 12**). The fragments of the right curtain suggest that the left and right inflatable curtain air bags were very similar. The left inflatable curtain air bag measured 100 centimeters [39.4 inches] horizontally and 29 centimeters [11.4 inches] vertically. The air bag was constructed from inner and outer panels of fabric that were stitched together. The pattern of the stitching was such that it defined two separate pillow-like areas that inflate. The forward pillow area was approximately egg-shaped and was large enough that it covered the entire distance from the instrument panel to the front seat back. The rear pillow area was U-shaped and relatively narrow. There were no interior tethers and no vent ports. There was copious blood staining on the right inflatable curtain fabric fragments near the front right seat position.

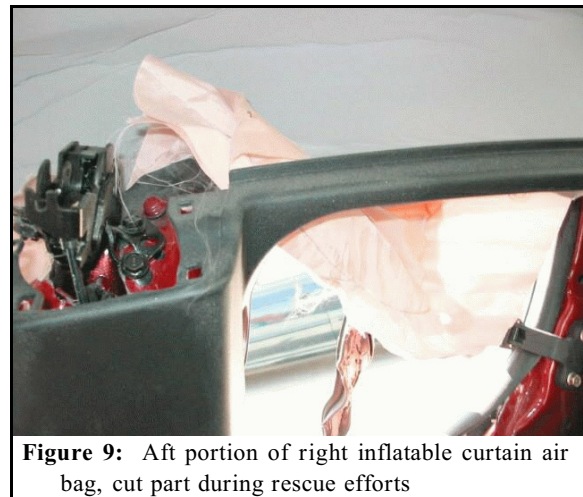
Figure 9: Aft portion of right inflatable curtain air bag, cut part during rescue efforts

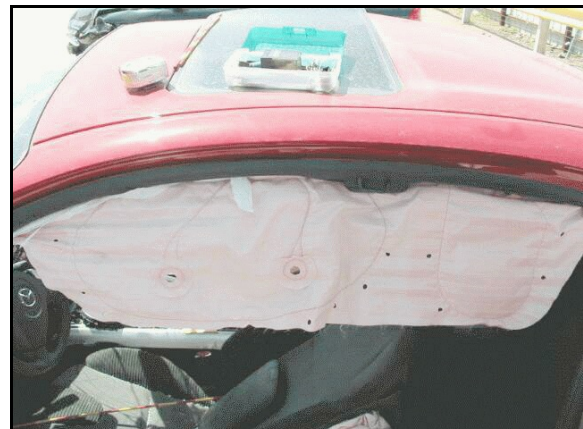
The left roof rail-mounted inflatable curtain air bag was installed along the junction where the headliner meets the roof rail and provides inflatable protection for the front and back seat positions (**Figures 10 - 12**). There is no cover flap as such. Rather, as the inflatable curtain air bag expands it causes the headliner joint to separate and the air bag emerges through this opening. The left inflatable curtain air bag measured 100 centimeters [39.4 inches] horizontally and 29 centimeters [11.4 inches] vertically. The air bag was constructed from inner and outer panels of fabric that were stitched together. The pattern of the stitching was such that it defined two separate pillow-like areas that inflate. The forward pillow area was approximately egg-shaped and was large enough that it covered the entire distance from the instrument panel to the front seat back. The rear pillow area was U-shaped and relatively narrow. There were no interior tethers and no vent ports.

Figure 10: Exterior view, whole left side inflatable curtain air bag

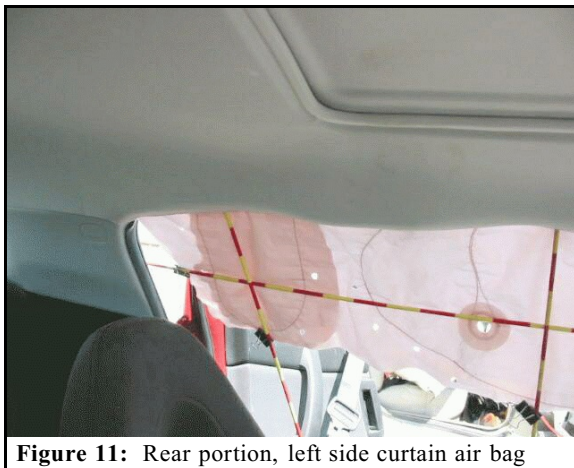
Figure 11: Rear portion, left side curtain air bag

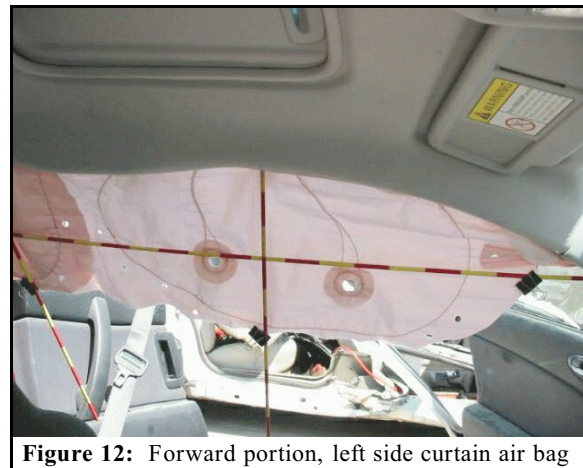
Figure 12: Forward portion, left side curtain air bag

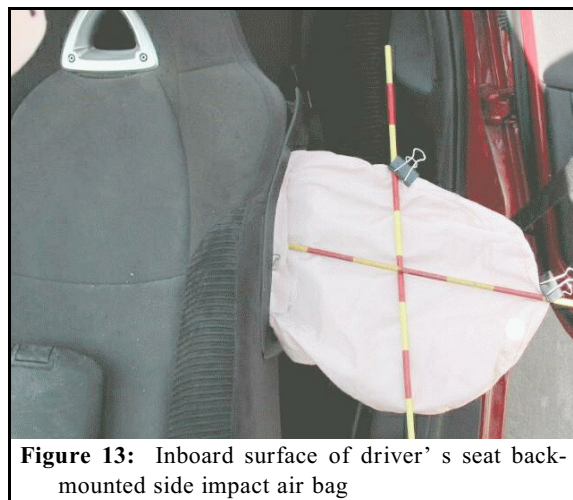
The driver's seat back-mounted side impact air bag was installed behind a trim panel in the outboard edge of the driver's seat back (**Figure 13**). The single air bag module cover flap was centered in this panel. The cover flap measured 20 centimeters [7.9 inches] vertically and 7 centimeters [2.6 inches] horizontally. The module cover flap opened along the tear points and was not damaged during the deployment. The deployed air bag was approximately oval in shape, measuring 27 centimeters [10.6 inches] vertically and 30 centimeters [11.8 inches] horizontally. There was a single vent port, of unknown diameter, located near the forward edge on the outboard surface, and no tether. There was no evidence of occupant contact on the air bag, but the outboard surface showed scuffing and two small tears which the NASS investigator attributed to the use of a pry bar to open the jammed driver's door.

Figure 13: Inboard surface of driver's seat back-mounted side impact air bag

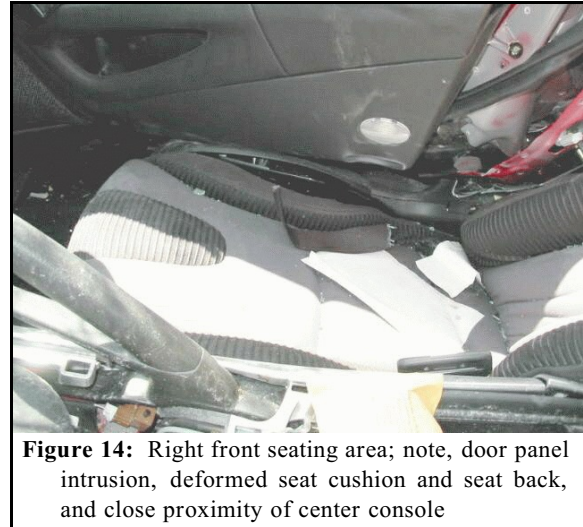
It is not known if the case vehicle driver attempted any avoidance maneuvers prior to the impact. The case vehicle was in the midst of executing a left turn and the front right passenger was probably leaning slightly to the right in response to this turning maneuver. The case vehicle's right front door was impacted by the other vehicle's front, causing the case vehicle's front right seat back-mounted side impact air bag and the right roof rail-mounted inflatable curtain air bag to deploy. The front right passenger moved forward and rightward, parallel and opposite to the 50 degree (2:00 o'clock) direction of force. The other vehicle's front bumper crushed the case vehicle's door inward and the leading edge of its engine hood broke out the case vehicle's right front door glazing and intruded into the case vehicle's interior as the passenger was moving rightward. The passenger's head was cushioned by the inflatable curtain air bag and she did not make direct physical contact with the other vehicle, but the impact compressed the inflated curtain and the force was transmitted to her head. She sustained a right cerebral subdural hemorrhage, a left cerebral subarachnoid hemorrhage and was knocked unconscious. The case vehicle's right side was crushed inward and the front right seat was deformed by the intruding right side components. The right side interior surface contacted the passenger's right hip/abdomen area, causing a rupture of her bladder and fractures of the inferior and superior pubic rami bilaterally. As a result of the intrusion by the right side components (**Figure 14**, see also **Figure 7**), the

passenger was pushed leftward and was compressed between the center console and the intruding right side components, causing a fracture on the left side of her sacrum. The intruding components also contacted her legs, causing contusions on her knees and distal thighs, bilaterally. As the case vehicle slid leftward, the front right passenger was held in place by the safety belt system and probably remained compressed between the intruded right side components and the center console as the case vehicle's left rear wheel impacted the curb. Her posture at final rest is not known.

Figure 14: Right front seating area; note, door panel intrusion, deformed seat cushion and seat back, and close proximity of center console

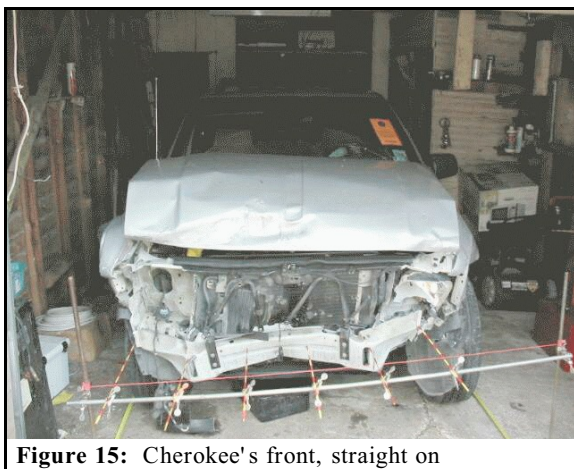
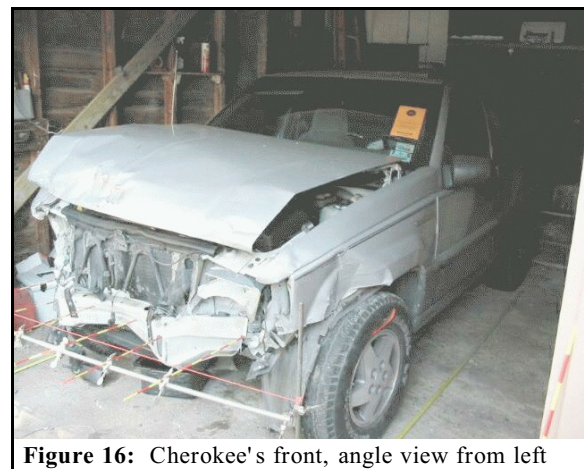
The Cherokee sustained direct contact damage across the entire front (**Figures 15 and 16**). The grille and both headlamp/turn signal assemblies were shattered and broken away, and the bumper cover was torn off. There was direct contact damage on the leading edge of the hood, with the hood buckled and displaced rearward. The leading edges of both fenders were crushed rearward, with slight left-to-right displacement of the fenders. The wheelbase was shortened by 4 centimeters [1.6 inches] on the left and stretched by 1 centimeter [0.4 inches] on the right. The right front wheel was restricted by the crushed fender but the tire was not deflated, and there was no other wheel or tire damage. Maximum crush was measured as 25 centimeters [9.8 inches] at the front right corner. There was slight cracking of the windshield at the lower left corner, from the hood being forced rearward, and no other glazing damage.
