Certified Advanced 208-Compliant (CAC) Vehicle Investigation / Vehicle to Object  
Dynamic Science, Inc. / Case Number: 2004-50-129G  
2004 Chevrolet 1500  
Texas  
October, 2004

1. Report No. 2004-50-129G	2. Government Accession No.		3. Recipient Catalog No.	
4. Title and Subtitle Certified Advanced 208-Compliant (CAC) Vehicle Investigation		5. Report Date February 12, 2005

**Dynamic Science, Inc.**  
**Crash Investigation**  
**Case Number: 2004-50-129G**

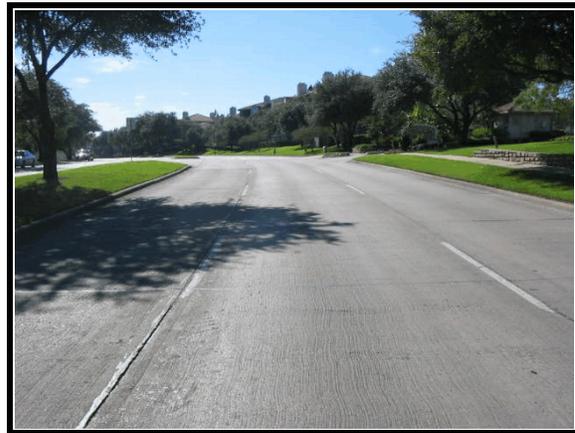
**Figure 1.** Approach to area of road departure (south)

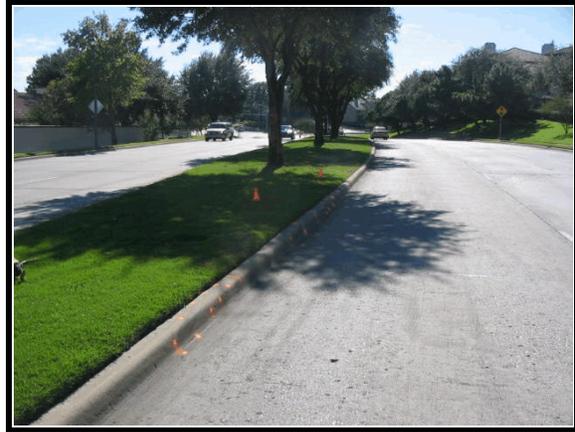
**Figure 2.** Area of roadway departure (south)

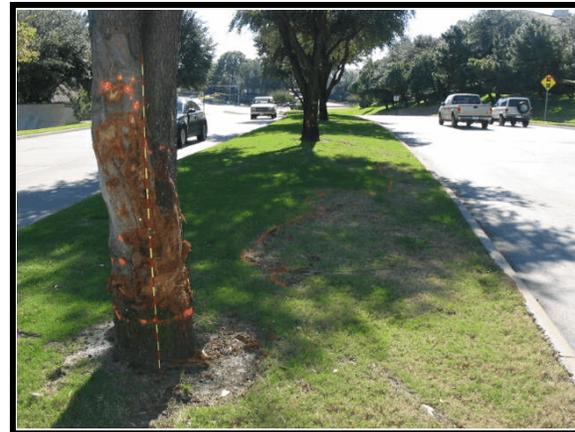
The Chevrolet entered the median and struck a tree that was roughly in the center of the median with its front end (81FDEW2). The total velocity change calculated by the damage only algorithm of the WinSmash collision model was 30.0 km/h (18.6 mph). The longitudinal and lateral components were -26.0 km/h (-16.2 mph) and -15.0 km/h (-9.3 mph), respectively. The barrier equivalent speed was calculated as 30.0 km/h (18.6 mph). The System Diagnostic Module (SDM) recorded a velocity change of -26.60 km/h (-16.53 mph). The driver's air bag deployed at this point. The Chevrolet rotated about the tree in a counterclockwise fashion while continuing to travel south in the median. After the vehicle had rotated approximately 270 degrees, the Chevrolet then struck a second tree with its left side (07LBEE2). The Chevrolet spun out from this impact and back onto the roadway where it came to rest in the center lane facing west.

**Figure 3.** Shows first tree impact (foreground) and second tree impact (background)

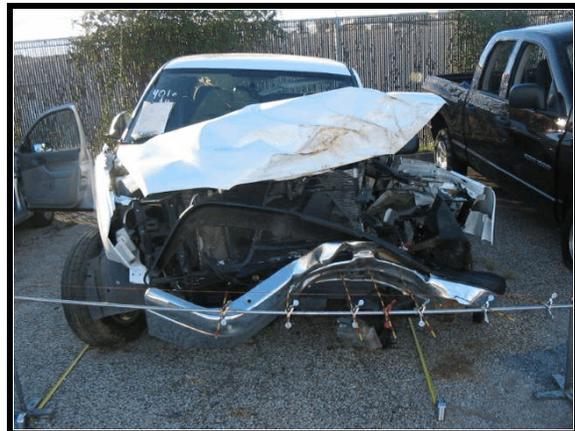
**Figure 4.** Front, 2004 Chevrolet pickup (impact 1)

There was 140.0 cm (55.1 in) of direct and induced damage to the front end from the first tree impact. The direct damage began 14.0 cm (5.5 in) from the front right bumper corner and extended laterally 80.0 cm (31.5 in). The residual crush measured along the bumper was as follows: C1=49.0 (19.3 in), C2 =26.0 cm (10.2 in), C3=44.0 cm (17.3 in), C4=43.0 cm (16.9 in), C5=10.0 cm (3.9 in), C6=0 cm (0 in).

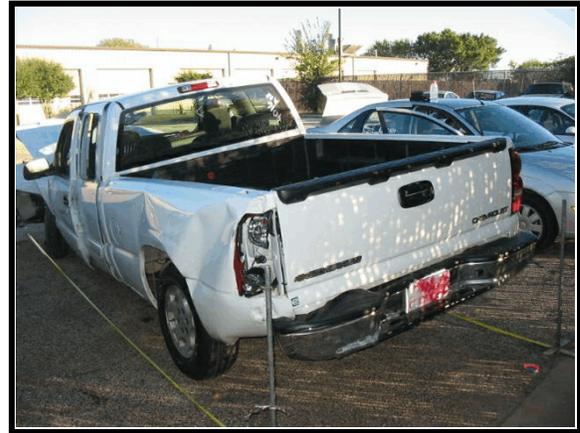
Figure 5. Left side, impact 2

Impact 2: 07LBEE2

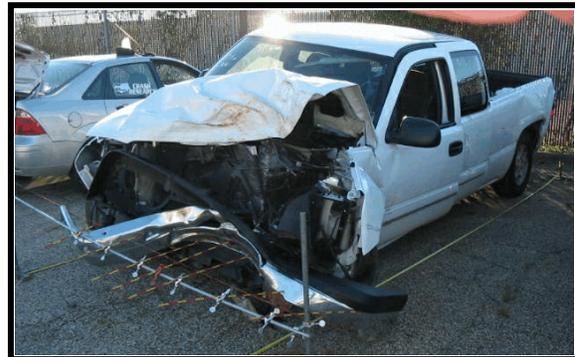
Damage Description: Moderate front end damage to the front bumper, grille, hood. Front end shifted to the left. Minor contact damage to left rear bumper corner area. Vehicle towed from the scene due to disabling damage.

Figure 6. Front left, Chevrolet 1500

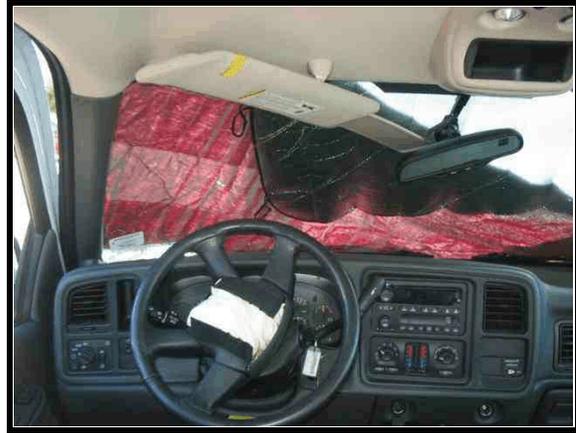
Interior damage to the 2004 Chevrolet was as a result of occupant contact and normal damage associated with an air bag deployment. There was scuffing observed on the sun visor, left side of the knee bolster, and to the face of the driver's air bag. The center console was shifted to the right. The windshield was cracked due to occupant contact. There was no other glazing damage. Both front doors remained closed and operational; there was no intrusion nor any integrity loss.

**Figure 7.** Overview of left side instrument panel and windshield

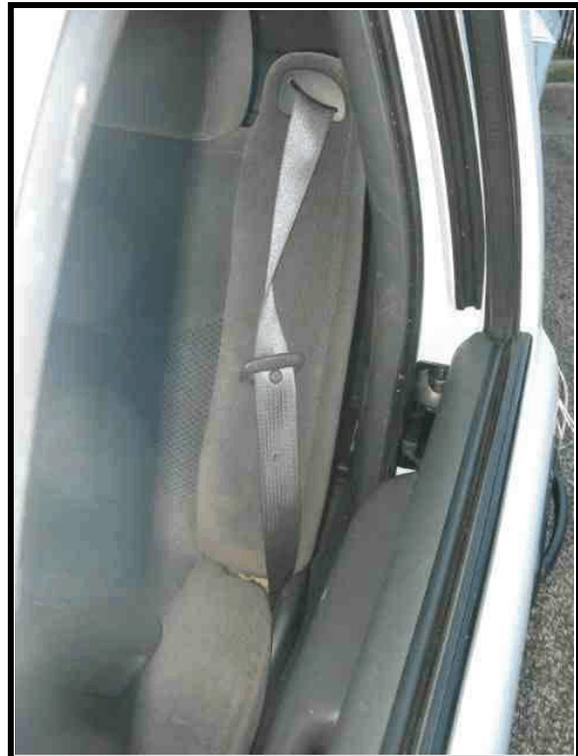
**Figure 8.** Driver's integral seat belt

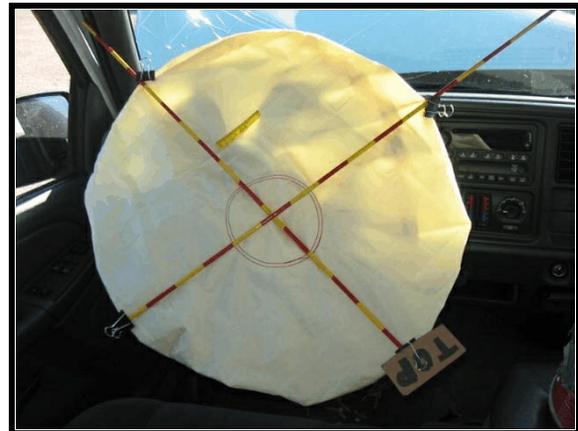
The case vehicle was equipped with advanced, CAC dual stage driver and front right passenger air bags. The driver's air bag was mounted in the steering wheel hub. The deployed driver's air bag was round and measured 62.0 cm (24.4 in). The dual module cover flaps opened in an "I" type configuration. Both flaps measured 6.0 cm (2.4 in) wide by 12.0 cm (4.7 in) high. There were no indications of any damage to driver's air bag or the module cover flaps. The front right passenger air bag was a mid instrument panel mount. The passenger sensing system did not detect a front right passenger and the front right passenger air bag was suppressed and did not deploy.

**Figure 9.** Face of driver's air bag

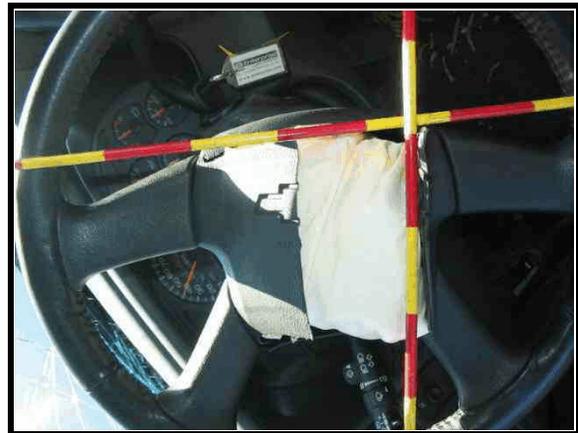
**Figure 10.** Driver's air bag module cover

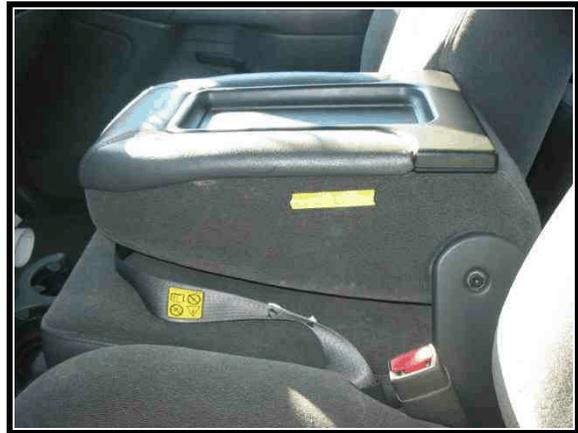
**Figure 11.** Contact to center console

As the vehicle jumped the curb and struck the tree, the driver's air bag deployed. The unbelted driver pitched forward and to the right in response to the 1 o'clock direction of force. Both knees contacted the knee bolster, causing a minor contusion to the right knee. His right hip likely caused the center console to shift to the right. The driver did sustain a small contusion to the right elbow that was attributed to the center console. There were also contacts to the visor and windshield. The initial impact with tree exacerbated the vehicle's counterclockwise rotation. This motion kept the driver generally moving to the right as the vehicle continue down the median. The vehicle then struck a second tree with its left corner. This appeared to be a relatively minor impact. The vehicle continued its rotation until coming to rest back on the roadway facing south after rotating approximately 340 degrees. The driver was able to exit the vehicle on his own. He did not receive any medical treatment.
