SCI/NASS COMBINATION CASE REPORT

CASE NUMBER - NASS-2004-50-150E

VEHICLE - 2004 HONDA ODYSSEY

CRASH DATE - December 2004

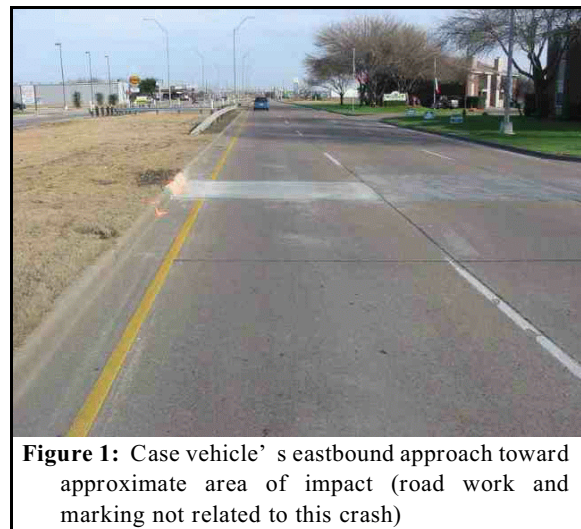
Figure 1: Case vehicle's eastbound approach toward approximate area of impact (road work and marking not related to this crash)

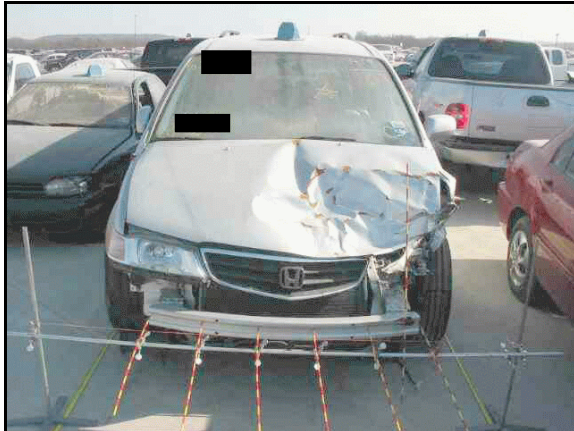
Figure 2: Case vehicle's front, straight on, bumper-level crush profile

The case vehicle sustained direct contact across the left half of the front and on the left fender from its impact with the back of the Mercury (**Figures 2 and 3**). The case vehicle's front bumper underrode the Mercury's rear bumper and the case vehicle's grille and the leading edge of its hood and left fender engaged the Mercury's back bumper, body panels and trunk lid. The case vehicle's bumper cover was torn off and the leading edge of its left fender was crushed and displaced rearward. The case vehicle's hood was crushed rearward and bent downward, its left headlamp/turn signal assembly was shattered and broken away, and the grille and radiator support bracket were crushed rearward on the left. Maximum crush was measured as 35 centimeters [13.8 inches] at C1, at the top of the leading edge of the left fender. (Note, due to the underride configuration, this value was crush-averaged to 18 centimeters [7.1 inches] for input into the WinSMASH reconstruction program.) There were light stress cracks in the windshield and no other glazing damage. None of the tires were restricted or deflated. The wheelbase was shortened by 2 centimeters [0.8 inches] on the left and unchanged on the right.

The CDC for the case vehicle's single impact was determined to be **12-FYEW-2 (0 degrees)**. The WinSMASH reconstruction program, damage-only algorithm based on the measured crush profiles of the two vehicles, with the crush averaging technique employed for the case vehicle's profile, was used. The total, longitudinal and lateral delta-Vs for the case vehicle are, respectively: 21 km.p.h. [13.0 m.p.h.], -21 km.p.h. [-13.0 m.p.h.] and 0 km.p.h. [0 m.p.h.]. Because this collision involved an underride configuration and crush averaging, these results are judged to be borderline but reasonable. This was a crash of low severity (14-23 km.p.h. [9-14 m.p.h.]) for the case vehicle.

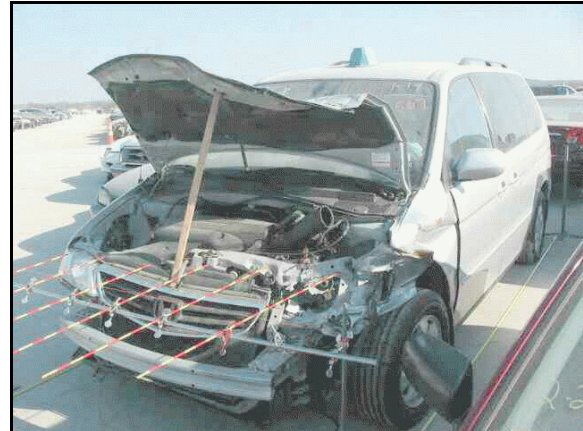
Figure 3: Case vehicle's front and left side, above-bumper crush profile

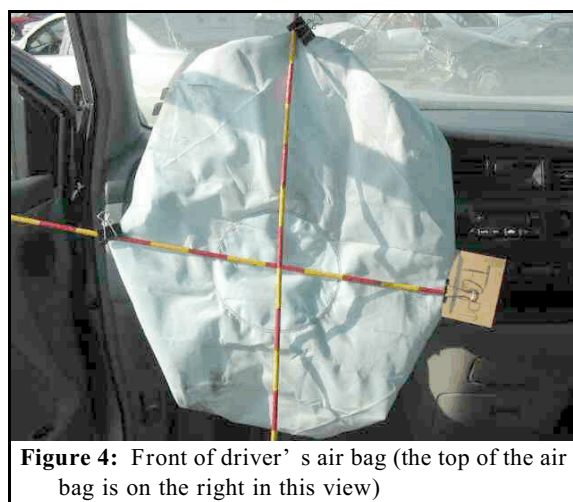
The driver's air bag was mounted in the steering wheel hub with the module cover flaps in the H-configuration. Both flaps measured 16 centimeters [6.3 inches] horizontally. The upper flap measured 6 centimeters [2.4 inches] vertically and the lower flap was 7 centimeters [2.8 inches]. The flaps opened at the tear points and there was no evidence of damage to the flaps or the adjacent structures. The driver's air bag was round with a diameter of 51 centimeters [20.1 inches]. There were two vent ports, of unknown diameter, located at the 11:00 and 1:00 o' clock positions on the back surface of the air bag. There were deployment scuffs on the lower edges of the front surface and no other evidence of damage or occupant contact on the air bag fabric.

Figure 4: Front of driver's air bag (the top of the air bag is on the right in this view)

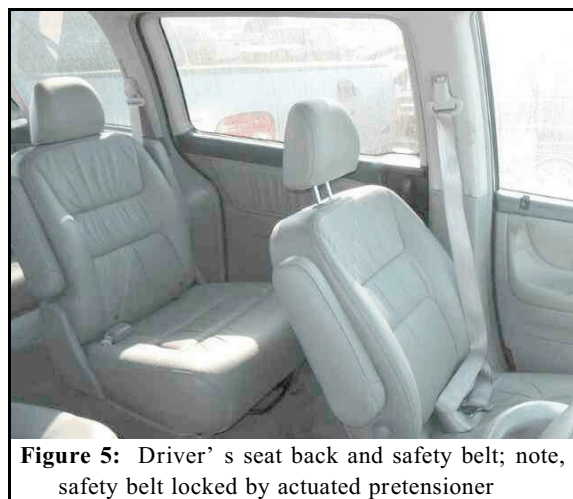
Figure 5: Driver's seat back and safety belt; note, safety belt locked by actuated pretensioner

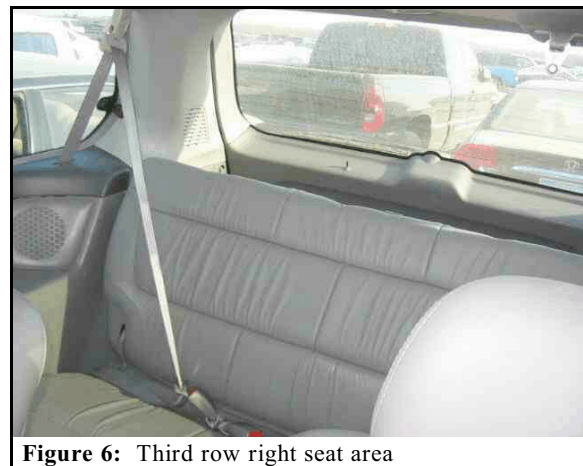
Figure 6: Third row right seat area

The case vehicle' s third row right passenger (10-year-old male, black, non-Hispanic, 147 centimeters, 41 kilograms [58 inches, 90 pounds]) was restrained by the available manual, three-point, lap-and-shoulder safety belt system. He was seated in a forward-facing posture, with his back against the seat back. His seat track and bench seat back were not adjustable (**Figure 6**). His posture is otherwise not known.

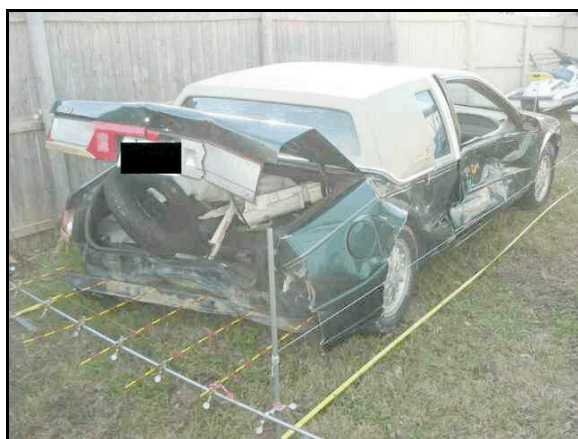
The Mercury sustained direct contact damage on the right half of the back plane, with induced damage extending across the entire back and on the right rear quarter panel, from its impact with the case vehicle (**Figures 7 and 8**). The bumper cover was torn away and the steel bumper was crushed against the back surface body panels. The vertical surface on the back of the trunk lid was crushed forward and the horizontal surface was bent downward. The right quarter panel was crushed forward and buckled outward. Maximum crush was measured as 48 centimeters [18.9 inches] at C6, at the back right corner. The wheelbase was shortened by 6 centimeters [2.4 inches] on the right and stretched by 2 centimeters [0.8 inches] on the left. The right rear tire was restricted due to the crushed body panels, but the tire was not damaged and there was no other wheel/tire damage. The right front door window glazing was shattered due to the second impact and there was no other glazing damage.

Figure 7: Mercury's back and right side; right side damage forward of the C-pillar is due to the second impact

The case vehicle pushed the Mercury forward and caused it to rotate counterclockwise, and the right side of the Mercury impacted the back of the Blazer (**Figure 7**). The CDC for the Mercury' s involvement in this second impact was determined to be **02-RZEW-2 (70 degrees)**. This impact did not involve the case vehicle and is not further discussed.

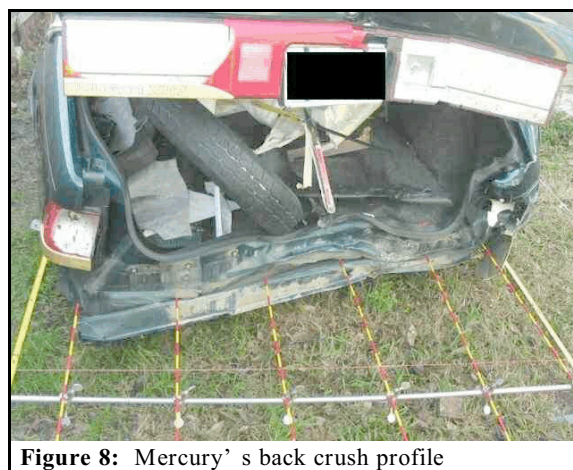
Figure 8: Mercury's back crush profile

The CDC for the Mercury's impact with the case vehicle was determined to be **06-BZEW-4 (190 degrees)**. The WinSMASH reconstruction program, damage-only algorithm based on the measured crush profiles of both vehicles, with the crush average technique employed for the case vehicle's profile, was used. The total, longitudinal and lateral delta-Vs for the Mercury are, respectively: 27 km.p.h. [16.8 m.p.h.], + 27 km.p.h. [+ 16.8 m.p.h.] and + 5 km.p.h. [+ 3.1 m.p.h.]. Because this collision involved an underride configuration and crush averaging, these results are judged to be borderline but reasonable. The Mercury's impact with the case vehicle was of moderate severity (24-40 km.p.h. [15-25 m.p.h.]) for the Mercury.
