### SCI/NASS COMBINATION REAR OCCUPANT PROTECTION PROGRAM INVESTIGATION

CASE NUMBER - NASS-2004-72-118J  
LOCATION - Illinois  
VEHICLE - 2003 JEEP GRAND CHEROKEE  
CRASH DATE - July 2004

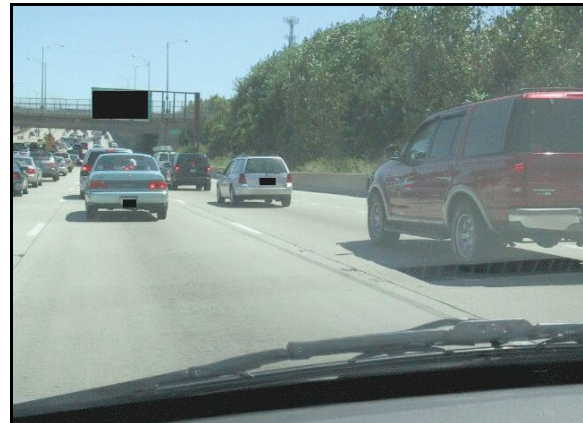
The case vehicle was traveling southward in the inside southbound through lane of a four lane, one-way roadway that was part of a divided urban Interstate trafficway (three through lanes with an entrance ramp and merge lane in the vicinity of this crash), intending to continue straight ahead (**Figure 1**). The weather was clear, it was dark but lighted, the bituminous road surface was dry and free of defects and the speed limit was 72 km.p.h. [45 m.p.h.]. The interviewee (back right passenger) indicated that the case vehicle was traveling approximately 97-113 km.p.h. [60-70 m.p.h.]. According to the interviewee, a non-contact vehicle cut in front of the case vehicle, the case vehicle driver braked hard, the right front tire blew out and the driver lost control. The case vehicle swerved to the right and departed the roadway.

**Figure 1:** Case vehicle's southbound pre-crash path of travel in the general area where control was lost; the concrete traffic barrier can be seen at the far right edge of the roadway (note, the crash occurred during the evening when traffic was not as heavy as seen in this photograph)

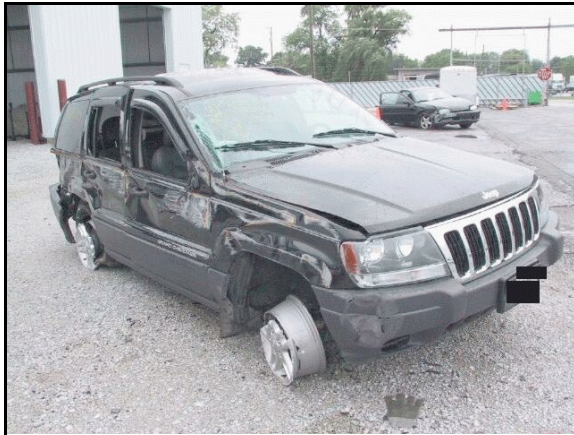
**Figure 2:** Case vehicle's front and right side

The case vehicle sustained extensive abrading but only minor deformation along the entire right side, and both right wheels were heavily damaged (**Figures 2, 4 and 5**). The front right corner of the bumper cover was abraded and slightly crushed, but the headlamp/turn signal assembly was intact. The right fender was slightly crushed and heavily abraded, and the hood was slightly displaced. The abrading continued along the front door, back door and quarter panel, with direct contact above the belt line on the A-, B- and C-pillars. The right outside rear view mirror was broken off. The windshield was cracked along its junction with the right A-pillar, the glazing in the right front and back doors was shattered and there was no other glazing damage.

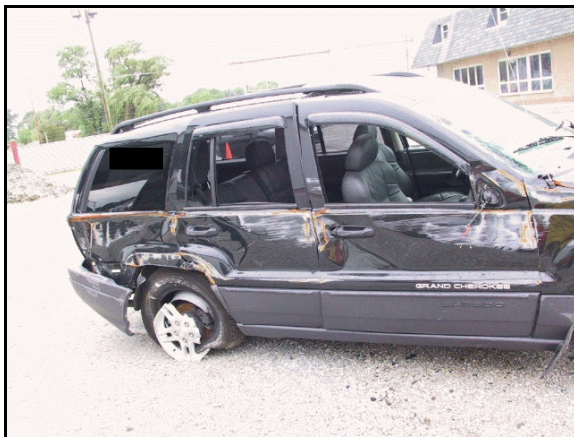
**Figure 4:** Case vehicle's right side, rear portion

The wheels were made of a brittle alloy and, for both the right front and rear wheels, portions of the rim were shattered and broken away. The right front tire was completely off the damaged wheel and was not available for inspection (**Figure 5**). The right rear tire was dismantled but otherwise not damaged (**Figure 4**). The left rear tire was dismantled and its sidewall was torn, but the wheel was intact (**Figure 3**). The manufacturer's specified tire size for the case vehicle was P225/75R16 and all of the tires that were available for inspection were of this size. The wheelbase on both sides was unchanged.

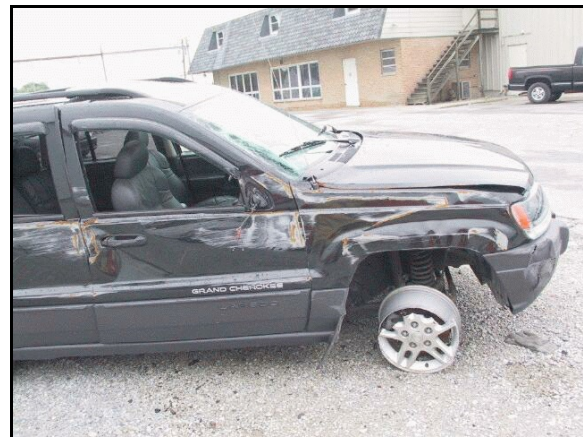
**Figure 5:** Case vehicle's right side, front portion

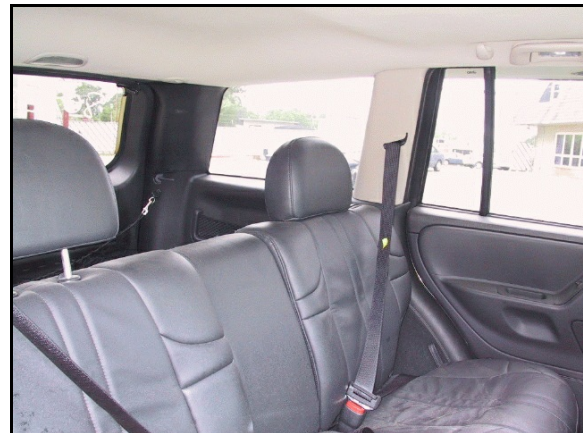
The case vehicle's back left passenger (21-year-old female, white, Hispanic, 140 centimeters, 64 kilograms [55 inches, 141 pounds]) was restrained by the available, manual, three-point, lap-and-shoulder safety belt system. The seat was a split bench with separate, folding backs, with the seat track and seat back not adjustable. The head restraint was adjusted at the full down position. She was seated in a normal posture, facing forward with her back against the seat back and her feet on the floor (**Figure 6**).

**Figure 6:** Back left passenger's seat area

back left passenger moved further forward and slightly rightward in response to the impact deceleration. She loaded against the torso portion of the safety belt system (which passed over her left shoulder and downward across the lower right side of her thorax) and she sustained fractures of right ribs 9 through 12. The case vehicle was redirected by the barrier into a slight counterclockwise yaw and it slid across the shoulder and back into the roadway, where it came to rest. The back left passenger was held in place by the safety belt system and she stayed in her seat.

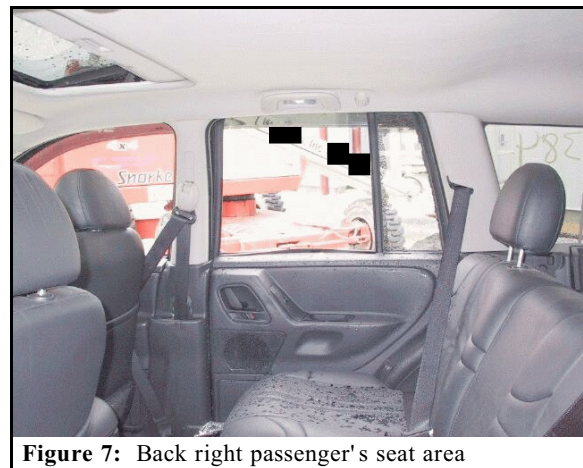
The case vehicle's back right passenger (16-year-old male, white, Hispanic, 168 centimeters, 86 kilograms [66 inches, 190 pounds]) was restrained by the available, manual, three-point, lap-and-shoulder safety belt system. The seat was a split bench with separate, folding backs, with the seat track and seat back not adjustable. The head restraint was adjusted several centimeters [approximately 1.5 inches] up from the full down position. He was seated in a normal posture, facing forward with his back against the seat back and his feet on the floor (**Figure 7**).

**Figure 7:** Back right passenger's seat area

cervical spine strain as his head moved forward while his torso and hips were held in place by the belt restraint system. The back right window glazing shattered and the back right passenger sustained abrasions on his right forearm from flying glass shards. The case vehicle was redirected by the barrier into a slight counterclockwise yaw and it slid across the shoulder and back into the roadway, where it came to rest. The back right passenger was held in place by the safety belt system and he stayed in his seat.

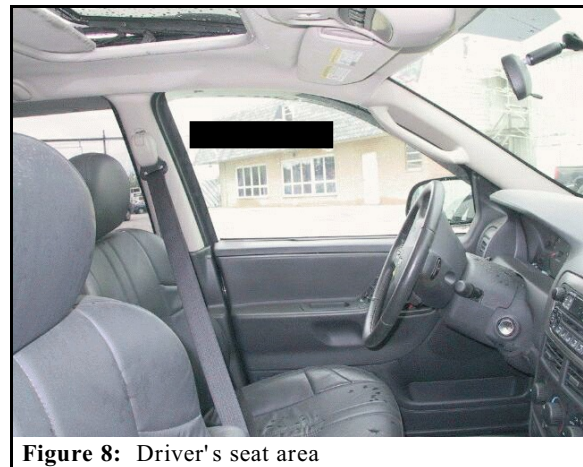
The case vehicle's driver (20-year-old male, white, Hispanic, 168 centimeters, 71 kilograms [66 inches, 157 pounds]) was restrained by the available, manual, three-point, lap-and-shoulder safety belt system. The driver's steering wheel air bag did not deploy. The bucket seat track was adjusted between the middle and rear most positions and the seat back was slightly reclined. The head restraint was adjusted slightly above full down. The driver was in a normal driving posture, with his back against the seat back, both hands on the steering wheel, his left foot on the floor and his right foot operating the foot controls (**Figure 8**).

**Figure 8:** Driver's seat area

wheel rims broke apart. The driver moved further forward and slightly rightward in response to the impact deceleration. His right hand/arm loaded against the steering wheel and this force was transmitted along his arm causing a sprain in his right shoulder. He also sustained a contusion and abrasion on his chin. The NASS injury causation data attribute the abrasion to flying glass from the shattered front right window glazing, with the contusion attributed to contact with the steering wheel, but it seems likely that both the abrasion and contusion were caused by the steering wheel contact. The case vehicle was redirected by the barrier into a slight counterclockwise yaw and it slid across the shoulder and back into the roadway, where it came to rest. The driver was held in place by the safety belt system and he stayed in his seat.

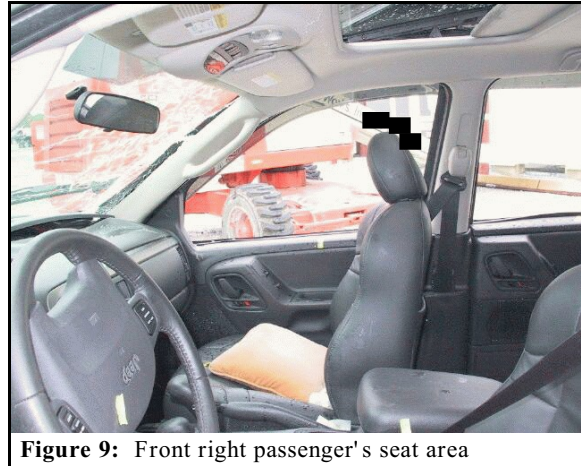
The case vehicle's front right passenger (15-year-old male, white, Hispanic, 168 centimeters, 66 kilograms [66 inches, 146 pounds]) was restrained by the available, manual, three-point, lap-and-shoulder safety belt system. The front right passenger's instrumental panel air bag did not deploy. The bucket seat track was adjusted at the full forward position and the seat back was slightly reclined. The head restraint was in the full down position. There was a supplemental cushion in the front right seat at the time of the vehicle inspection, but it is not known if this was in use at the time of the crash. The front right passenger was otherwise in a normal posture with his back against the seat back and his feet on the floor (**Figure 9**).

right passenger moved further forward and slightly rightward in response to the impact deceleration. The front right window glazing shattered and the front right passenger sustained lacerations on this right hand from flying glass. The case vehicle was redirected by the barrier into a slight counterclockwise yaw and it slid across the shoulder and back into the roadway, where it came to rest. The front right passenger was held in place by the safety belt system and he stayed in his seat.

**Figure 9:** Front right passenger's seat area
