Certified Advanced 208-Compliant Vehicle Investigation / Vehicle to Vehicle
Dynamic Science, Inc. / Case Number: 2004-75-046G
2004 Ford F150 pickup
Colorado
April, 2004

1. Report No. 2004-75-046G	2. Government Accession No.		3. Recipient Catalog No.	
4. Title and Subtitle Certified Advanced 208-Compliant Vehicle Investigation			5. Report Date April 5, 2006

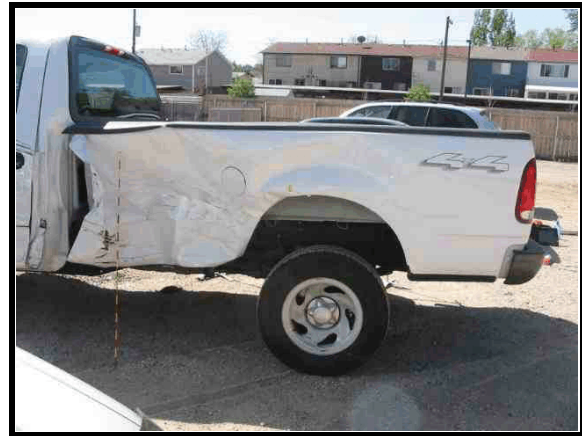
The Ford F150 was then pushed laterally in a southwest direction until the left side (10LZEW3) of the F150 struck the front of the stopped Ford Explorer (11FLEE6). There was 212.0 cm (83.5 in) of direct contact to the Ford F150 that began 12.0 cm (4.7 in) forward the rear axle and extended forward. The maximum crush was located at C3 and measured 21.0 cm (8.3 in). The total velocity change as computed by the WinSmash program was 10.0 km/h (6.2 mph). The longitudinal and lateral components were -5.0 km/h (-3.1 mph) and 8.7 km/h (5.4 mph), respectively.

Figure 5. Case vehicle, 2004 Ford F150, left side impact

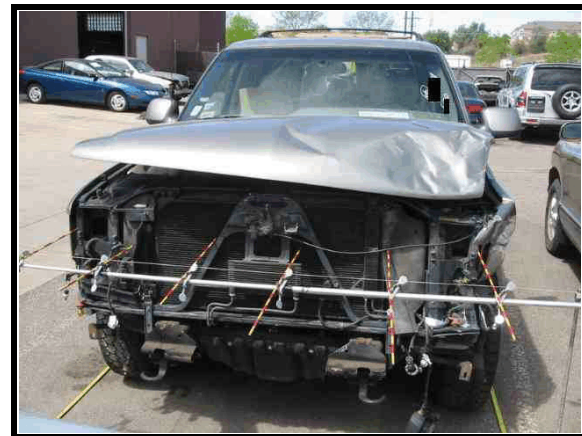
Figure 6. 2000 Chevrolet Suburban (impact to right side of case vehicle, 1st impact)

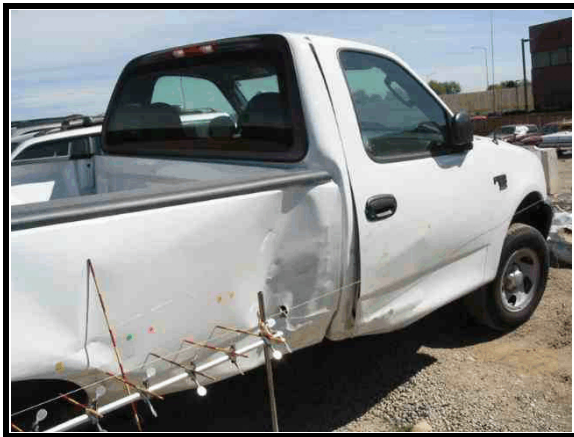
Prior to impact, the driver of the Ford F150 began making a left turn, intending to travel west. The driver of the southbound Suburban was unable to stop in time and struck the right side of the Ford F150 (02RZEW2). There was 118.0 cm (46.4 in) of direct contact that began 100.0 cm (39.4 in) forward. The maximum crush was located at C2 and measured 17.0 cm (6.7 in). The total velocity change as computed by the WinSmash program was 10.0 km/h (6.2 mph)¹. The longitudinal and lateral components were -3.4 km/h (-2.1 mph) and -9.4 km/h (-5.8 mph), respectively. The impact was moderate and resulted in the deployment of the frontal air bag system in the Ford F150. The EDR-reported longitudinal delta V was estimated to be -6.9 km/h (-3.7 mph)², 55 milliseconds into the crash.

Figure 7. Right side, Ford F150

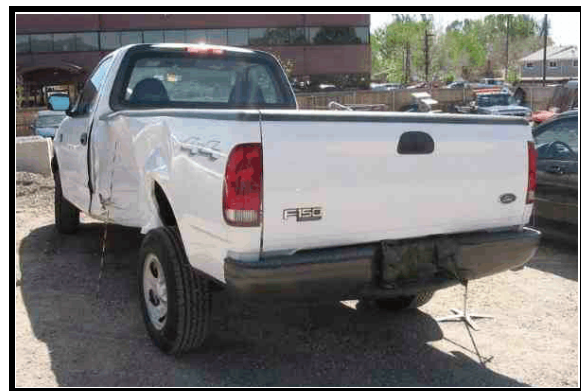
Figure 8. Rear left, Ford F150

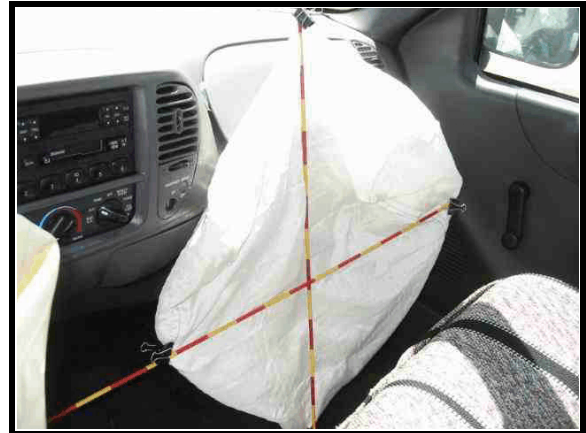
Figure 9. Passenger air bag

The front right passenger air bag was a mid instrument panel mount. There was a single module flap that was rectangular in shape and measured 41.0 cm (16.1 in) wide by 18.0 cm (7.1 in) high. The air bag was generally rectangular in shape and measured 70.0 cm (27.6 in) vertically and 63.0 cm (24.8 in) horizontally. There were no tethers or vent ports. There was no damage or contacts noted to either the air bag or the module cover.

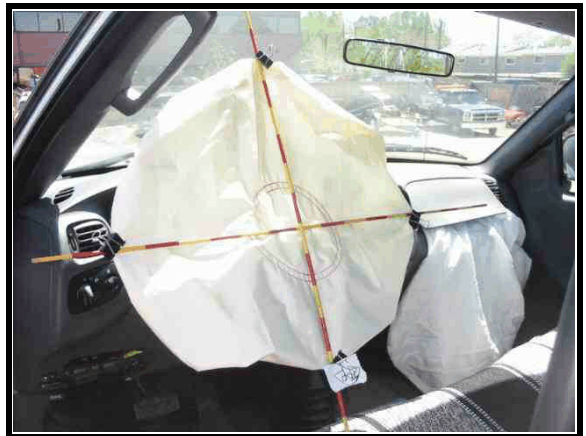
Both front air bags deployed during the crash. It is believed that the air bags deployed during the first impact.

Figure 10. Driver's and front right passenger's air bag

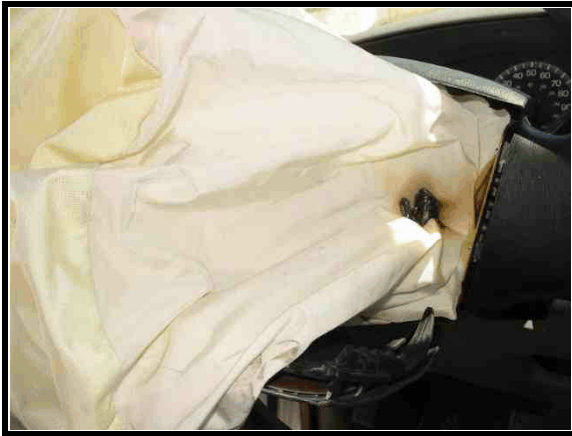
Interior damage to the Ford pickup was generally limited to normal damage associated with front air bag deployments. There was a burn mark found on the right side of the air bag—near the module/air bag attachment.

Figure 11. Burn to right side of driver's air bag

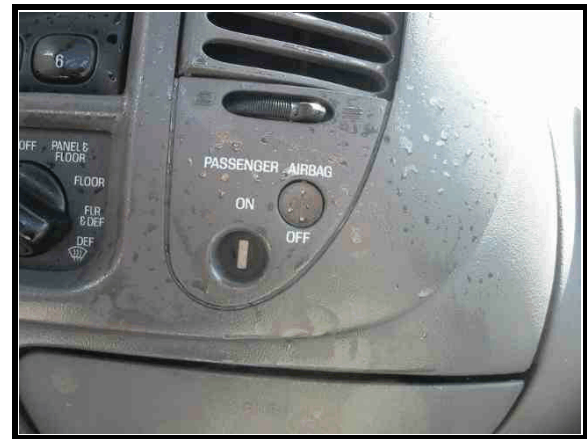
Figure 12. Passenger air bag cut off switch set to "ON" position

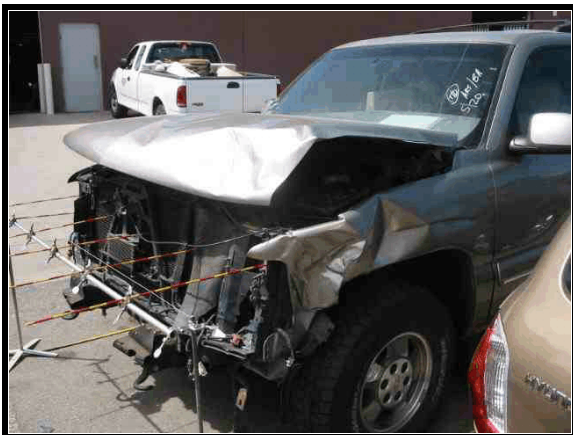
Description:	2000 Chevrolet Suburban 4x4 sport utility vehicle	
VIN:	3GNFK16T1YGxxxxxx	
Odometer:	153,149 km (95,165 miles), per repair facility	
Engine:	5.3L 8 cylinder	
Reported Defects:	None	
Cargo:	None, per inspection	
Damage Description:	Moderate front end damage. Damage to bumper, hood, and left front fender.	
CDC:	Impact 1: 11FYEW1 Impact 2: Unknown	
Delta V (impact 1) ⁵ :	Total	9.0 km/h (5.6 mph)
	Longitudinal	-8.5 km/h (-5.3 mph)
	Latitudinal	3.1 km/h (1.9 mph)
	Energy	12,294 joules (9,068 ft lbs)

Figure 14. Front left, Chevrolet Suburban

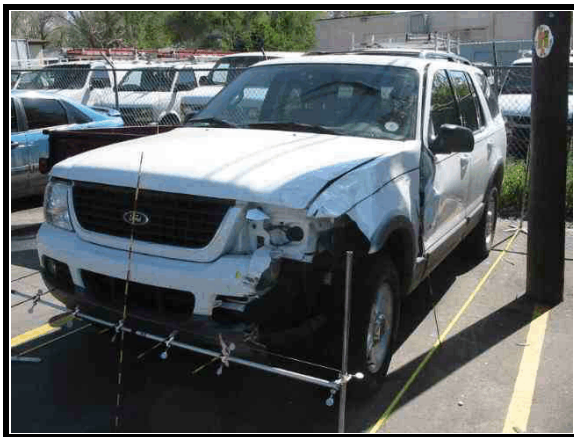
Description: 2002 Ford Explorer 4x2
 VIN: 1FMZU73K42Zxxxxxx
 Odometer: 26,459 km (16,440 miles)
 Engine: 4.0L (245 CID) 6 cylinder
 Reported Defects: None
 Cargo: 3 kg (7 lbs), bookcase/sleeping bag
 Damage Description: Minor front and rear end damage.
 CDC: Impact 1: 11FLEE6 (impact with Ford pickup)
 Impact 2: 06BZEW1 (impact with Toyota Camry)
 Delta V: Total Unknown
 Longitudinal Unknown
 Latitudinal Unknown
 Energy Unknown

Figure 16. Front left, Ford Explorer

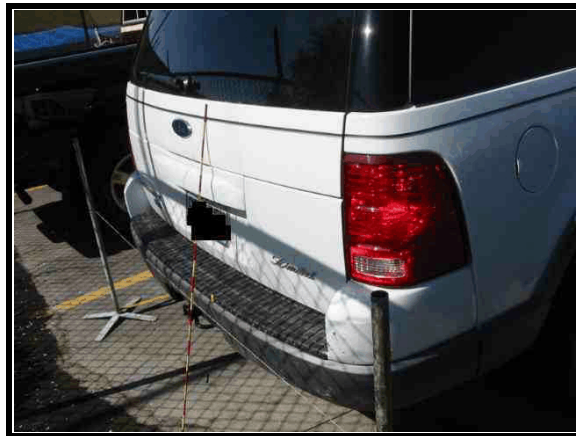
Figure 17. Back right, Ford Explorer

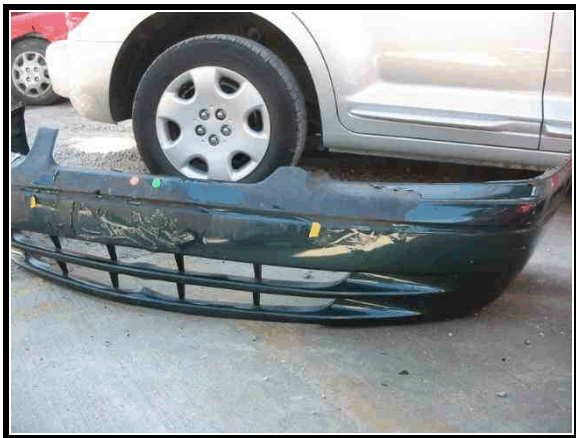
Description:	1997 Toyota Camry	
VIN:	JT2BG22K1V0xxxxxx	
Odometer:	Unknown	
Engine:	2.2L 4 cylinder	
Reported Defects:	None	
Cargo:	None	
Damage Description:	Moderate front end damage. Damage to bumper, bumper fascia, hood, and radiator support.	
CDC:	12FYEW1 (impact with Ford Explorer)	
Delta V:	Total	Unknown
	Longitudinal	Unknown
	Latitudinal	Unknown
	Energy	Unknown

Figure 18. Bumper fascia, Toyota Camry

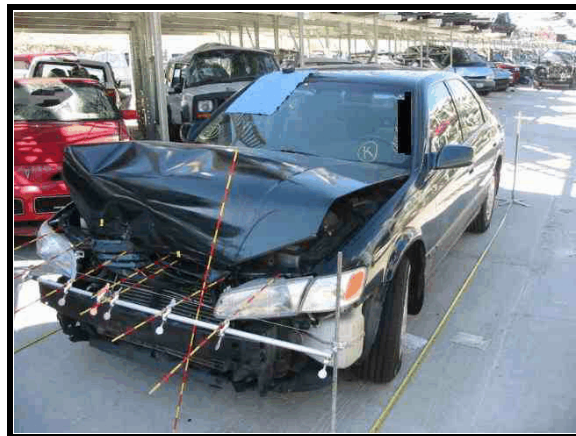
Figure 19. Front left, Toyota Camry

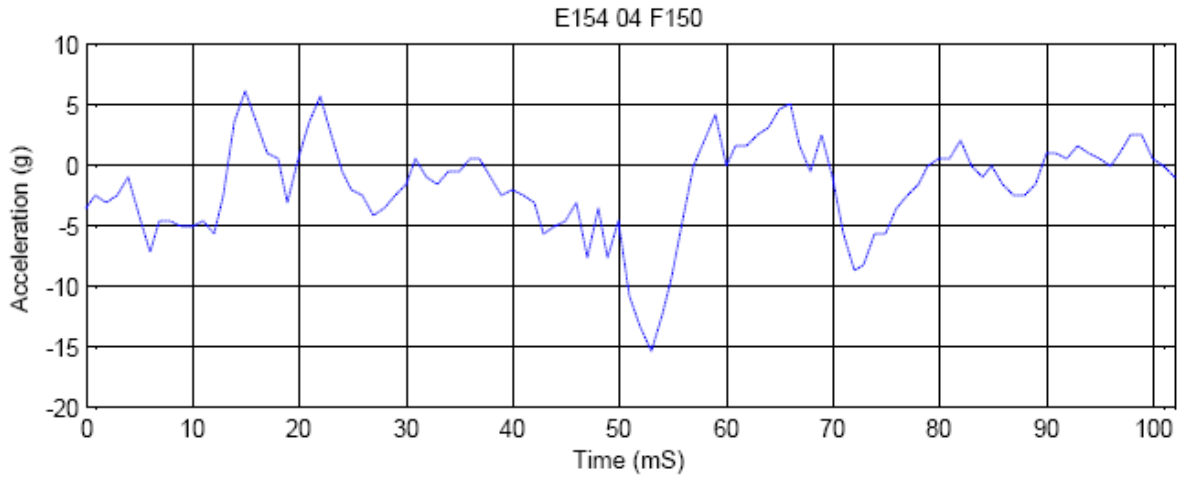
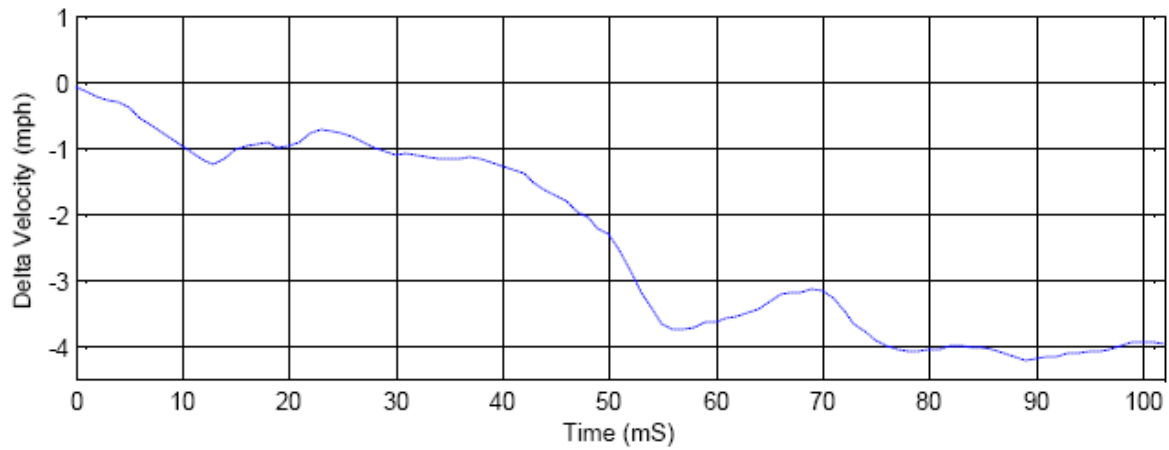
Attachment 2. Acceleration and delta V traces for Ford F150

- The EDR-reported longitudinal delta V was estimated to be -6.9 km/h (-3.7 mph), 55 milliseconds into the crash.
- There was a flash code 19 (Crash memory full status code) present when the restraint control module was powered on at Autoliv.
- The restraint control module issued a command to deploy the front airbags and pretensioners. The fire time was 54 ms after algorithm wakeup. The safing sensor closed 1 ms after the microcontroller's deploy decision.
- The passenger front airbag was enabled at the time of the event.
- There were no faults present at the time of the event.
- There were no internal faults recorded.
- The historical faults are listed on the following page.
