**CALSPAN ON-SITE SIDE IMPACT INFLATABLE OCCUPANT PROTECTION
SYSTEM CRASH INVESTIGATION**

CASE NO: CA04-002

VEHICLE: 2003 FORD CROWN VICTORIA POLICE INTERCEPTOR

CRASH DATE: JANUARY 2004

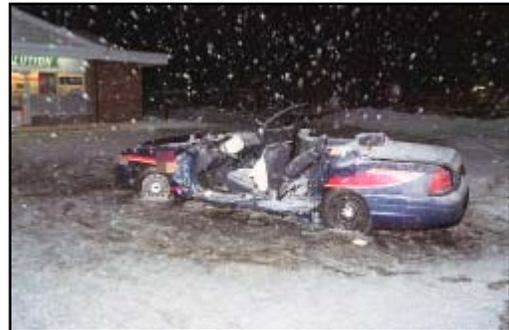
Figure 1. On-scene view of the damaged CVPI

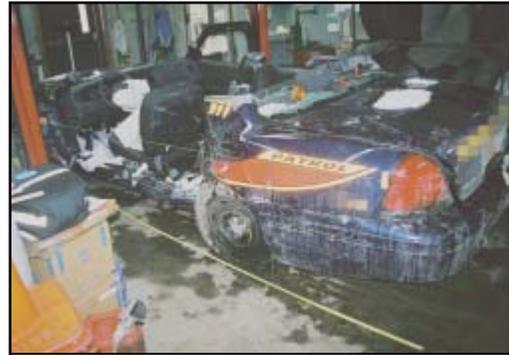
The 2003 Ford CVPI sustained moderate left side damage (**Figure 4**) as a result of the impact with the Chevrolet Trailblazer. At the time of the vehicle inspection, both left doors, left B-pillar, and roof had been removed by rescue personnel, but were available for inspection. The direct contact damage began at the leading edge of the left front door and extended rearward 246.4 cm (97.0”). Lateral crush and deformation were present on both left side doors. Longitudinal abrasions were present on both left side doors from direct engagement with the front of the Trailblazer, which extended vertically to the beltline. The left sill sustained lateral crush from the impact, and

Figure 4. Left side view of damaged 2003 Ford CVPI

the maximum crush measured 15.2 cm (6.0”) at the rear aspect of the left sill. The forward aspect of the left rear quarter panel sustained pocketing as a result of the Trailblazer rotating against the rear aspect of the sill. The snagging of the Trailblazer against the left rear tire/wheel of the CVPI displaced the left rear wheel rearward which elongated the left wheelbase by 10.9 cm (4.3”). The combined direct and induced damage measured 246.4 cm (97.0”) from the leading edge of the left front door to the end of the deflection point on the left rear quarter panel. The left aspect of the rear bumper fascia was displaced. Due to the removal of the left side doors and masking left side damage from the rollover event, a crush profile was documented along the left sill. Six crush measurements were documented along the entire length of the left sill, which measured 188.0 cm (74.0”), and were as follows: C1 = 15.2 cm (6.0”), C2 = 12.7 cm (5.0”), C3 = 12.1 cm (4.8”), C4 = 8.9 cm (3.5”), C5 = 6.4 cm (2.5”), C6 = 2.5 cm (1.0”). The Collision Deformation Classification for the initial impact with the Trailblazer was 10-LPEW-2.

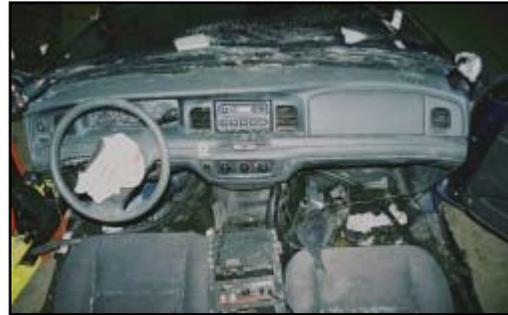
The 2003 Ford CVPI sustained minor interior damage as a result of passenger compartment intrusion. The driver’s head restraint was separated from the top of the seat back, and sustained a tear on the rear outboard aspect, possibly as a result of rescue operations. As shown in **Figure 5**, the center console, which housed the radio and emergency lighting controls, was displaced laterally to the left. The outboard aspect of the left rear seat and seat back were buckled inward due to the lateral intrusion. The specific intrusions were documented as follows:

Figure 5. Interior view of the front seating positions in the 2003 Ford CVPI

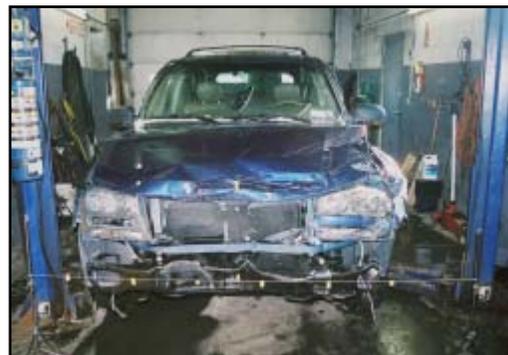
The 2002 Chevrolet Trailblazer sustained moderate frontal damage (**Figure 6**) as a result of the frontal impact with the Ford CVPI. The direct contact damage began at the left front bumper corner and extended 154.9 cm (61.0") across the entire frontal plane. Red paint transfers from the CVPI began at the left front corner of the hood, extended laterally across the leading edge of the hood 111.8 cm (44.0"), and terminated 40.6 cm (16.0") right of the centerline. Red paint transfers were also present across the left front headlamp. The front bumper fascia and grille were separated from the Trailblazer. The bumper beam was deformed and crushed rearward. The combined direct and induced damage involved the entire frontal width of the vehicle. The hood was buckled rearward and left front fender was buckled outward. Six crush measurements were documented across the front

Figure 6. Frontal damage to the 2002 Chevrolet Trailblazer

bumper beam of the Trailblazer and were as follows: C1 = 24.8 cm (9.8”), C2 = 5.7 cm (2.3”), C3 = 12.7 cm (5.0”), C4 = 14.0 cm (5.5”), C5 = 3.8 cm (1.5”), C6 = 7.6 cm (3.0”). The CDC for the frontal impact with the Ford CVPI was 01-FDEW-1.

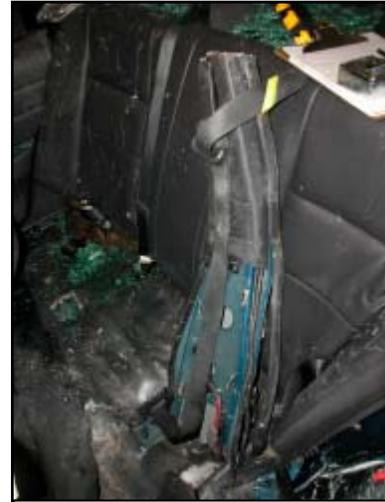
Figure 7. View of separated left B-pillar and driver's safety belt webbing

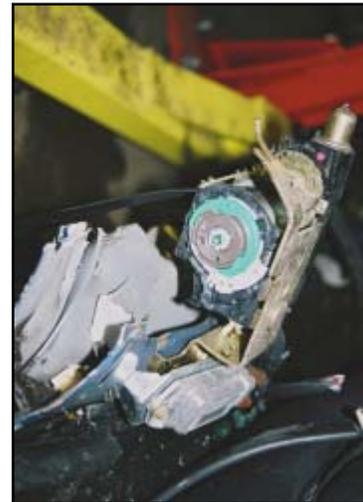
The retractor (**Figure 8**) was located on the lower B-pillar, and was restricted at the time of the vehicle inspection with a length of webbing that measured 34.9 cm (13.8”). Two linear diagonal scuffmarks were present on the inside aspect (against the occupant) of the shoulder belt and were located 19.1 cm (7.5”) below to the D-ring (relative to the anchor). The scuffmarks measured the entire width of the webbing and were heavier on the outboard aspect.

Figure 8. View of driver's safety belt retractor and pretensioner

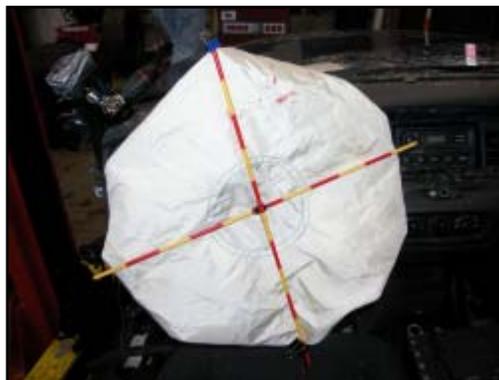
The dual-stage driver's air bag deployed as a result of the longitudinal deceleration during the impact with the Chevrolet Trailblazer. The driver's air bag (**Figure 9**) was housed in the center of the steering wheel hub with a single cover flap design. The cover flap was hinged at the top aspect and measured 14.6 cm (5.8") in width and 11.4 cm (4.5") in height. The driver's air bag measured 61.0 cm (24.0") in diameter. The air bag was vented by two circular ports located on the rear aspect of the air bag at the 11 and 1 o'clock positions, located 5.1 cm (2.0") inboard of the circumferential seam. The vent ports measured 2.5 cm (1.0") in diameter. The air bag was tethered by two internal straps that measured 7.6 cm (3.0") in width and were located at the 12 and 6 o'clock positions of the center of the air bag. There was no evidence present on the driver's air bag from occupant contact.

Figure 9. View of deployed driver's air bag

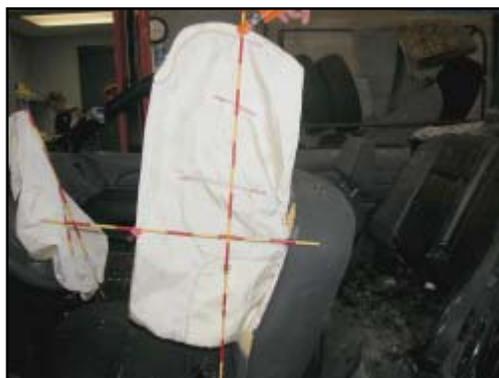
Figure 10. View of deployed driver's side impact air bag

The driver's side impact air bag deployed as a result of the left side impact with the Chevrolet Trailblazer. The side air bag (**Figure 10**) deployed through a tear seam along the outboard edge of the seat back that measured 38.1 cm (15.0") in length. The air bag was rectangular in shape and measured 63.5 cm (25.0") in height and 34.3 cm (13.5") in width. The forward excursion of the side impact air bag measured 25.4 cm (10.0") from the seat back. The air bag was tethered by two internal straps that measured 2.5 cm (1.0") laterally, measured 10.2 cm (4.0") in width, and were located 14.0 cm (5.5") and 31.1 cm (12.5") from the top of the air bag, respectively.

There was no occupant contact evidence on the driver's side impact air bag. The top inboard corner sustained faint scuffmarks and minor tears from rescue operations and post-crash debris.
