**CALSPAN REMOTE SCHOOL BUS CRASH INVESTIGATION**

**CASE NO: CA04-003**

**VEHICLES: 1989 BLUEBIRD TC-2000 SCHOOL BUS  
2002 BLUEBIRD TC-2000 SCHOOL BUS**

**CRASH DATE: JANUARY 2004**

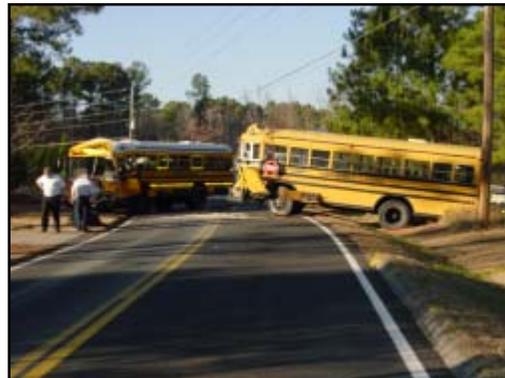
**Figure 1. On-scene view of the buses at final rest**

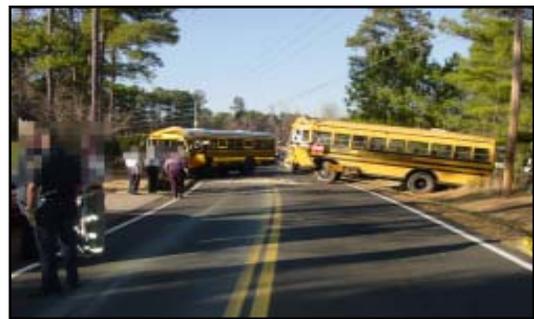
The 54-year-old female driver of the 1989 Blue Bird TC2000 school bus was operating the vehicle in a northbound direction on the two-lane roadway (**Figure 2**). The 66-year-old male driver of the 2002 Blue Bird TC2000 school bus was operating the vehicle southbound on the same roadway. The pre-crash speeds of the buses were unknown. Both buses were on approach to the curve, a left curve for the 1989 bus and a right curve for the 2002 bus. As the 2002 bus attempted to negotiate the right curve, the bus traveled across the centerline into the opposing northbound lane.

**Figure 2. Northbound approach for the 1989 school bus**

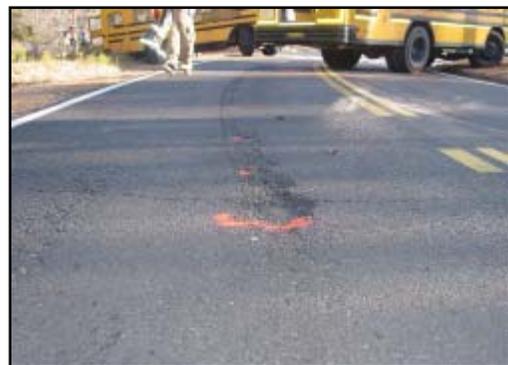
The driver of the 2002 bus applied the brakes and steered right in an attempt to avoid the collision when he detected the oncoming 1989 bus in the same lane. Police reported a tire mark from the left front wheel of the 2002 bus that measured 12.5 m (41.0') in length to the deflection at the point of impact (**Figure 3**). The driver of the 1989 bus did not attempt any avoidance maneuvers.

**Figure 3. View of the left front tire mark from the 2002 school bus**

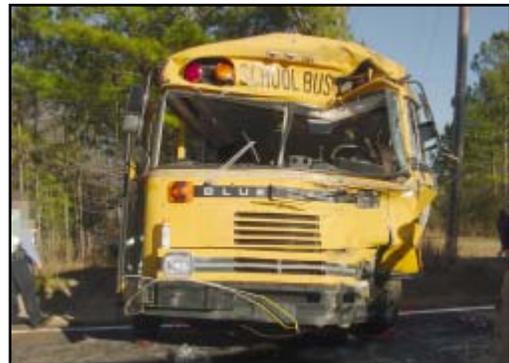
The damage to the 1989 Blue Bird TC2000 school bus was based on photographs obtained from the school district. The 1989 TC2000 bus sustained severe frontal damage as a result of the collision with the 2002 TC2000 school bus (**Figures 4 and 5**). The direct contact damage began approximately 30 cm (12”) left of the centerline and extended laterally to the front left corner. Due to the identical nature of the bus models, the direct contact involved the entire vertical height of the front of the bus. The left aspect of the steel front bumper was deflected rearward and abraded.

**Figure 4. Frontal view of the damaged 1989 school bus**

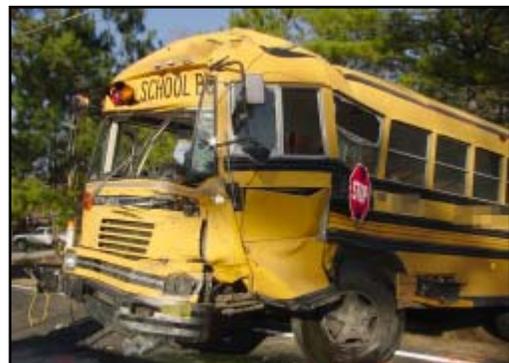
The front left corner sustained abrasions and deformation above the bumper. The lower front panel that housed the headlights was displaced and crushed on the left aspect. The windshield was fractured and out-of-place in the on-scene photographs. The maximum crush at the front left bumper corner was approximately 45 cm (18”), based on the on-scene photographs. The maximum crush along the windshield header was located approximately 30 cm (12”) to the left of the centerline and was estimated to be approximately 30 cm (12”). The combined direct and induced damage involved the entire frontal width of the bus. Vertical body panel separation occurred along the front left corner due to the longitudinal crush. The left front side access door beneath the left A- and B-pillars sustained longitudinal and outward buckling on the top aspect. The access door and side panel under the access door were displaced outward and rearward as a result of induced damage, although, there was no apparent left side body panel separation. The highest degree of lateral deflection occurred at the beltline at the left B-pillar and

**Figure 5. Left front view of the damaged 1989 school bus**

was approximately 20 cm (8"). The bottom aspect of the panel was crushed and displaced rearward approximately 30 cm (12"). The roof sustained induced buckling at the left A-, B-, C-, and D-pillars. There did not appear to be any reduction of the wheelbase, and the right side of the bus did not sustain visible damage. The school bus was out of the scope of the Collision Deformation Classification (CDC); therefore, a CDC was not assigned for this impact.

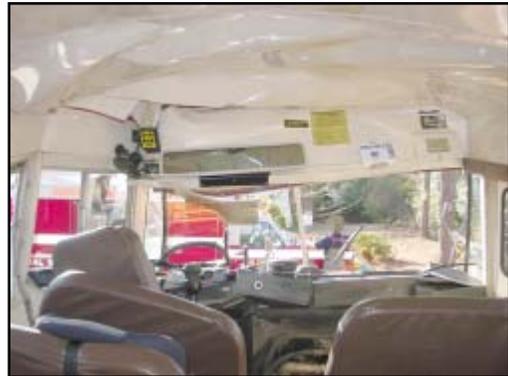
Interior damage to the 1989 TC2000 school bus was severe and was a result of occupant contact and passenger compartment intrusion. The left instrument panel, center instrument panel, toe pan, and windshield header intruded longitudinally and vertically into the forward aspect of the passenger compartment. The longitudinal intrusion of the windshield header resulted in the buckling and separation of the interior roof sheet metal at the top left aspect of the windshield header and leading edge of the roof on the left aspect.

**Figure 6. Interior view looking forward from the second row**

The entire instrument panel was displaced and fractured from crash forces. The engine shroud located against the center floor and instrument panel was separated and the engine was exposed in the available photographs. The longitudinal intrusion and crush resulted in the upward buckling and intrusion of the floor pan under the driver's seat. The floor was also slightly buckled in the area of the D-pillars. Multiple estimated intrusions were documented in the table below:

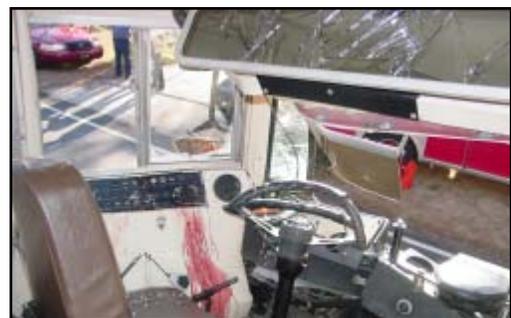
The driver's seat was deflected forward and approximately 20 degrees to the left. The steering column was deflected forward and the rear half of the horizontally oriented steering wheel rim was deflected upward (forward) approximately 90 degrees, although, rescue personnel may have further deformed the steering wheel and rim to extricate the driver. The driver's plastic sun visor was extended downward and fractured as a result of

**Figure 7. View of driver's seat position and driver contacts**

occupant contact. The visor and mounting hardware were also deformed forward on the left side from direct contact with the driver's head. A small semi-circular depression was present in the sheet metal on the left interior corner of the windshield header above the sun visor from possible contact with the driver's head. The rear view mirror located on the forward wall above the windshield was fractured from crash forces. The padded partition located behind the driver's seat was deflected rearward and slightly inboard. Body fluid (blood) was present on the left side driver's control panel and on the floor under the driver's seat. The sliding left front glazing panels were positioned forward, relative to the bus. The outboard pane was fractured and the inboard pane exhibited body fluid (blood) as a result of post-impact contact with driver.

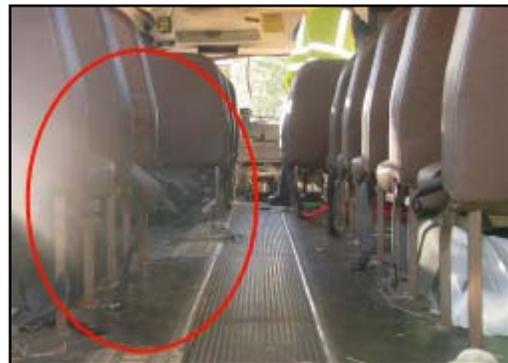
The seat cushion on the left seat of the fifth row was displaced forward and slightly clockwise (CW). It could not be confirmed if the displacement was related to an occupant seated in that position. The circled area in **Figure 8** highlights the seat cushion displacement.

**Figure 8. View from the rear of the 1989 bus highlighting the displaced left 5th row seat**

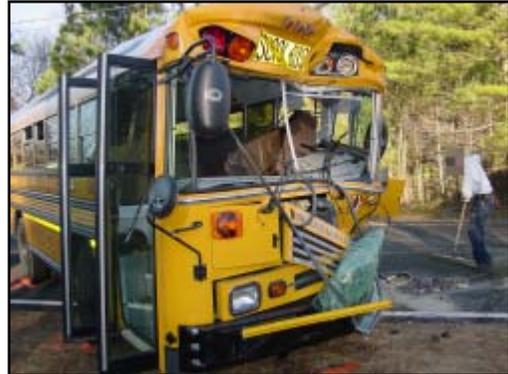
The damage to the 2002 Blue Bird TC2000 school bus was based on photographs obtained from the school district. The 2002 Blue Bird TC2000 school bus sustained severe frontal damage as a result of the collision with the 1989 TC2000 school bus. The direct contact damage began approximately 30 cm (12”) left of the centerline and extended laterally to the front left corner. Due to the identical nature of the bus models, the direct contact involved the entire vertical height of the front of the bus. The left aspect of the steel front bumper was deflected rearward. The front panel/engine hood in front of the radiator was displaced. The gasket-mounted windshield was fractured and out-of-place in the on-scene photographs. The lower front panel that housed the headlights was displaced. The front left aspect of the bus was crushed rearward and included the left aspect of the bumper, front panel, the right A-pillar, right aspect of the windshield header, and the right aspect of the roof. The front left corner sustained abrasions and deformation above the bumper. The left A-pillar was displaced slightly to the left. The combined direct and induced damage involved the entire frontal width of the bus. The entire vertical section on the left front aspect that encompassed the left A- and B-pillars was displaced downward and rearward. The lower rear aspect of the left body panel located below the left B-pillar was displaced rearward to the left C-pillar, although, there was no apparent separation of the body panels. The rearward displacement of the left front body panel resulted in the outward deflection of the left side steel rub rail at the forward aspect and the upward deflection of the roof side rail at the B-pillar. The rearward displacement and crush resulted in induced buckling of the roof at the left B- and C- pillars. There appears to be a minor reduction of the wheelbase and the right side of the bus did not sustain visible damage. The school bus was out of the scope of the CDC; therefore, a CDC was not assigned for this impact.

Figure 9. Frontal view of the damaged 2002 school bus

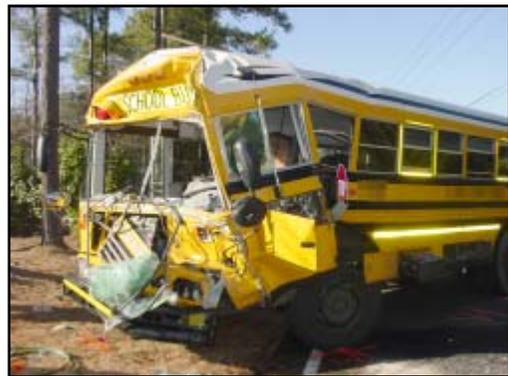
Figure 10. Left front view of the damaged 2002 school bus

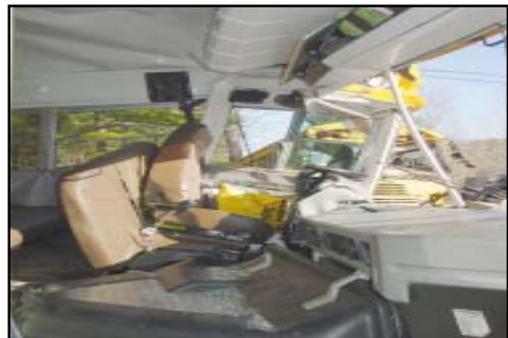
Interior damage to the 2002 TC2000 school bus was severe and was a result of occupant contact and passenger compartment intrusion. The left instrument panel, center instrument panel, windshield header, toe pan and floor pan intruded longitudinally and vertically into the forward aspect of the passenger compartment (Figure 11). The vertical intrusion of the windshield

Figure 11. Lateral view of the driver's seat position and longitudinal intrusion

header resulted in the buckling and separation of the interior roof sheet metal at the top left aspect of the windshield header and leading edge of the roof on the left aspect. The interior roof-mounted HVAC unit was displaced and deformed due to the intrusion (**Figure 12**). Multiple estimated intrusions were documented in the table below:

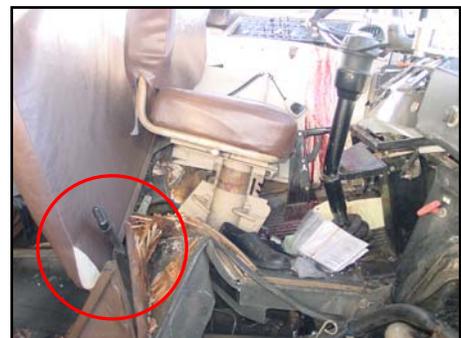
The 1989 TC2000 school bus was configured with a manual 2-point lap belt for the driver’s position. The configuration of the lap belt was unknown, as the webbing and latch plate were not visible in any of the available photographs. The buckle stalk appeared to be mounted on

**Figure 13. Driver's buckle and stalk (highlighted) in the 1989 bus**

the floor on the inboard aspect of the seat, and was displaced rearward and clockwise (CW) against the padded partition due to the floor buckling (**Figure 13**).

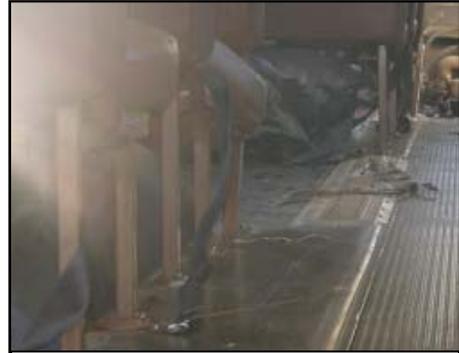
The school bus passenger seats were configured with fixed-length manual lap belts with locking latch plates for each seating position. Although the police report indicated that the bus monitor, 9-year-old, and 10-year-old were restrained, the specific seating positions were unknown, and images of specific lap belts were unavailable. The lap belt webbing on the outboard aspect of the left side fifth row bench seat appeared cupped and corrugated (**Figure 14**). The deformation to the safety belt webbing combined with the displacement of the seat cushion suggested probable occupancy of the seat. However, a specific occupant could not be linked to the seat position at the time of this PCS.

**Figure 14. Close up of the lap belt in the fifth row left seat**

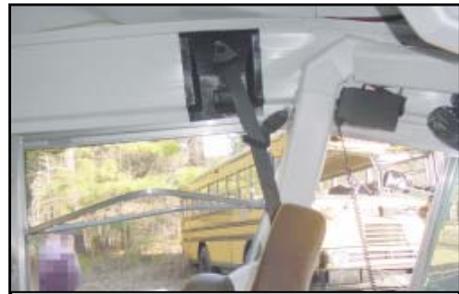
The 2002 TC2000 school bus was configured with a manual 3-point lap and shoulder belt for the driver's position. The buckle stalk was attached to an L-shaped bracket that was mounted longitudinally on the on the inboard aspect of the seat base. There was no visible damage to the buckle or buckle stalk in the available photographs. The retractor was located along the left roof side rail approximately 20 cm (8") aft of the left B-pillar (**Figure 15**). The retractor was fixed to a metal plate, which was attached to the roof side rail, and a fixed plastic-covered D-ring was located approximately 10 cm (4") above the retractor. A second D-ring was present on the lower aspect of the roof side rail, and utilized as a guide for the shoulder belt webbing. The secondary D-ring was attached to a short section of webbing that was fixed to the aft edge of the left B-pillar at the roof side rail, and was located below the retractor. A section of the shoulder belt webbing that was visible in one of the photographs appeared to be corrugated as a result of occupant loading. The lap belt anchor and latch plate were not visible in any of the available photographs.

**Figure 15. Driver's retractor, D-ring, and shoulder belt in the 2002**

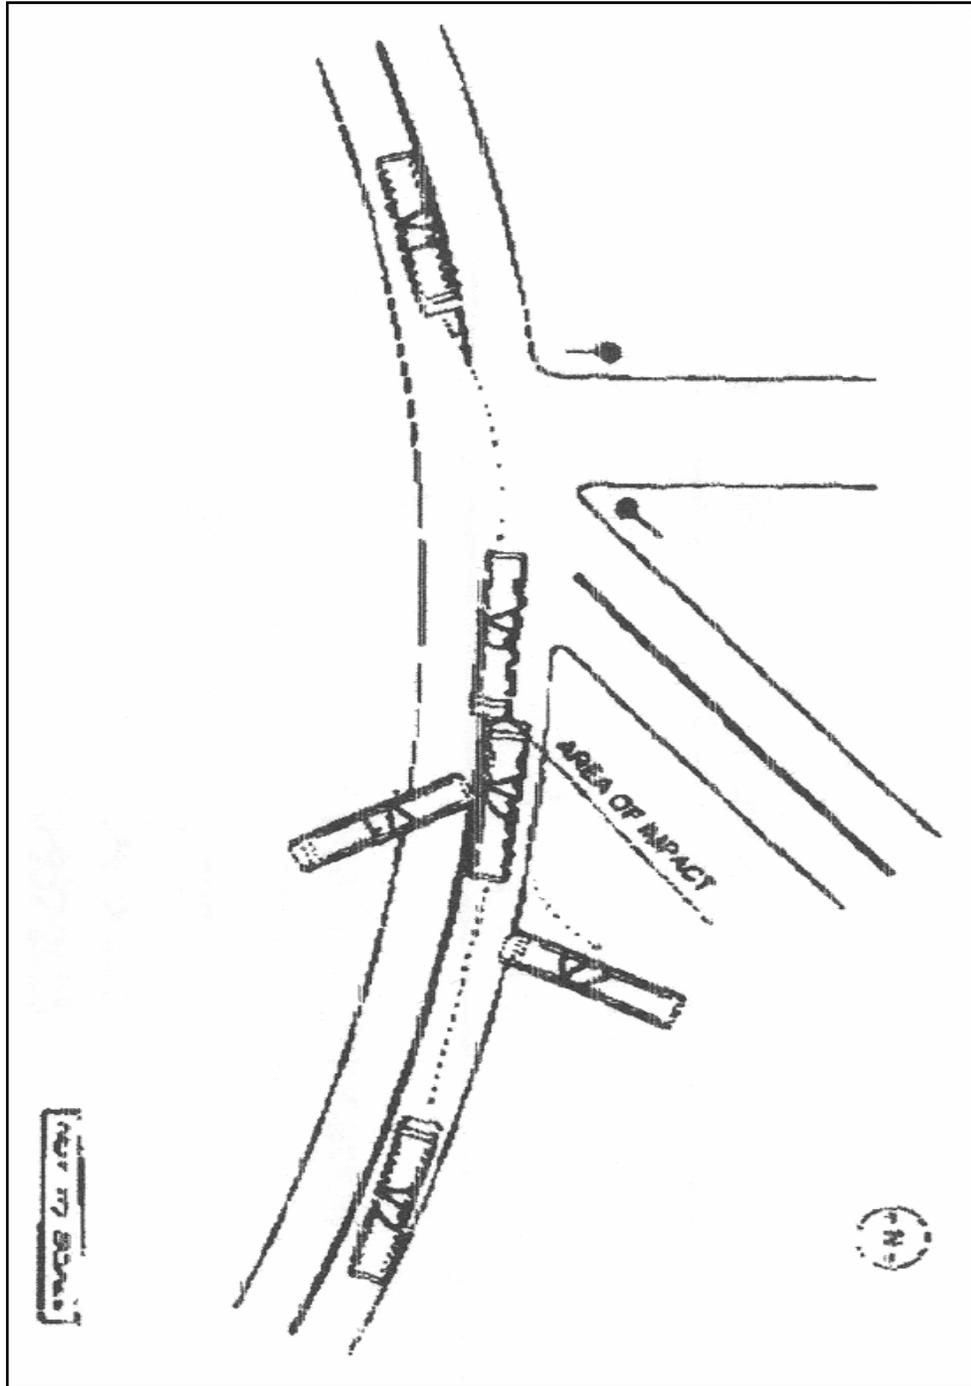
Figure 16. Police scene schematic.

This two-vehicle crash occurred during the daylight hours of January 2004 in the state of Georgia. At the time of the crash, there were no adverse weather conditions and the asphalt roadway surface was dry. The curved north/south two-lane roadway was configured with one travel lane in each direction separated by a double-yellow centerline. The crash occurred at the apex of a northbound left curve. North of the crash site, two local roadways intersected the north/south roadway on the east aspect. The roadway was bordered by white fog lines and narrow dirt shoulders. A drainage ditch was present on the east side of the roadway adjacent to the shoulder. The police-reported roadway width at the crash site measured 5.8 m (19.1'). The roadside environment consisted of private driveways and wooded areas. The posted speed limit for the north/south roadway was 56 km/h (35 mph). The police scene schematic is included as **Figure 16** at the end of this report.
