ON-SITE CERTIFIED ADVANCED 208- COMPLIANT VEHICLE INVESTIGATION

CASE NUMBER - IN-04-003
LOCATION - Texas
VEHICLE - 2003 Chevrolet Silverado
CRASH DATE - December 2003

16. <i>Abstract</i> This report covers an on-site investigation of an air bag non-deployment crash involving a 2003 Chevrolet Silverado (case vehicle) and a 1994 Honda Accord EX (other vehicle). This crash is of special interest because the supplemental restraint (air bag) system in the case vehicle, which did not deploy, is certified by the manufacturer to be compliant to the Advanced Air Bag portion of the Federal Motor Vehicle Standard (FMVSS) No. 208. The case vehicle was equipped with multiple Advanced Occupant Protection System (AOPS) features, and the case vehicle's driver (18 year-old female) sustained only minor injuries while the front right passenger (16-year-old female) sustained no injury as a result of the crash. The case vehicle was traveling east in the inside lane of a five-lane divided city street. The Honda had been traveling west in the left turn lane and was in the process of executing a left turn through a median cut and across eastbound traffic. The case vehicle's driver stated she applied the

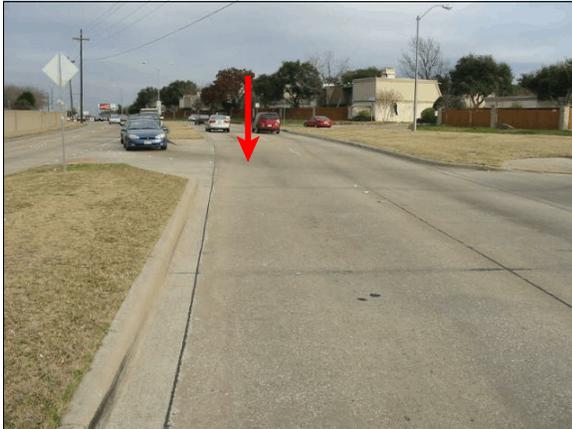
Pre-Crash: The case vehicle was traveling east in the inside lane (**Figure 1**), and the driver was intending to proceed straight ahead. The Honda had been traveling west in the left turn lane. Its driver was in the process of traveling through the median cut (**Figure 2**) and executing a left turn across eastbound traffic to continue southwestbound on another city street. The case vehicle's driver stated she braked just as the case vehicle impacted the Honda. The crash occurred in the "Y" intersection in the inside eastbound lane.

Figure 1: Case vehicle's eastbound approach to impact area (arrow) in inside lane(case photo #02)

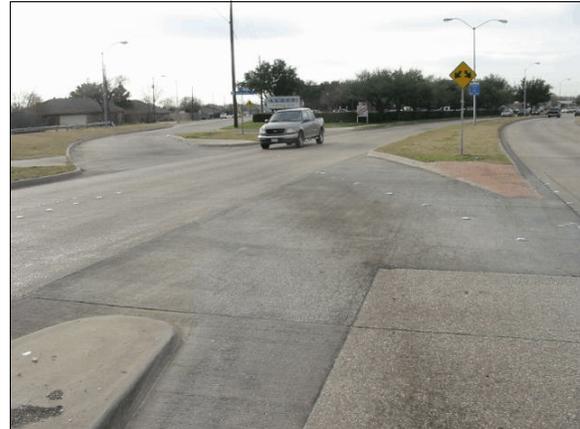
Figure 2: Honda's southwestbound approach in left turn lane to impact area (case photo #07)

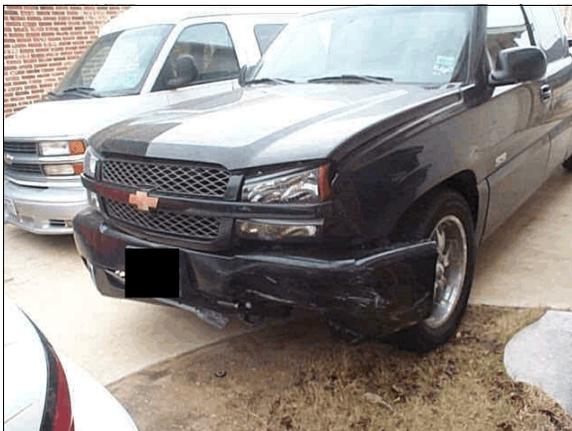
Crash: The front of the case vehicle (**Figure 3**) impacted the front of the Honda (**Figure 4**). The left portion of the case vehicle's front bumper was the primary component of engagement to the Honda's bumper, grille and hood. The case vehicle's driver and front right passenger air bags did not deploy as a result of the impact. The Honda's driver and front right passenger air bags did deploy.

Figure 3: Insurance photo of case vehicle's front damage from impact with Honda (case photo #12a)

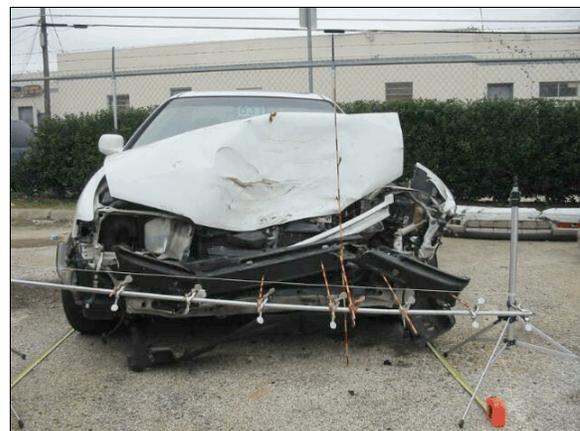
Figure 4: Honda's front damage from impact with the case vehicle (case photo #34)

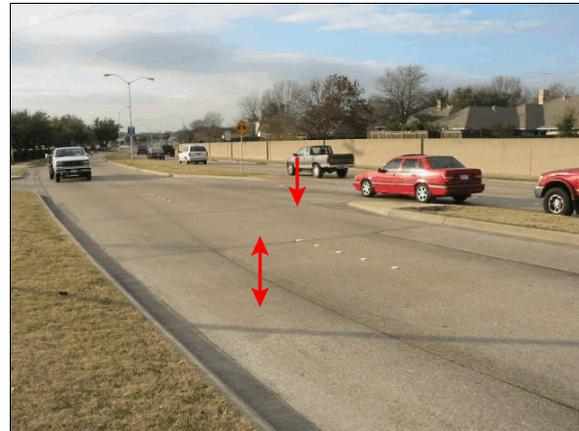
estimated to be in the inside eastbound lane of the roadway facing northeast (**Figure 5**).

Figure 5: Double head arrow shows estimated final rest of case vehicle, single head arrow shows estimated final rest of Honda (case photo #04)

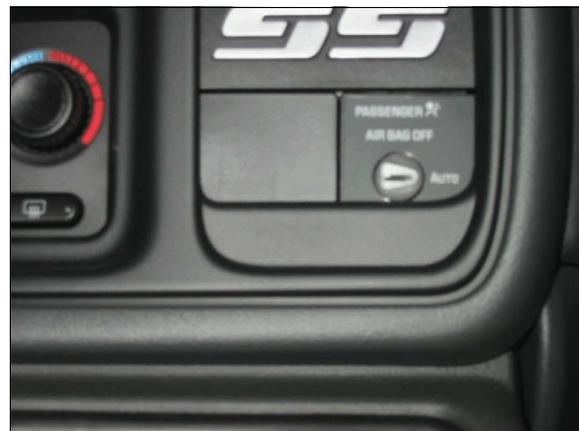
Figure 6: Front right air bag suppression switch, found in the “Auto” position (case photo #27)

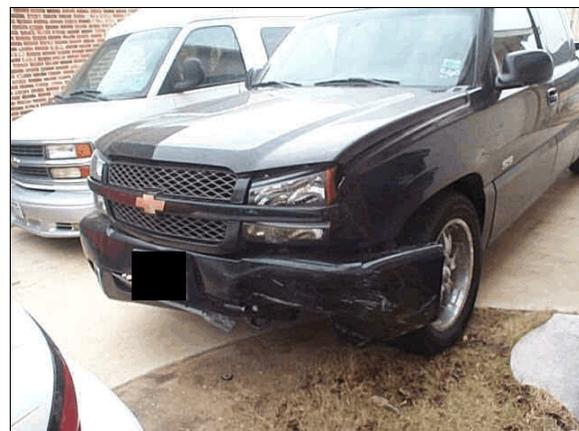
Figure 7: Insurance photo showing case vehicle's front damage from impact with Honda (case photo #12a)

Exterior Damage: The case vehicle’s contact with the Honda involved the bumper, bumper fascia, left headlamp/turn lamp assembly and the grille (**Figure 7** above). Direct damage began at the left front bumper corner and extended 88 centimeters (34.6 inches), along the front bumper. No crush measurements were taken at the time of inspection because the repair process had started and the front bumper and other damage components had been removed from the vehicle. The left portion of the case vehicle’s front bumper, bumper fascia, left turn lamp assembly and grille were all directly damaged and crushed rearward.

The case vehicle’s wheelbase was unchanged as a result of the crash. There was slight induced damage to the left headlamp/turn lamp assemblies, grille and left fender. No obvious induced damage or remote buckling was noted to the remainder of the case vehicle’s exterior.

Damage Classification: Based on the vehicle inspection and photographs of the damage to the case vehicle provided by the insurance company, the CDC for the case vehicle was determined to be: **12-FYEW-1 (350 degrees)**.

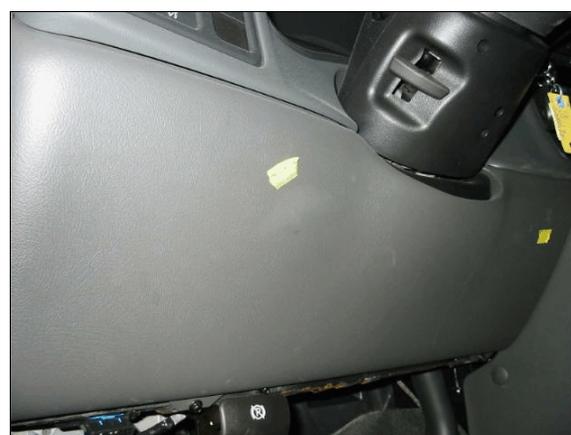
Interior Damage: Inspection of the case vehicle’s interior revealed slight evidence of occupant contact on the knee bolster on each side of the steering column. A light scuff in the rigid plastic of the knee bolster was observed on each side of the steering column (**Figure 8**). No other evidence of occupant contact was observed on any the case vehicle’s interior surfaces or components. Finally, there was no evidence of intrusion of the case vehicle’s interior, and no evidence of compression of the energy absorbing steering column or deformation to the steering wheel rim was observed (**Figure 9** below).

Figure 8: Yellow tape shows occupant contact scuffs on driver’s knee bolster (case photo #22)

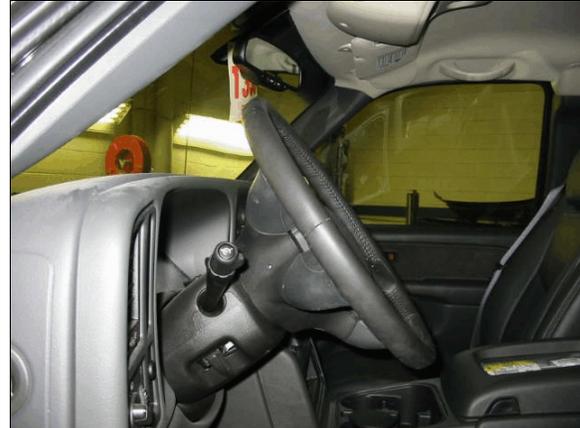
Figure 9: Left side view of steering wheel and steering column showing lack of deformation (case photo #18)

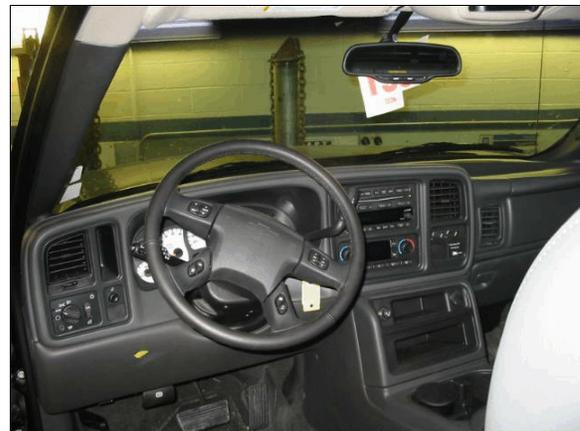
Figure 10: Overview of instrument panel and steering wheel (case photo #19)

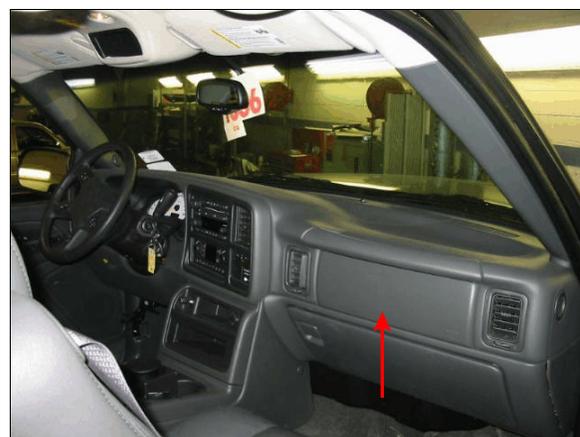
Figure 11: Overview of right instrument panel, arrow shows location of front right air bag (case photo #25)

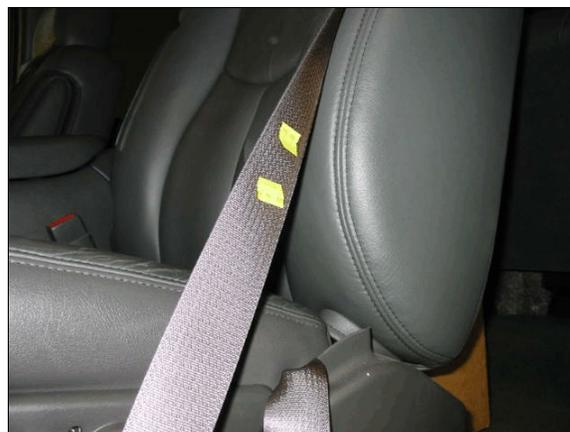
Based on this contractor's vehicle inspection and supported by the EDR data, the case vehicle's driver was restrained by her three-point, integral, lap-and-shoulder safety belt system. Also, the driver stated she sustained a small bruise on her left shoulder from the safety belt. A small area of rippling was also found in the shoulder belt webbing (Figure 12). It appeared to correspond to the location of the shoulder belt guide when the belt was configured in the approximate restrained position. In addition, the shoulder belt guide was pulled out of the seat (Figure 13).

Figure 12: Ripple in driver's shoulder belt webbing between the pieces of yellow tape (case photo #30)

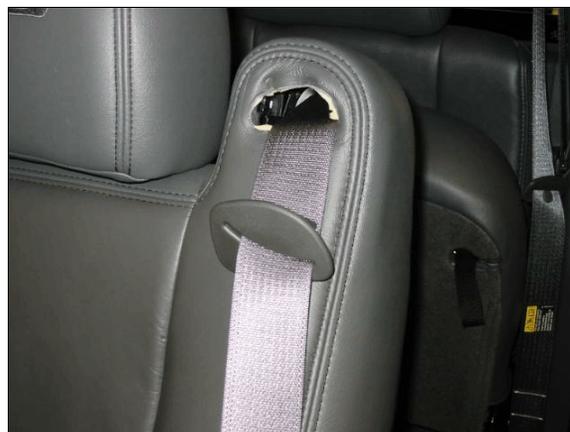
Figure 13: Driver's shoulder belt guide pulled out of the seat (case photo #33)

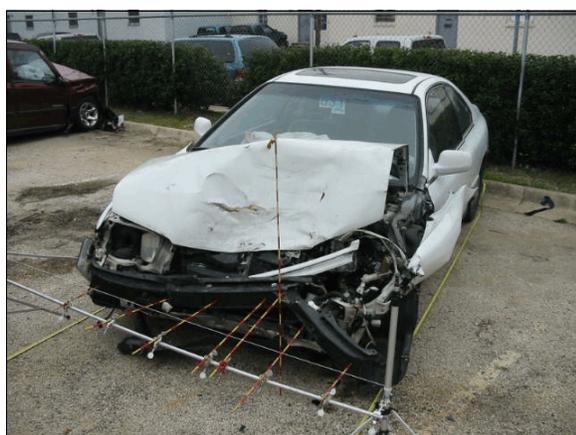
Exterior Damage: The Honda’s impact with the case vehicle involved the front bumper, grille, hood and left headlamp/turn lamp assembly (Figure 14). The direct damage began at the left bumper corner and extended 135 centimeters (53.1 inches) along the front bumper. The maximum residual crush to the front bumper was 33 centimeters (13 inches) occurring at C₃ (Figure15). The table below shows the Honda’s crush profile.

Figure 14: Damage to front of Honda from impact with case vehicle, each stripe on rods is 5 cm (2 in) (case photo #35)

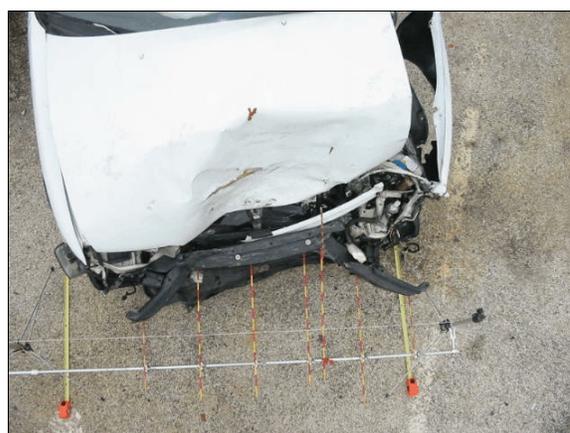
Figure 15: Top view of Honda’s front crush (case photo #40)

The Honda’s left side wheelbase was reduced 6 centimeters (2.4 inches) by the impact, and the right side wheelbase was extended 5 centimeters (2 inches). The Honda’s front bumper, grille, hood, and front of the left fender were directly damaged and crushed rearward. Induced damage involved the front bumper, hood, left and right fenders, left front wheel, left front door and the windshield. Sideswipe type damage was noted to the Honda’s right quarter panel; however, no corresponding damage was found on the left side of the case vehicle. This damage was therefore determined to be unrelated to this crash.

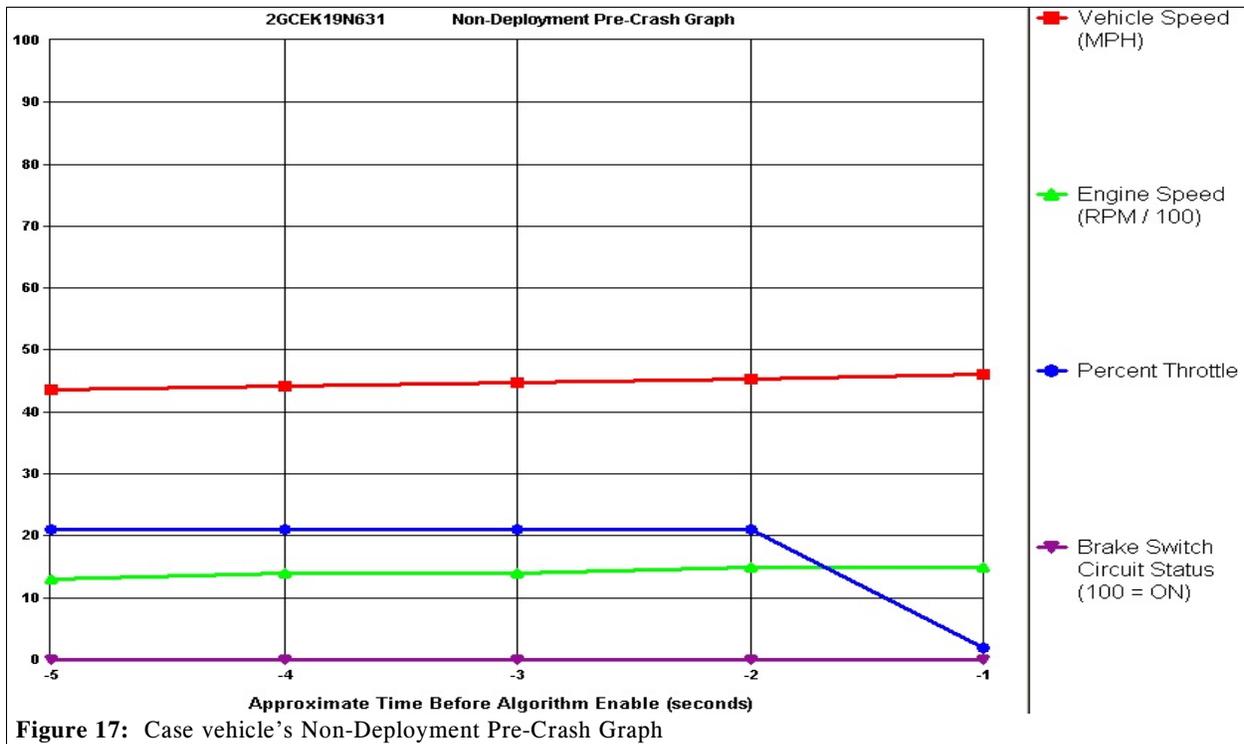
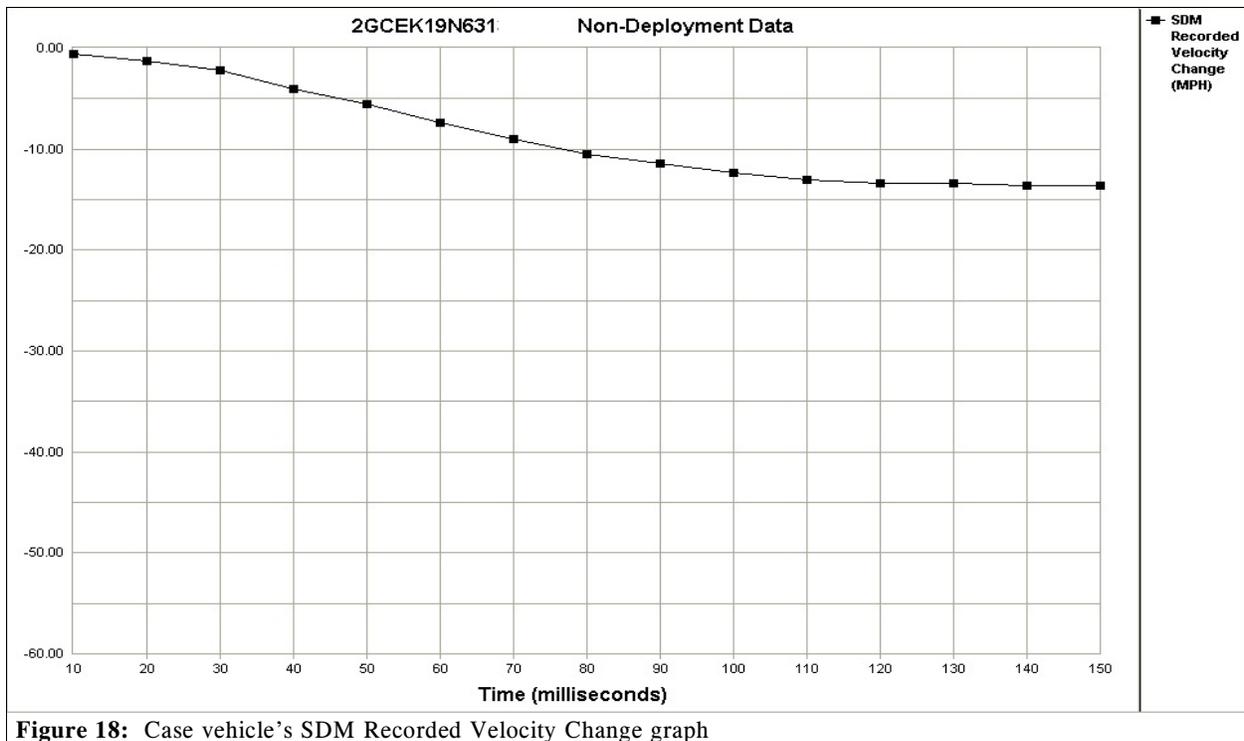
km.p.h. (-13.99 m.p.h.) occurring at 292.5 milliseconds (0.2925 seconds) after algorithm enable. The pre-crash data indicated the case vehicle was traveling 71 km.p.h. (44 m.p.h) to 72 km.p.h. (45 m.p.h.) at 21% throttle with the brake switch off from five to two seconds prior to the crash (i.e., algorithm enable). At one second prior to the crash, the vehicle's speed is recorded as 74 km.p.h. (46 m.p.h) and percent throttle falls to 2% indicating the driver has removed her foot from the throttle, and supports the driver's interview statement that she applied the brakes at about the time of the impact. The EDR reports are presented in **Figures 16-18** at the end of this report.
