ON-SITE CERTIFIED ADVANCED 208- COMPLIANT VEHICLE INVESTIGATION

CASE NUMBER - IN-04-005

VEHICLE - 2003 CHEVROLET SILVERADO

CRASH DATE - December 2003

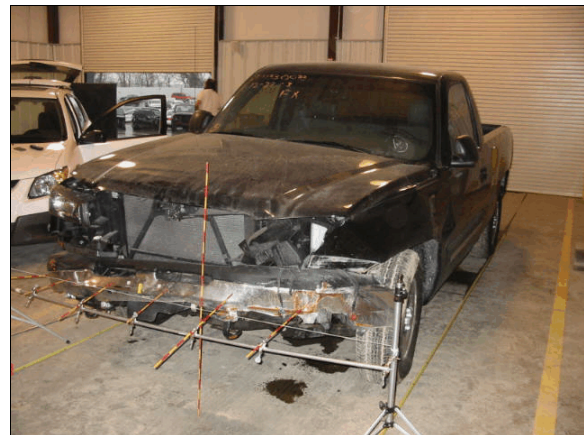
Crash: The front left (**Figure 3**) of the case vehicle impacted the concrete longitudinal median barrier, causing the case vehicle's driver and front right passenger supplemental restraints (air bags) to deploy. The EDR data indicated that only the first stage of the dual stage air bags activated. The case vehicle then deflected clockwise off the median barrier and the left quarter panel sustained a minor secondary sideswipe impact with the median barrier (**Figure 4**). As a result of the frontal impact, the case vehicle rotated clockwise an unknown number of rotations and traversed diagonally across all four lanes of northeastbound traffic. The case vehicle departed the right side of the roadway, and the front left impacted a metal guardrail. The case vehicle continued to rotate clockwise and traveled backwards, and the left quarter panel sustained a minor sideswipe impact with the guardrail (**Figure 4**).

Figure 3: Oblique view of front and left sides of case vehicle showing direct damage to the front, each stripe on rods is 5 cm (2 in), (case photo #08)

The case vehicle’s wheelbase was unaltered from the crash. The case vehicle’s front bumper, grille, left headlamp/turn lamp assemblies, left fender and hood were directly damaged and crushed rearward. The case vehicle’s windshield sustained a slight crack due to induced damage. No other obvious induced damage or remote buckling was noted to the remainder of the case vehicle’s exterior.

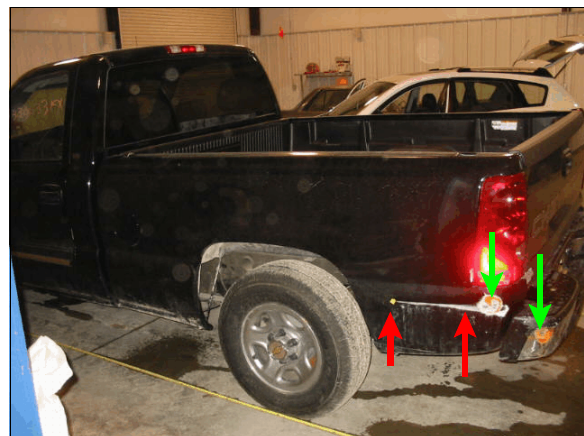
Figure 4: Damage to left quarter panel from impacts with concrete median barrier (green arrows) and guardrail [red arrows (case photo #11)]

be separated. The CDC for the case vehicle's impact with the concrete median barrier was determined to be: **11-FYEW-1 (330 degrees)**. The CDC for the guardrail impact was determined to be: **11-FYEW-1 (330 degrees)**. The CDCs for the sideswipe damages to the left quarter panel were determined to be: **12-LBES-2 (0 degrees)** for the concrete median barrier impact, and **06-LBLS-2 (180 degrees)** for the guardrail impact. The case vehicle was towed due to damage.

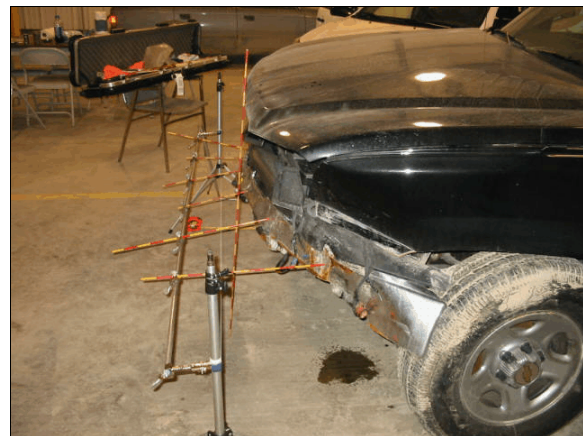
Exterior Damage: The case vehicle's contact with the concrete median barrier involved approximately the left half of the front plane including the bumper, grille, hood and front of the left fender. There was also overlapping damage from the subsequent guardrail impact in the same area. Direct damage began at the left front bumper corner and extended 82 centimeters (32.3 inches) along the front bumper. Residual maximum crush was measured as 21 centimeters (8.3 inches) at C₁ (**Figure 5**). Direct damage from the sideswipe impacts to the left quarter panel from the concrete median barrier and the guardrail began at the back left bumper corner and extended 59 centimeters (23.2 inches) forward. There was no residual crush from these impacts. The table below shows the case vehicle's crush profile.

Figure 5: Left side view of crush to front of case vehicle (case photo #09)

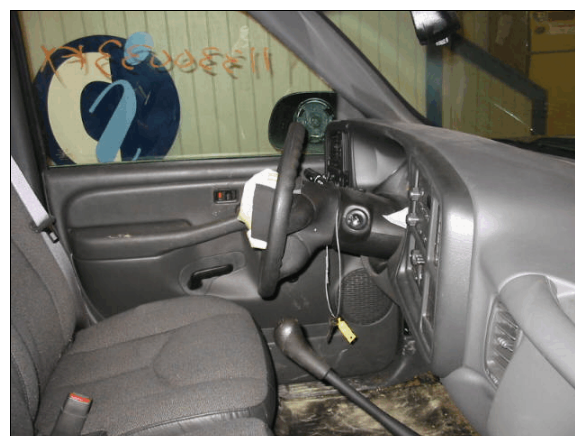
Vehicle Interior: Inspection of the case vehicle’s interior revealed a minor bend to the top of the steering wheel rim (**Figure 6**) and a contact scuff to the left side of the driver’s knee bolster (**Figure 7** below). In addition, there was no evidence of intrusion to the case vehicle’s interior. Finally, it could not be determined if there was any compression to the energy absorbing shear capsules in the steering column.

Figure 6: Case vehicle’s steering assembly viewed from right showing deformation to upper portion of rim (case photo #28)

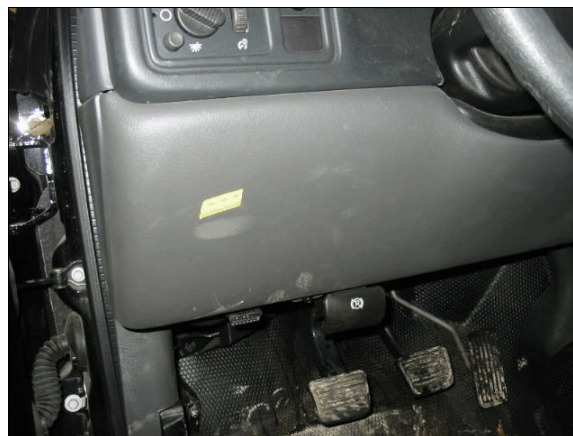
Figure 7: Tape shows scuff on driver's left knee bolster (case photo #29)

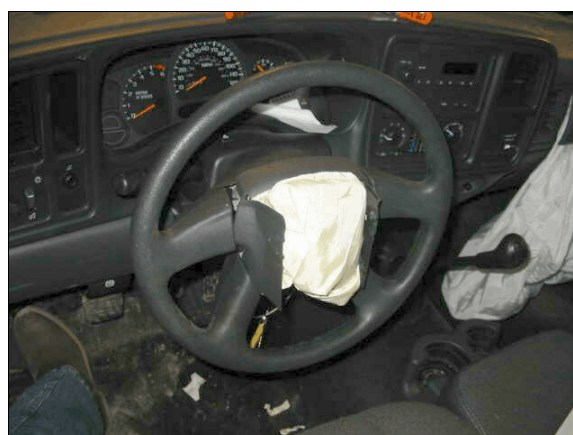
The case vehicle's driver air bag was located in the steering wheel hub. The module cover consisted of symmetrical "I"-configuration cover flaps made of thick vinyl (**Figure 8**). Each cover flap was 12 centimeters (4.7 inches) in width at the top seam, 11 centimeters (4.3) in width at the bottom seam and 11.5 centimeters (4.5) in height along the vertical seam between the two flaps. The distance between the mid-center of the driver's seat back, as positioned at the time of the vehicle inspection (i.e., seat in full rear position,

Figure 8: Case vehicle's steering wheel and air bag module flaps (case photo #32)

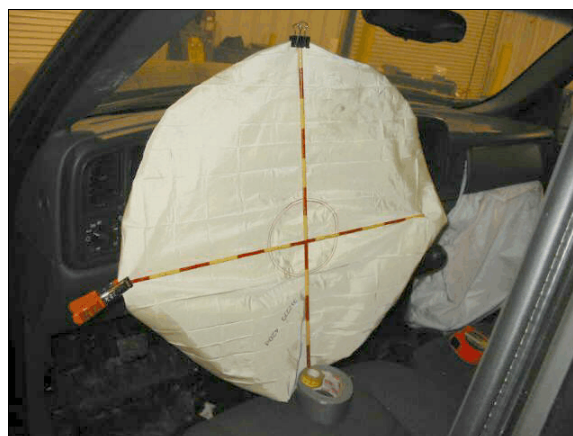
Figure 9: The driver's air bag (case photo #31)

seat back slightly reclined), and the front surface of the air bag's fabric at full excursion was 42 centimeters (16.5). An inspection of the air bag module's cover flaps and air bag fabric revealed that the cover flaps opened at the designated tear points. There was no evidence of damage during the deployment to the air bag or the cover flaps. The deployed driver's air bag (**Figure 9** above) was round with a diameter of 66 centimeters (26.0 inches), and the air bag was designed with two tethers, each approximately 14 centimeters (5.5 inches) in width. The driver's air bag had two vent ports, approximately 3 centimeters (1.2 inches) in diameter located at the 11 and 1 o'clock positions. An inspection of the driver's air bag revealed no evidence of occupant contact.

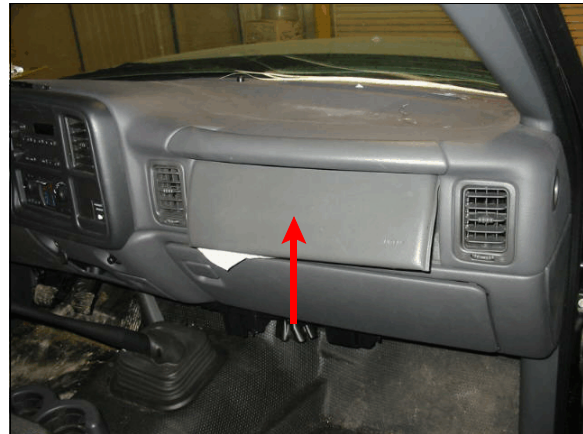
The front right passenger's air bag was located in the middle of the instrument panel. There was a single, essentially rectangular, module cover flap (**Figure 10**). The cover flap was made of semi-pliable vinyl. The cover flaps dimensions were 39 centimeters (15.4 inches) at the bottom horizontal seam and 14 centimeters (5.5 inches) along both vertical seams. The profile of the case vehicle's instrument panel was flush with the leading edge of the cover flap. The distance between the mid-center of the front right seat back, as positioned at the time of the crash (i.e., seat full rear, seat back slightly reclined), and the front surface of the air bag's fabric at full excursion was 46 centimeters (18.2 inches). An inspection of the front right air bag module's cover flap and the air bag's fabric revealed that the cover flaps opened at the designated tear points. There was no evidence of damage during the deployment to the air bag or the cover flap.

Figure 10: Overview of front right air bag module flap, indicated by arrow (case photo #38)

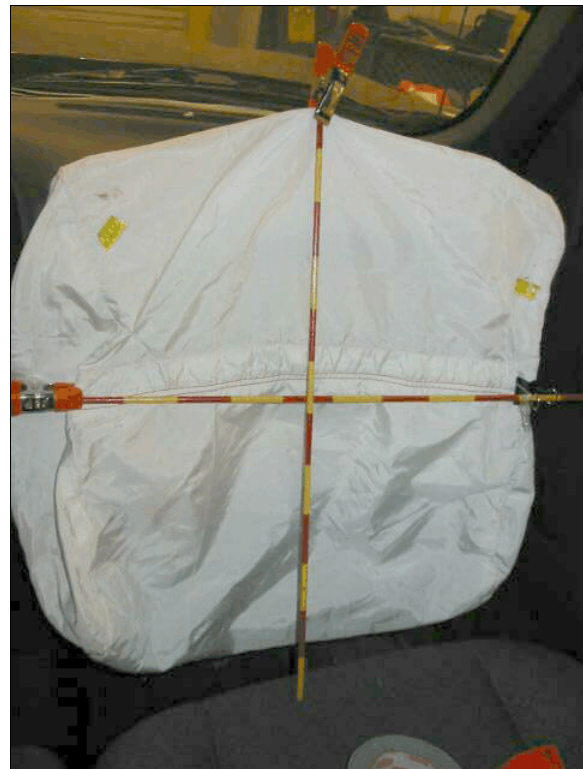
The deployed front right air bag (**Figure 11**) was rectangular with a height of approximately 49 centimeters (19.3 inches) and a width of approximately 60 centimeters (23.6 inches), and was designed with one wide tether, approximately 37 centimeters (14.6 inches) in width. The front right air bag had two vent ports, approximately 3 centimeters (1.2 inches) in diameter (**Figure 12** below), located at the 9:30 and 2:30 clock positions. An inspection of the air bag fabric revealed a pair of small blood stains on the far upper right side of the front of the bag, a blood stain on the upper left corner on the top side of the bag and a similar stain on the upper left corner of the bag, toward the front edge.

Figure 11: Front right passenger air bag. Yellow tape shows location of blood stains (case photo #33)

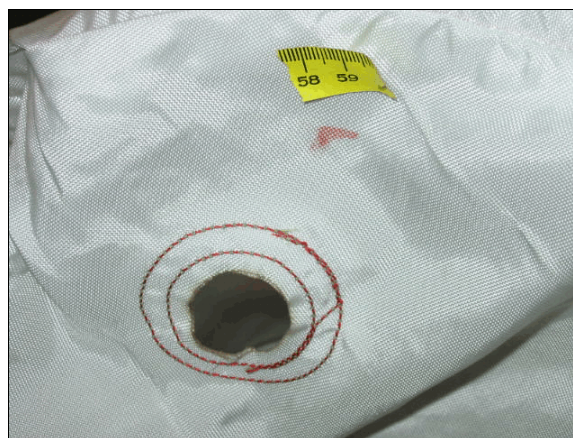
Figure 12: Vent port of left side of front right passenger air bag and blood stain (case photo #36)

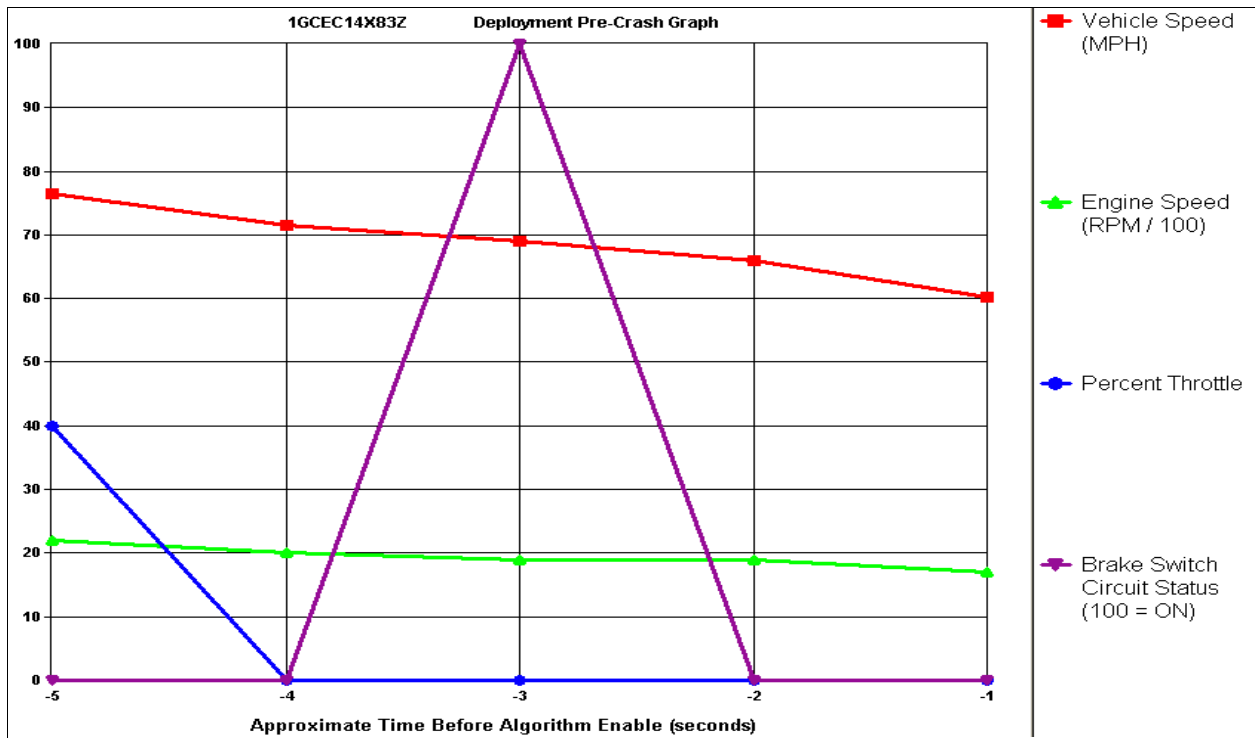
The system status report and associated graphs for the deployment event are presented in **Figures 13-15** at the end of this report. They indicate the SIR warning lamp was off, the driver's seat belt was unbuckled and the vehicle's speed was 122 km.p.h. (76 m.p.h.) five seconds prior to algorithm enable decreasing to 97 km.p.h. (60 m.p.h.) one second prior to algorithm enable. Also, the pre-crash data indicates the brake light circuit was on three seconds prior to algorithm enable, then off two seconds prior to algorithm enable and maximum SDM recorded velocity change (i.e., longitudinal component of Delta-V) was -15.5 km.p.h. (-9.62 m.p.h.) occurring at 177.5 milliseconds following algorithm enable. Lastly, the data indicate that only the first stage deployment criteria was met for the driver and front right passenger air bag modules. This occurred 30 milliseconds after the first stage time algorithm was enabled.

Figure 14: Case vehicle's Deployment Pre-Crash Graph

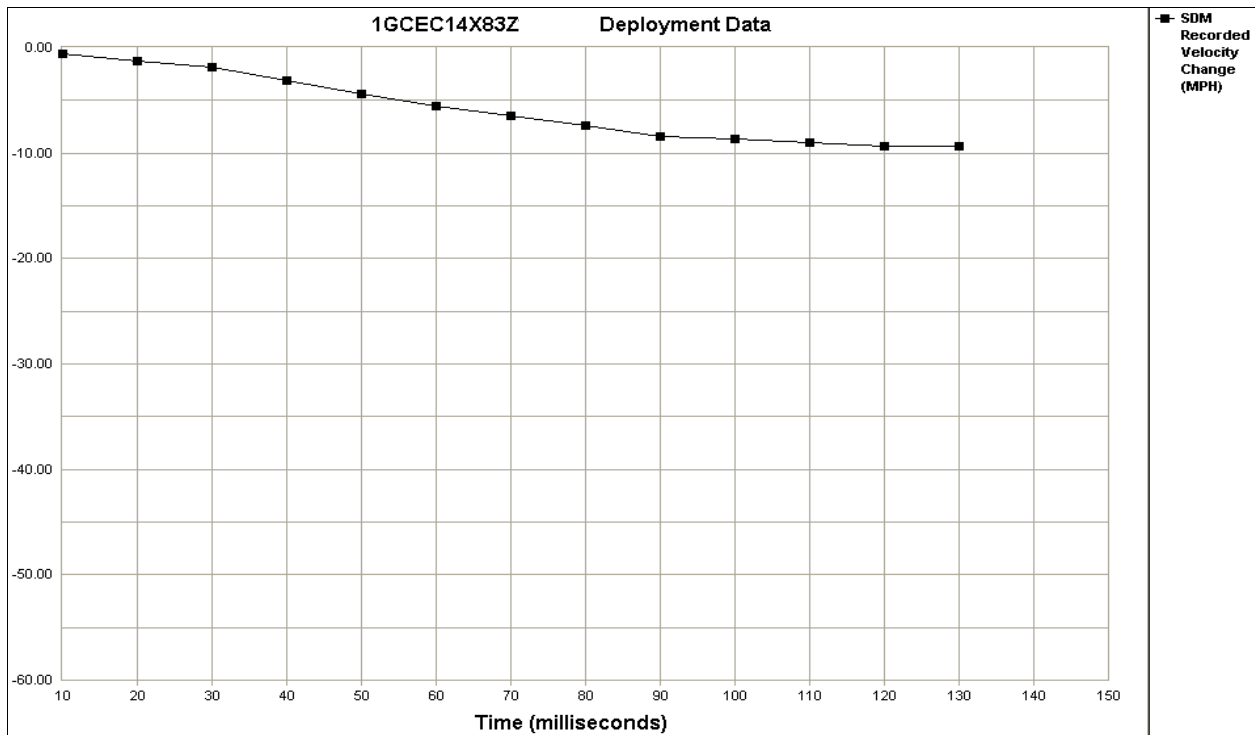
Figure 15: Case vehicle's deployment SDM Recorded Velocity Change graph

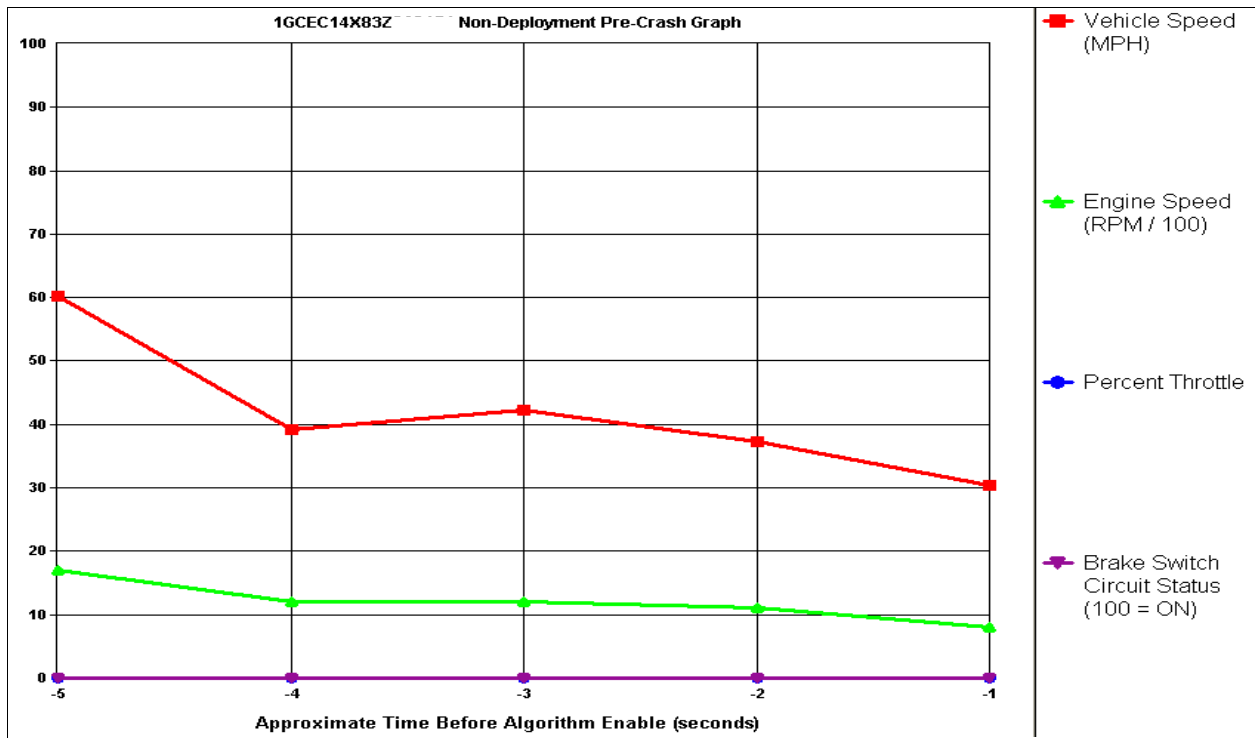
The system status report and associated graphs for the deployment level event (i.e., recorded as a non-deployment event) are presented in **Figures 16-18** at the end of this report. The data show a maximum SDM recorded velocity change of -29.6 km.p.h. (-18.37 m.p.h.) occurring at 257.5 milliseconds after algorithm enable. The data also indicate that the event recording was complete and there was one or more associated events not recorded. It appears likely that the non-recorded event was the sideswipe impact between the left quarter panel of the case vehicle and the guardrail.

Figure 17: Case vehicle's Non-Deployment Pre-Crash Graph

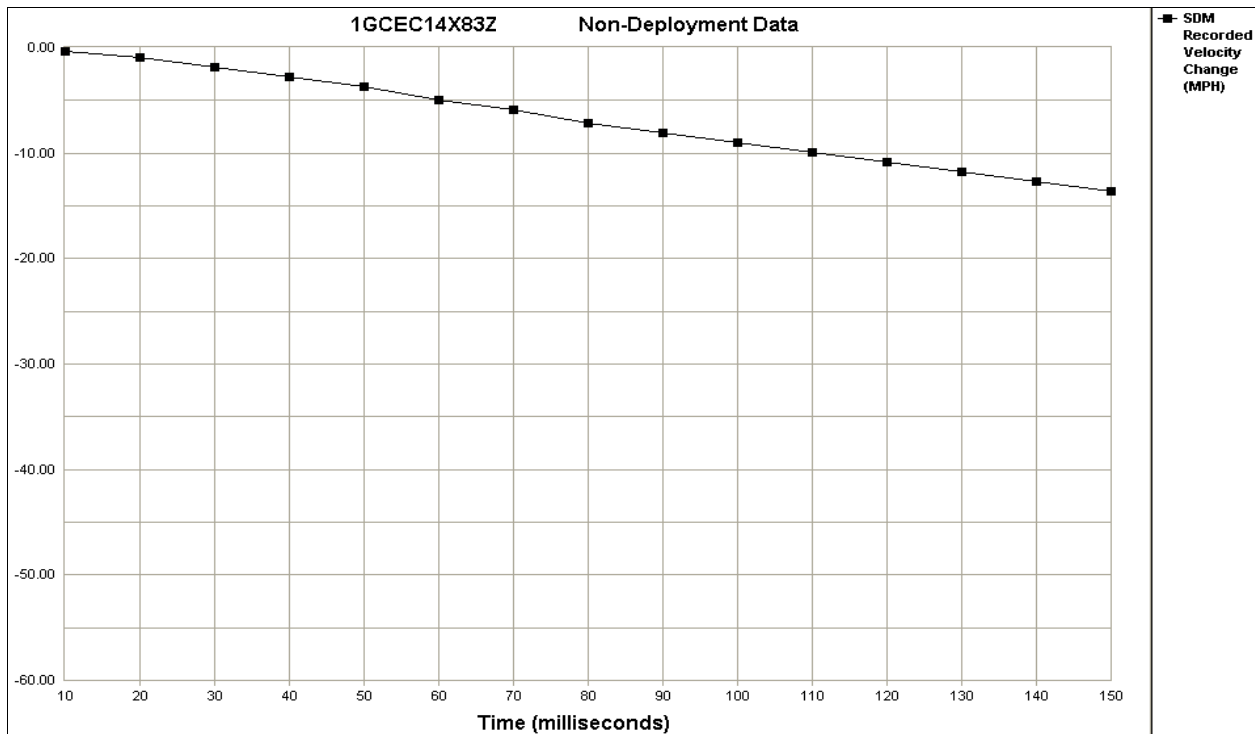
Figure 18: Case vehicle's non-deployment SDM Recorded Velocity Change graph
