Child Safety Seat Fatality Investigation / Vehicle v. Tree  
Dynamic Science, Inc. / Case Number: DS04005  
2001 Mazda Protégé  
California  
April, 2004

1. Report No. DS04005		2. Government Accession No.		3. Recipient Catalog No.	
4. Title and Subtitle  Child Safety Seat Fatality Investigation				5. Report Date September 15, 2004

**Dynamic Science, Inc.**  
**Crash Investigation**  
**Case Number: DS04005**

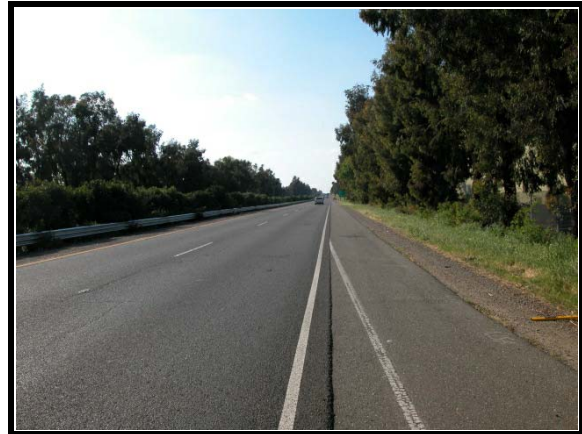
**Figure 1.** Approach to area of roadway departure (north)

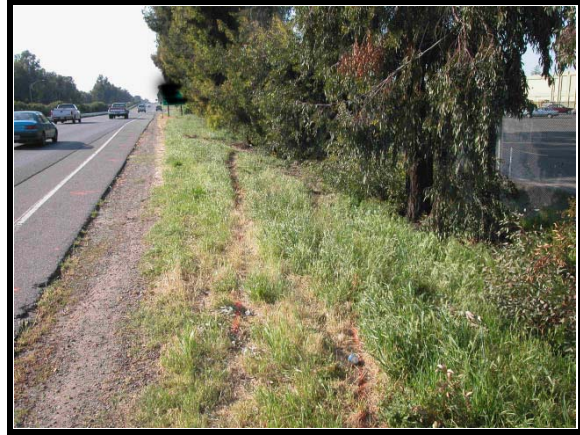
**Figure 2.** Approach to area of first and second tree impacts

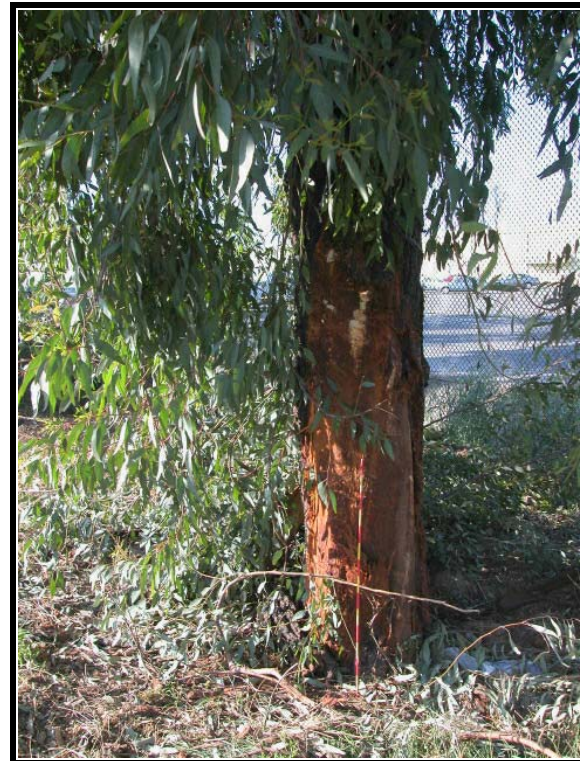
**Figure 3.** Second tree impact (impact 2)

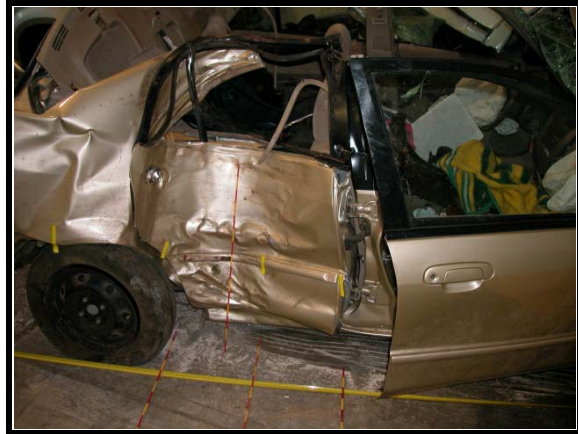
approximately 6 m (20 ft) and had rotated 90 degrees prior to striking a 58 cm (23 in) diameter eucalyptus tree with its right side (03RPAW4). The case vehicle sustained a total velocity change of 16.0 km/h (9.9 mph) as calculated using the barrier algorithm of the WinSmash program. The longitudinal and lateral components of the delta v were -2.8 km/h (-1.7 mph) and -15.8 km/h (-9.8 mph), respectively. The results appear to be low. This impact intruded significantly into the right rear passenger seating area. The right side C pillar/roof transition was forced into the head of the seated child occupant and she was killed instantly. The impact caused the case vehicle to rotate sharply 180 degree where it struck a 45 cm (18 in) in diameter eucalyptus tree with its left rear (09LBEN4). The case vehicle sustained a total velocity change of 26.0 km/h (16.2 mph) as calculated using the barrier algorithm of the WinSmash program. The longitudinal and lateral components of the delta v were 0 km/h (0 mph) and 26.0 km/h (16.2 mph), respectively.

**Figure 4.** Right side impact (impact 2)

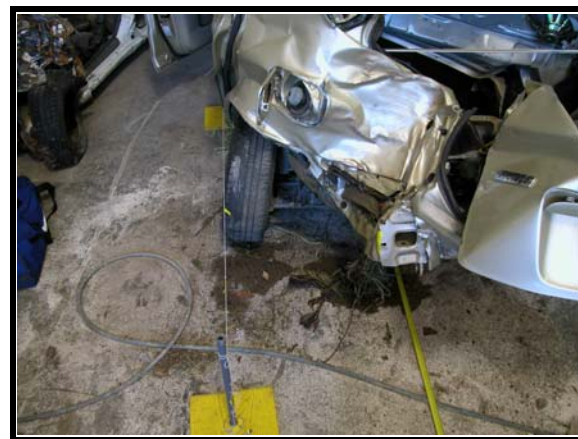
**Figure 5.** Left side impact with third tree

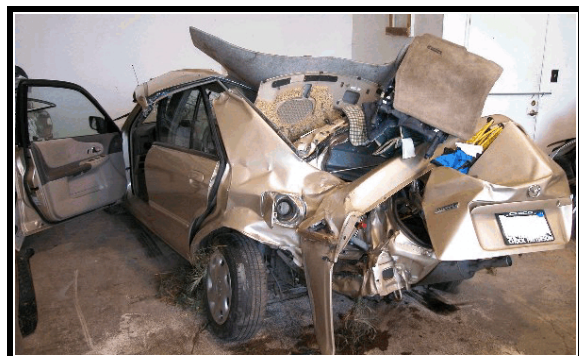
**Figure 8.** Left side impact (impact 3)

The vehicle sustained 39.0 cm (15.4 in) of direct contact to the left side from the impact with the third tree. The damage began 25.0 cm (9.8 in) rear of the left rear axle and extended forward. The residual crush as measured above the sill was as follows: C1=47.0 cm (18.5 in), C2=45.0 cm (17.7 in), C3=2.0 cm (0.8 in), C4=0 cm (0 in). The maximum crush fell at C1.

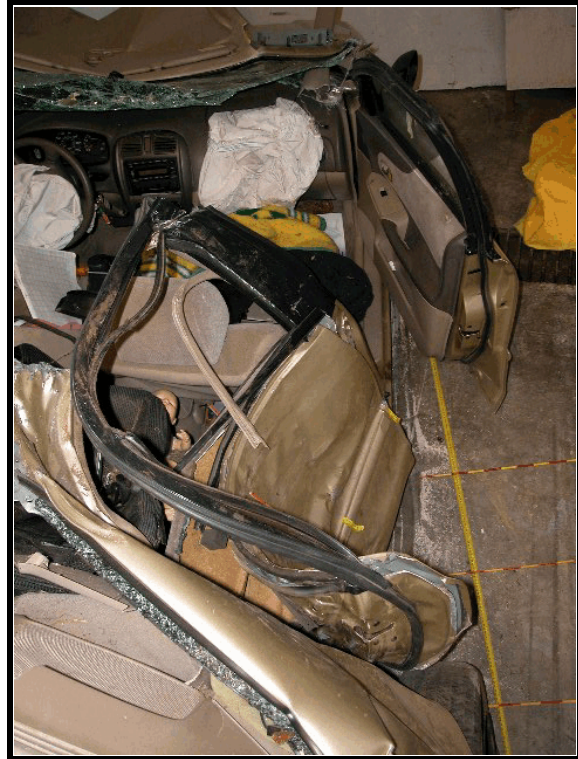
The case vehicle sustained 85.0 cm (33.4 in) of direct contact to the right side from the impact with the second tree. The damage began 10.0 cm (3.9 in) forward of the right rear axle and extended forward. The residual crush as measured above the sill was as follows: C1=3.0 cm (1.2 in), C2=16.0 cm (6.3 in), C3=26.0 cm (10.2 in), C4=12.0 cm (4.7 in). The maximum crush fell between C2/C3 and measured 27.0 cm (10.6 in). The principle direction of force was within the 3 o'clock sector and was an estimated 80 degrees.

The damaged components included the right side door area and the left rear quarter panel. The rear bumper was knocked off during the impact with the second tree. The wheelbase was lengthened by 2.0 cm (0.8 in) on the right side and shortened by 10.0 cm (3.9 in) on the left.

**Figure 9.** Right side impact (impact 2)

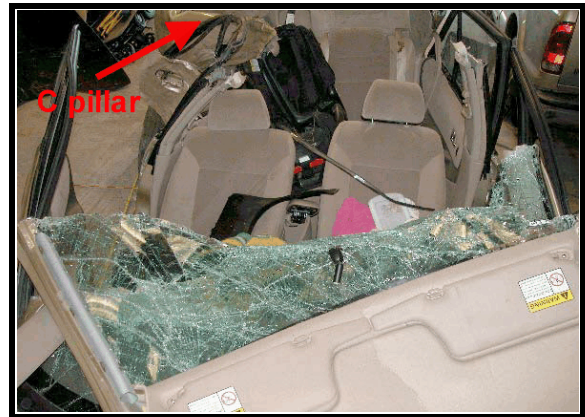
The Protégé sustained substantial interior damage from both intrusion and occupants contacts. There was intrusion primarily through the right rear that included the C pillar, roof, B pillar, sill, and door side panel. The C pillar and roof transition came into direct contact with the head of the rear seat child occupant. Blood and tissue was found at this location. A blood and tissue spray pattern from the rear seat occupant traversed the top of the rear deck as a result of the final tree impact. A substantial amount of tissue came to rest on the shoulder harness at the left rear seat location. There were loading contacts to the center console and the left side of the right front seat. Both rear doors were jammed shut. Passenger compartment integrity was lost through the backlight and the right rear window.

Figure 10. Overview of right side intrusion

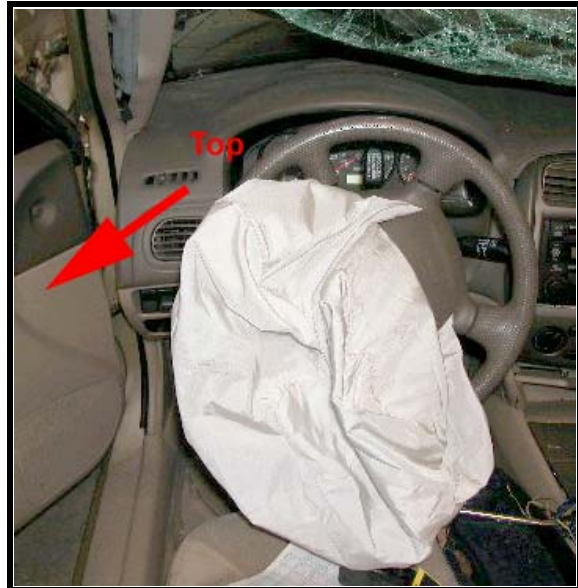
The driver's air bag was mounted in the steering column. It measured 46.0 cm (18.1 in) in diameter in its deflated state. It was equipped with two vent ports at the 11 and 1 o'clock positions. It was equipped with a single tether. There were eight horizontal folds on the air bag face. The air bag module cover had an H configuration and measured 17.0 cm (6.7 in) wide by 6.0 cm (2.4 in) high on the top and 17.0 cm (6.7 in) wide by 7.0 cm (2.8 in) high on the bottom. There was no damage to the air bag or the module cover.

Figure 11. Driver's air bag

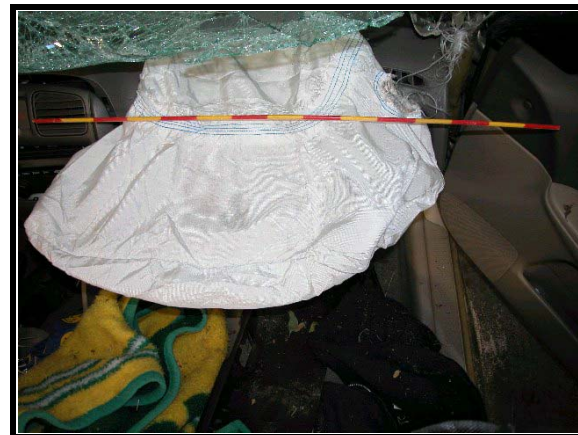
The front right passenger air bag had a top mount installation. It measured 65.0 cm (25.6 in) wide seam to seam and 63.0 cm (24.8 in) high. There were two circular vent ports at the 3 and 9 o'clock positions. The module cover was generally rectangular in shape and measured 33.0 cm (12.9 in) wide by 11.0 cm (4.3 in) high. There were no indications of any damage or contact to either the air bag or the module cover.

Figure 12. Front right passenger air bag

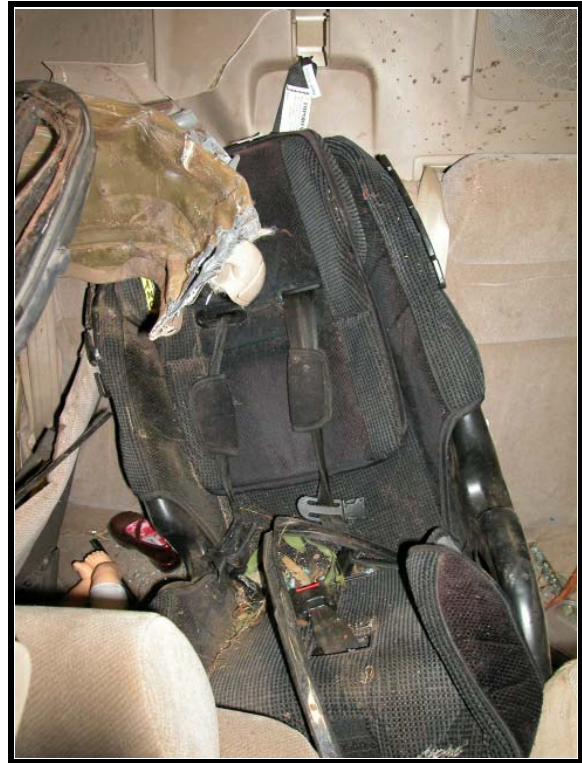
The Cosco Alpha Omega convertible child seat was found in the case vehicle during the vehicle inspection. It was anchored to the vehicle using the available lap and shoulder belt in the middle seat position. This seat position was equipped with a switchable retractor that appears to have been switched to the automatic locking retractor (ALR) mode. The child seat was further secured by a top tether. The harness was threaded through the top slots. A chest clip was available but its location is not known. The right side of the seat was fractured during the crash. The left side of the seat was rotated upward and to the right 17.0 cm (6.7 in) from the seat bottom.

**Figure 13.** Cosco Alpha Omega convertible child safety seat (C-pillar to left side of image)

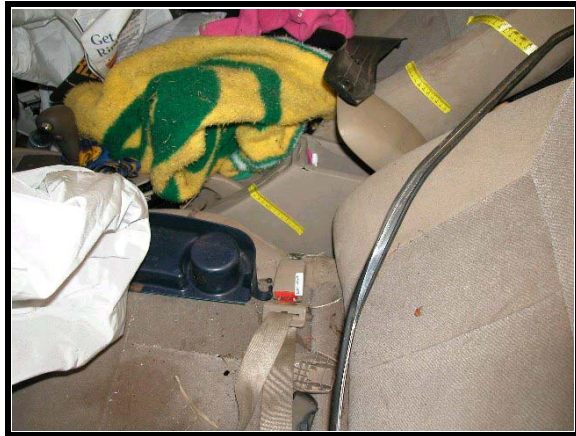
**Figure 14.** Driver contact to upper center console and right seat back

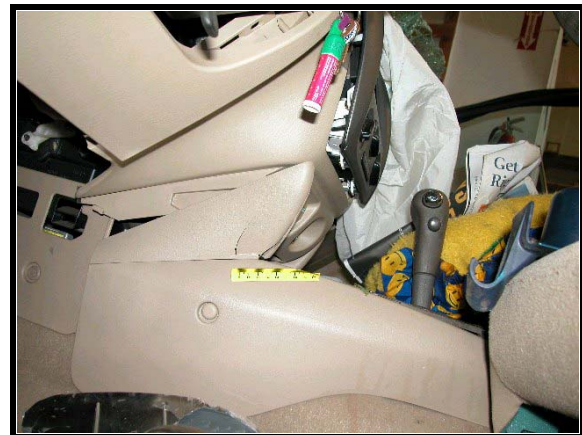
**Figure 15.** Driver contact to lower center console

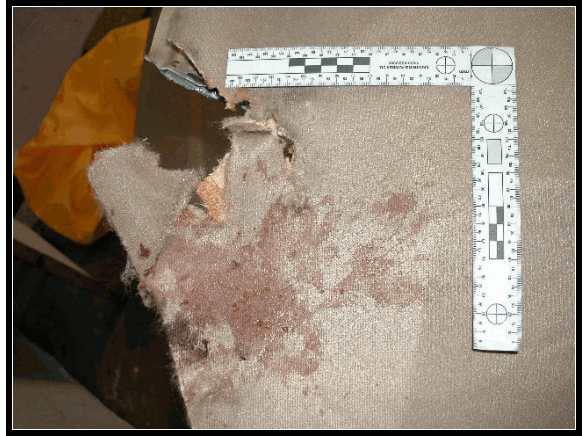
side of the child occupant's head causing the fatal head injuries. The case vehicle rotated sharply in a clockwise direction before striking the third tree with its left side. At impact with the third tree the child and child seat pitched to the left to some degree. Body fluid and tissue formed a splatter pattern along the top of the rear seat and onto the left side of the vehicle. The right side of the seat was fractured during the impact with the second tree. The left side of the seat was rotated upward and to the right 17.0 cm (6.7 in) from the seat bottom.

**Figure 16.** Head contact to right C pillar/roof transition

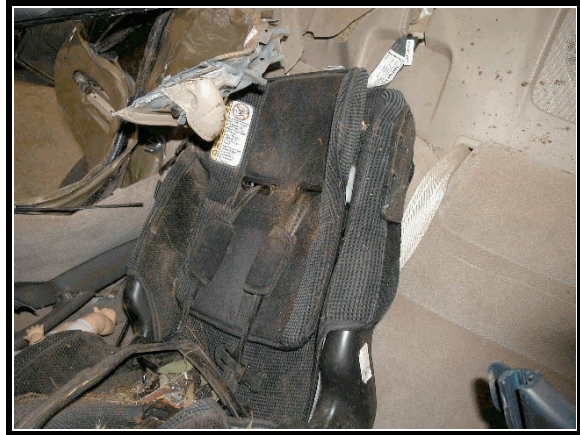
**Figure 17.** Child seat with view of intruding C pillar and splatter pattern to right of image
