ON-SITE CHILD AIR BAG-RELATED FATALITY INVESTIGATION

CASE NUMBER - IN-04-006
LOCATION - Louisiana
VEHICLE - 1999 HYUNDAI ELANTRA
CRASH DATE - February 2004

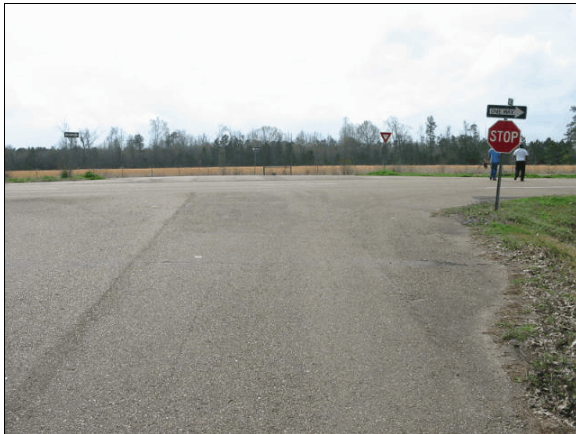
Figure 2: Approach of the Ford south southwest bound to the intersection

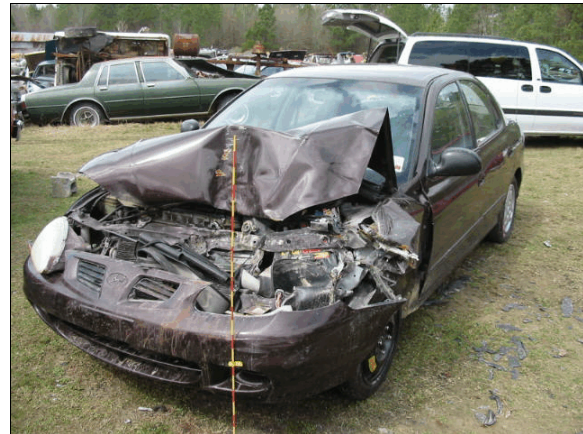
Figure 3: Overview of damage to front of case vehicle from impact with the Ford

Exterior Damage: The case vehicle’s contact with the Ford involved the front bumper, bumper fascia, grille, hood, and left fender. Direct damage began at the front left bumper corner and extended 75 centimeters (29.5 inches), along the front bumper. Due to significant damage above the front bumper as a result of the underride, the C-Measurements were taken at the bumper level and along the upper radiator support. The crush values were averaged at C₁, C₂, and C₃. Residual crush at the bumper was 0 centimeters along the entire front bumper. The residual maximum crush above the bumper was 26 centimeters (10.2 inches) occurring at C₁ (**Figure 7** below). The case vehicle’s front bumper, bumper fascia, grille, radiator, left turn signal and headlamp assemblies, left fender and hood were directly damaged and crushed rearward. The case vehicle’s average front crush values are shown in the table below.

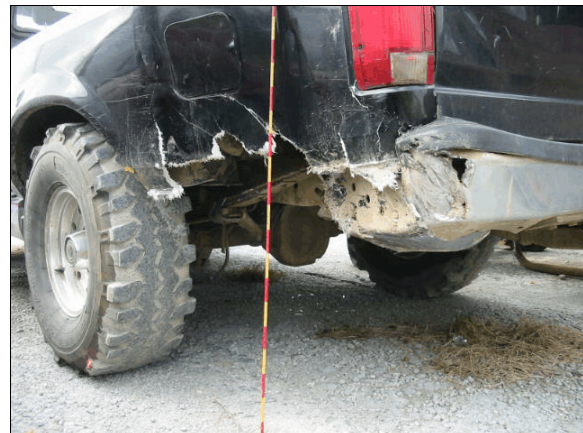
Figure 4: Damage to left rear side of Ford's truck bed from impact with the case vehicle

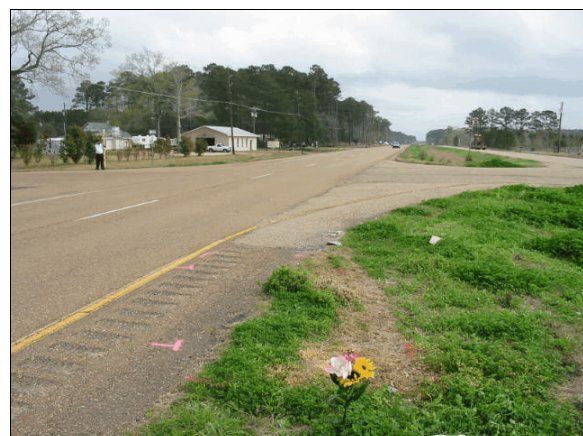
Figure 5: Case vehicle's final rest position partially on shoulder and in median, view is back to impact area

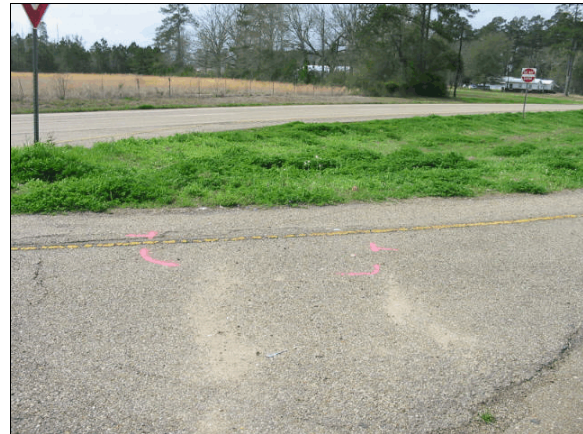
Figure 6: Final rest location of the Ford (indicated by pink lines) partially on shoulder and in median, view is south southwest

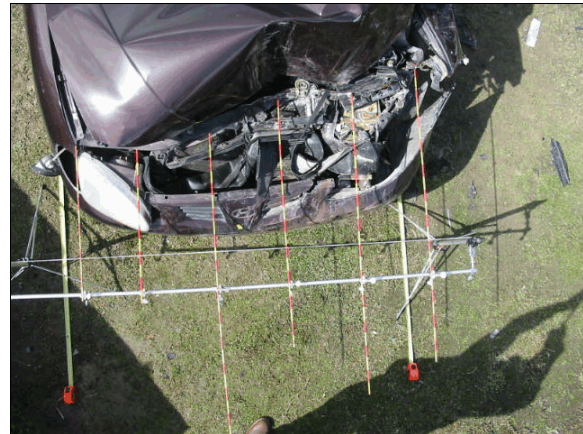
Figure 7: Top view of above bumper crush to case vehicle, each stripe on rods in 5 cm (2 in)

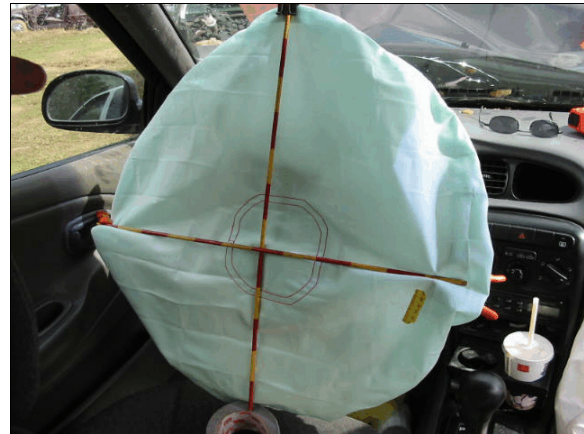
Figure 9: Overview of case vehicle’s driver air bag, yellow tape shows light scuff on air bag, which appeared related to deployment

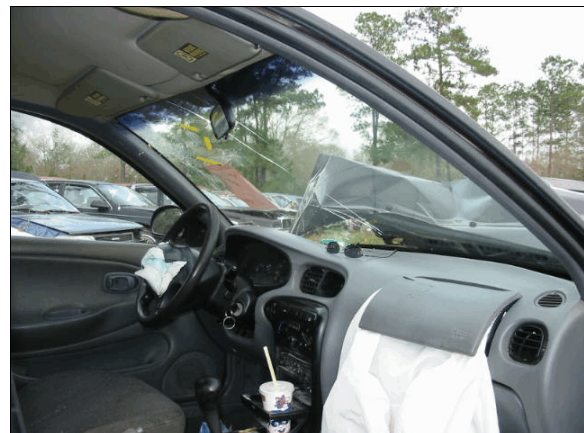
The front right passenger’s air bag was located on the top of the instrument panel (Figure 10). An inspection of the air bag module cover flap and air bag fabric revealed that the cover flap opened at the designated tear points. There was no damage to the cover flap or the air bag due to the deployment. However, there were cracks in the exterior vinyl of the cover flap as well as skin transfers on the cover flap (Figure 11) indicating the unrestrained front right passenger was projected forward into the instrument panel due to driver braking and was in contact with the module cover flap when the air bag deployed. The single module cover flap was rectangular in shape and constructed of thick vinyl. The cover flap was 18.5 centimeters (7.3 inches) in width and 30.5 centimeters (12 inches) in height. The leading edge of the cover flap was flush with the front edge of the instrument panel. The front right passenger’s air bag was designed without tethers

Figure 10: Overview of location of front right air bag and case vehicle’s instrument panel, windshield and steering wheel

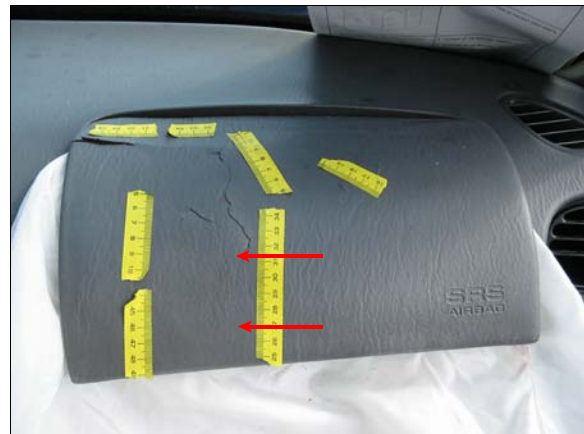
Figure 11: Case vehicle’s front right passenger air bag module cover flap, yellow tape outlines damage to flap as well as area of skin transfer (arrows) due to contact with front right passenger

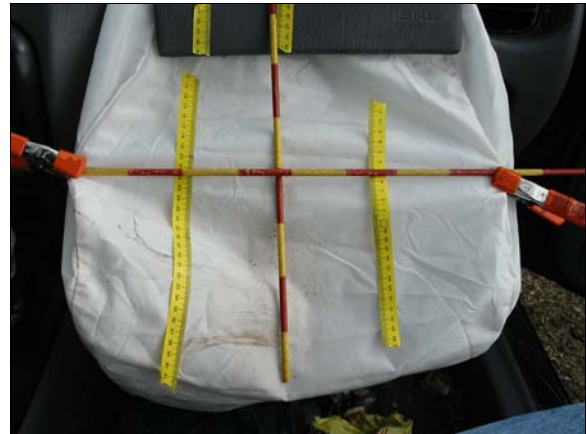
Figure 12: Case vehicle's front right passenger air bag, yellow tape outlines area of skin transfer on air bag and module cover flap and possible cloth transfer on air bag

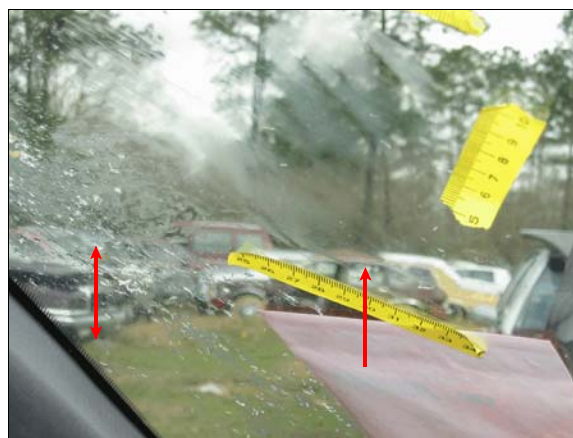
Figure 13: Hand print (single head arrow) and food deposit (double head arrow) on windshield

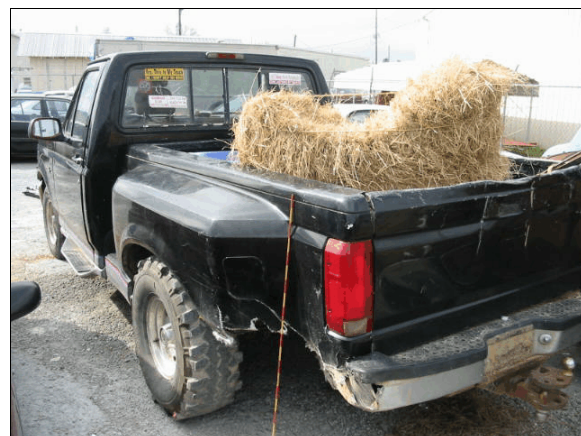
Exterior Damage: The Ford’s impact with the case vehicle involved the left rear portion of the truck bed and the left corner of the back bumper (**Figure 14**). The direct damage began at the left corner of the back bumper and extended 85 centimeters along the left side of the truck bed and fender. Crush values could not be obtained because the left side of the truck bed and the fender were made of fiberglass. The fiberglass in the contact area had fractured and broken away from the vehicle as a result of the crash.

Figure 14: Overview of damage to left rear side of Ford from impact with the case vehicle
