Child safety seat fatality Investigation / Vehicle to Vehicle
Dynamic Science, Inc. / Case Number: DS04007
1994 Oldsmobile Cutlass
Colorado
April, 2004

| 4. Title and Subtitle Child safety seat fatality Investigation | | | 5. Report Date September 10, 2004 | |
| 7. Author(s) Dynamic Science, Inc. | | | 8. Performing Organization Report No. | |

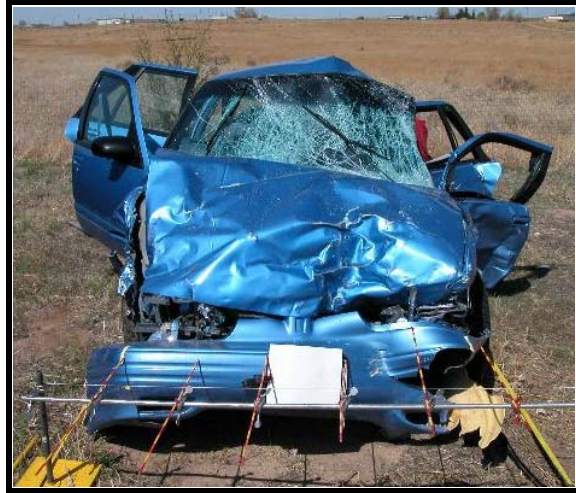
Figure 5. Front of case vehicle (Oldsmobile Cutlass)

Direct damage from the impact with the Buick LeSabre began at the left front bumper corner. It extended across the entire end width and measured 136.0 cm (53.5 in). A crush profile was taken at the bumper which measured: C1= 33.0 cm (12.9 in), C2= 49.0 cm (12.3 in), C3=40.0 cm (15.7 in), C4=26.0 cm (10.2 in), C5=15.0 cm (5.9 in), C6=9.0 cm (3.5 in). The maximum crush was found between C2/C3 and measured 50.0 cm (19.7 in).

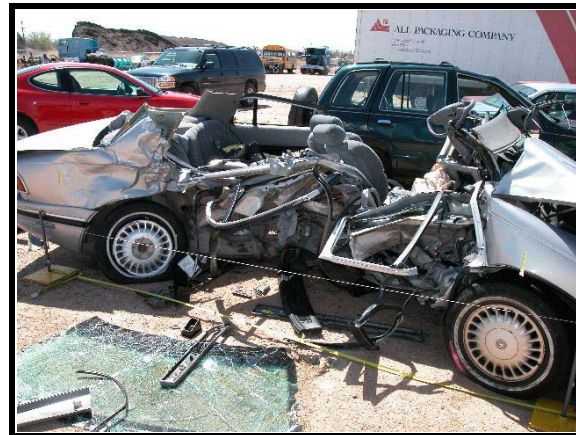
Figure 4. Right side, other vehicle (Buick LeSabre)

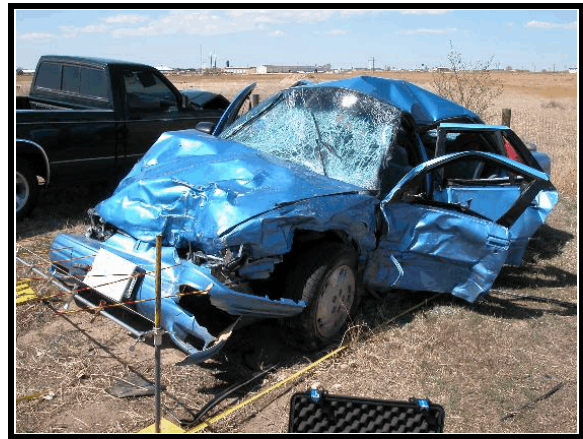
Figure 7. Front left, Oldsmobile Cutlass

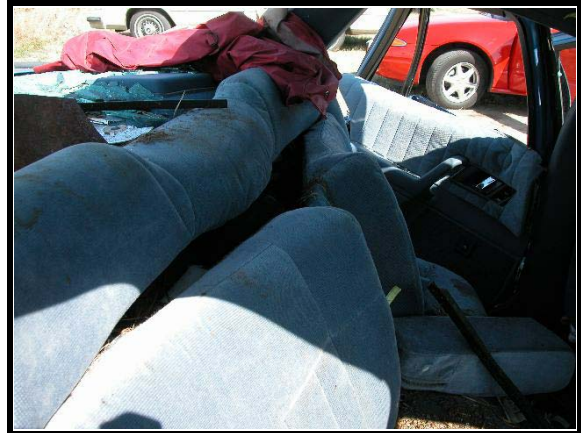
Both halves of the rear bench seat back and the rear center fold-down arm failed due to loading from the trunk area. The bottoms of the two seat backs are held in place by metal pins that are inserted into holes at the center and at both outboard ends—forming a hinge. In normal operation, the seat rotates about the left and right hinges as this seat is folded down to allow access to the trunk area. At impact, the seat backs were loaded from materials in the trunk and forced forward. This forced the pins out of the respective holes at the left, middle left, and middle right positions (as seen facing toward the front of the vehicle). The right pin remained in place. The trunk lid was jammed shut but the materials in the trunk as viewed from the inside of the vehicle rearward consisted of two soft luggage bags and a bag containing travel materials (i.e., hair dryer, cosmetics, etc.). None of the bags appear to weigh more than 23 kg (50 lbs) as they were moved about by this investigator.

Figure 11. Overview of rear seat failure/intrusion

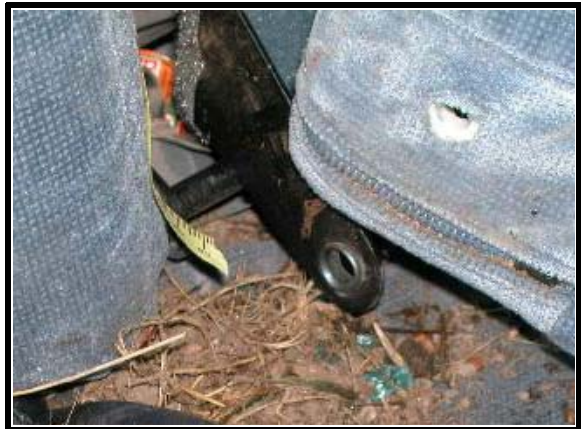
Figure 10. View of the bottom of the right rear seat back, the center arm rest, and the pin and pin hole

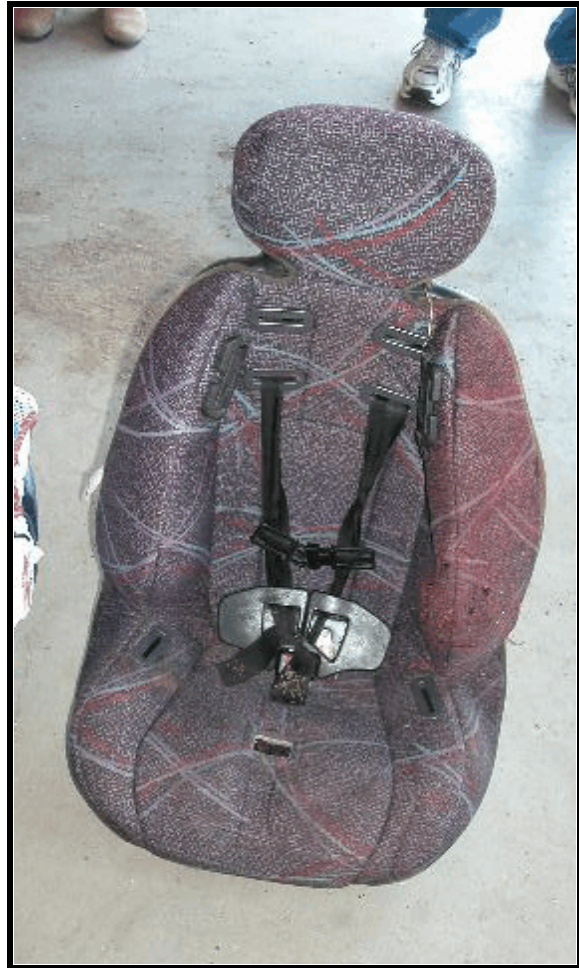
The rear left seat was occupied by a 3-year-old female who was seated in a Century Breverra Premier booster seat (Model 4885, manufacture date 2/27/97)¹. This seat is designed to be used with or without the 5-point harness system, depending on the weight and height of the child. In this case, the seat was being used with the harness system threaded in a 3-point mode. For use of this seat, the manufacture states that the child must meet the following requirements: weight is 14-18 kg (30-40 lbs), height is 89-103 cm (35-43 in), the child is able to sit upright unassisted, and the child's shoulders are not above the top harness slots. It is not known if the child met the height and requirements, though she would likely be nearer to the upper end of the usage range. The harness was threaded through the lower harness slots. Also, at some point the harness had been removed and then re-threaded incorrectly. The hip harness slots were bypassed, essentially converting the seat from a 5-point restraint to a 3-point restraint. The child seat was anchored to the vehicle using the available lap and shoulder belt. The lap and shoulder belt was equipped with an switchable retractor. It is not known if the retractor was in the automatic locking retractor (ALR) or emergency locking retractor (ELR) mode. There was no indication that a locking clip was used. According to first responders, the child seat was tightly in place and the seat belt needed to be cut in order to remove the seat. However, given the deformation of the rear seat back, slack in the vehicle restraint system would have been reduced or eliminated.

Figure 12. Century Breverra Premier booster seat (rear left)

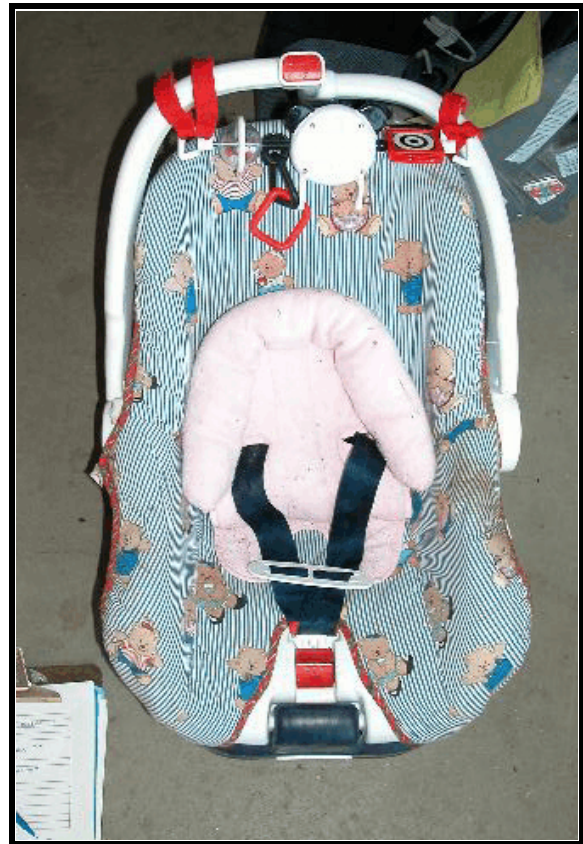
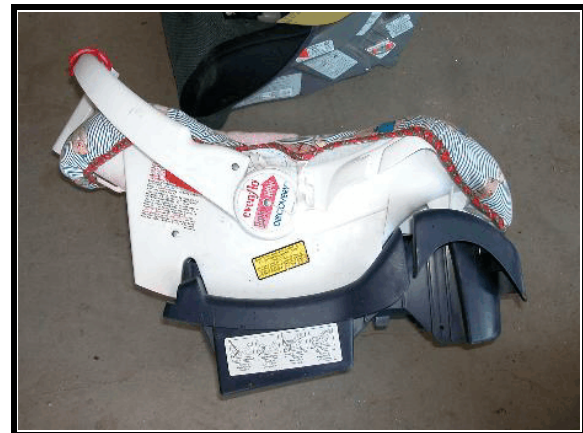
The rear middle seat was occupied by a 4-month-old female 7 kg (16 lbs) who was seated in a rear facing Evenflo Discovery infant safety seat (Model 2093 M9, manufactured date 7/24/2001). The manufacturer recommends that the seat be used for infants weighing 2-8 kg (5-20 lbs). The seat was attached to the base and the base was anchored to the vehicle using the available lap belt. The carrying handle was in the down position and the shoulder harnesses were in the lower slots. According to first responders, the infant seat was tightly anchored to the vehicle. However, given the deformation of the rear seat back, slack in the vehicle restraint system would have been reduced or eliminated.

Figure 13. Evenflo Discovery infant safety seat (rear middle)

Figure 14. Evenflo Discovery infant safety seat (rear middle)

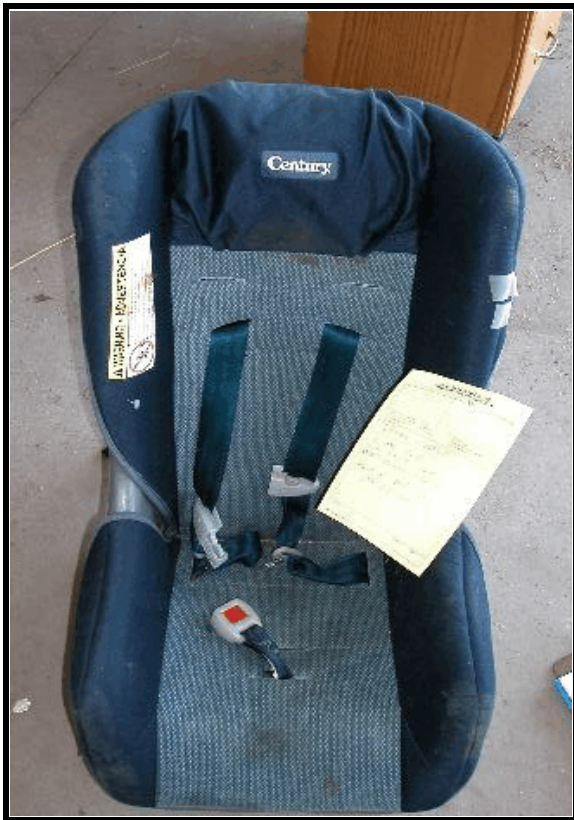
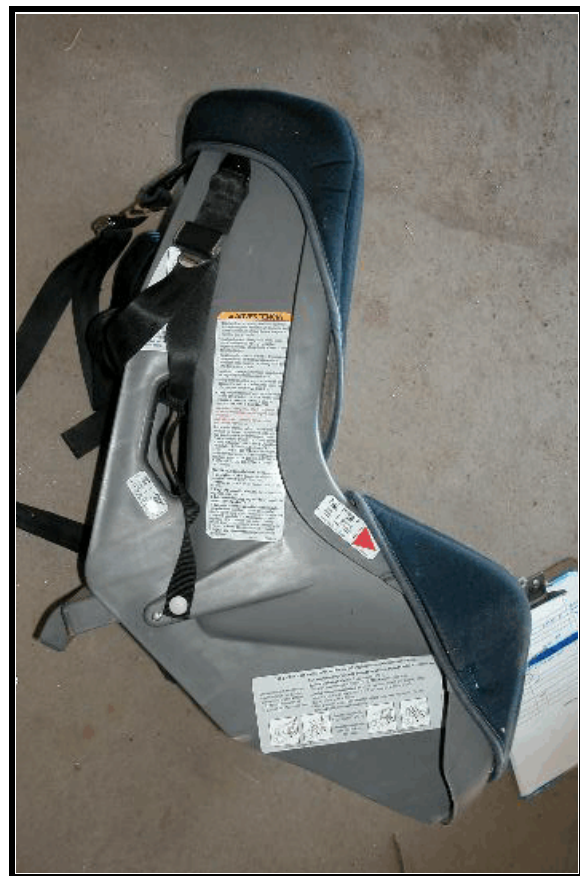
The rear right seat was occupied by a 2-year-old male who was seated in a Century 1000 STE convertible safety seat (manufacture date 8/21/2002). This seat is designed to be used in the rear facing mode for children weighing 10 kg (22 lbs) or less, or if the child is less than a year old. It is designed to be used in the forward facing mode for children weighing 18 kg (40 lbs) or less. In this crash the seat was being used in the forward facing mode and the harness was threaded through the middle set of slots. The five point harness was latched. The retainer clip was found to be in a low position at the time of inspection. The child seat was anchored to the vehicle using the available lap and shoulder belt. The lap and shoulder belt was equipped with a switchable retractor. It is not known if the retractor was in the ALR or ELR mode. There was no indication that a locking clip was used.

Figure 15. Century 1000 STE convertible safety seat (rear right)

Figure 16. Century 1000 STE convertible safety seat (rear right)

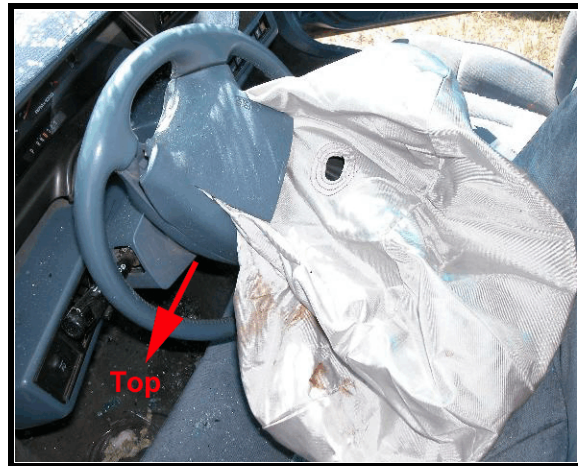
The 1994 Oldsmobile was equipped with a driver's frontal air bag that deployed as a result of the impact with the 1997 Buick LeSabre. The driver's air bag was housed in the steering wheel hub split I configuration cover flaps. The top and bottom flaps measured 16.0 cm (6.3 in) wide, 8.0 by 8.0 cm (3.1 by 3.1 in). The center vertical tear seam measured 13.0 cm (5.1 in). The driver's air bag was circular in shape and measured 48.0 cm (18.9 in) in diameter in its deflated state. There were nine horizontal folds. The air bag was vented by two circular ports which were located at the 3 and 9 o'clock positions on the rear aspect. There were no tethers. There were post-crash drip blood patterns found on both the air bag face and the back of the air bag.

Figure 17. Driver's air bag

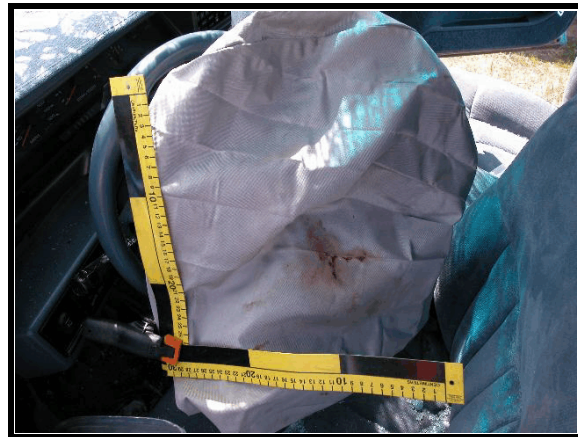
Figure 18. Blood drip pattern on air bag face

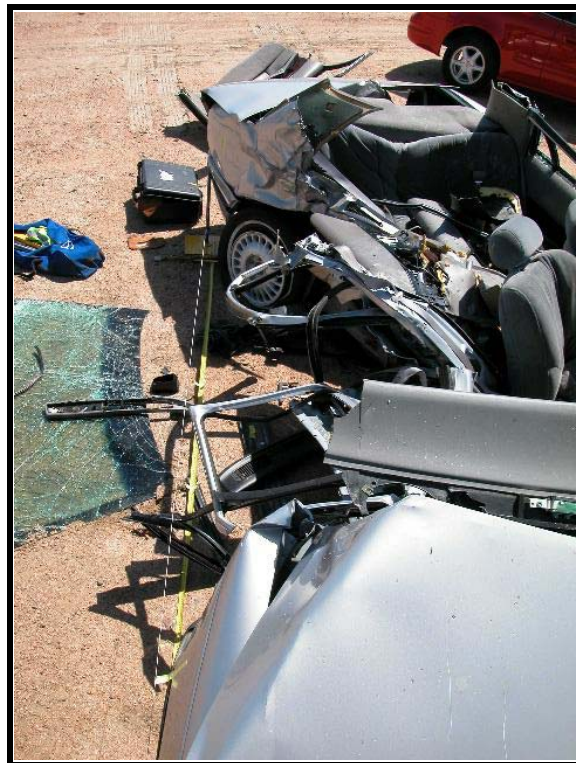
Direct damage began 50.0 cm (21.7 in) rear of the rear axle and extended forward 246.0 cm (96.8 in). The direct plus induced damage began 55.00 cm (21.7 in) rear of the rear axle and extended forward 286.0 cm (112.6 in). Measurements were taken generally along the sill and measured as follows: C1 = 0 cm (0 in), C2 = 63.0 cm (24.8 in), C3 = 113.0 cm (44.5 in), C4 = 77.0 cm (30.3 in), C5 = 40.0 cm (15.7 in), C6 = 0 cm (0 in).

Figure 19. Overhead view of Buick, looking towards rear of vehicle

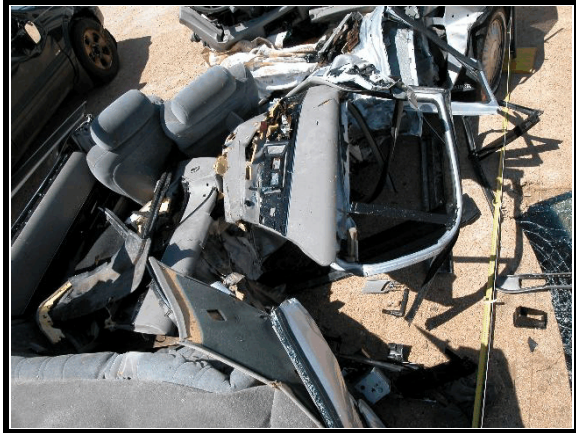
Figure 20. Overhead view of side damage as seen from the rear of the vehicle (1997 Buick LeSabre)

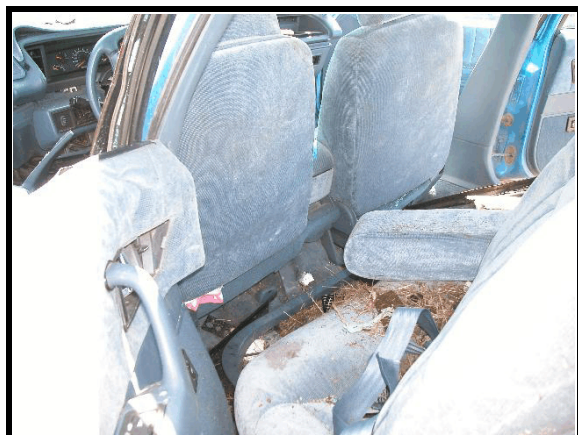
The rear left seat was occupied by a 3-year-old female who was seated in a Century Breverra Premier booster seat (see Attachment 3). It is not known if the child met the height and requirements, though she would likely be nearer to the upper end of the usage range given her age. The harness was threaded through the lower harness slots. At some point in the past the harness had been removed and then re-threaded incorrectly. The hip harness slots were bypassed, essentially converting the seat from a 5-point restraint to a 3-point restraint. The crotch strap is connected to the seat structure using a metal bar that is attached to the base of the seat. At impact, the rear left seat occupant loaded the crotch strap and it failed at the webbing. This occupant sustained abrasions to the chest, abdomen, and vulva as the child seat harness was initially loaded. As the harness failed, this occupant pitched out of the child seat and struck the rear of the driver's seat causing the multiple head and brain injuries which were ultimately fatal.

Figure 25. Back of driver's seat

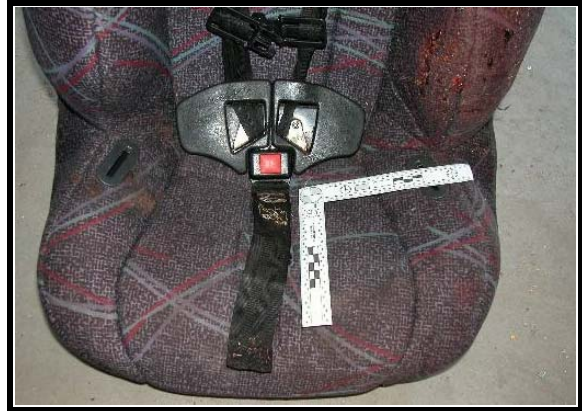
The Century Breverra Premier booster seat in the left rear seat position was being used with the harness modified as a 3 point system. The harness was threaded through the lower harness slots. At some point in the past the harness had been removed and then re-threaded incorrectly. The hip harness slots were bypassed, essentially converting the seat from a 5-point restraint to a 3-point restraint.

Figure 27. Seat from case vehicle, upper thigh straps not in place

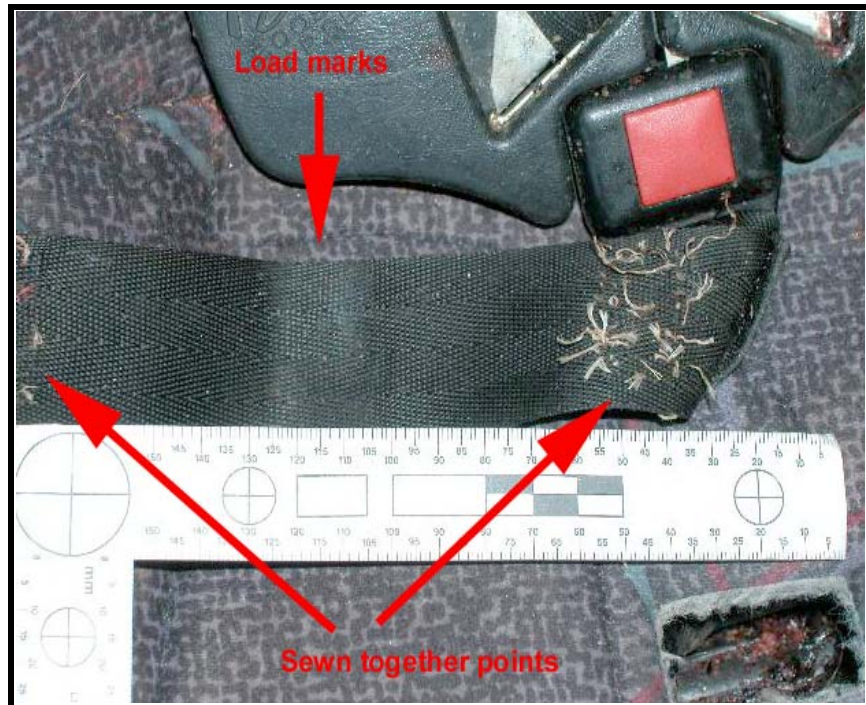
The crotch strap with buckle is connected to the seat structure using a metal bar that is attached to the base of the seat. The strap passes through the seat cushion, through a slot in the seat base, loops around the bar, and returns back through the slot and the seat cushion, and then is fixed in place by stitches to the buckle. The strap can be removed by removing the metal bar. At impact, the rear left seat occupant loaded the crotch strap and it failed at the webbing. The metal bar remained in place and undamaged.

Figure 29. Crotch strap

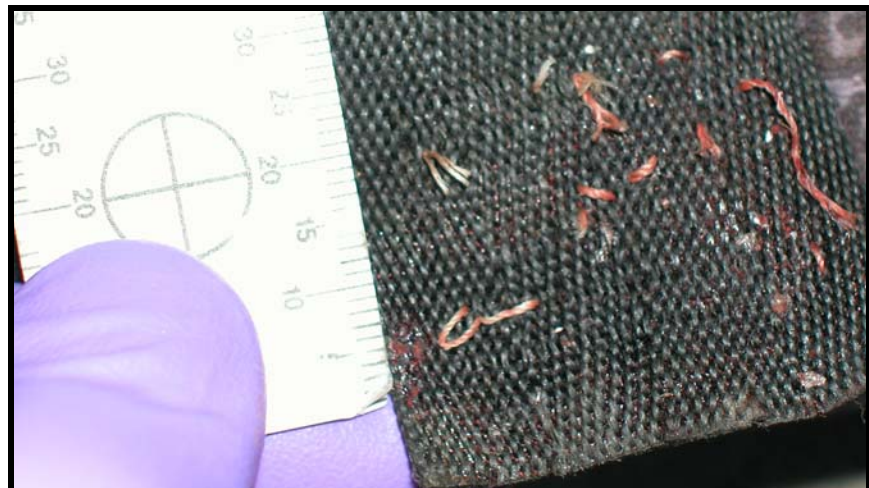
Figure 30. Close up of stitching to end furthest from latch
