**CALSPAN ON-SITE ADVANCED OCCUPANT PROTECTION SYSTEM  
CRASH INVESTIGATION**

**CASE NO: CA04-007**

**VEHICLE: 2004 LEXUS LS430**

**CRASH DATE: FEBRUARY 2004**

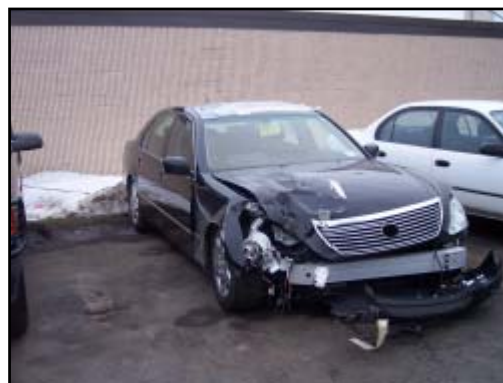
**Figure 1. Damaged 2004 Lexus LS430**

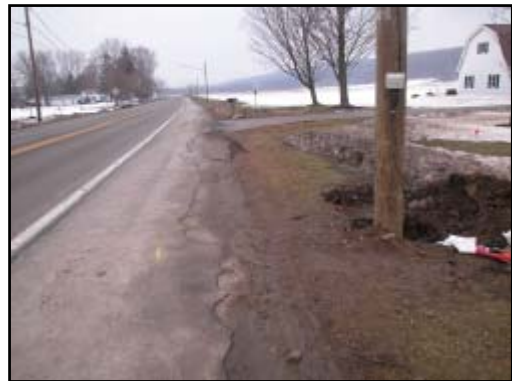
**Figure 2. View of utility pole (replaced), driveway, and mailboxes (replaced)**

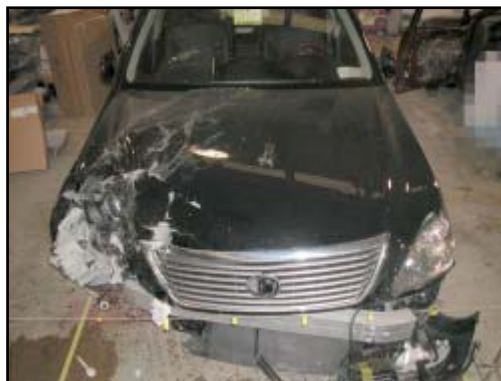
The 2004 Lexus LS430 sustained moderate frontal damage as a result of the impact with the utility pole. The direct contact damage from the utility pole began 38.1 cm (15.0") right of the centerline and extended 43.2 cm (17.0") laterally to the front right corner. The front right headlamp assembly was crushed. The front right aspect of the hood was scuffed, deformed, and crushed longitudinally. Scuff marks from contact with the fractured pole extended longitudinally and laterally to the left to the rear center aspect of the hood (**Figure 4**).

**Figure 4. Overhead view of frontal damage and hood contact**

The bumper fascia was separated and fractured at the right corner. The front aspect of the right fender was crushed rearward. The combined direct and induced damage from the pole impact involved the entire frontal width of the vehicle. The bumper beam was crushed rearward about the left corner, the right aspect exhibiting the most severe longitudinal displacement. The entire hood was buckled rearward, and the right front fender was buckled outward. Six crush measurements were documented along the front bumper beam, which measured 121.9 cm (48.0") in width and were as follows: C1 = 0.0 cm. C2 = 2.9 cm (1.1"), C3 = 6.6 cm (2.6"), C4 = 12.7 cm (5.0"), C5 = 19.1 cm (7.5"), C6 = 24.8 cm (9.8"). The Collision Deformation Classification for the impact with the utility pole was 12-FREW-1.

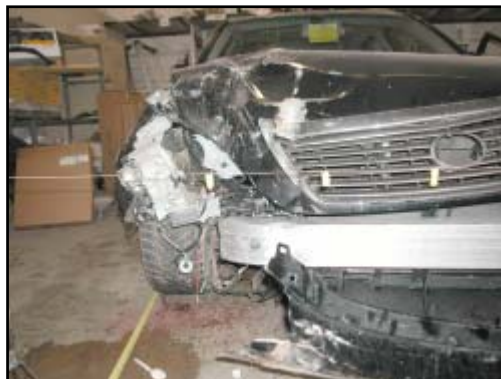
The secondary impact with the mailboxes resulted in minor frontal damage to the bumper fascia and the hood. A narrow area of deformation from contact with a mailbox post was located on the leading edge of the hood 30.5 cm (12.0") right of the centerline and measured 5.1 cm (2.0") in width (**Figure 5**). Minor crush was present on the leading edge of the hood from the engagement with the post. Scuff marks on the bumper fascia were present in line with the hood contact, although there was no fracture or deformation to the bumper fascia from the mailbox post contact. A lateral crease that measured 25.4 cm (10.0") in width was present on the hood from contact with the bottom aspect of the mailbox. The crease was located 3.8 cm (1.5") aft of the leading edge of the hood and 22.9 cm (9.0") right of the centerline. Abrasions to the hood were present aft of the crease from contact with the mailbox as the Lexus continued forward. The CDC for the mailbox impact was 12-FREN-1.

**Figure 5. Close up of front right damage from the mailbox post**

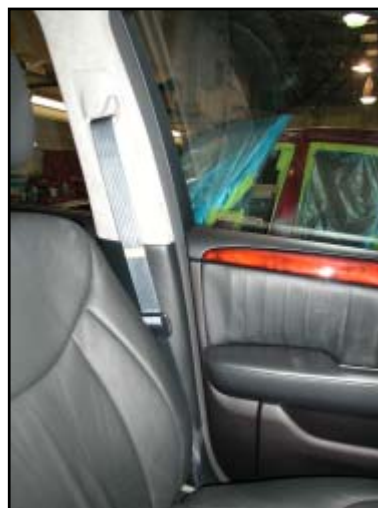
The Lexus LS430 was equipped with 3-point lap and shoulder belts with sliding latch plates for each seating position. The front seat restraints were configured with motorized adjustable D-rings that exhibited 10.2 cm (4.0") of vertical travel. The controls for the motorized D-rings were on the interior door panel, forward of the release handle. The driver's D-ring was located 1.3 cm (0.5") below the full-up position and the front right passenger's D-ring was positioned in the full-up position. The driver's safety belt was configured with an Emergency Locking Retractor (ELR). The driver's safety belt was restricted in the stowed position at the time of the vehicle inspection (**Figure 6**), however, slack was present in the webbing. Since the webbing was not taut, it suggested the safety belt was spooled back into the retractor post-crash, and due to the pretensioner actuation, the retractor would not extend the webbing. The driver's plastic-covered latch plate exhibited heavy abrasions from occupant loading, and moderate abrasions were present on the driver's D-ring. Load-induced rippling was present on the webbing that began 52.1 cm (20.5") above the lower anchor and extended through the D-ring behind the B-pillar trim.

**Figure 6. View of restricted driver's safety belt**

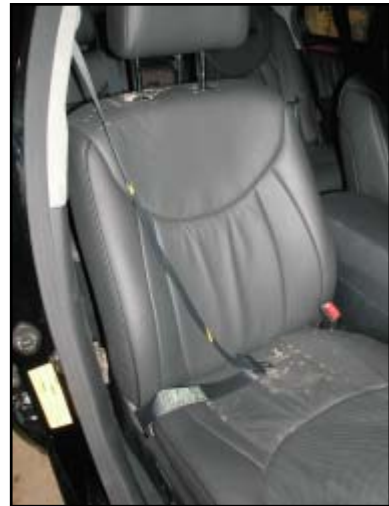
The front right passenger's safety belt was configured with a switchable ELR/Automatic Locking Retractor (ALR) and was restricted in the used position. A portion of the webbing had been spooled back into the retractor post-crash, which did not allow enough webbing to engage the buckle during the inspection (**Figure 8**). The total exposed webbing measured 111.8 cm (44.0") in length. Heavy abrasions were present on the plastic-covered latch plate from occupant loading and faint abrasions were present on the D-ring. Corrugation from occupant loading began 50.8 cm (20.0") above the anchor and extended 33.7 cm (13.3") up the webbing.

**Figure 8. View of front right passenger's safety belt**

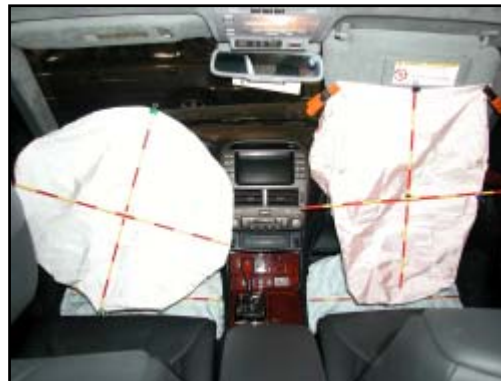
**Figure 10** shows the deployed frontal air bags and deployed knee air bags in the 2004 Lexus LS430. The driver's air bag deployed from the center of the steering wheel hub through H-configuration module cover flaps. The top flap measured 10.2 cm (4.0") in height and the bottom flap measured 7.6 cm (3.0") in height. The lateral tear seam measured 14.6 cm (5.8") in width. The air bag measured 66.0 cm (26.0") in diameter in its deflated state. It was tethered by two internal straps that measured 6.4 cm (2.5") in width and were located at the 3 and 9 o'clock positions. The tether stitching on the center of the air bag face measured 7.6 cm (3.0") in diameter. The air bag was vented by two flap-like rectangular ports that were located 6.4 cm (2.5") inboard of the peripheral seam and 8.9 cm (3.5") laterally from the centerline. The ports measured 1.3 cm (0.5") in width and 4.1 cm (1.6") in length. There was no occupant contact evidence present on the air bag.

**Figure 10. View of deployed frontal air bags and deployed knee air bags**

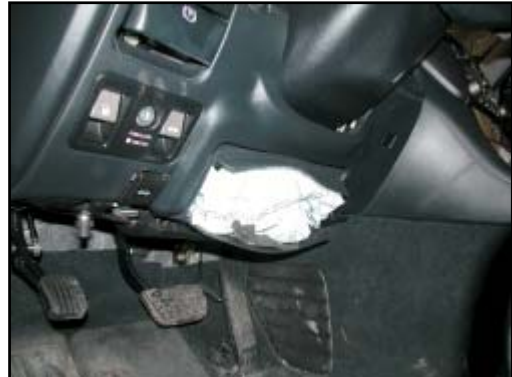
The frontal knee air bags deployed in conjunction with the frontal air bags. Both knee air bags deployed from the left and right lower instrument panels. The knee air bag modules measured 26.0 cm (10.3") in width and 10.2 cm (4.0") in height and were flush with the lower instrument panel faces. Each module exhibited H-configuration cover flaps. Each top flap measured 5.1 cm (2.0) in height and each bottom flap measured 3.8 cm (1.5") in height. The flaps measured 25.4 cm (10.0") in width. The driver's knee air bag module (**Figure 11**) was located 17.1 cm (6.8") inboard of the left aspect of the lower instrument panel and 4.4 cm (1.8") below the steering column. The module tear seam was located 30.5 cm (12.0") above the floor. The front right passenger's knee air bag module was centered under the glove box door. The lateral tear seam was located 30.5 cm (12.0") above the floor.

**Figure 11. Driver's knee air bag module**

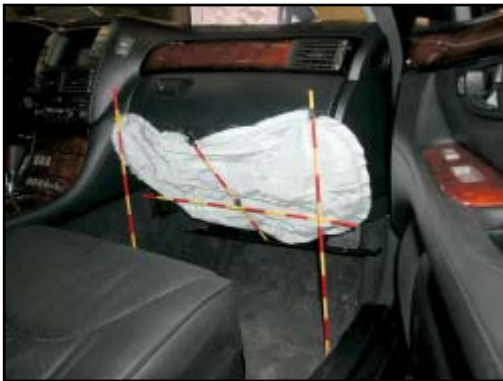
The knee air bags deployed outward and upward (**Figure 12**). Each knee air bag measured 35.6 cm (14.0") in height and 61.0 cm (24.0") in width in their deflated state (**Figure 13**). The knee air bags were tethered by a single internal strap that measured 38.7 cm (15.3") in width that was laterally centered. The tether was located 17.8 cm (7.0") from the leading edge of the knee air bag, and the maximum inflated thickness of the air bag measured 10.2 cm (4.0").

**Figure 12. Deployed front right passenger's knee air bag in deployed position**

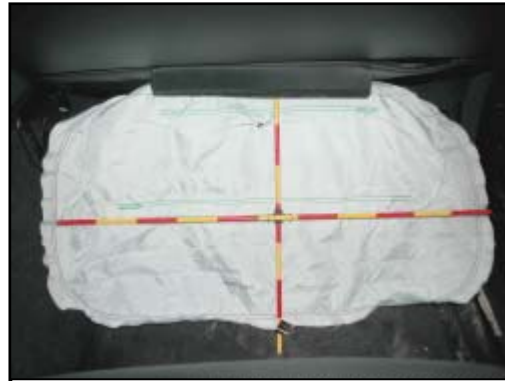
**Figure 13. Rear aspect (against instrument panel) of deployed front right passenger's knee air bag**
