**CALSPAN ON-SITE CERTIFIED ADVANCED 208-COMPLIANT
VEHICLE CRASH INVESTIGATION**

CASE NO: CA04-011

VEHICLE: 2004 HONDA ACCORD

CRASH DATE: MARCH 2004

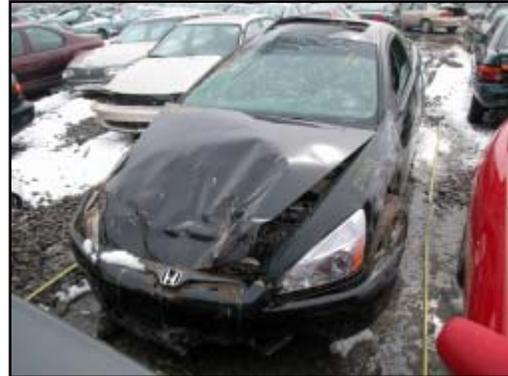
Figure 1. Damaged 2004 Honda Accord

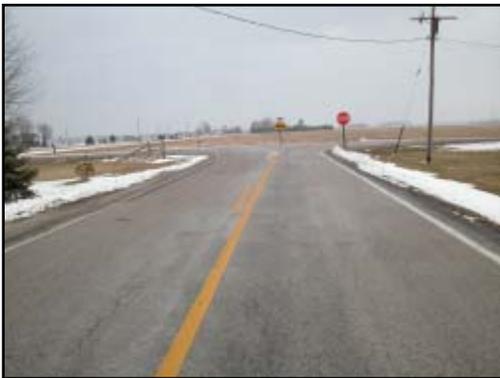
The police report indicated that the driver of the Accord might have been operating the vehicle under the influence of alcohol. She was operating the vehicle in an eastbound direction on approach to the top of the south T-intersection (**Figure 2**). The police reported that the driver's pre-crash speed was approximately 64 km/h (40 mph). The driver disregarded the stop sign on the west leg of the intersection and continued across the north/south roadway. She steered left as the vehicle departed the roadway surface, in an attempt to cross the field and re-enter the roadway. Her left steering input caused the Accord to initiate a counterclockwise (CW) yaw as it departed the roadway, evidenced by tire furrows in the field (**Figure 3**). Four distinct tire furrows began in the field on the east roadside where the Accord departed the roadway. The furrows continued in a northeast direction and curved gradually to the left across the field. The two left side furrows and two right side furrows merged 112.3 m (368.4') east of the original roadside departure to create two furrows, which indicated the Accord had resumed a tracking mode prior to traveling onto the east leg of the north T-intersection. The furrows merged 4.7 m (15.4') outboard of the roadside. Due to the soft ground and the distance traveled, the driver applied power to the vehicle as she attempted to cross the field and reenter the roadway.

Figure 2. Eastbound approach for the Honda Accord

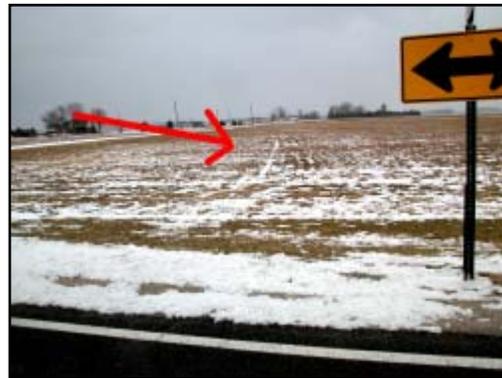
Figure 3. Roadside departure and furrows through the field

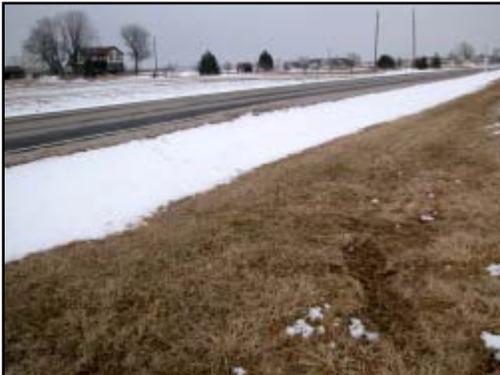
The Honda Accord traveled into the roadside drainage ditch in a tracking mode and ramped up onto the east leg of the roadway (**Figure 4**). The undercarriage struck the ditch bank and the south road edge as the Accord traveled onto the roadway, evidenced by gouges on the asphalt

road edge. The impact was sufficient to fire the driver's pretensioner, evidenced by the restriction of the safety belt in the used position. The driver steered right as the Accord traveled onto the eastbound travel lane, in an attempt to resume her eastbound direction of travel on the roadway. Due to the right steering input, the Accord initiated a CW yaw in the roadway and the resistance of wheels on the roadway surface induced a four quarter-turn trip over with the left side leading (**Figure 5**). The left side aspect of the Accord, traveled across the westbound travel lane, evidenced by heavy longitudinal abrasions on the left side aspect of the Accord and gouges on the north road edge. The trip over onto the left side was sufficient to deploy the driver's side air bag and the left side IC. As the Accord departed the north roadside, it continued in a forward direction and rolled onto its roof, right side, and landed upright in the roadside field 7.2 m (23.6') from the north road edge.

Figure 4. Impact with the roadside ditch and entrance to the roadway

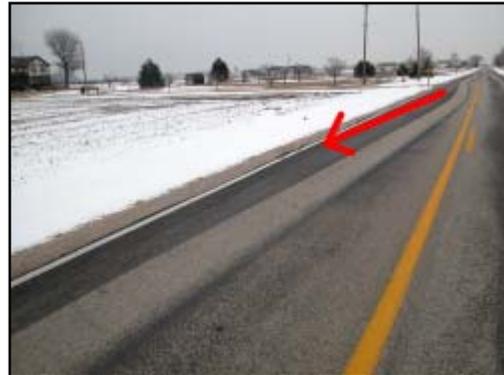
Figure 5. Area of trip-over and related roadway gouge

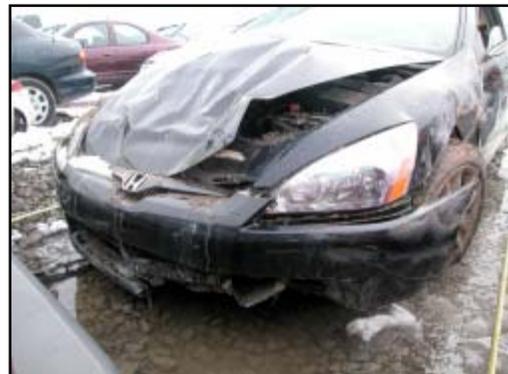
The 2004 Honda Accord sustained minor undercarriage damage as a result of the ditch impact prior to the rollover (**Figure 6**). The bottom aspect of the plastic bumper fascia was fractured from the centerline to the front left corner. Contact to the undercarriage did not extend above the lower radiator support and did not involve the bumper beam. The Collision Deformation Classification for the minor undercarriage impact was 00-UFYW-1.

Figure 6. View showing damage to the front left area of the undercarriage beneath the bumper

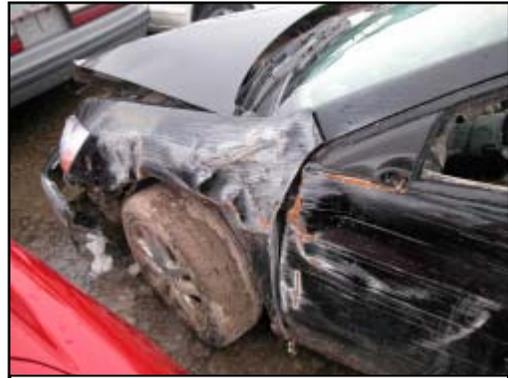
The Accord also sustained moderate damage as a result of the rollover event. The entire left side of the Accord sustained longitudinal abrasions from contact with the asphalt roadway surface (**Figure 7**). The abrasions began on the front left corner of the headlamp and left front bumper corner, extended rearward 418.0 cm (164.6”), and terminated 11.4 cm (4.5”) forward of the left rear bumper corner. The abrasions involved the entire vertical height of the left front fender, began 10.2 cm (4.0”) above the sill and extended 50.8 cm (20.0”) to the beltline on the left front door. The left A-pillar sustained abrasions, which terminated 45.7 cm (18.0”) above the beltline. Minor longitudinal deflection was present on the leading edge of the left front door and leading edge of the left rear quarter panel. The left front fender, left door, and left rear quarter panel exhibited minor lateral deformation. The sheet metal on the left front fender above the left front wheel was deflected upward and inward from direct vertical contact with the left front tire/wheel. The lateral deflection measured 6.4 cm (2.5”) above the wheel. The left front wheel was displaced rearward, and the rearward displacement resulted in the reduction of the left wheelbase by 5.1 cm (2.0”). The left side mirror was separated.

Figure 7. View of left side abrasions and damage to the left front fender

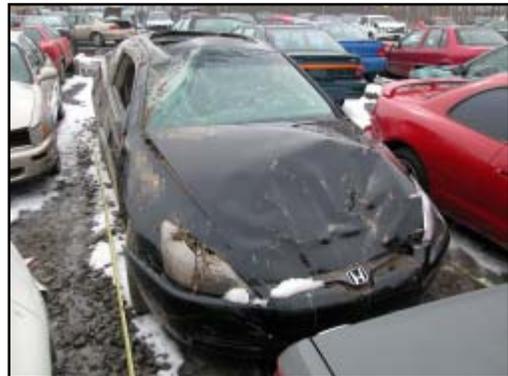
The Accord sustained moderate damage from the rollover (**Figure 8**). The hood was crushed vertically and buckled at the forward aspect from direct contact with the ground. The vertical crush began 16.5 cm (6.5”) left of the centerline and extended to the front right corner. The vertical hood deformation at the front aspect resulted in a 6.4 cm (2.5”) upward deflection of the right rear corner of the hood. The outboard aspects of the front bumper fascia were partially separated. The leading edge of the right front fender was deflected slightly inward. The roof sustained moderate deformation as a result of the rollover. The windshield was fractured, the left door glazing was partially open, the right door glazing was disintegrated, and the right side door was jammed shut. There were no direct contact abrasions on the roof. The right front corner of the roof and the windshield header were crushed vertically and deformed laterally inboard. The vertical displacement of the roof and windshield header resulted in the vertical and lateral deflection of the right A-pillar. The area around the moon roof was slightly buckled, and the windshield header also sustained lateral buckling. The moon roof was partially retracted but was not fractured. Minor lateral deformation and buckling was present on the right front fender, right door, and right rear quarter panel. The right exterior mirror was separated. The right side sill trim was partially separated at the rear aspect. The right side of the Accord exhibited mud and vine fragments from the field. The CDC for the rollover event was 00-TDDO-3.

Figure 8. Overall view of rollover damage

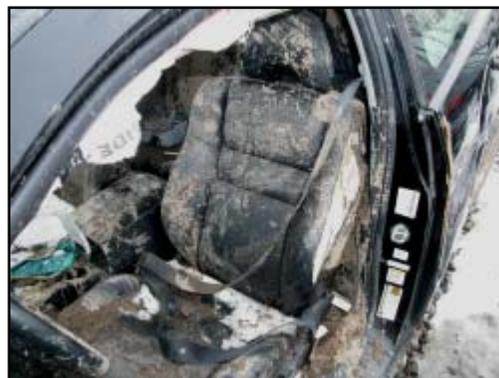
The 2004 Honda Accord was configured with manual 3-point lap and shoulder belts for each seating position. The driver’s safety belt (**Figure 9**) was configured with a sliding latch plate and an Emergency Locking Retractor (ELR). The D-ring was fixed. The safety belt was found restricted in the used position at the time of the vehicle inspection, and partially gathered in the forward aspect of the D-ring. A total length of 189.2 cm (74.5") of the webbing was extended between the D-ring and the anchor. The plastic-coated latch plate exhibited minor abrasions consistent with loading, and the webbing exhibited minor rippling that began 92.7 cm (36.5") above the anchor and extended 45.7 cm (18.0") up the webbing.

Figure 9. View of driver's safety belt

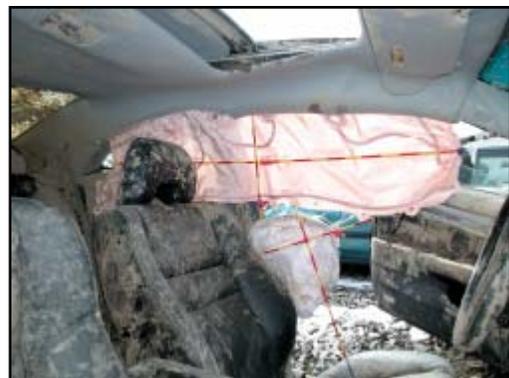
The driver's side impact air bag and left IC deployed as a result of the rollover event (**Figure 10**). The driver's side air bag deployed from the outboard aspect of the driver's seat back. The tear seam began at the air bag identifier tab located 5.1 cm (2.0") below the top aspect of the seat back. The tear seam measured 38.1 cm (15.0") in height. A plastic module cover flap was located behind the seatback fabric on the outboard plane of the seat back that measured 20.3 cm (8.0") in height and 7.6 cm (3.0") in width.

Figure 10. Overall view of the driver's side impact air bag and left side IC

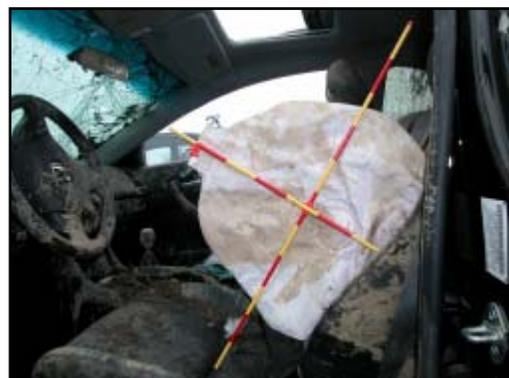
The driver's side air bag (**Figure 11**) was semi-circular in shape and measured 34.3 cm (13.5") in height and 30.5 cm (12.0") in length. A 7.6 cm (3.0") diameter circular stitch was present on the air bag, which acted as a tether between both side panels of the air bag. The center of the circular stitch was located 19.1 cm (7.5") rear of the leading edge of the air bag. A small non-inflatable tab that measured 3.8 cm (1.5") in length and 7.6 cm (3.0") in height was attached to the forward aspect of the air bag. The driver's side air bag was located 19.1 cm (7.5") above the driver's seat cushion and the forward excursion from the driver's seat back tear seam measured 26.0 cm (10.3"). There was no

Figure 11. Close-up of deployed driver's side impact air bag

occupant contact evidence on the side impact air bag.

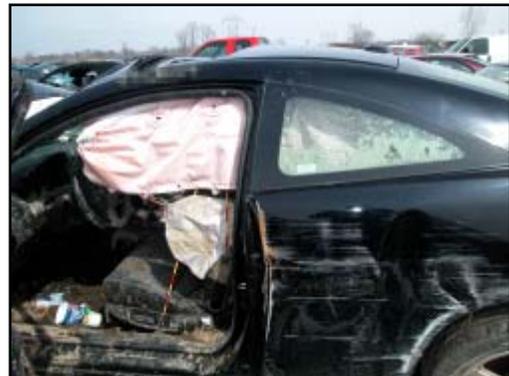
The left side IC deployed downward from the left roof side rail. The separation of the roof side rail trim measured 121.9 cm (48.0”) between the left A-pillar and left C-pillar. The left IC measured 121.9 cm (48.0”) in length and 35.6 cm (14.0”) in height. A 1.3 cm (0.5”) diameter tether was located 12.7 cm (5.0”) below the top of the A-pillar and measured 7.6 cm (3.0”) in length between the left A-pillar and the leading edge of the left IC. A fabric liner that measured 8.9 cm (3.5”) in circumference began at the leading edge of the IC and continued along the headliner. The fabric liner housed the non-deployed IC, and the IC deployed through a tear seam in the bottom aspect of the liner. **Figure 12** illustrates how the IC deployed along the entire height of the left side glazing, and the distance between the bottom of the IC, and the top of the driver’s side impact air bag measured 2.5 cm (1.0”). There was no occupant contact evidence on the left side IC.

Figure 12. Exterior view of coverage area of the left side IC and driver's side impact air bag
