Hybrid Vehicle Investigation / Vehicle to Object  
Dynamic Science, Inc. / Case Number: DS04013  
2004 Honda Civic Hybrid  
California  
April, 2004

1. Report No. DS04013	2. Government Accession No.	3. Recipient Catalog No.	
4. Title and Subtitle  On Site Hybrid Vehicle Investigation		5. Report Date August 12, 2005

**Dynamic Science, Inc.**  
**Crash Investigation**  
**Case Number: DS04013**

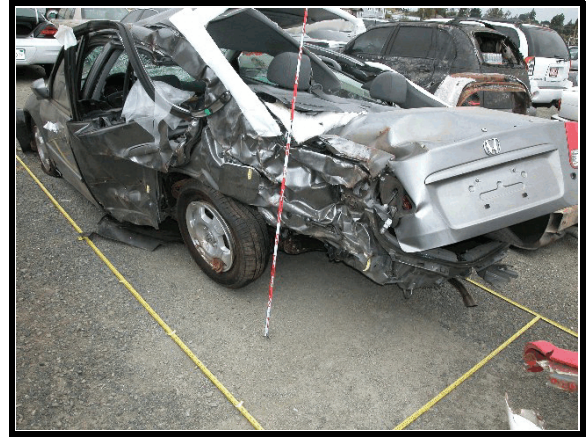
**Figure 1.** Left rear corner of case vehicle, impact 3 (tree)

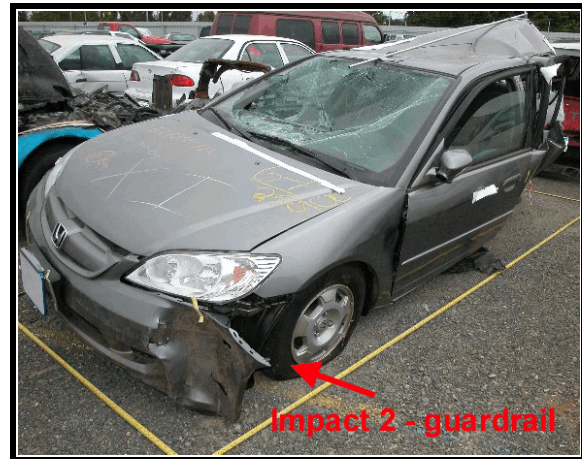
Figure 5. Front left, impact 2, guardrail

There was direct contact damage that began at the front left bumper corner and extended into the front left wheel area as a result of the guardrail impact. There was 154.0 cm (60.6 in) of direct contact from the third impact that began 82.0 cm (32.2 in) rear of the rear axle and extended forward. The maximum crush was located at C1 and measured 66.0 cm (25.9 in). There was diagonal crease type damage to the front right door. The damage was 3.0 cm (1.2 in) wide and measured 92.0 cm (36.2 in) in vertical height.

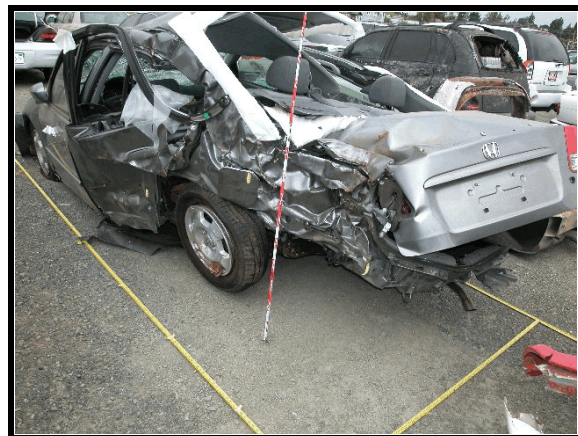
Figure 7. Left rear corner of case vehicle, impact 3 (tree)

Damage Description:	Major lateral crush to left rear corner.	
CDC:	Impact 1: 10LZAN2 (One-way sign impact) Impact 2: 09LFEE2 (Guardrail impact) Impact 3: 08LZAW4 (Tree impact) Impact 4: 00RYEO1 (Rollover)	
Delta V (Impact 3):	Total	27.4 km/h (17.0 mph)
	Longitudinal	4.8 km/h (3.0 mph)
	Latitudinal	27.0 km/h (16.8 mph)
	Energy	66,384 joules (48,962 ft-lbs)

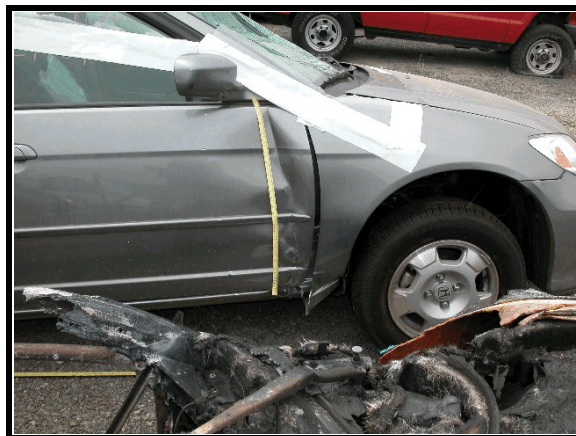
Figure 6. Damage from guardrail from rollover

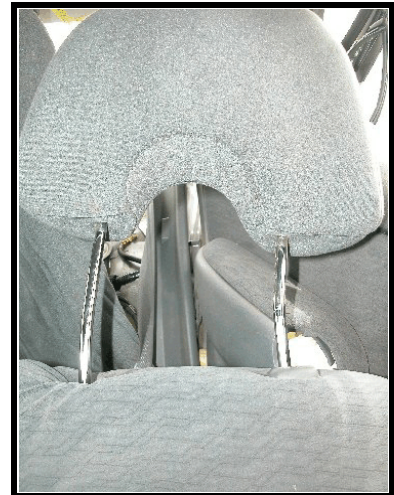
The front seating positions in the 2004 Honda Civic Hybrid were equipped with bucket seats with adjustable head restraints. The driver's seat back had a 54 degree post-crash angle; the front right seat had a 43 degree post-crash angle. The driver's seat back was deformed laterally to the left. The rear seating positions were configured with a bench seat with adjustable head restraints for the outboard positions. The driver's head restraint was deformed rearward.

**Figure 8.** Deformed driver's head restraint

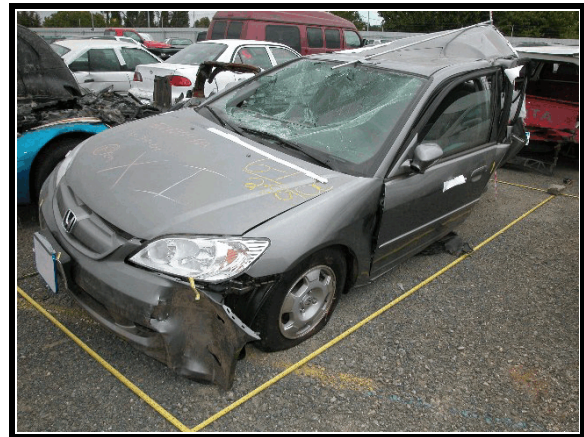
**Figure 9.** Front left, Honda Civic

The wheelbase on the left side was shortened by 18.0 cm (7.1 in) and the track width was compressed by 27.0 cm (10.6 in).

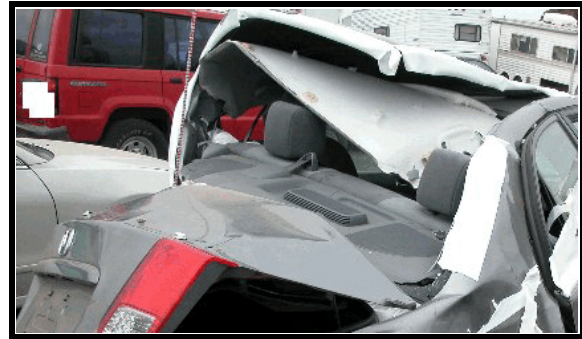
**Figure 10.** Back light area

The interior of the Honda Civic sustained major damage. Both left side doors were jammed shut. There was crash related glazing damage to the backlight, windshield, and left rear door glass. The right side seam of the roof panel separated during the crash. The separation measured 32.0 cm (12.6 in) laterally at the right rear edge and continued longitudinally for 116.0 cm (45.7 in). There was lateral intrusion into the left rear seat position from the left rear door and C pillar with a maximum intrusion of 20.0 cm (7.9 in). The center console was shifted to the driver's side 10.0 cm (3.9 in) due to contact from the front right occupant. The driver's seat back had a 54 degree post-crash angle; the front right seat had a 43 degree post-crash angle. The driver's seat back was deformed laterally to the left. The driver's head restraint was deformed rearward. There was a heavy vertical abrasions to the left side of the front right seat back and to the second row left seat back due to occupant movement.

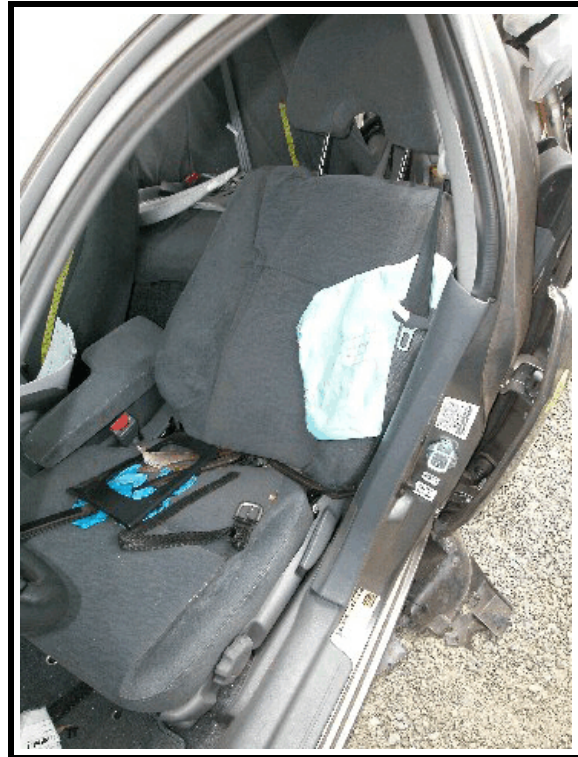
The driver's side seat back mounted side air bag deployed as a result of the impact with the tree (impact 3). The air bag measured 32.0 cm (12.6 in) wide by 27.0 cm (10.6 in) high. There were two circular vent ports on the leading edge of the bag at the 12 and 6 o'clock positions. There was a single, rectangular tether in the center of the bag. There was no damage to the air bag.

**Figure 12.** Driver's seat back mounted side air bag

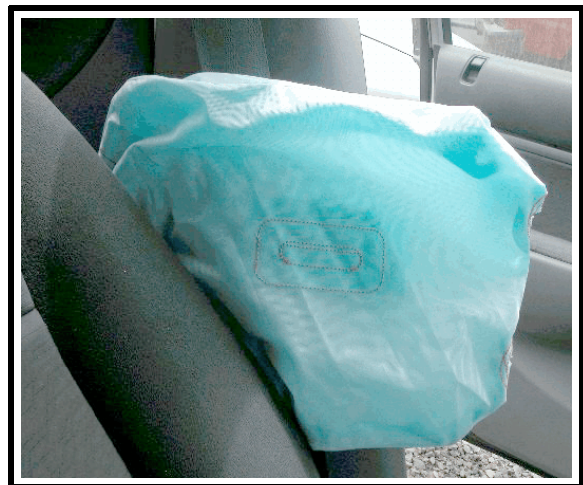
**Figure 13.** Driver's side seat back mounted side air bag—interior side

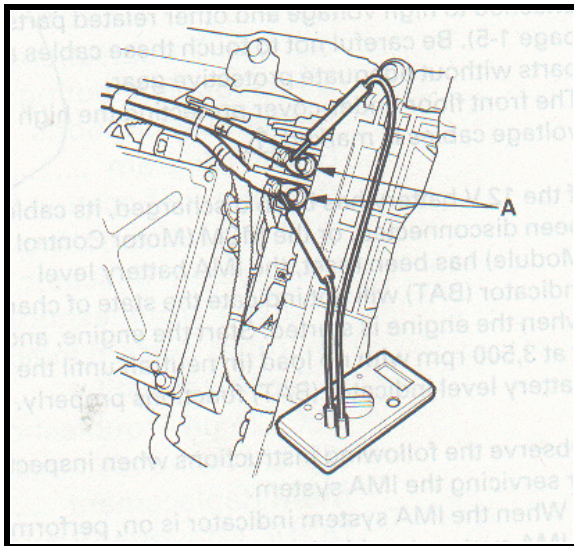
This test was conducted during the vehicle inspection. The voltage measurement was less than 30 V.

**Figure 16.** IPU circuit test at battery end of high voltage line

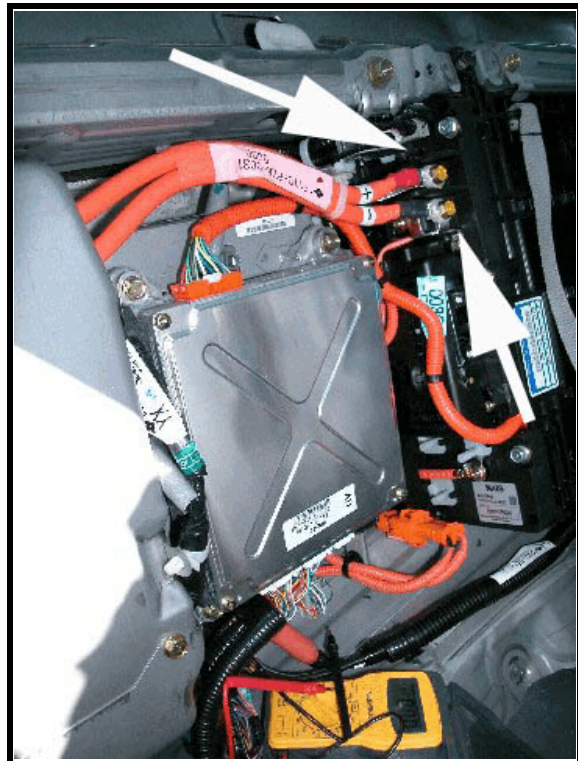
**Figure 17.** IPU circuit test. Junction board terminals as viewed with rear seat and IPU lid removed.

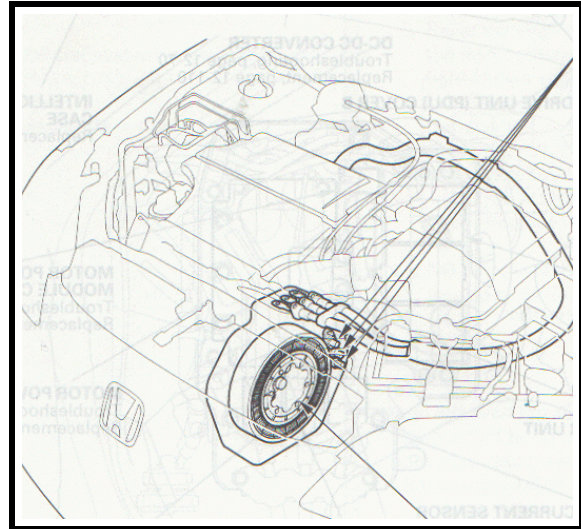
This area of the vehicle could not be accessed and the test was not completed. There were no indications of any damage to the high voltage cables.

**Figure 18.** Engine side of high voltage line

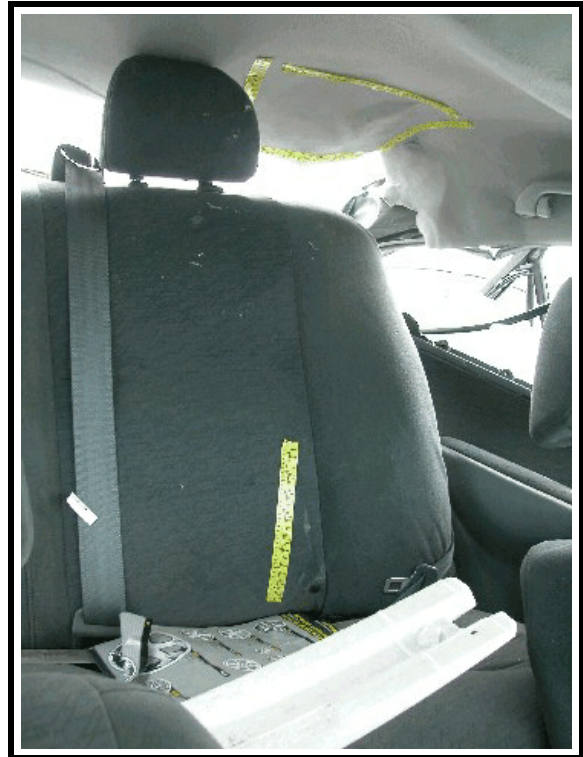
The 21-year-old male second row right seat occupant was likely seated in a normal, upright fashion in the fabric covered bench seat. He was not wearing the available 3-point manual lap and shoulder belt. Prior to impact, the driver began actively steering to the right and braking. The vehicle went into a clockwise yaw. This action caused this occupant to shift to the left, possibly all the way over to the left door area. The impact with the wooden pole through the left side plane had a negligible lateral effect. As the left front corner of the vehicle impacted the guardrail end, the vehicle's yaw increased. This impact was also relatively light. The vehicle rotation increased to approximately 120 degrees from its original direction of travel. At this point the case vehicle struck a tree on the median with its left side. Just prior to ejection, it appears that this occupant was in the left rear seating position. The vehicle rotated sharply in a counterclockwise direction around the tree and pitched onto its right side. This occupant was ejected through the left side back light area. He sustained multiple abrasions and contusions, as well as a left inferior pubic ramus fracture. He came to rest in the travel lane 3 m (10 ft) north of the case vehicle. He was initially treated by law enforcement personnel. He was transported by ground ambulance to a local hospital for treatment.

**Figure 20.** Ejection path for Occupant 3

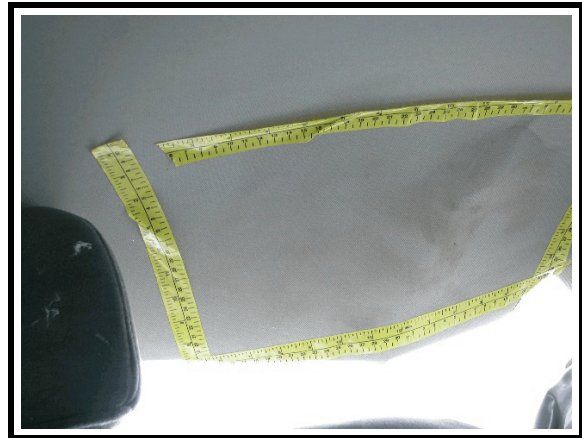
**Figure 21.** Area of clothing transfer/ejection area
