**GENERAL DYNAMICS ON-SITE CERTIFIED ADVANCED-208 COMPLIANT  
VEHICLE CRASH INVESTIGATION**

**SCI CASE NO. – CA04-013**

**SUBJECT VEHICLE – 2003 CHEVROLET AVALANCHE**

**CRASH DATE – FEBRUARY 2004**

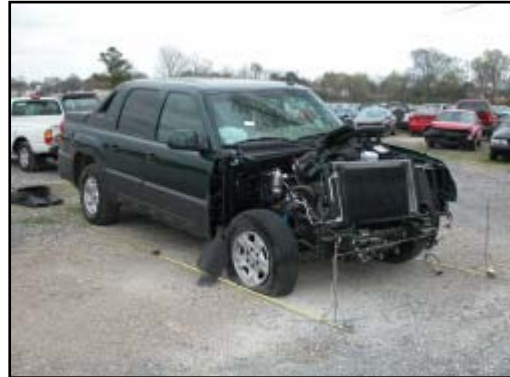
**Figure 1. Subject vehicle - 2003 Chevrolet Avalanche.**

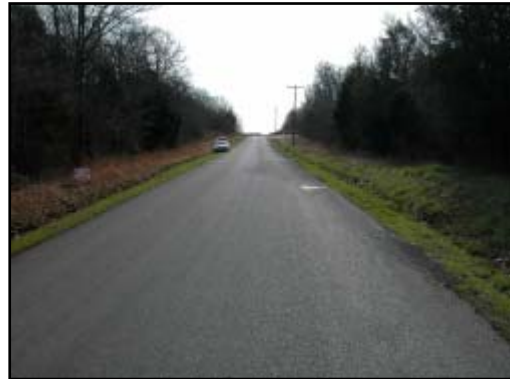
This run-off-road crash occurred during the daylight hours of March 2004. At the time of the crash, the weather was clear with no adverse conditions. The crash occurred off-road of an east/west two-lane, two-way, rural roadway (**Figure 2**). A left curve for eastbound travel terminated 37.5 m (123.0') west of the point of departure from the travel lane. The Avalanche ascended a positive grade that averaged 1.5 percent. The south roadside consisted of a 0.4-meter (1.3 feet) wide stone/gravel shoulder, a 1.1-meter (3.6 feet) wide by 30.5 cm (12.0") deep ditch, grass, and a tree line. The posted speed limit for the north/south roadway was 72 km/h (45 mph). The scene schematic is included as (**Figure 15**) of this report.

**Figure 2. Eastbound view of the crash site.**

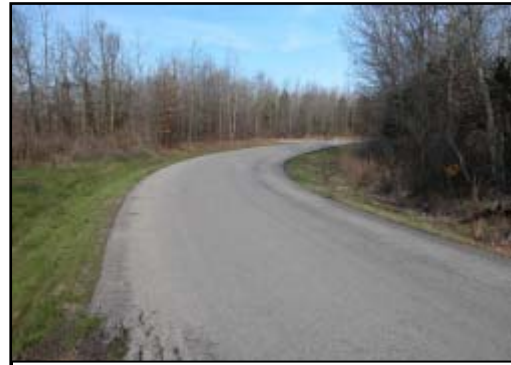
**Figure 3. Look back view of the curve.**

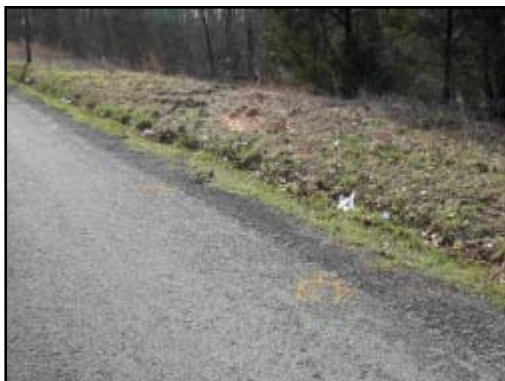
**Figure 4. Point of road departure.**

The front undercarriage aspect of the Chevrolet impacted a shallow earth embankment (**Figure 4**) as it traversed the drainage ditch. This event resulted in the EDR recorded Non-Deployment event that indicated the vehicle speed had reduced to 61.2 km/h (38.0 mph) one-second prior to AE with the embankment. The maximum EDR recorded delta-V for this impact was -4.0 km/h (-2.5 mph) at 140 milliseconds from Algorithm Enable (AE). The low delta-V recorded by the EDR was consistent with the minor undercarriage impact from the embankment. The embankment was gouged by this impact.

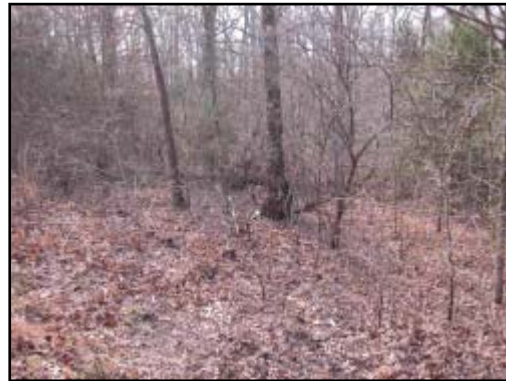
**Figure 5. Vehicle's trajectory and struck trees.**

The Chevrolet continued on a tracking trajectory off-road for approximately 20.5 meters (67.3 feet) where the front of the vehicle impacted four small diameter trees (**Figure 5**). The trees ranged from 2.5-6.4 cm (1.0-2.5”) in diameter and were knocked down and overrode by the vehicle. These impacts were minor and probably resulted in no damage to the bumper of the Avalanche. Additionally, these small diameter tree impacts did not alter the vehicle’s trajectory.

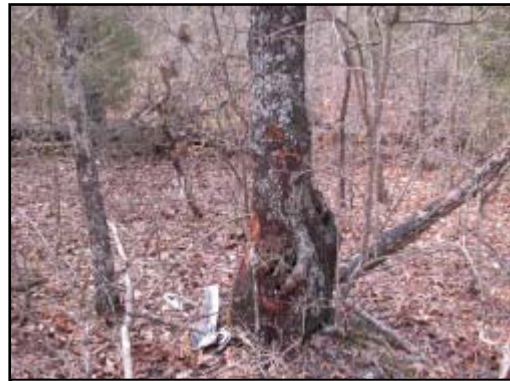
The Chevrolet continued forward and impacted a large diameter tree with its front right area. The tree diameter measured 50.8 cm (20.0”) at the base and reduced to 25.4 cm (10.0”) in diameter at a point 60.1 cm (24.0”) above ground level (**Figure 6**). The direction of force was 12 o’clock and the impact resulted in the Stage One deployment of the driver and front right air bags. The EDR recorded a Deployment file that identified the travel speed at 80.5 km/h (50.0 mph) five-seconds prior to AE and 35.4 km/h (22.0 mph) at one-second prior to AE for this crash event. The brake switch status was in the off-position five-seconds prior and in the on-position from four to two seconds prior to AE.

**Figure 6. Event 6 impact to large tree.**

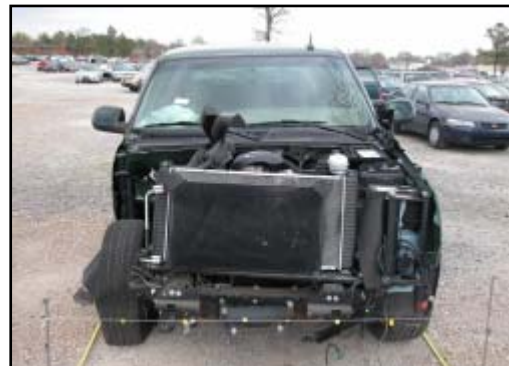
The Chevrolet sustained moderate front right damage from the impact with the large diameter tree (**Figure 7**). Although the frontal components were removed from the vehicle, the right front fender, upper radiator support, and the fan shroud were placed in the bed of the truck and removed for inspection. The leading edge of the right front fender was crushed from the tree impact. Comparison measurements from the left front fender yielded a crush depth of 29.8 cm (11.75") at the top surface of the right front fender and 41.9 cm (16.5") at the mid aspect of the fender, at top bumper level. The aluminum upper radiator support was not crushed. The components that were removed from the vehicle were the bumper, hood, grille, both headlamp assemblies, and the upper radiator support. The large diameter tree impact displaced the entire frontal structure of the Avalanche. Two crush profiles were documented for this impact; one at the level of the front frame rails and crossmember, and the second at the level of the lower radiator support. The width of the frame rails was 119.4 cm (47.0"), which served as the Field L. The crush profile at the frame and crossmember level was as follows: C1 = 0, C2 = 2.5 cm (1.0"), C3 = 3.8 cm (1.5"), C4 = 5.1 cm (2.0"), C5 = 7.6 cm (3.0"), C6 = 7.1 cm (2.8"). The six crush measurements were documented at the level of the lower radiator support using a width of 143.0 cm (56.3") and were as follows: C1 = 21.8 cm (8.6"), C2 = 21.5 cm (8.5"), C3 = 0, C4 = 6.3 cm (2.5"), C5 = 10.6 cm (4.2"), C6 = 45.0 (17.7").

**Figure 7. Overall view of the dismantled frontal damage.**

The CDC for this impact was estimated at 12-FREW-2 based on the diameter of the tree and maximum crush at the leading edge of the right front fender.

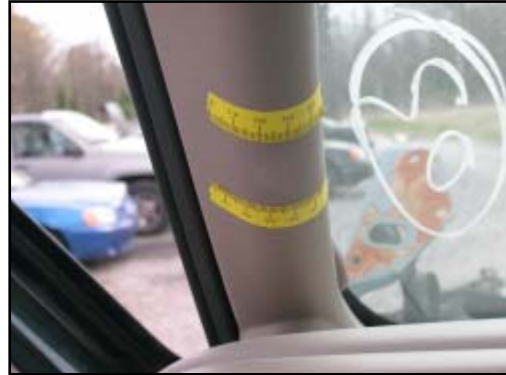
**Figure 8. Driver's left arm contact to the left upper A-pillar.**

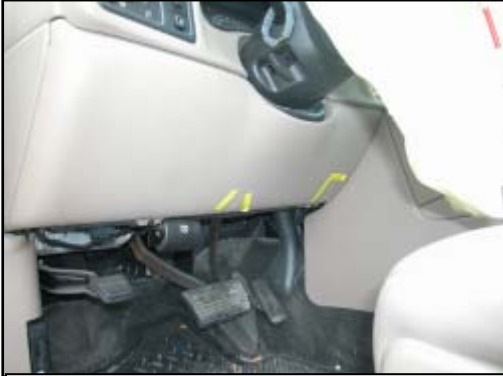
**Figure 9. Driver's knee contacts to the knee bolster.**

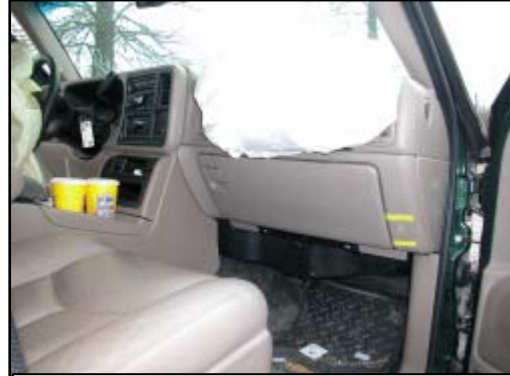
The front right occupant initiated a forward trajectory in response to the frontal impact force. Her right knee contacted the lower right instrument panel, outboard of the glove box door. A circular tissue transfer was noted to the plastic panel located 75.6-78.7 cm (29.75-31.0") right of the vehicle's centerline and 28.5-31.4 cm (11.25-12.375") below the upper instrument panel. **Figures 9 and 10** are views of the occupant's knee contacts to the knee bolster and the lower right instrument panel.

**Figure 10. Passenger's right knee contact to the lower right instrument**

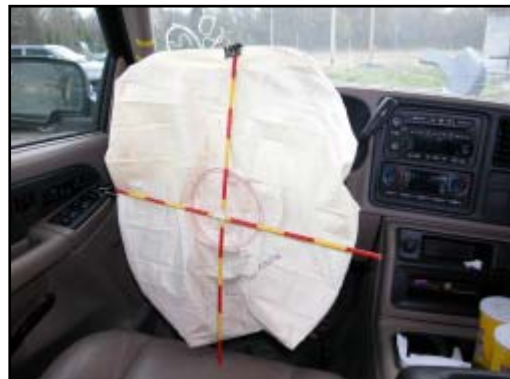
The driver's air bag was located in the center of the steering wheel hub (**Figure 11**). Two symmetrical I-configuration cover flaps concealed the air bag. Both cover flaps measured 11.7 cm (4.625") in height at the center tear seam. The left flap measured 7.0 cm (2.75") in width at the top and 5.3 cm (2.1") in width at the bottom. The right cover flap measured 7.3 cm (2.9") in width at the top and 5.1 cm (2.0") in width at the bottom. The air bag membrane was 69.9 cm (27.5") in diameter in its deflated state and was vented by two 2.5 cm (1.0") diameter vent ports that were located on the rear aspect of the air bag at the 11

**Figure 11. Deployed driver's frontal air bag.**

and 1 o'clock positions. The driver's air bag was tethered by two 13.9 cm (5.5") wide band tethers at the 12 and 6 o'clock positions. The maximum excursion of the air bag from the face of the module cover was measured at 25.4 cm (10.0") at the tether locations. There were no occupant contact points present on the air bag membrane; however, dirt transfers were present on the bag face at the 4 and 8 o'clock positions from post-crash handling of the air bag. The driver bag was identified by the following nomenclature printed to the face of the air bag:

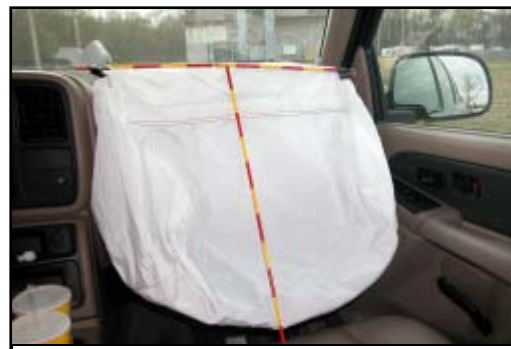
The front right passenger air bag was a mid-mount design in the right instrument panel (**Figure 12**). The air bag was concealed by a single cover flap that measured 14.3 cm (5.6") in height and 38.9 cm (15.3") in width. The flap opened in an upward direction with a top mounted horizontal hinge point. A bar-coded label affixed to the left inside surface of the flap read as follows: AL781AZ8223Y0126

**Figure 12. Deployed front right air bag.**

The front right air bag membrane measured 46.9 cm (18.5") in height and 53.3 cm (21.0") in width and was tethered by a single wide band tether that was approximately 29.2 cm (11.5") wide, located 16.5 cm (6.5") below the top apex of the air bag. Two vent ports that measured 2.8 cm (1.1") were located at the 3 and 9 o'clock positions of the side panels vented the air bag. No occupant contact or damage was noted to the front right air bag.

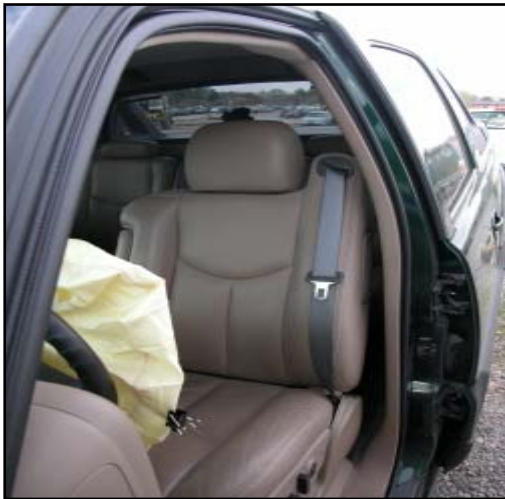
The 2003 Chevrolet Avalanche was equipped with integrated manual 3-point lap and shoulder safety belts for front outboard seating positions (**Figures 13 and 14**). The rear outboard positions were equipped with manual 3-point lap and shoulder safety belts. The rear center safety belt was configured with a 2-point manual lap belt. The driver's safety belt was configured with a sliding latch plate, and an Emergency Locking Retractor (ELR). The front right safety belt was configured with a sliding latch plate and a switchable ELR/Automatic Locking Retractor (ALR). Historical usage evidence was noted to the front latch plates, which consisted of minor scratches. There was no loading evidence to verify restraint usage in this multiple event crash. The rear safety belts were configured with sliding latch plates and switchable ELR/Automatic Locking Retractor's (ALR). Historical usage evidence was noted to the rear outboard latch plates, which consisted of minor scratches; however, the rear center latch plated showed no evidence of historical usage.

**Figure 13. Driver's safety belt.**

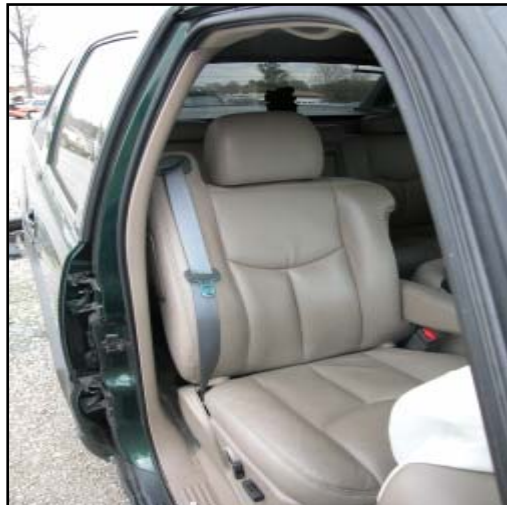
**Figure 14. Front right safety belt.**
