ON-SITE SIDE IMPACT INFLATABLE OCCUPANT PROTECTION INVESTIGATION

CASE NUMBER - IN-04-013

VEHICLE - 2002 VOLKSWAGEN PASSAT GLX

CRASH DATE - April 2004

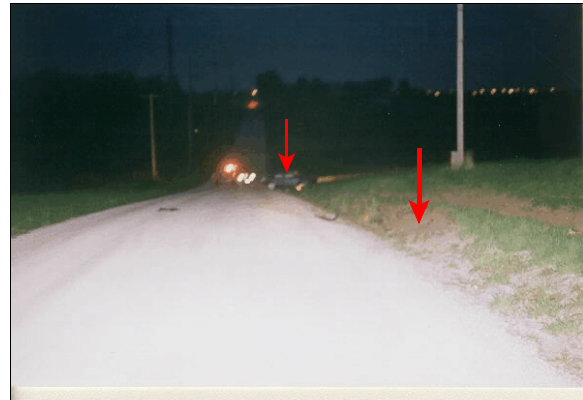
Pre-Crash: The case vehicle was traveling north; however, it is not known if the case vehicle was traveling in the northbound lane. The driver lost control of the case vehicle for an unknown reason, and it was in a clockwise yaw prior to departing the roadway. The location of the control loss is not known; however, the police documented about 18 meters (59 feet) of the case vehicle's yaw path prior to the roadway departure. The police documentation of the tire marks indicated the case vehicle was yawed clockwise about 47 degrees at the beginning of the documented tire marks. The case vehicle continued to rotate and was yawed about 57 degrees clockwise as it departed the east side of the roadway and traveled an additional 5 meters (16.4 feet) to the first impact (**Figure 1**).

Figure 1: Police on-scene photo showing case vehicle's approach to roadway departure and final rest position; arrows show final rest and area of ditch impact and location where case vehicle became airborne (bare strip in grass to right of arrow in foreground is not crash related)

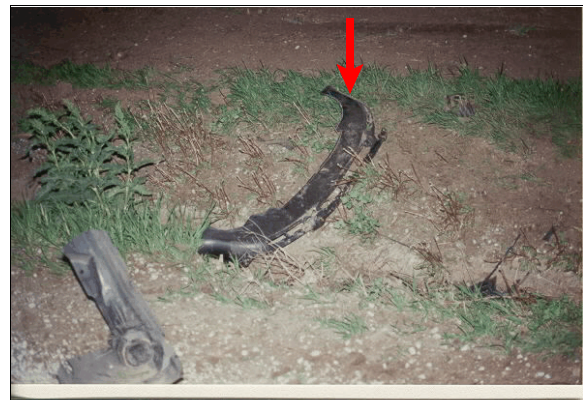
Figure 2: Police on-scene photo showing close view of ditch impact area; Note: components are case vehicle's lower front bumper fascia (arrow) and an unidentified undercarriage component

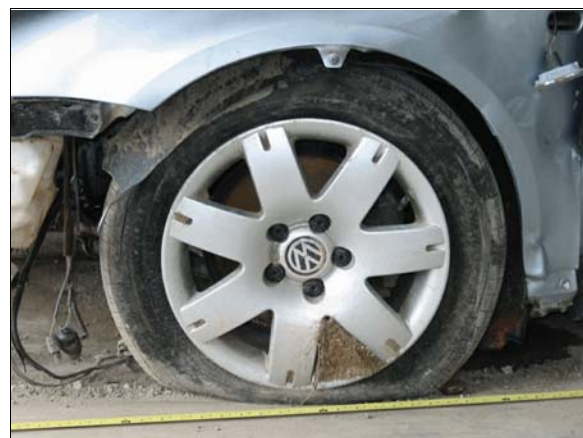
Figure 3: Damage and rearward displacement of case vehicle's left front wheel

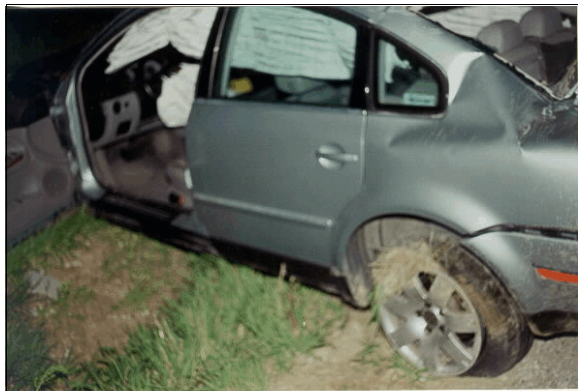
Figure 4: Police on-scene photo of the case vehicle at final rest showing dirt and grass jammed in rim and bead of left rear wheel

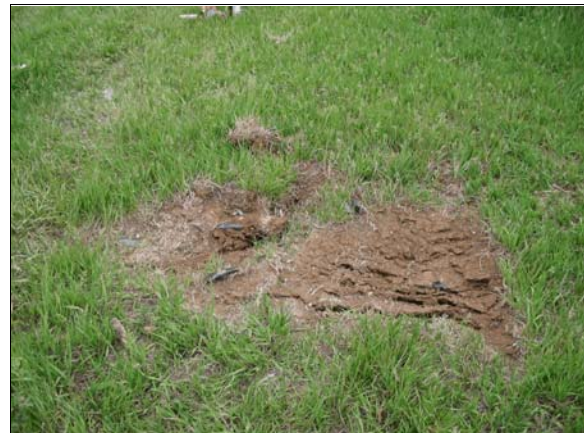
Figure 5: Back of case vehicle impacted ground here

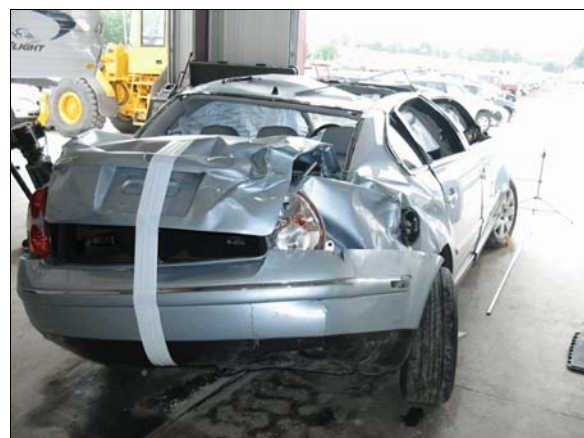
The impact to the back of case vehicle crushed primarily the right portion of the back bumper and trunk, shoved the right rear wheel forward, and vertically displaced the right portion of the trunk (**Figure 7** below). The damage indicates the force of the impact was non-horizontal coming from under the vehicle. This indicates the front of the case vehicle was off the ground and angled up to some degree when the impact occurred. Given the location and appearance of the direct damage to the back right

Figure 6: Damage to the back of the case vehicle

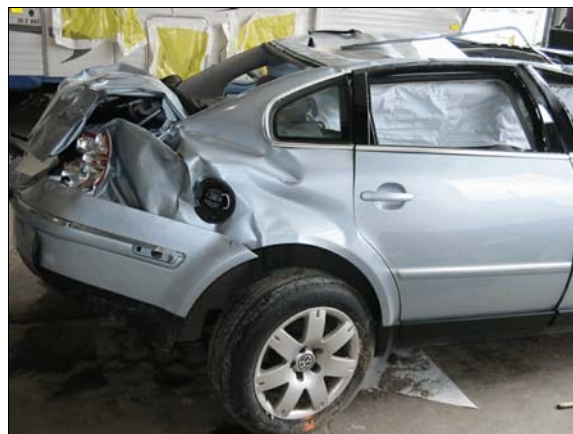
Figure 7: Damage to the back of case vehicle and right rear wheel

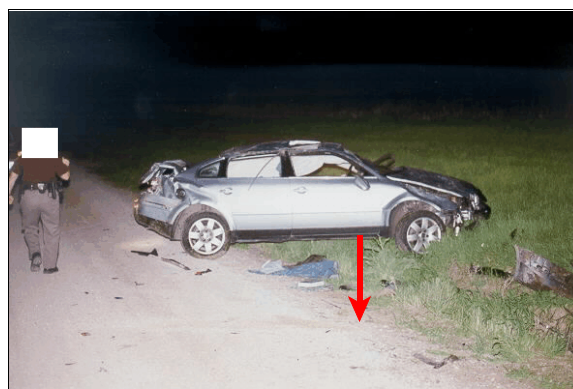
Figure 8: Police on-scene photo showing final rest position of case vehicle and damage to right fender and hood, arrow shows mark in gravel where right roof side rail impacted

Post-Crash: The case vehicle came to final rest on its wheels facing southeast with the back of the case vehicle on the roadway (**Figure 8** above). The case vehicle’s total airborne and rollover distance was approximately 51 meters (167 feet).

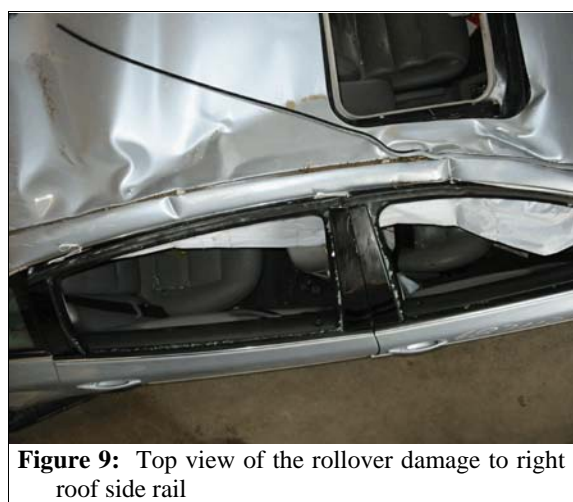
Figure 9: Top view of the rollover damage to right roof side rail

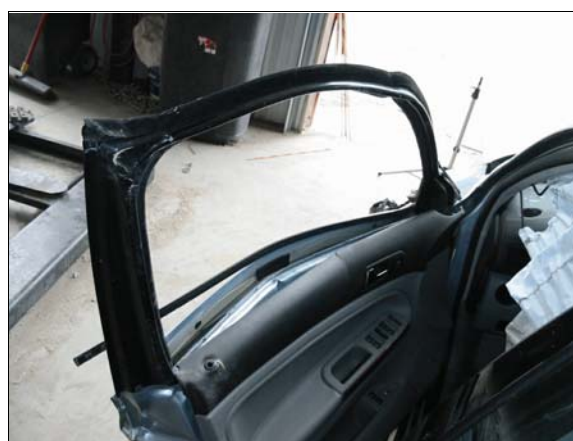
Figure 10: Case vehicle’s driver door is bowed outward from occupant loading

The driver's door was found open upon this contractor's vehicle inspection, and was observed to be open in the police scene photographs. This and the outward bowing of the door raised the possibility that the door had come open during the crash. Inspection of the door gave conflicting indicators of it opening during the crash. Subsequent information provided by one of the police scene investigators indicated that the door had been forced open by the first two police officers on the scene in an attempt to find some identification of the victim and for an inventory of the items in the vehicle. This would explain the downward bending of the window frame and kink in the sheet metal below the exterior door handle, and the lack of dirt and other ground contact evidence on the door.

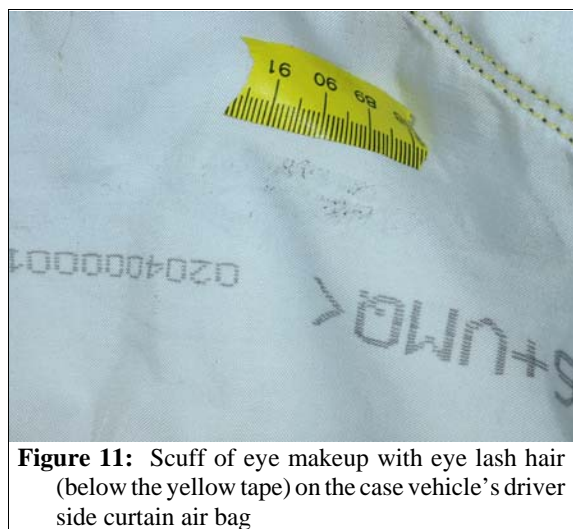
Figure 11: Scuff of eye makeup with eye lash hair (below the yellow tape) on the case vehicle’s driver side curtain air bag

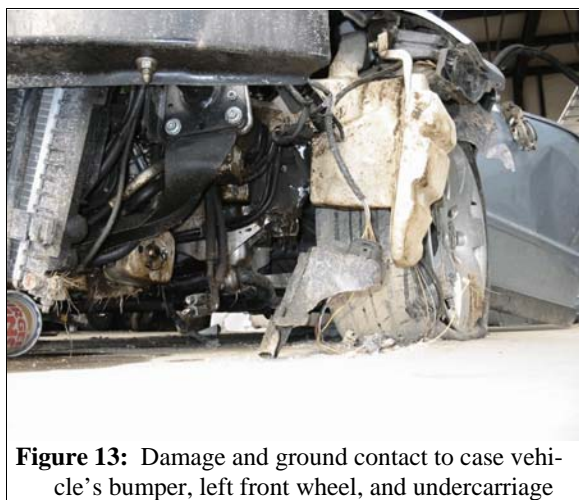
Figure 13: Damage and ground contact to case vehicle's bumper, left front wheel, and undercarriage

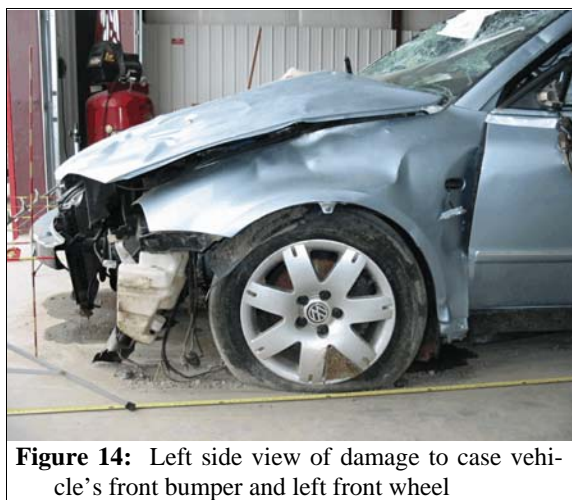
Figure 14: Left side view of damage to case vehicle's front bumper and left front wheel

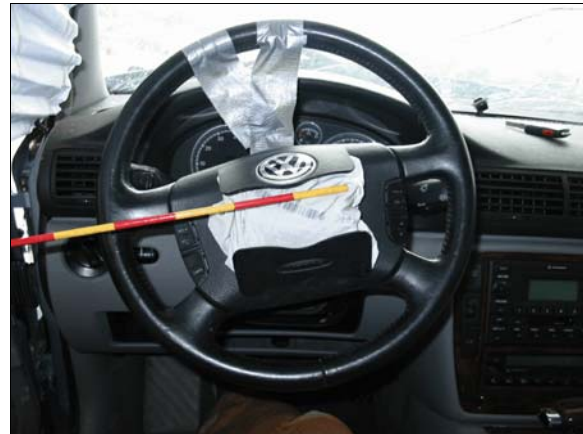
Figure 15: Driver's air bag module cover flaps

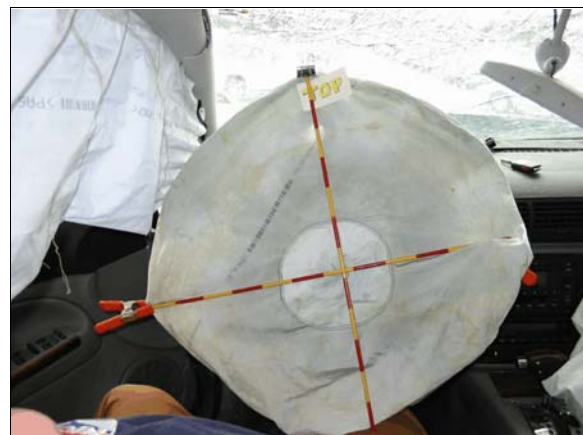
The case vehicle's driver air bag was located in the steering wheel hub. It deployed as a result of the ditch impact as the case vehicle departed the roadway. An inspection of the air bag module cover flaps and the air bag fabric revealed that the cover flaps opened at the designated tear points (**Figure 15**) and there was no evidence of damage to the air bag or the cover flaps. The two air bag module cover flaps were approximately rectangular in shape and were constructed of pliable vinyl. There was a small rounded contour on the center of each flap at the center tear seam, which accommodated the "VW" emblem. The top cover flap was 12.5 centimeters (4.9 inches) in width and 7 centimeters (2.8 inches) in height. The bottom cover flap was 12 centimeters (4.7 inches) in width and 6 centimeters (2.4 inches) in height. The deployed driver's air bag (**Figure 16**) was round with a diameter of approximately 60 centimeters (23.6 inches). The air bag was designed with four tethers, each approximately 8 centimeters (3.1 inches) in width and had one vent port, approximately 3 centimeters (1.2 inches) in diameter, located at the 12 o'clock position (**Figure 17**). The distance between the mid-center of the driver's seat back, as positioned at the time of the vehicle inspection, and the front surface of the driver air bag at maximum excursion was 35 centimeters (13.8 inches). Inspection of the air bag revealed no evidence of occupant contact; however, the entire surface of the air bag was covered intermittently with a rust colored stain.

Figure 16: Overview of the driver's air bag

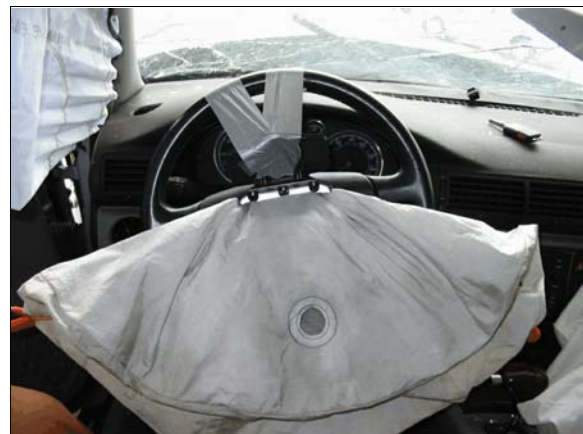
Figure 17: Driver's air bag vent port

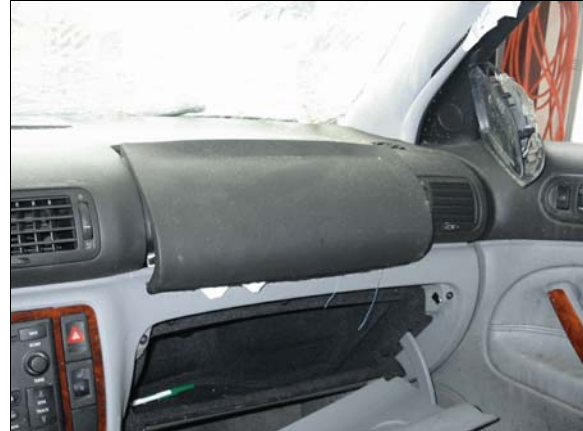
The front right passenger's air bag was located in the middle of the instrument panel (**Figure 18**). It deployed as a result of the ditch impact as the case vehicle departed the roadway. An inspection of the air bag module cover flap and the air bag fabric revealed that the cover flap opened at the designated tear points, and no deployment damage to the air bag or the cover flap was observed. The deployed front right air bag (**Figure 19**) was approximately 65 centimeters (25.6 inches) in width and 75 centimeters (29.5 inches) in height. The air bag was designed without tethers and had one vent port, approximately 5.5 centimeters (2.2 inches) in diameter, located at the 11 o'clock position. The air bag module cover flap was constructed of metal, covered by padded vinyl and was 33 centimeters (13 inches) in width and 15 centimeters (5.9 inches) in height. The distance between the mid-center of the front right passenger's seat back, as positioned at the time of the vehicle inspection, and the front surface of the front right passenger air bag at maximum excursion was 24 centimeters (9.5 inches).

Figure 18: Location of front right passenger's air bag in middle of right instrument panel

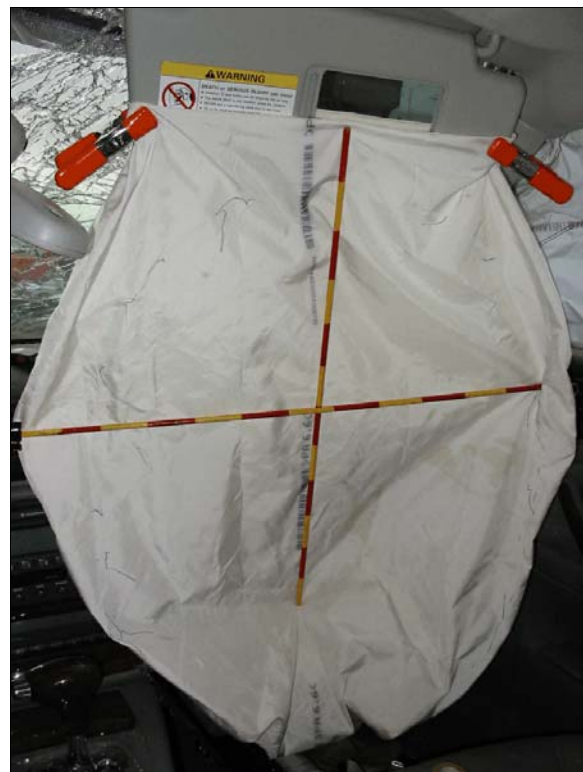
Figure 19: The front right air bag

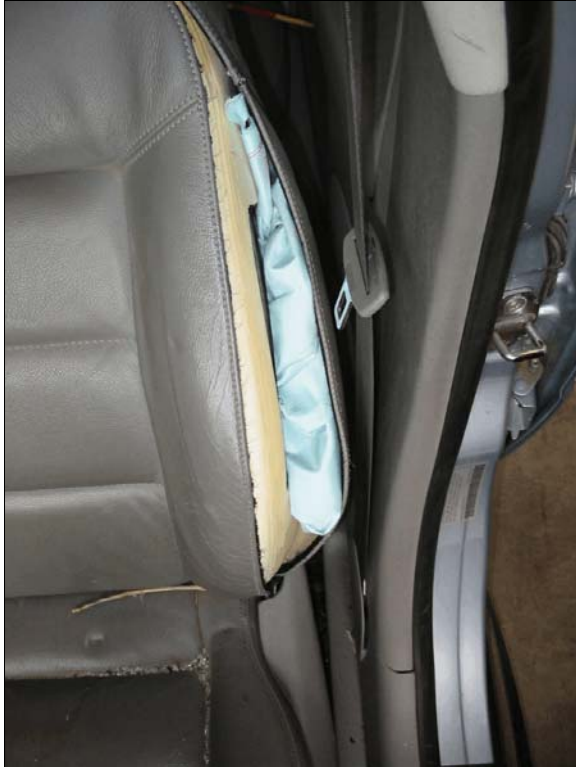
The case vehicle's front seat back-mounted, side impact air bags were located in the outboard side of the driver's seat back (**Figure 20** below) and the front right seat back. The left and right side curtain air bags were located along the left roof side rail (**Figure 21** and **22** below) and the right roof side rail. Both the driver and front right, seat back-mounted side impact air bags and the left and right side curtain air bags deployed in this crash. It is likely that the ground impact to the right roof side rail during the third or fourth roll caused the front right seat back-mounted side impact air bag and right side curtain air bag to deploy. The driver's seat back-mounted side impact air bag and the left side curtain air bag deployed during the initial impacts as the case vehicle departed the roadway and impacted the ditch. The bases for this conclusion are twofold: (1) the location of the occupant contact on the upper front portion of the left side curtain air bag is consistent with the driver's kinematics in response to the 310 degree direction of principal force acting on the vehicle during the impact with the ditch, and (2) the reconstruction of the rollover event indicated the driver was ejected from the vehicle before any other impacts occurred to the left side of the case vehicle.

Figure 20: Driver's seat back-mounted side impact air bag

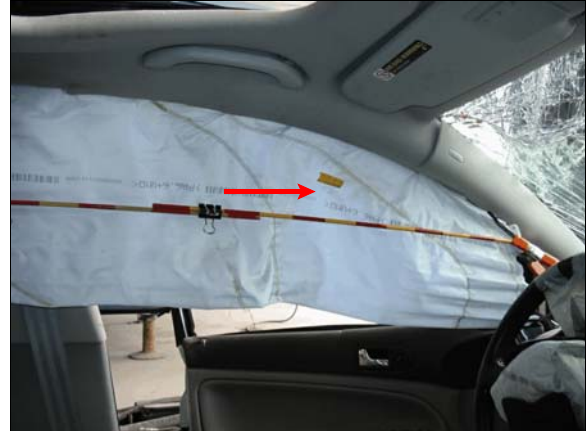
Figure 21: Front portion of left side curtain air bag, arrow shows driver contact

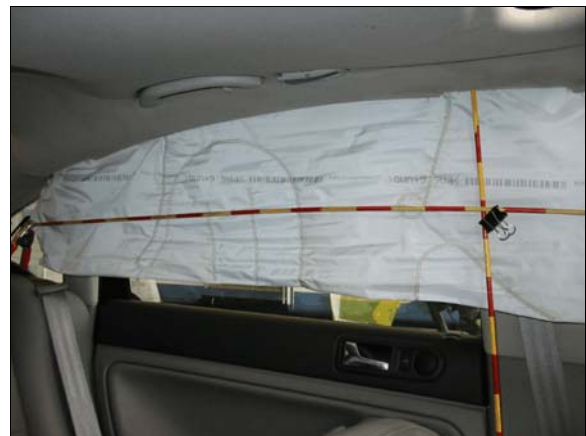
Figure 22: Back portion of left side curtain air bag

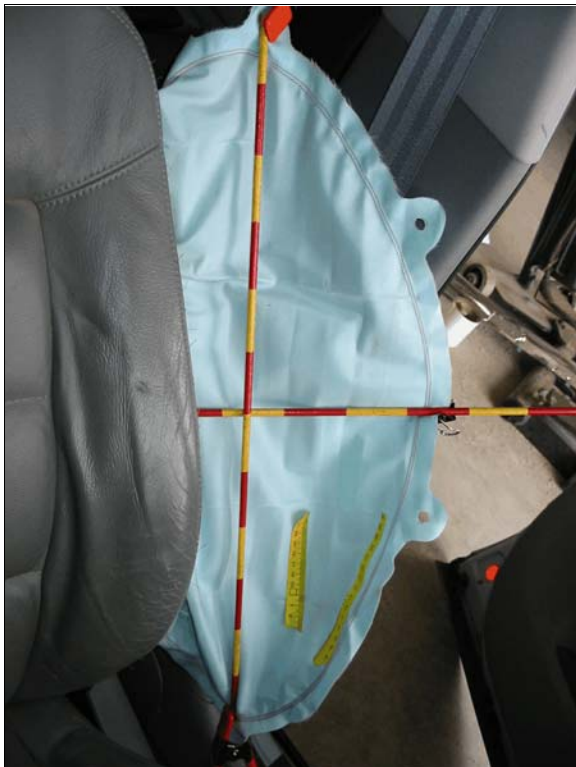
Figure 23: Inboard surface of case vehicle's driver seat back-mounted side impact air bag, yellow tape shows possible occupant contact
